SUBJECT: Compliance Evaluation Inspection: 33-SDP-02-83C

IOWA DEPARTMENT OF NATURAL RESOURCES
Field Office #1
1101 Commercial Court., Ste10, Manchester, IA 52057
(563) 927-2640 (ph.) (563)927-2075 (fax)
Closed Sanitary Disposal Project Inspection (Landfill)

Permit # 33-SDP-02-83C

Site: Fayette County Landfill (Closed)

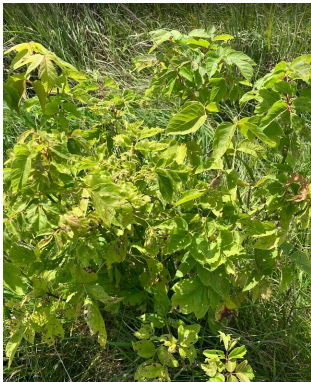
A few areas of small trees were present (photos 1-3) and are identified in purple on the map below. Photos 1 and 2 appeared to be saplings that had sprouted from previously being cut. These may need to be chemically treated. Photo 3 is new growth. Areas of small willows were observed through, but appear to be managed with mowing. Mowing should continue to address these areas.

Photo 1-
Woody Vegetation

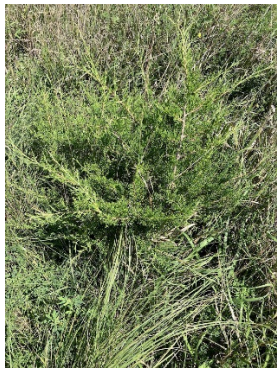
Photo 2-
Cedar Tree

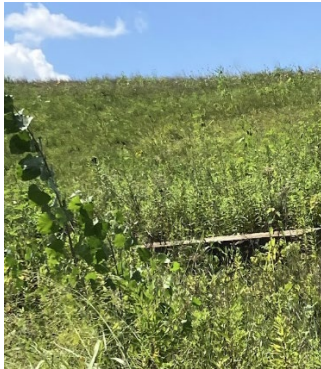
Photo 3-
Cottonwoods

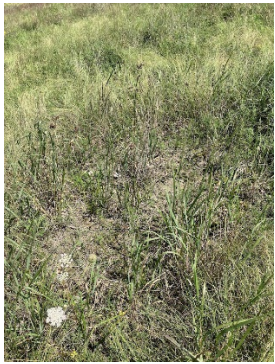
Photo 4-

No leachate seeps were observed during this visit. Some areas of stressed, minimal vegetation were observed as shown in photo 4. The approximate location is identified in yellow on the map.

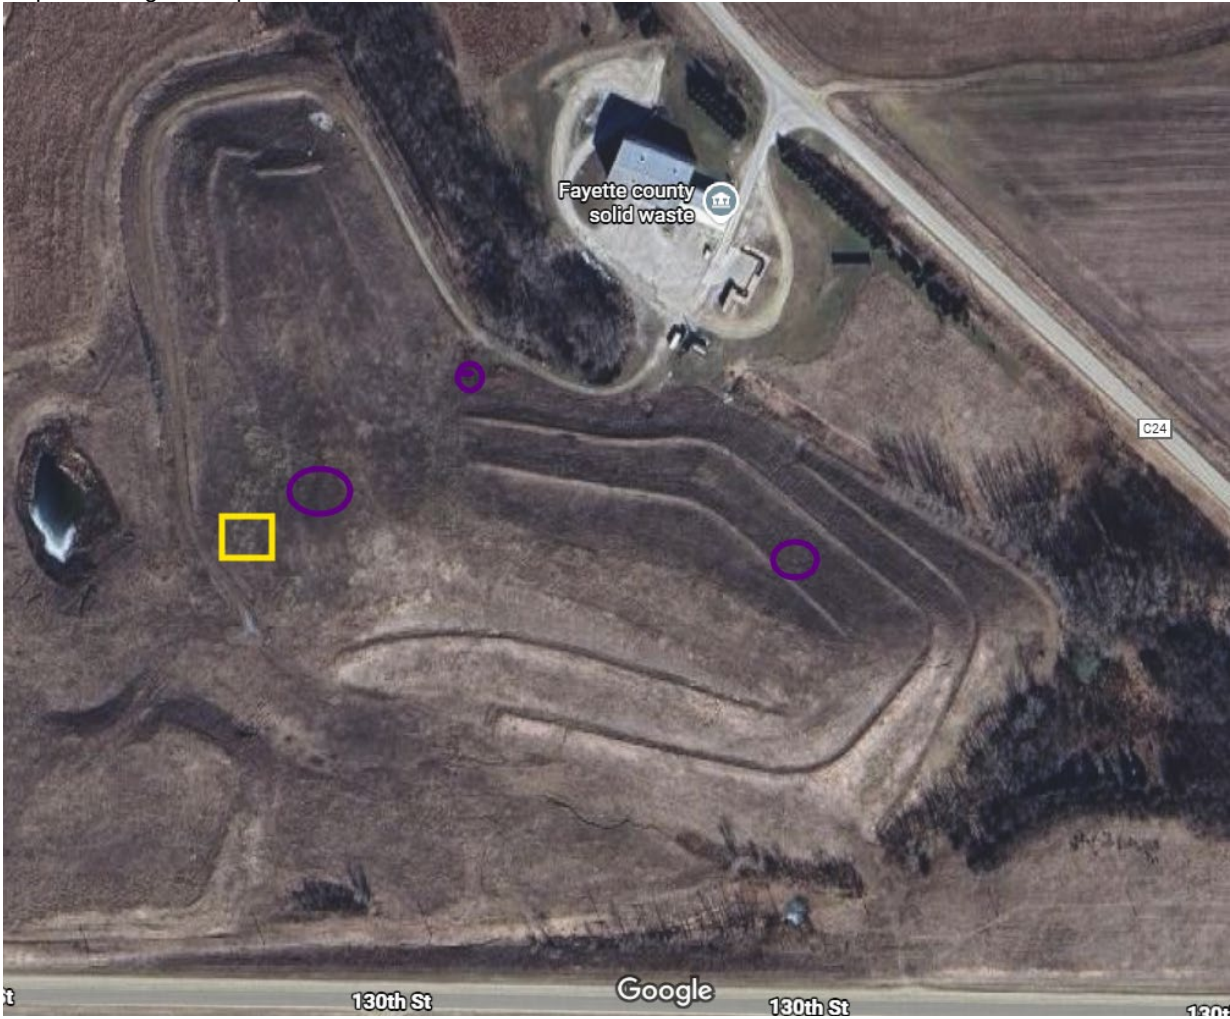
Map indicating where photos 1-3 were taken.
