2025 Fall Site Inspection

Keokuk Ferro-Sil Monofill (Closed)

Permit No. 56-SDP-17-91P

Klingner & Associates, P.C.

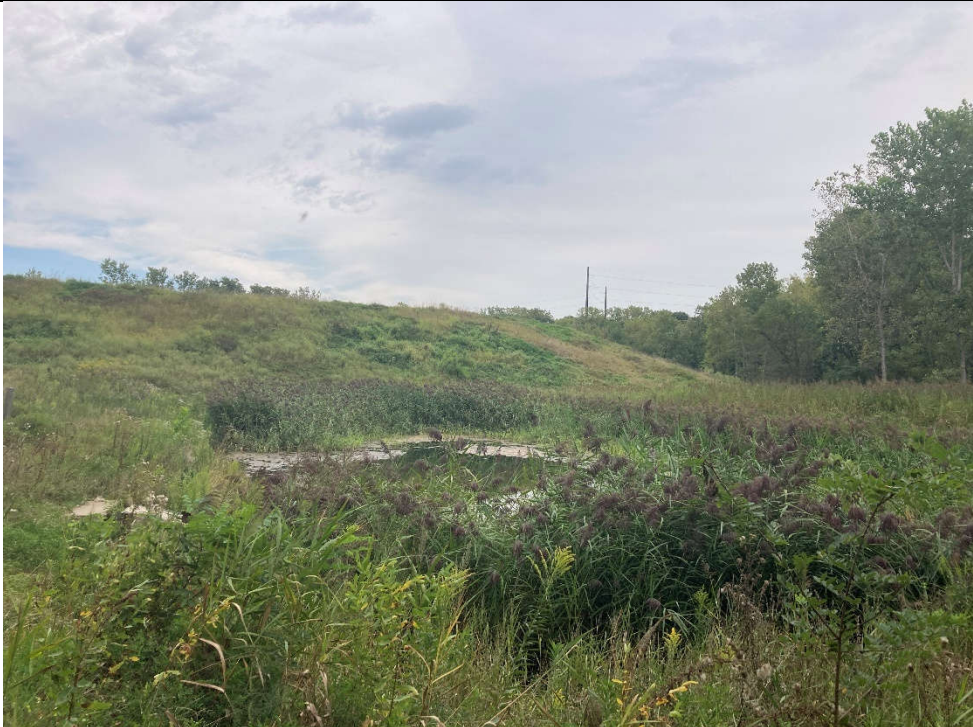
Description	Leachate collection area, looking north	14
Date	9/5/2025

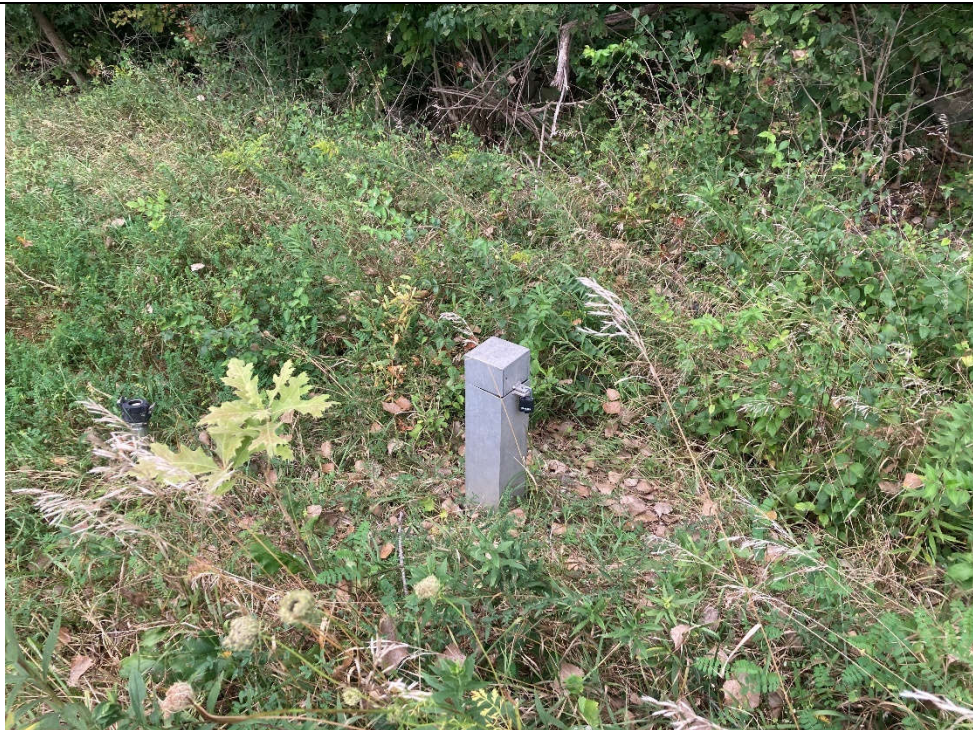
Description	MW 16	15
Date	9/5/2025

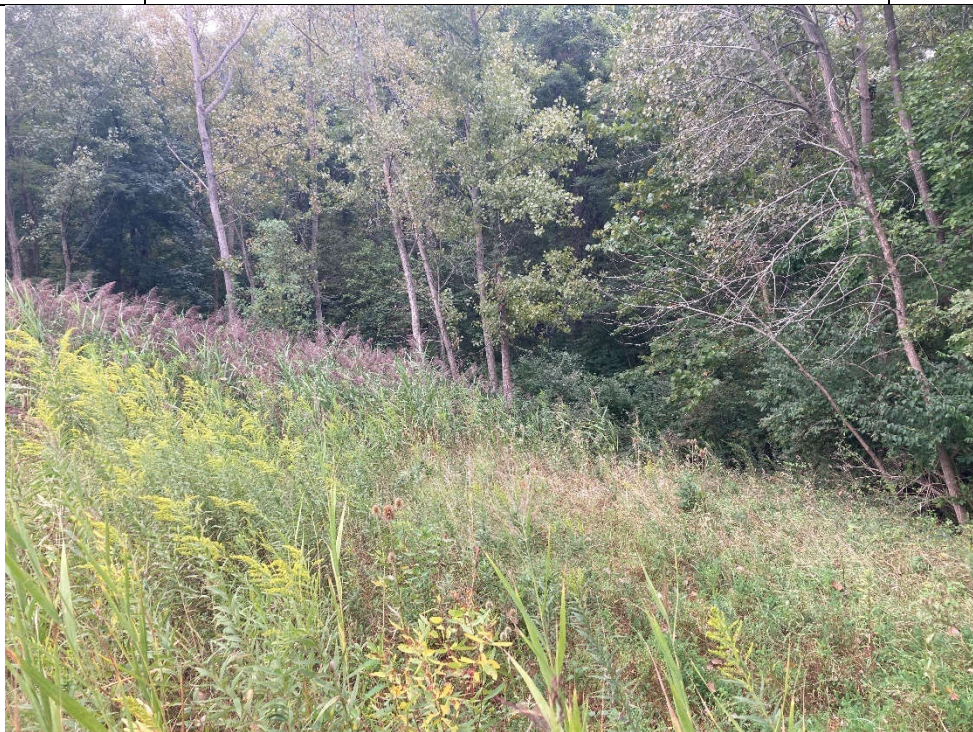
Description	Southeast side of berm of leachate collection area	16
Date	9/5/2025

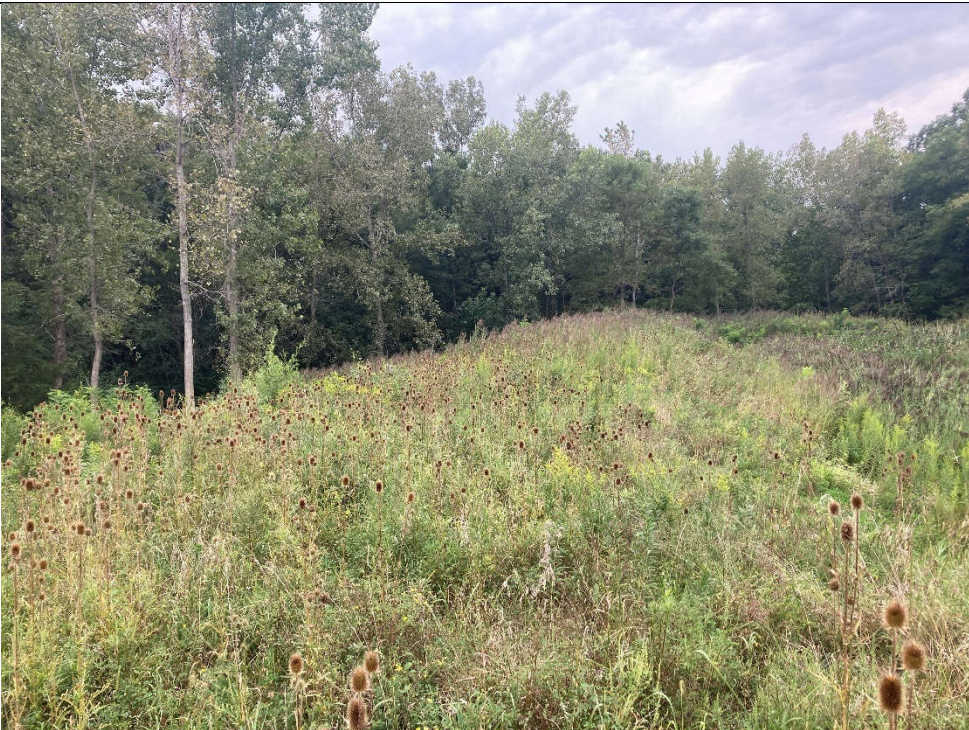
Description	Looking south, along east berm of leachate lagoon	21
Date	9/5/2025

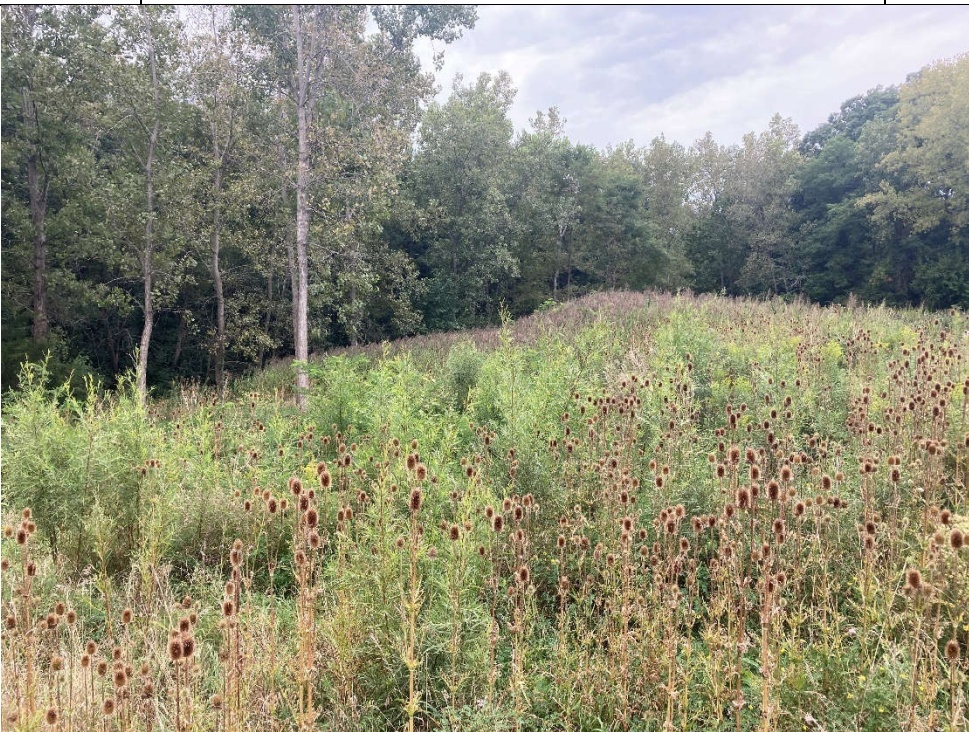
Description	Looking south, along east berm of leachate lagoon	22
Date	9/5/2025

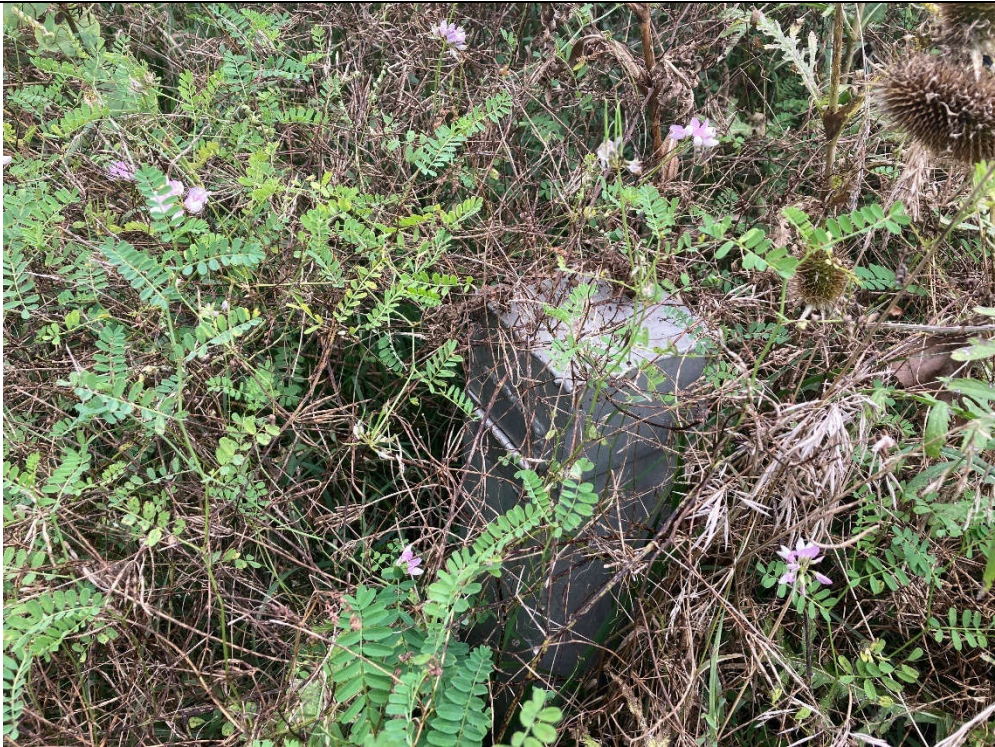
Description	MW 14	23
Date	9/5/2025

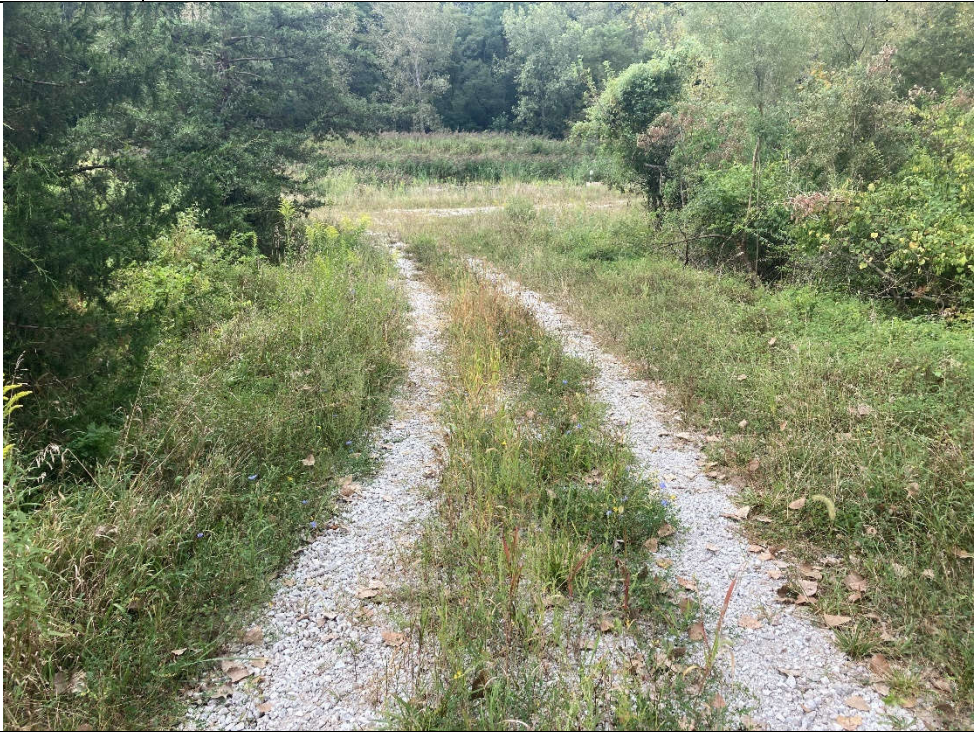
Description	Road to leachate collection area	24
Date	9/5/2025
