**RE: SEMI-ANNUAL INSPECTION – FALL, 2025  
AMES/STORY ENVIRONMENTAL LANDFILL  
IDNR PERMIT NO. 85-SDP-13-91  
HLW P.N. 6004-24A.750**

SITE PLAN  
FALL 2025 INSPECTION  
AMES/STORY ENVIRONMENTAL LANDFILL  
AMES, IOWA

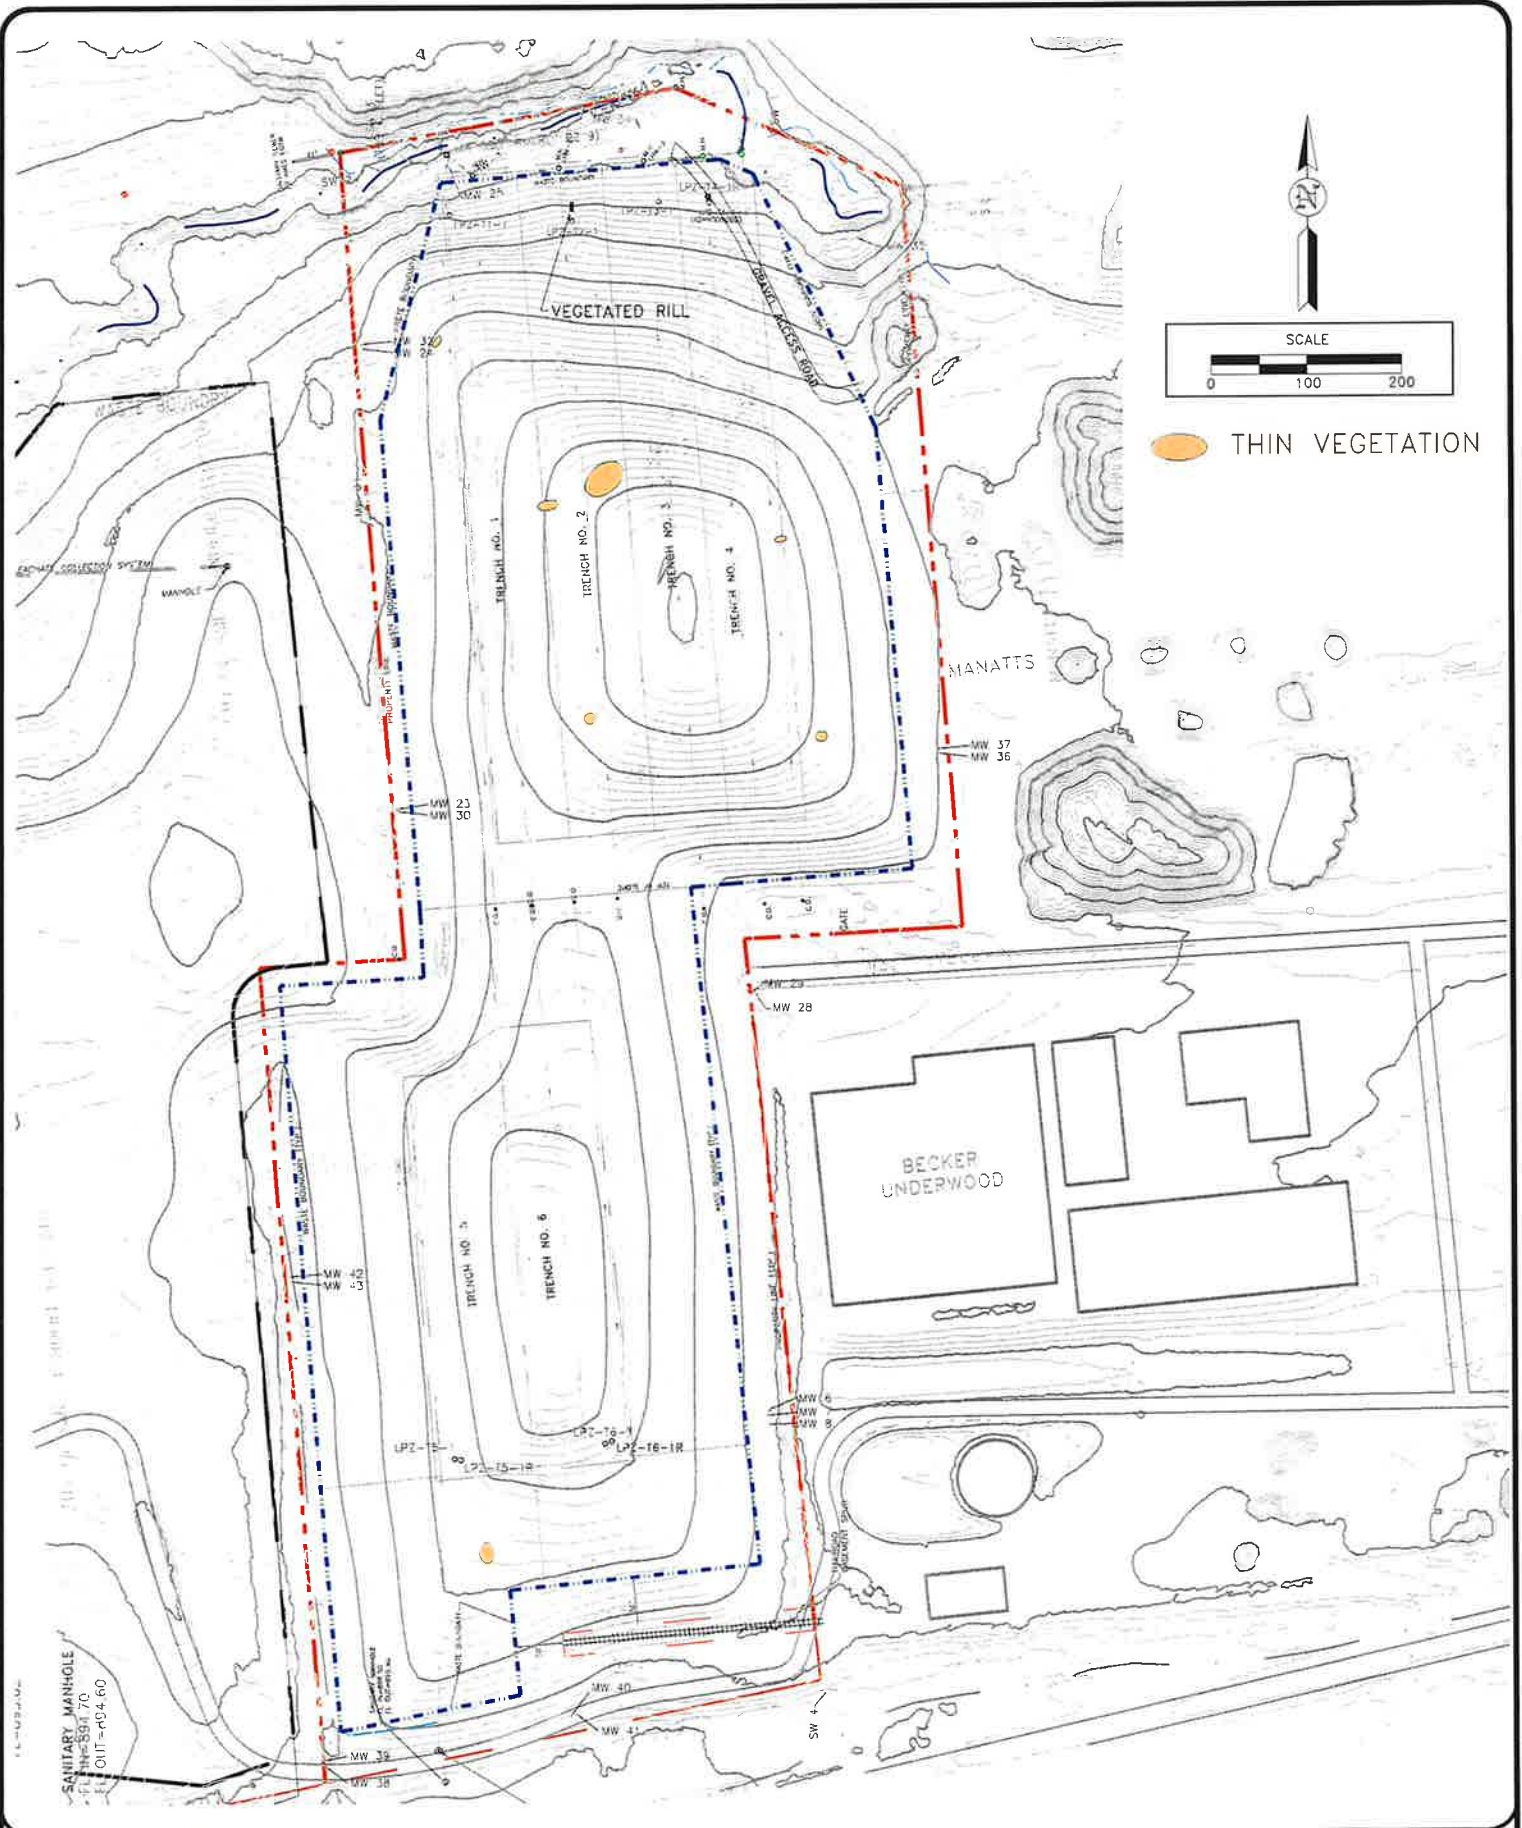
FIGURE: 1

The seeding on the south half of the site developed excellent coverage relatively quickly. As a result of the vegetation, there was minimal erosion noted on the south half of the site and the silt fence was removed prior to the Fall, 2017 inspection. One small area where vegetation was thin was noted during this inspection. No erosion was noted in this area. The approximate location of this area is shown on the attached figure

Vegetation is in excellent condition on the majority of the north half with the exception of a few areas where thin vegetation was noted during this inspection. No erosion was noted in the areas with thin vegetation. The approximate locations of these areas are shown on the attached figure.

No erosion was noted on cap with the exception of an erosion rill noted near LPZ-T2-1. The rill was referenced in past inspection reports. The rill is well vegetated and based on the condition of vegetation in this area, the rill does not appear to be active. No waste is exposed in the rill. The approximate location of the vegetated rill is shown on the attached figure.

1. Continue to remove trees from the landfill cap as needed.
2. Continue to monitor condition of vegetation, focusing on the areas with thin vegetation noted during this inspection, and reseed and control weeds as necessary.
3. Continue to monitor leachate levels in LPZ-T5-1R and discuss in the 2025 Annual Water Quality Report (AWQR).
4. Monitor the vegetated rill near LPZ-T2-1. Continue to monitor the remainder of the cap for erosion rills and repair as needed.
5. Monitor the sedimentation thickness at MW-34 and MW-8 during routine sampling events.
6. Continue to monitor bank erosion near MW-35 – if erosion appears to threaten the integrity of the well install bank stabilization to protect the MW.
