**RE: SEMI-ANNUAL INSPECTION – SPRING, 2026  
AMES/STORY ENVIRONMENTAL LANDFILL  
IDNR PERMIT NO. 85-SDP-13-91  
HLW P.N. 6004-24A.750**

**SITE PLAN**  
**SPRING 2026 INSPECTION**  
 AMES/STORY ENVIRONMENTAL LANDFILL  
 AMES, IOWA

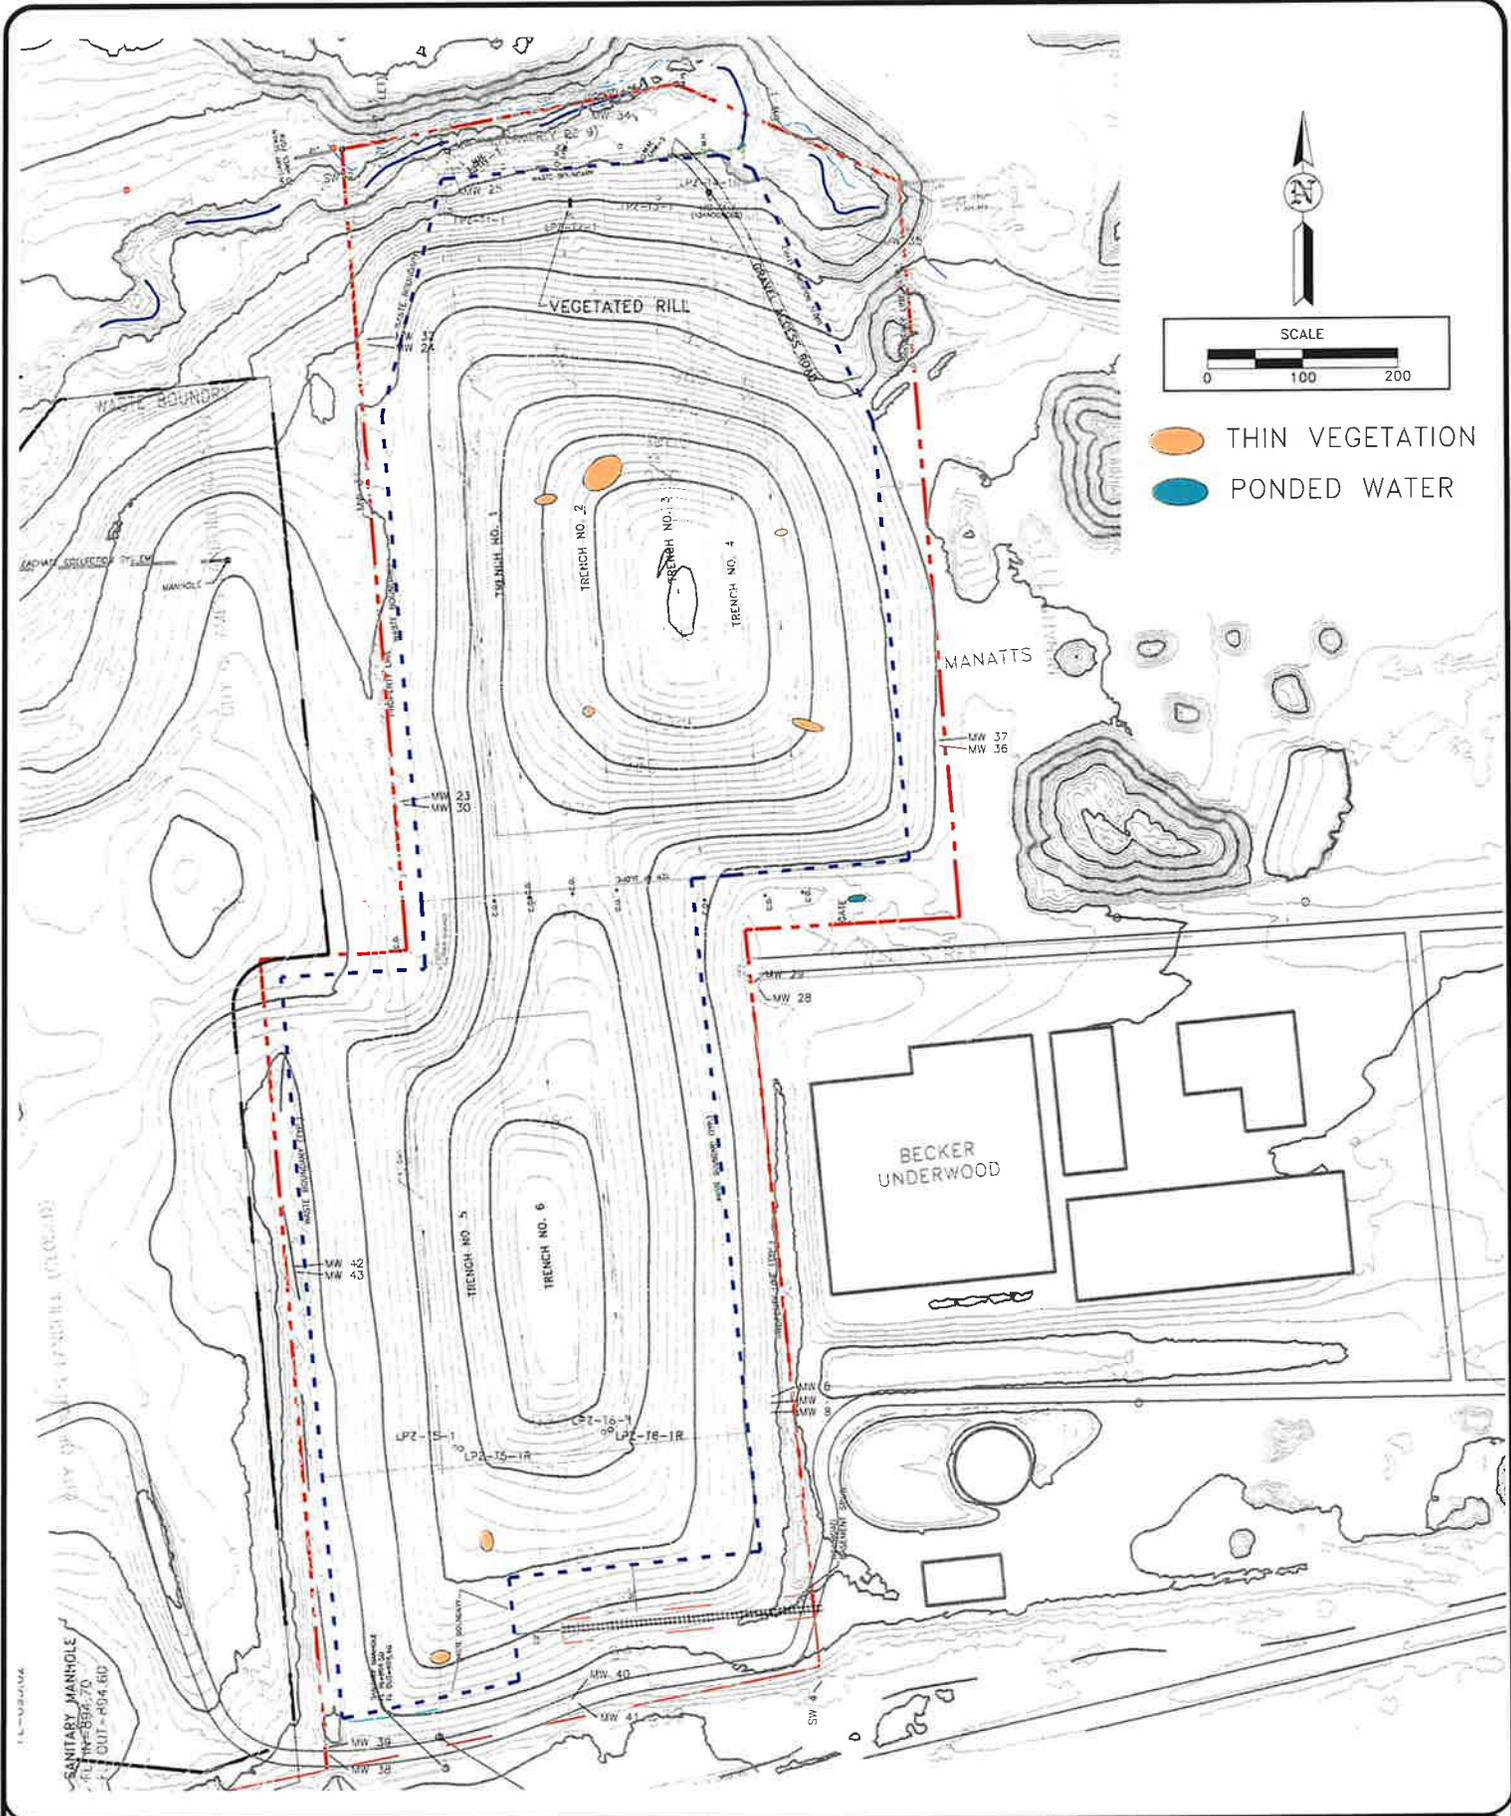
FIGURE:		1	
REVISION	NO.	DATE	
DRAWN JGH	PROJECT NO. 6004-10A	DATE 3/10/26

The seeding on the south half of the site developed excellent coverage relatively quickly. As a result of the vegetation, there was minimal erosion noted on the south half of the site and the silt fence was removed prior to the Fall, 2017 inspection. Two small areas where vegetation was thin were noted during this inspection. No erosion was noted in these areas. The approximate locations of these areas is shown on the attached figure.

Vegetation is in excellent condition on the majority of the north half with the exception of a few areas where thin vegetation was noted during this inspection. No erosion was noted in the areas with thin vegetation. The approximate locations of these areas are shown on the attached figure.

No erosion was noted on cap with the exception of an erosion rill noted near LPZ-T2-1. The rill was referenced in past inspection reports. The rill is well vegetated and based on the condition of vegetation in this area, the rill does not appear to be active. No waste is exposed in the rill. The approximate location of the vegetated rill is shown on the attached figure.

One area of ponded water was noted during the inspection. The ponding was noted immediately north of the entrance gate in the area of the former access road, the ponding was outside of the solid waste boundary. The approximate location of the ponding is shown on the attached figure.

1. Continue to remove trees from the landfill cap as needed.
2. Continue to monitor condition of vegetation, focusing on the areas with thin vegetation noted during this inspection, and reseed and control weeds as necessary.
3. Continue to monitor leachate levels in LPZ-T5-1R and discuss in the 2026 Annual Water Quality Report (AWQR).
4. Monitor the vegetated rill near LPZ-T2-1. Continue to monitor the remainder of the cap for erosion rills and repair as needed.
5. Monitor the sedimentation thickness at MW-34 and MW-8 during routine sampling events.
6. Continue to monitor bank erosion near MW-35 – if erosion appears to threaten the integrity of the well install bank stabilization to protect the MW.
