2026 Spring Site Inspection

Keokuk Ferro-Sil Monofill (Closed)

Permit No. 56-SDP-17-91P

Klingner & Associates, P.C.

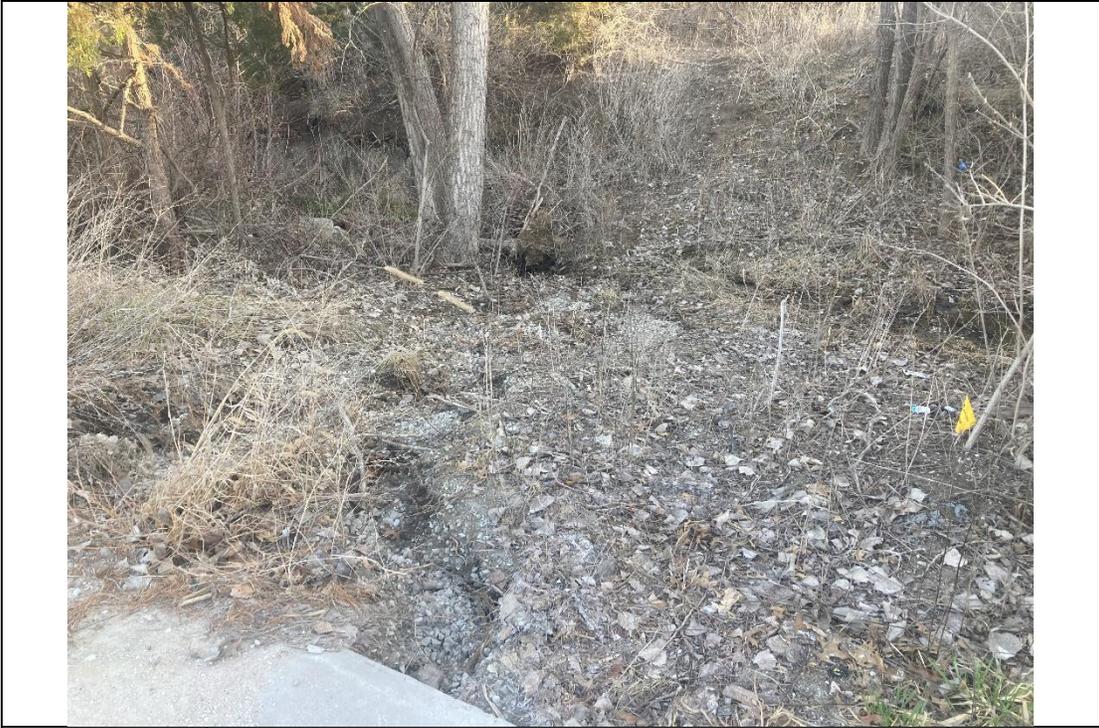
The leachate pond level appeared to be normal. The area of the leachate line repair (2023) was walked. Some erosion is starting in the City right-of-way along Kindustry Park Road. No other areas of erosion were noted.

Description	Erosion at road edge beginning near sanitary manhole in Kindustry Park	1
Date	3/13/2026

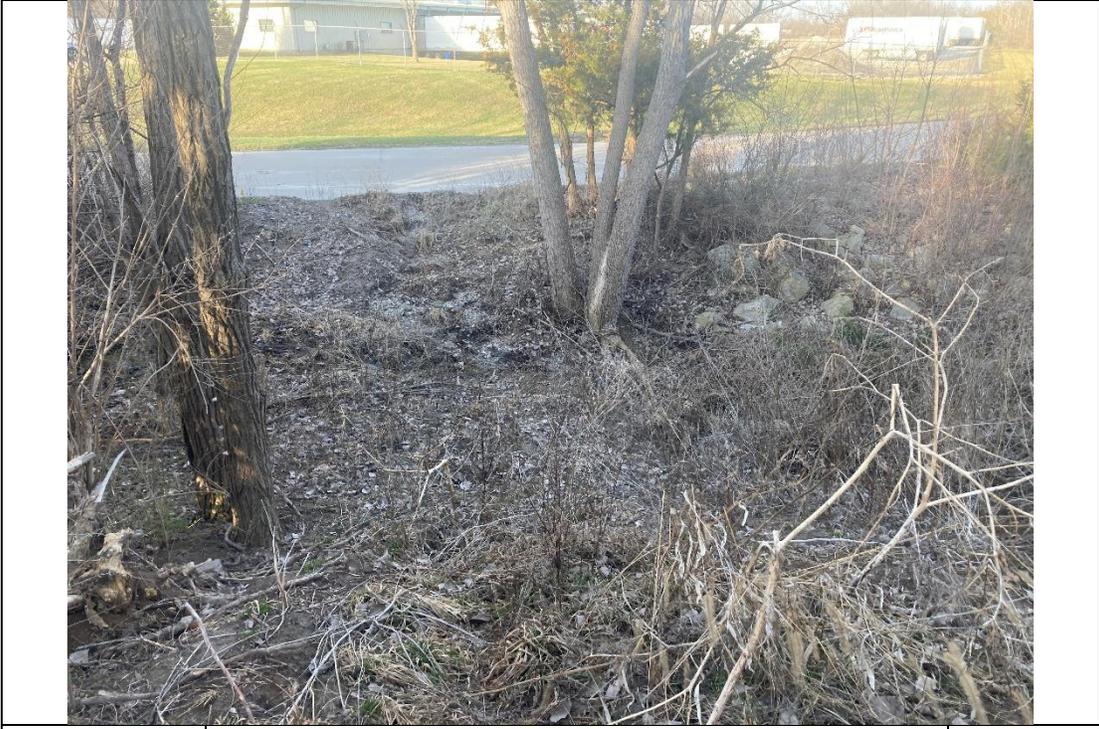
Description	Looking south at Kindustry park road, erosion from road to creek beginning	2
Date	3/13/2026

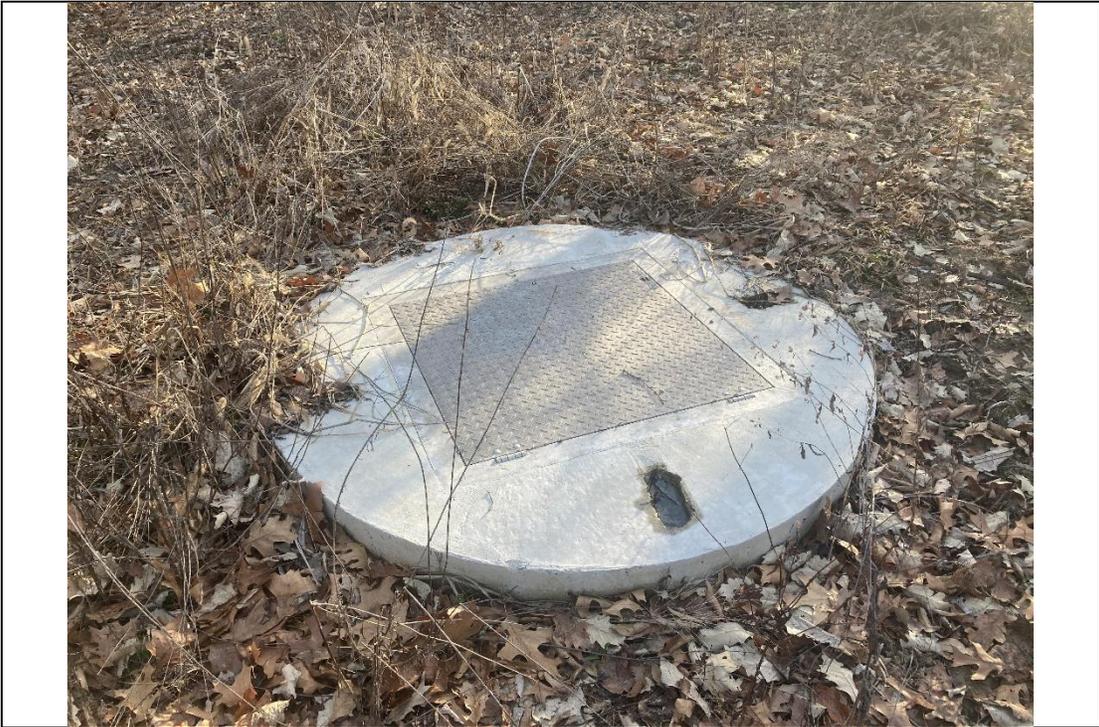
Description	Venting structure manhole	5
Date	3/13/2026

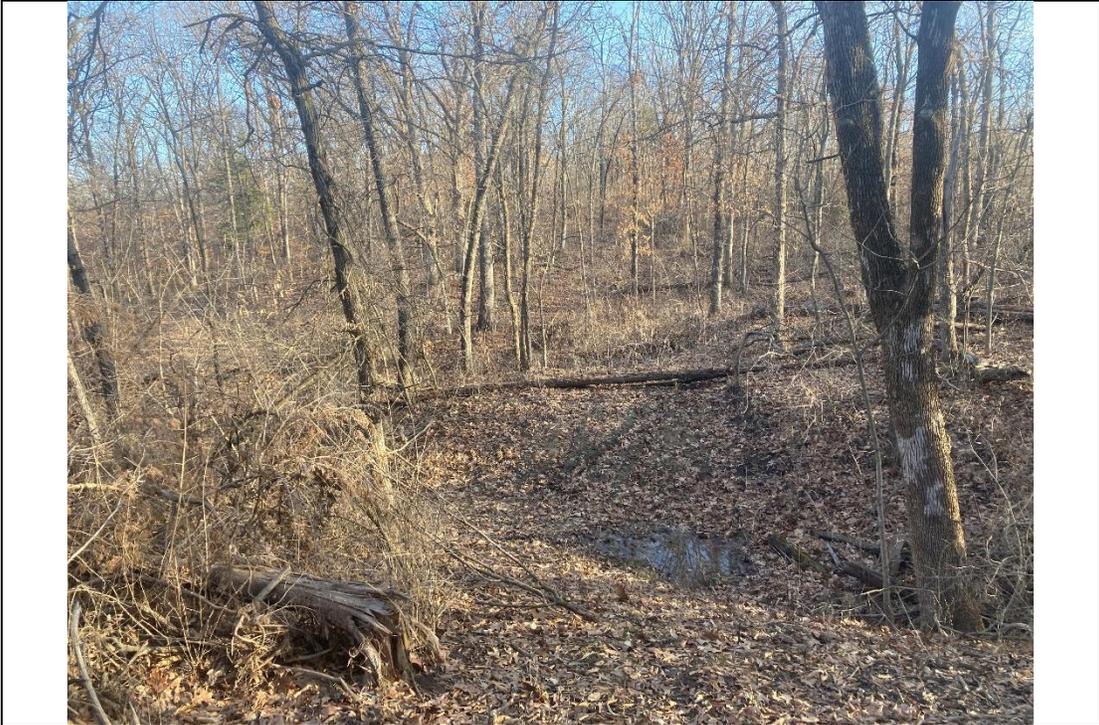
Description	Looking north along north end of force main repair area	7
Date	3/13/2026

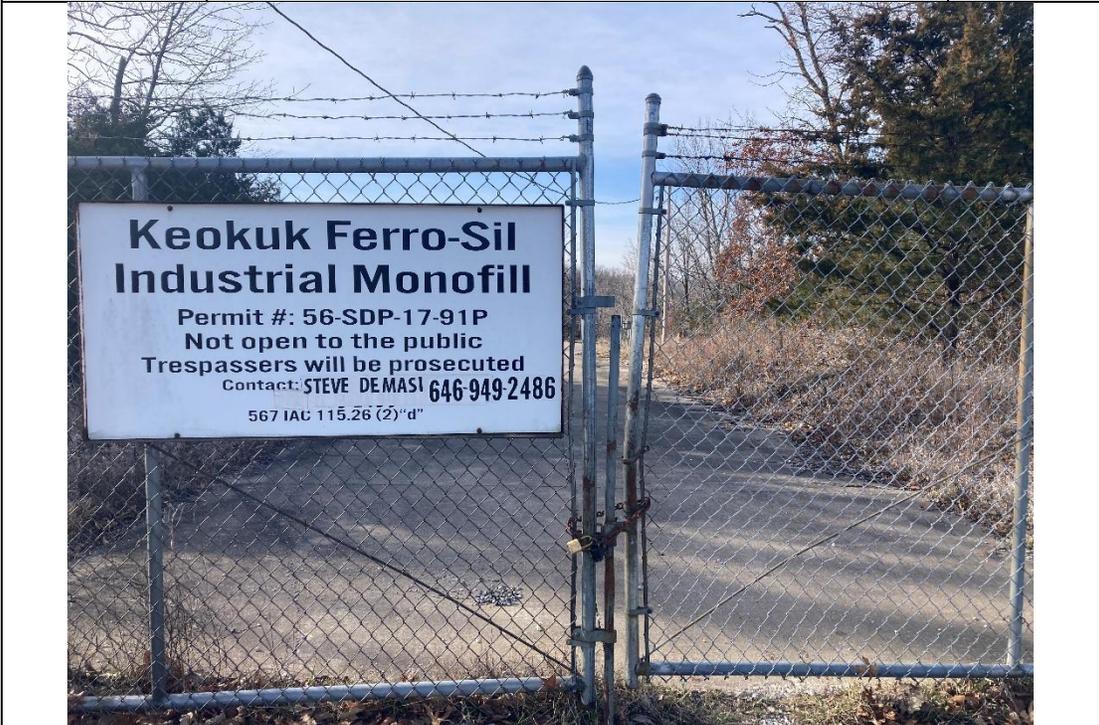
Description	Landfill entrance gate signage. Gate loked.	8
Date	3/13/2026

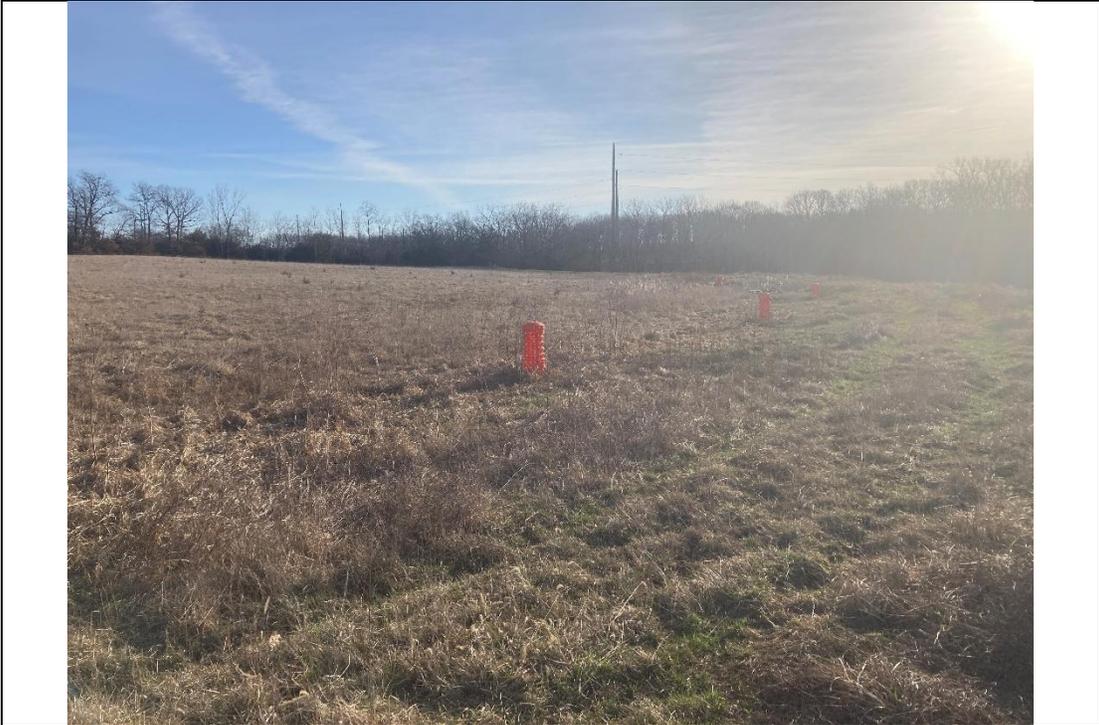
Description	Stormwater intakes on south side of landfill	17
Date	3/13/2026

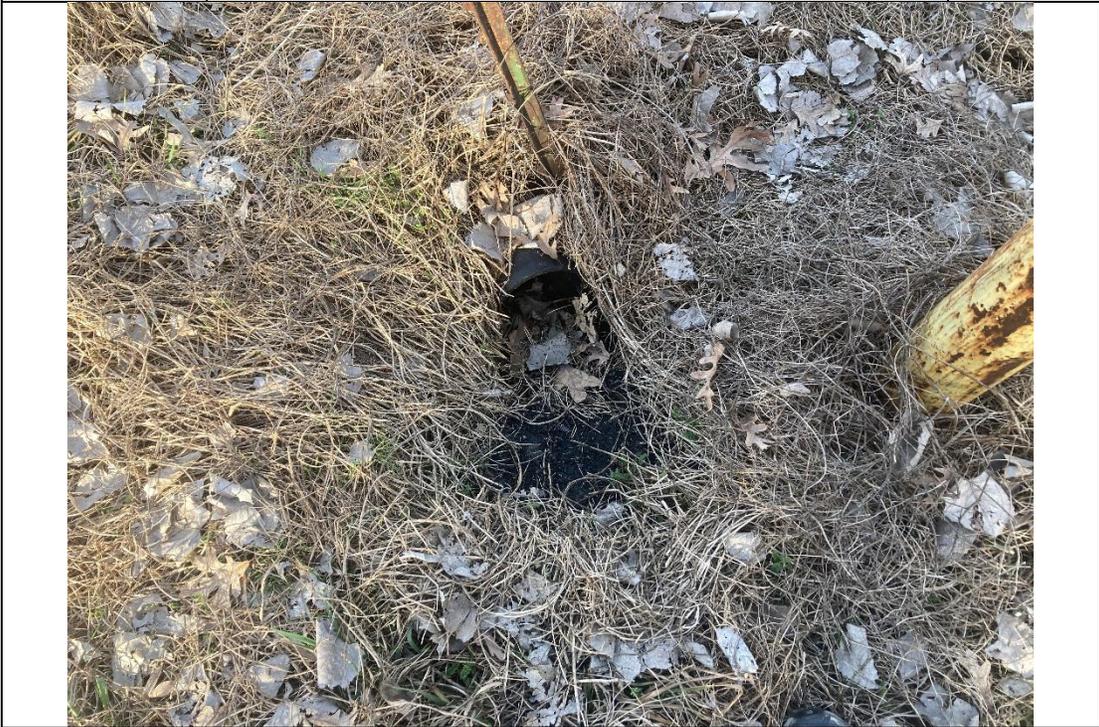
Description	Leachate collection line, cleanout, cap missing	28
Date	3/13/2026

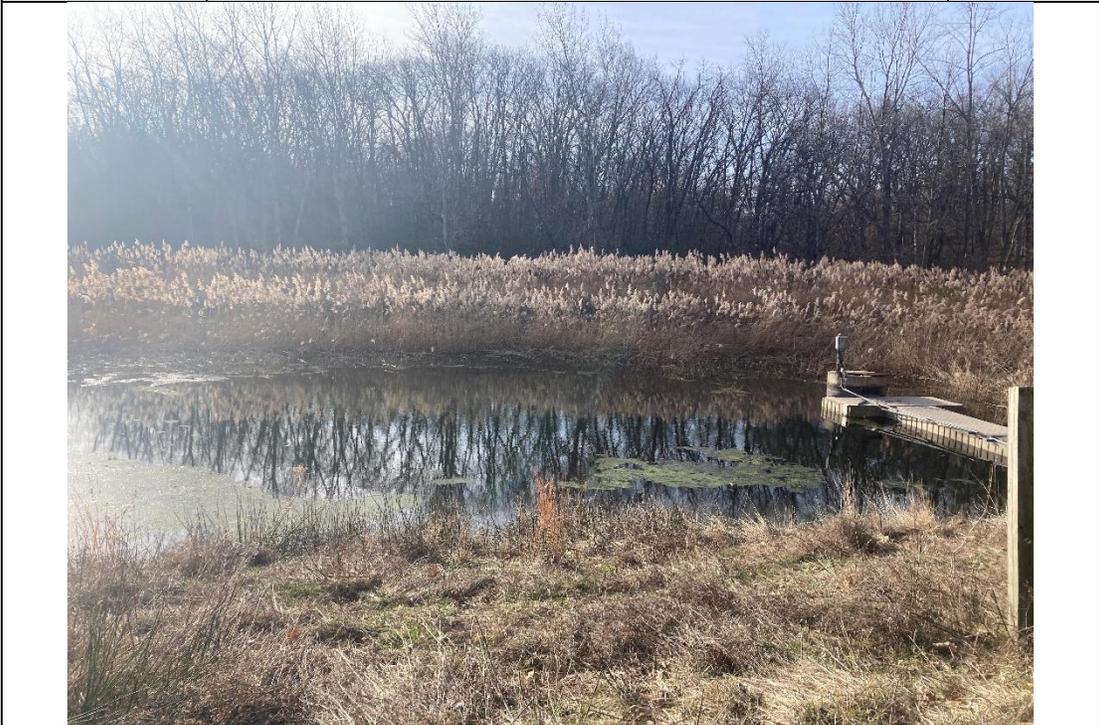
Description	Leachate lagoon	36
Date	3/13/2026
