**RE: CONSTRUCTION CERTIFICATION - FML REPAIR
LEACHATE STORAGE LAGOON
MARSHALL COUNTY SLF – IDNR PERMIT NO. 64-SDP-02-75P
HLW PN 6003-23A.200**

MARSHALL COUNTY SANITARY LANDFILL
 MARSHALL COUNTY, IOWA

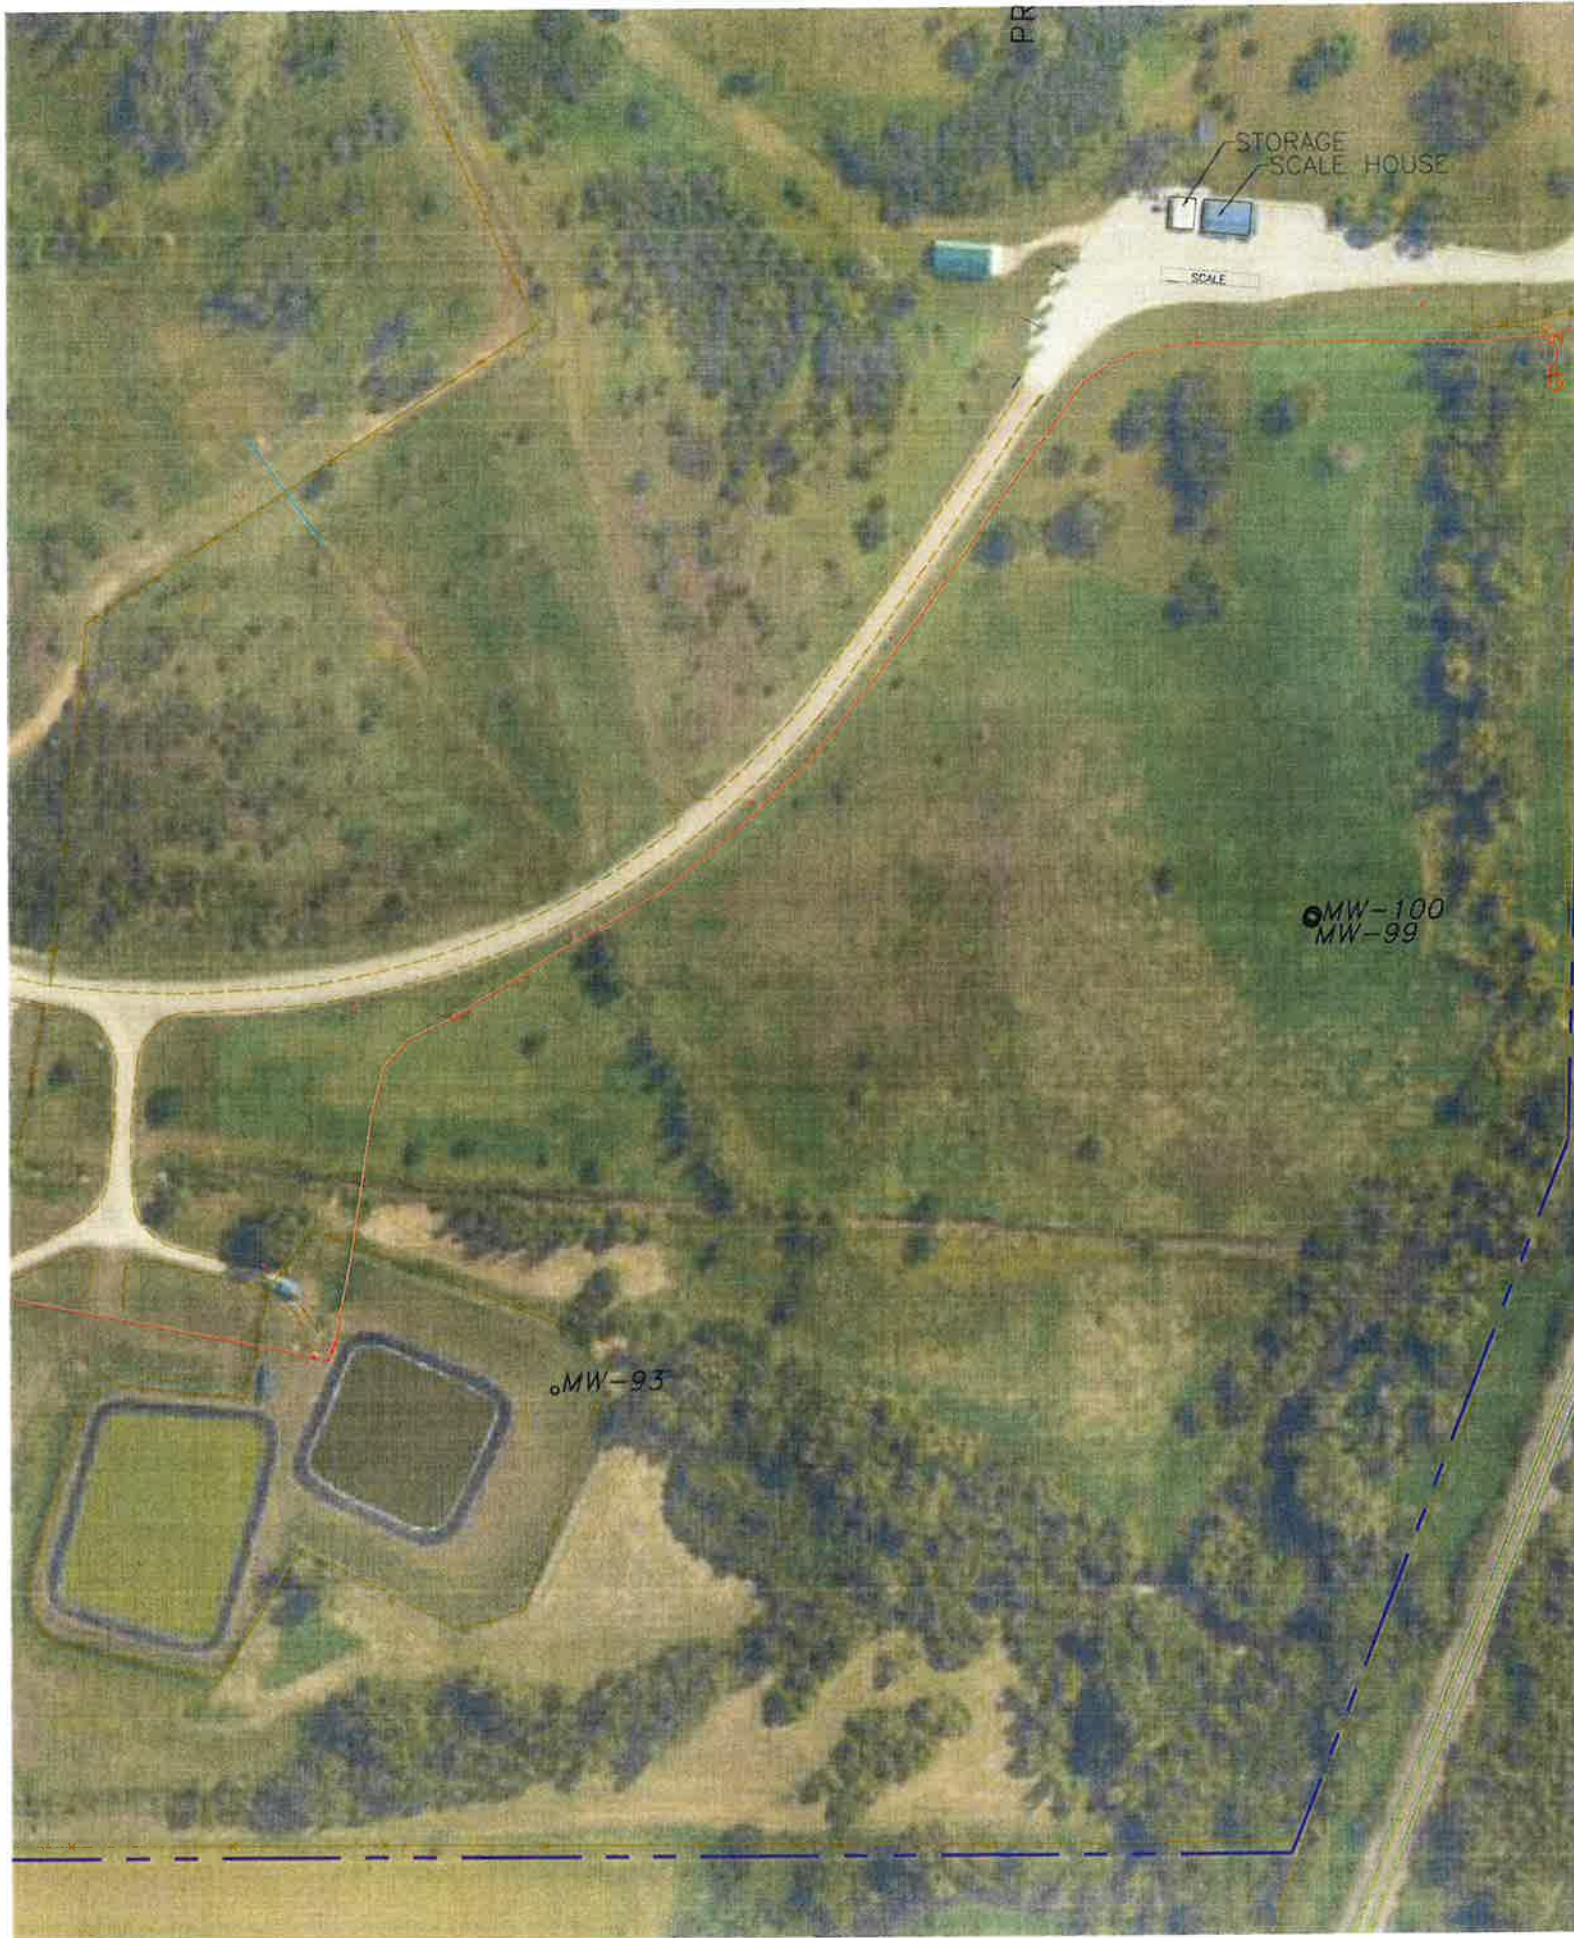
FIGURE: 1

LAGOON REPAIR

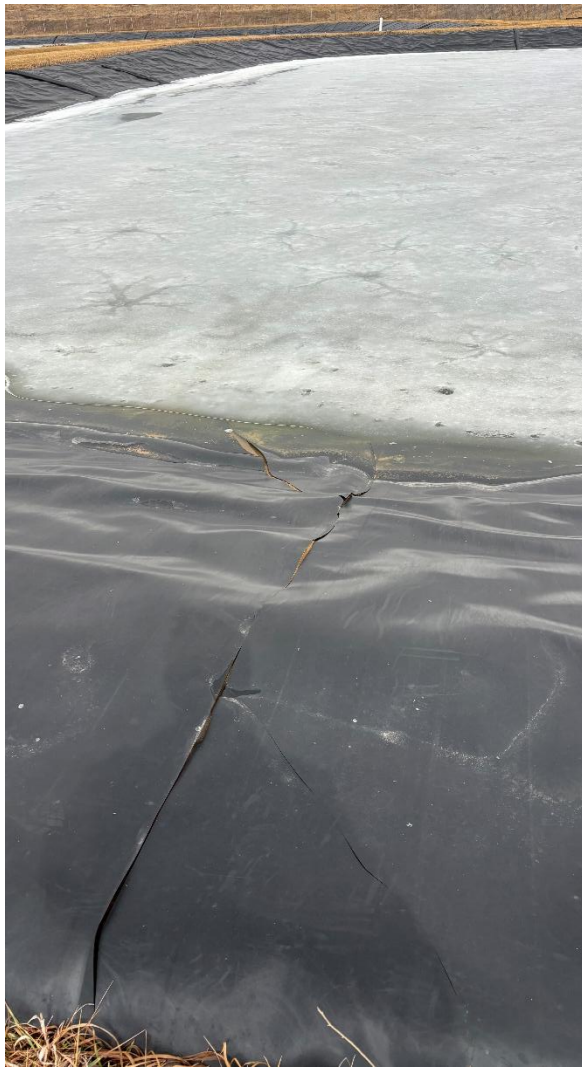
During routine staff inspections of the 1991 lagoon in March, 2026, a tear in the FML was noted. The tear was approximately 14 feet in length and split into two tears at the base and top. All noted damage was above the leachate level of the lagoon. Staff immediately directed leachate inflow to the other leachate storage lagoon and placed heavy bags adjacent to the tear to limit additional damage. The leachate level in the lagoon has been kept below the level of the damage since it was discovered.

Photo 1: Damage in 1991 lagoon, looking north, 03-09-26.
