**RE: SEMI-ANNUAL INSPECTION REPORT – SPRING 2026
FAYETTE COUNTY SANITARY LANDFILL (CLOSED)
IDNR PERMIT NO. 33-SDP-02-83C
HLW P.N. 6041-24A.750**

SPRING 2026 INSPECTION

FAYETTE COUNTY SANITARY LANDFILL
FAYETTE, IOWA

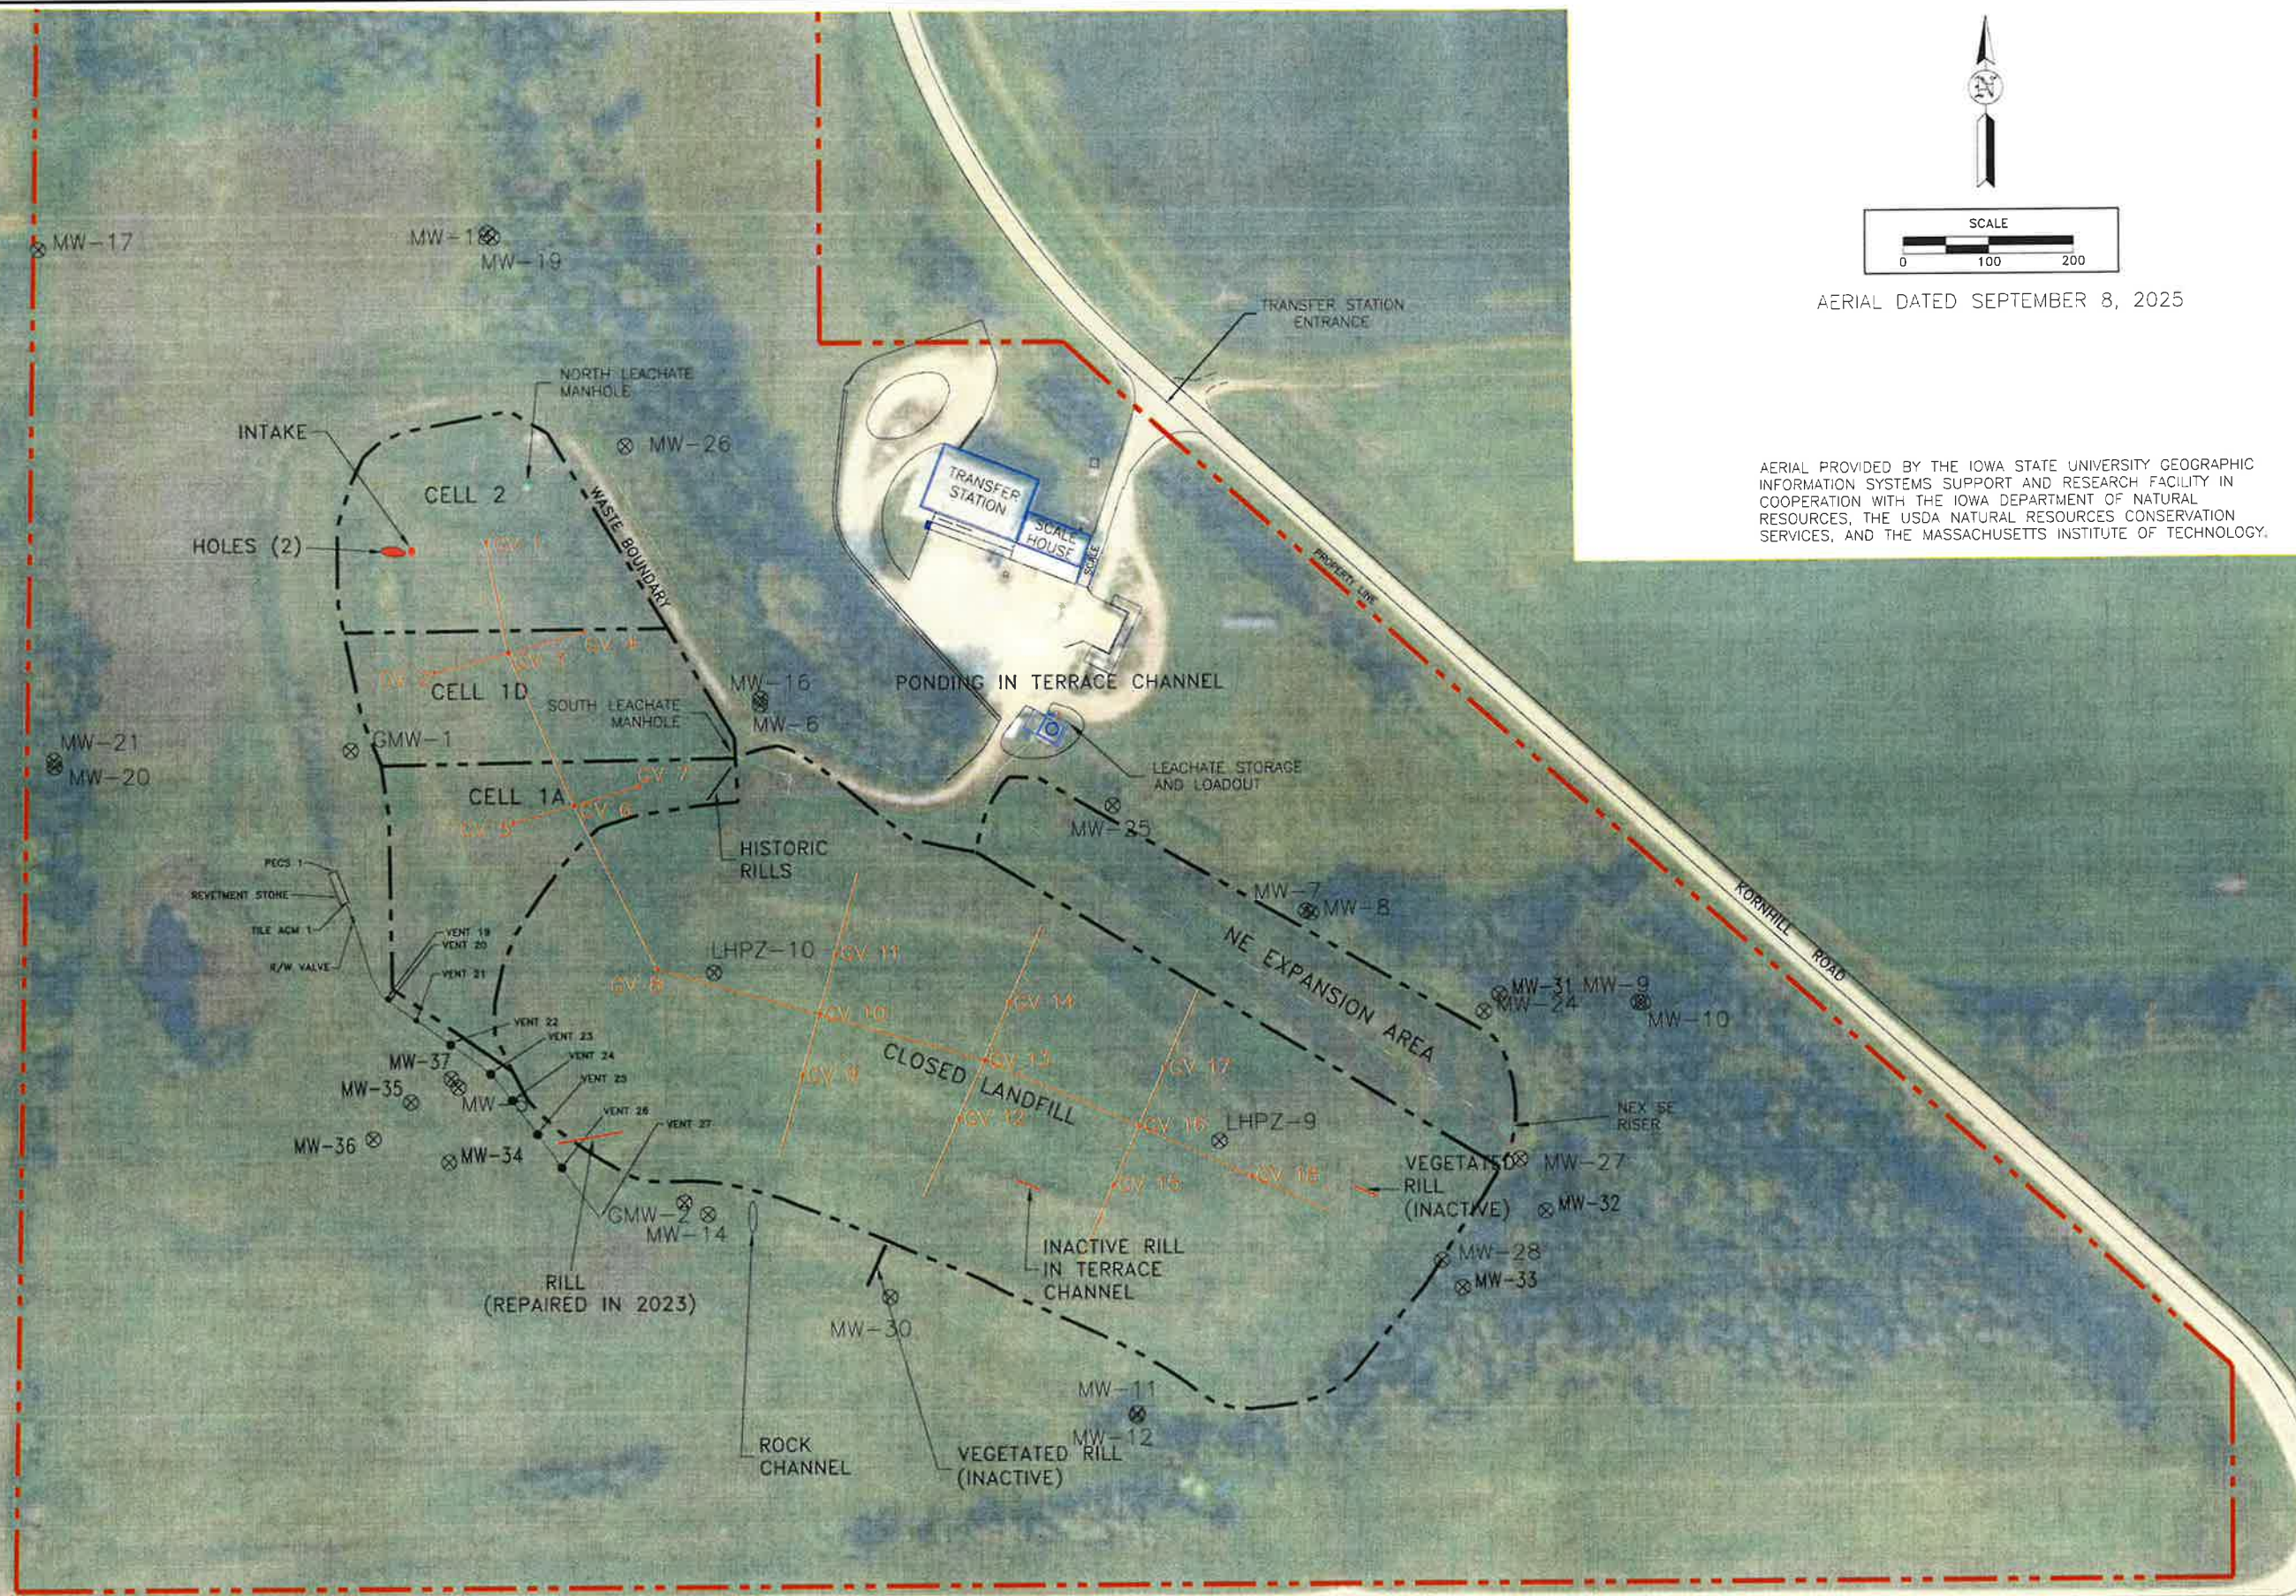
FIGURE: 1

An erosion rill was noted on the northwest corner of the cap, downgradient from the terrace intake, during the Fall, 2021 inspection. The erosion was repaired; however, a hole then formed in a portion of the repaired area. In late 2022, the hole was repaired. During the Fall 2025 inspection, three (3) holes were noted over the pipe downgradient of the intake, the pipe was visible in one of the holes. The three (3) holes were promptly repaired. The repair areas were observed and appeared to be seeded and covered with straw. During this inspection, two (2) additional holes were noted up the slope from those repaired in the Fall of 2025. These need to be filled. The approximate location of the areas needing repair are shown on the attached figure.

Three inactive rills were observed during the inspection: one in the upper terrace channel near GV-15, one on the slope southwest of MW-27, and one on the lowest terrace on the south side (near MW-30) outside of the historic waste boundary. There were no apparent changes to the rills in comparison to past inspections and the vegetation adjacent to the rills is in excellent condition. The rills will continue to be observed during future inspections. The approximate locations of the rills are shown on the attached figure.

The ponding in the lower terrace on the north side discussed in the Spring 2022, 2023, 2024, and 2025 inspections was not present during this inspection. Vegetation in this area is well established; however, vegetation differences in the channel provide evidence that ponding occurs occasionally and is a temporary condition after rain events until the channel has a chance to drain to the drop pipe. The approximate location is shown on the attached figure.

A rill was observed at the letdown (west end) of the lower terrace on the south side of the cap near Vent 25 in 2023. The rill was repaired and seeded in 2023 and again in 2024. Site vegetation is becoming established in the repair area, but there are areas where the rill appears to be again active. This area should be repaired and seeded in order to eliminate the rill. The approximate location of the repair/rill is shown on the attached figure.

1. Repair the two (2) voids below the terrace intake in the northwest corner of the site.
2. Continue to monitor all repaired areas and reseed if needed.
3. Continue to monitor the inactive rills for signs of instability.
4. Continue to monitor vegetation and erosion and repair as necessary.
5. Continue tree removal as needed.
6. Continue to monitor diversion and drainage systems and repair as necessary.
