**REFERENCE: 2026 SPRING SEMI-ANNUAL ENGINEERING INSPECTION REPORT  
CONTINENTAL CEMENT – DAVENPORT CKD LANDFILL  
301 EAST FRONT STREET, BUFFALO, IA 52728  
PERMIT # 82-SDP-15-97P**

This report serves as Continental Cement Company, LLC's (Continental's) Spring 2026 Engineering Inspection Report. This document is in support of Sanitary Disposal Project Permit No. 82-SDP-16-97P, 82-SDP-15-96C, and Iowa solid waste rule 567 Iowa Administrative Code (IAC) 115. This document provides a description and condition of various components Continental's Cement Kiln Dust (CKD) Landfill (Site).

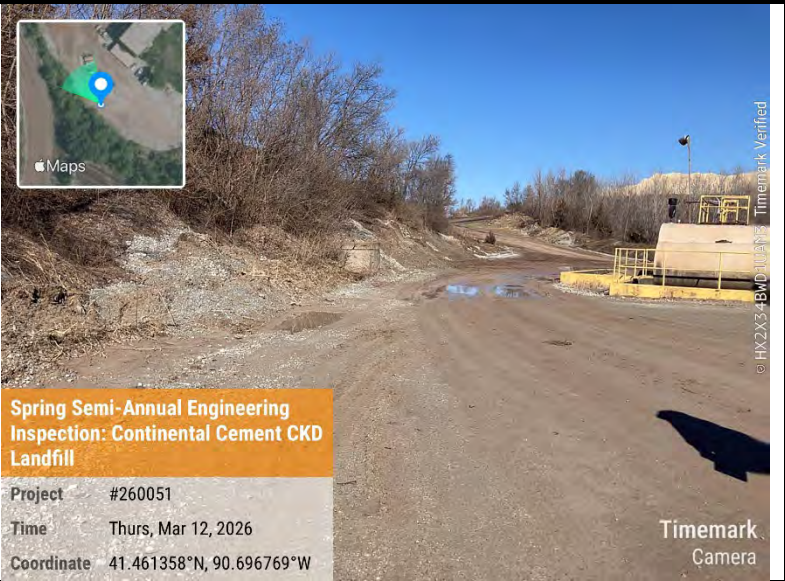
| <b>Photo No.:</b><br>1 | <b>Date:</b><br>03/12/2026 |

**Description:**  
View looking northwest at an access road on the western edge of the landfill.

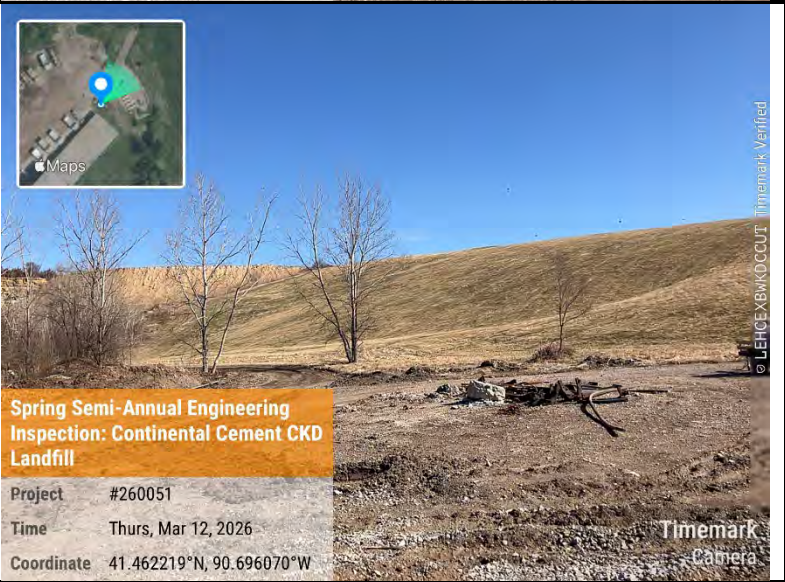
| <b>Photo No.:</b><br>2 | <b>Date:</b><br>03/12/2026 |

**Description:**  
View looking at the western slope of the Phase I Closed cell and parking/storage area near the Quarry building.

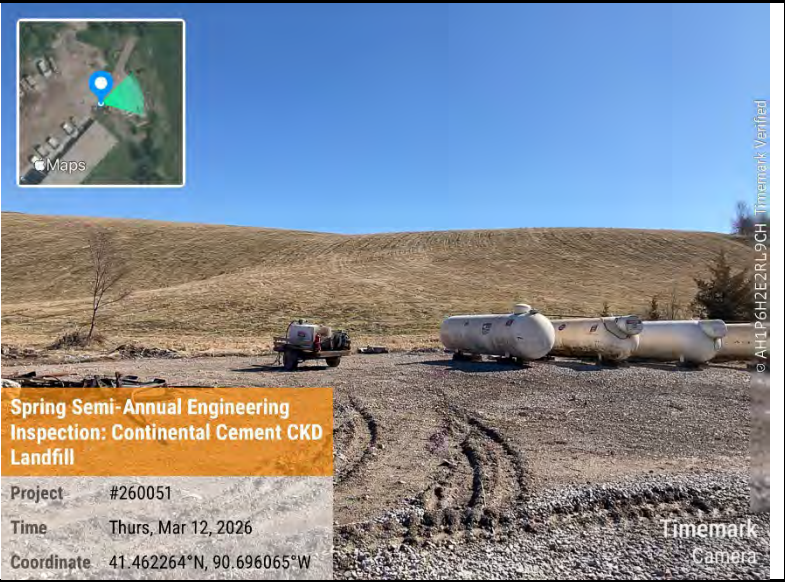
| <b>Photo No.:</b><br>3 | <b>Date:</b><br>03/12/2026 |

**Description:**  
View looking at the western slope of the Closed Cell and parking/storage area near the Quarry building.

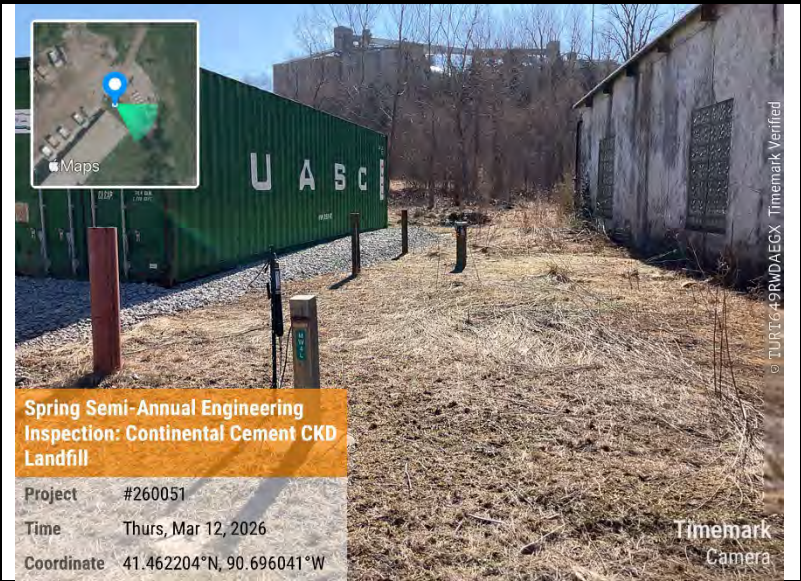
| <b>Photo No.:</b><br>4 | <b>Date:</b><br>03/12/2026 |

**Description:**  
View looking at monitoring wells, MW-3, MW-4L, and MW-18 located to the west of the landfill and north of the Quarry Building. Monitoring wells were locked.

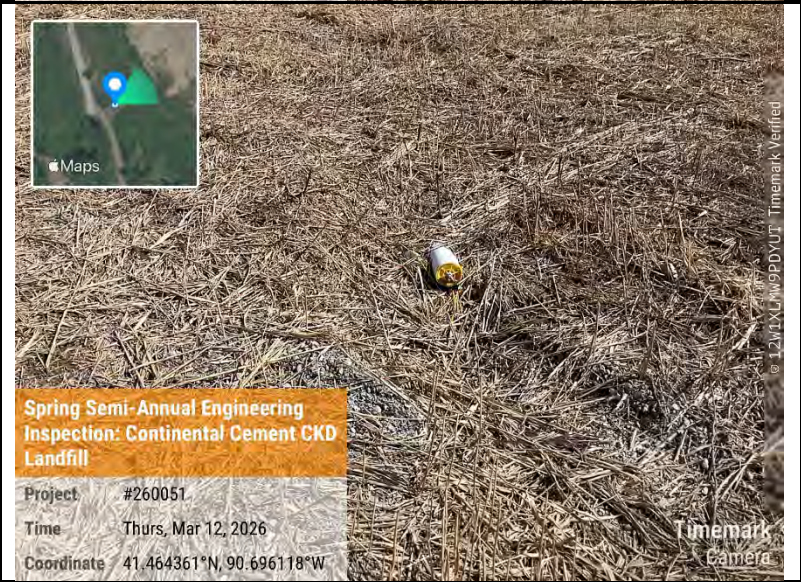
| <b>Photo No.:</b><br>5 | <b>Date:</b><br>03/12/2026 |

Leachate collection and recirculation systems were observed and not active at time of inspection. Leachate sump and lysimeters were reported to be functional. The leachate drainage pipes were sealed with no observed leaks. Minor evidence of erosion around the drainage pipes was observed.

**Description:**  
View looking at the landfill's southern drainage pipe.

- Continue to maintain vegetation on capped areas through seeding, mowing and re-grading as necessary.
- Engineer a fixture to the leachate drainage pipes to capture detritus and media from piping during maintenance / jetting activities.

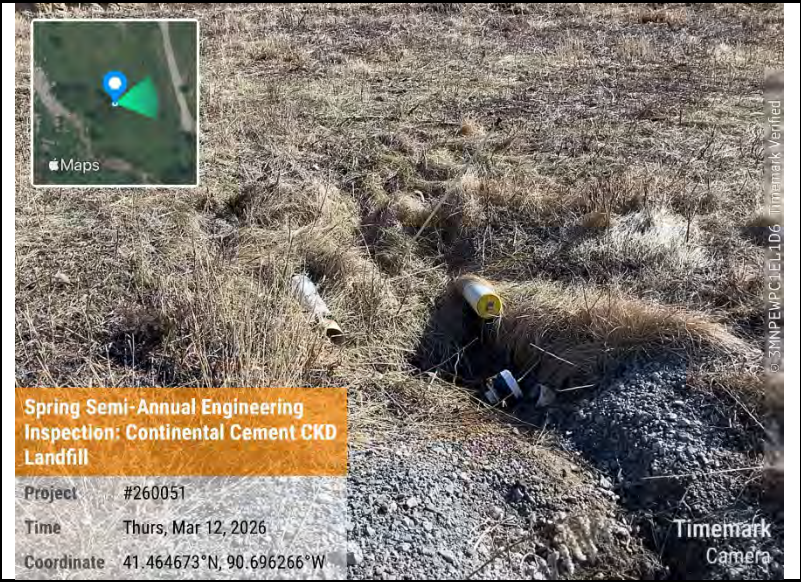
| <b>Photo No.:</b><br>6 | <b>Date:</b><br>03/12/2026 |

**Description:**  
View looking at the landfill's northern drainage pipe.

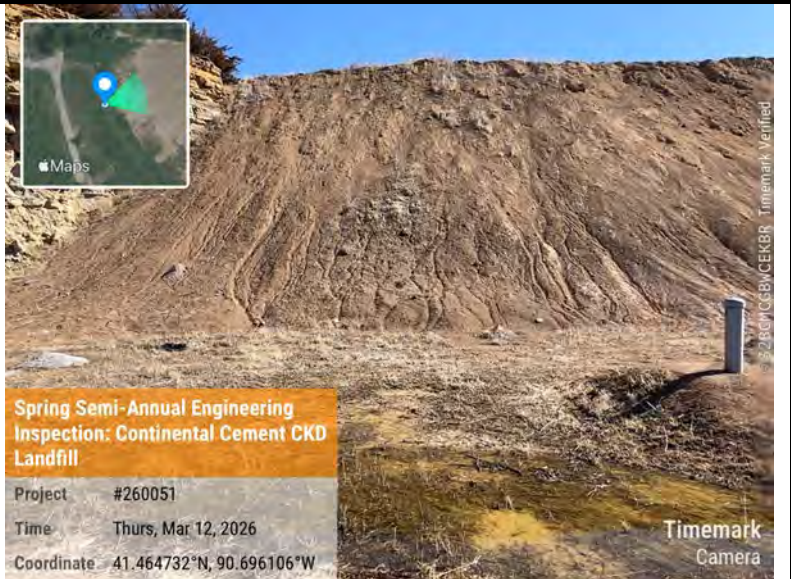
| <b>Photo No.</b><br>7 | <b>Date:</b><br>03/12/2026 |

**Description:**  
View looking at clay berm of the Phase II Active Cell. Also, in view lysimeter, UL-3R.

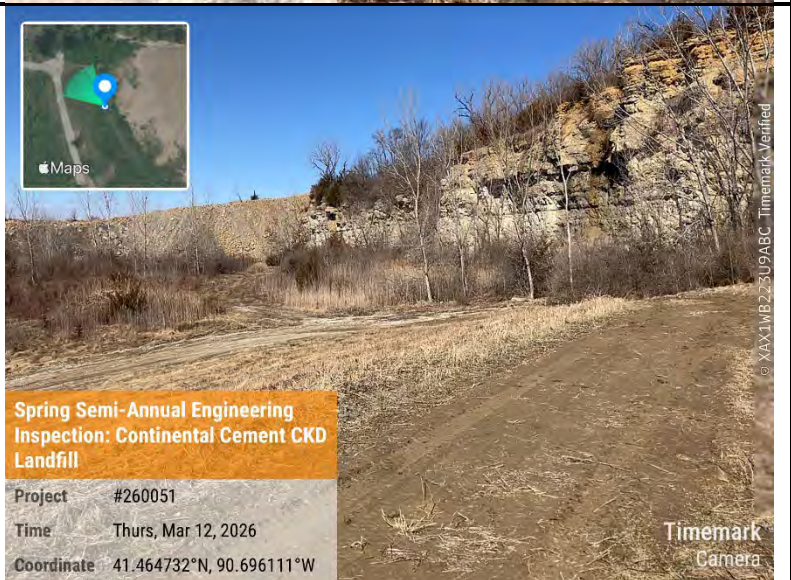
| <b>Photo No.</b><br>8 | <b>Date:</b><br>03/12/2026 |

**Description:**  
View of access road leading up to lysimeters and west slope of the Phase II Active cell.

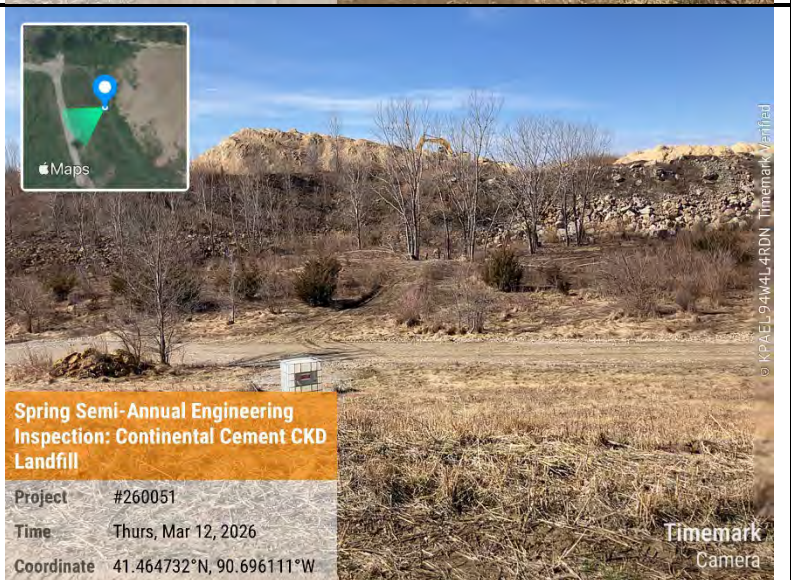
| <b>Photo No.</b><br>9 | <b>Date:</b><br>03/12/2026 |

**Description:**  
View of access road with landfill drainage pipes down gradient and quarry operations in the background.

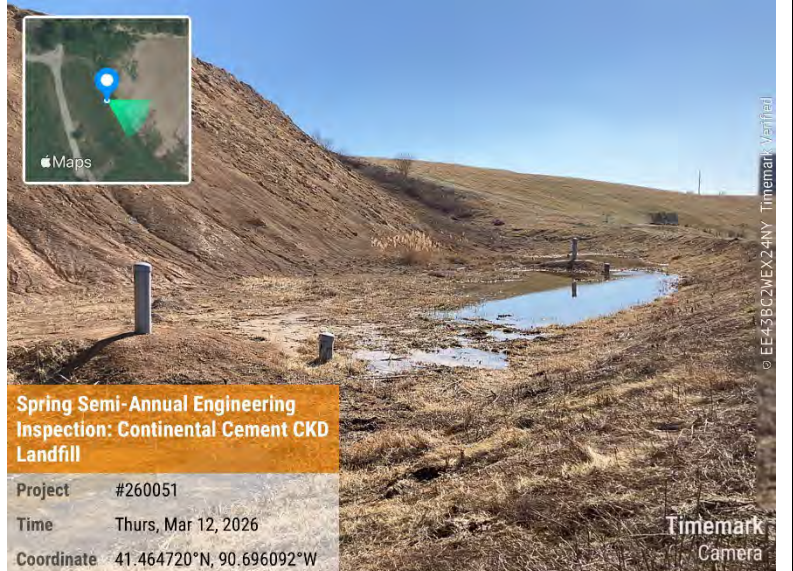
| <b>Photo No.</b><br><b>10</b> | <b>Date:</b><br>03/12/2026 |

**Description:**  
View looking at lysimeters at the base of the clay berm of the Phase II Active cell. Lysimeters in view are UL-3R, LL-3, LL-2, and UL-2R

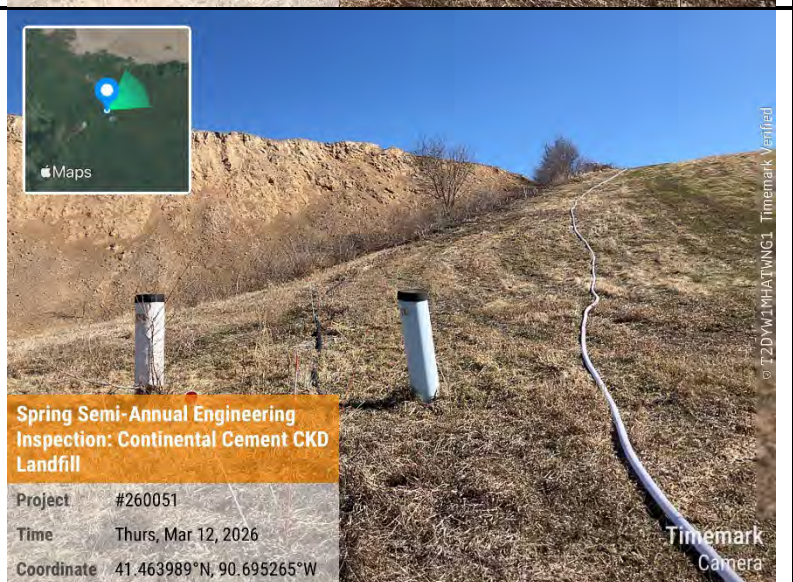
| <b>Photo No.</b><br><b>11</b> | <b>Date:</b><br>03/12/2026 |

**Description:**  
View looking at lysimeters LL-1 and UL-1 with the edge of the clay berm of the Phase II Active cell and the edge of the western slope of Phase I Closed Cell.

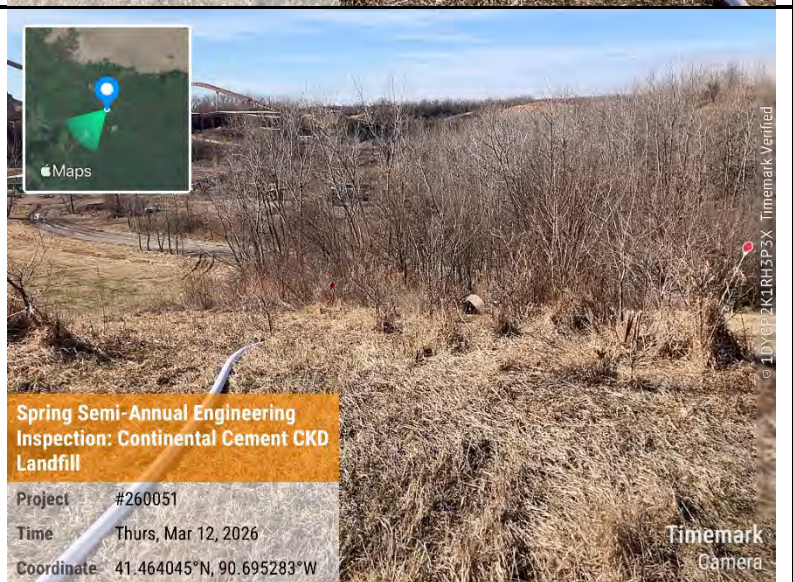
| <b>Photo No.</b><br><b>12</b> | <b>Date:</b><br>03/12/2026 |

**Description:**  
View looking downgradient of lysimeters LL-1 and UL-1 towards L-sump.

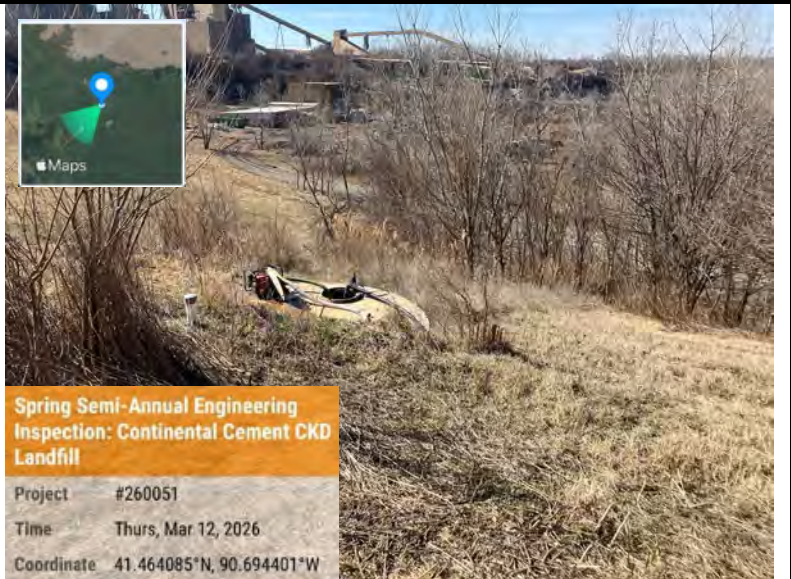
| <b>Photo No.</b><br>13 | <b>Date:</b><br>03/12/2026 |

**Description:**  
View looking at L-sump. Sump was inactive at time of inspection but set up to push collected leachate to Phase II Active cell.

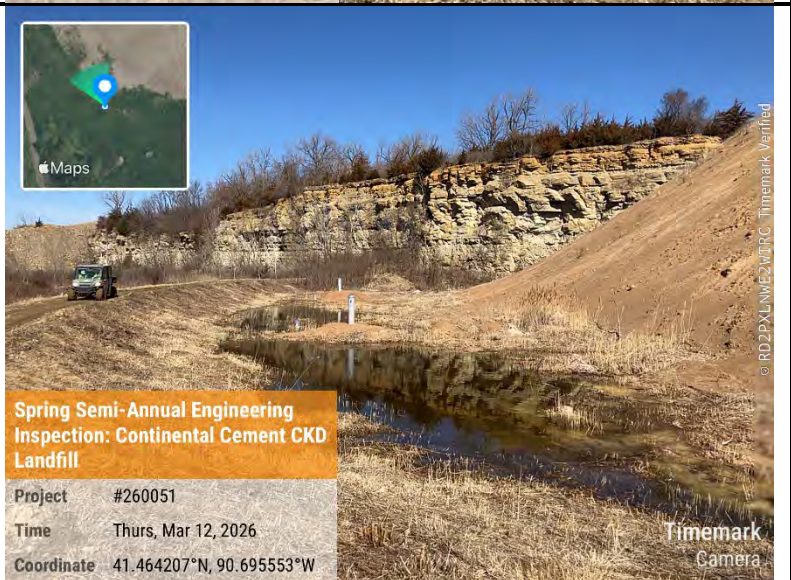
| <b>Photo No.</b><br>14 | <b>Date:</b><br>03/12/2026 |

**Description:**  
View looking at lysimeters at the base of the clay berm of the Phase II Active Cell. Pooled water is stormwater runoff that accumulates.

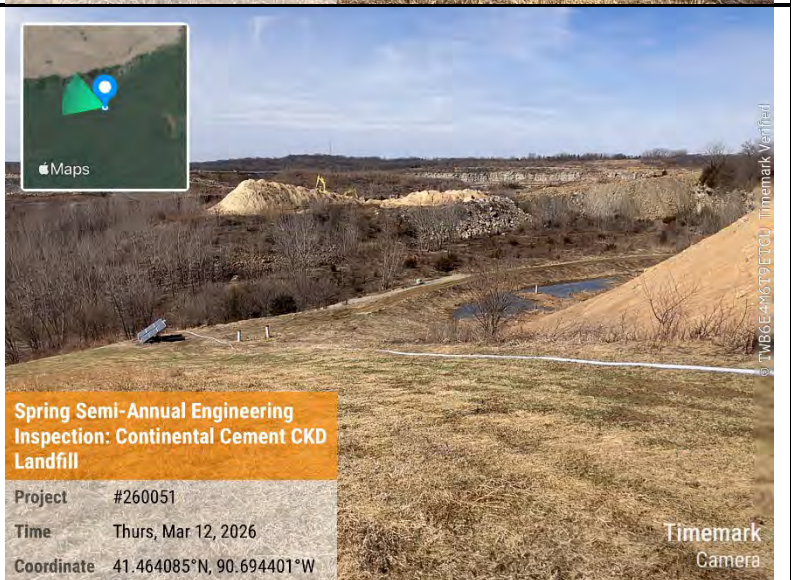
| <b>Photo No.</b><br>15 | <b>Date:</b><br>03/12/2026 |

**Description:**  
View looking at the edge of the Phase I Closed cell.

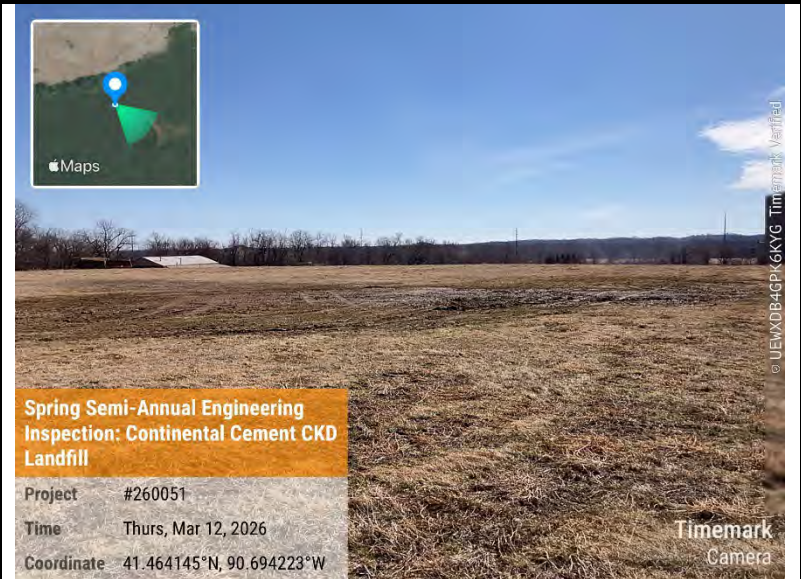
| <b>Photo No.</b><br>16 | <b>Date:</b><br>03/12/2026 |

**Description:**  
View looking at the Phase I Closed Cell. No pooled water was observed. Seeding and mowing of the closed cells are planned for this spring.

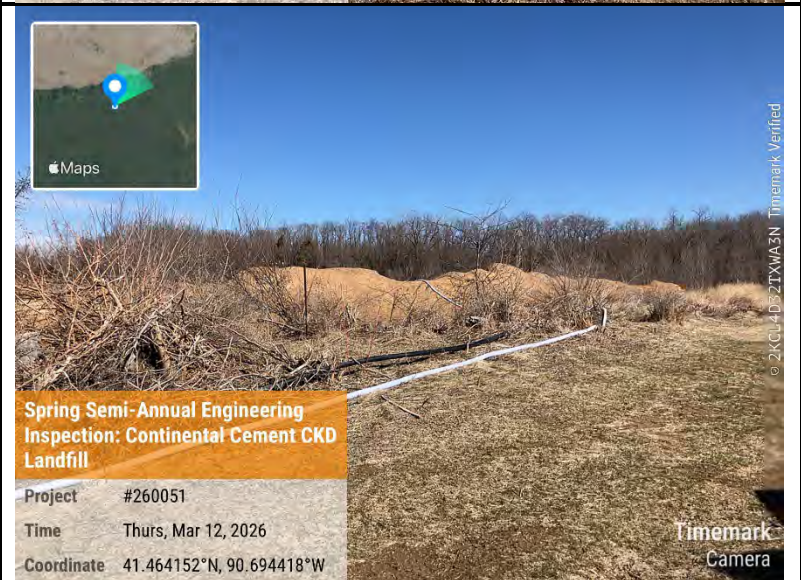
| <b>Photo No.</b><br>17 | <b>Date:</b><br>03/12/2026 |

**Description:**  
View looking at the edge of the phase I closed cell and the phase II active cell. Also in view is the leachate pipe.

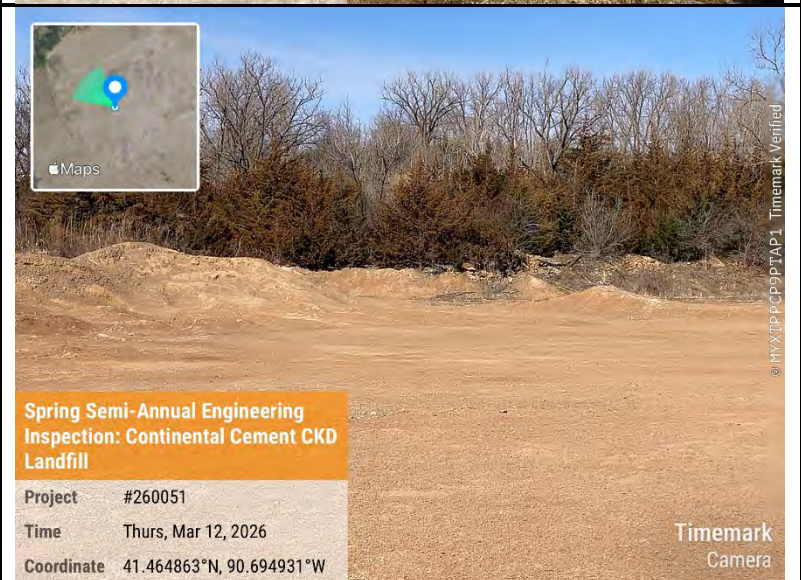
| <b>Photo No.</b><br>18 | <b>Date:</b><br>03/12/2026 |

The Phase II Active Cell's working slope was stable with minor erosion rills observed. The clay berm at the base of the depositional slope was intact.

**Description:**  
View looking at the Phase II Active cell.

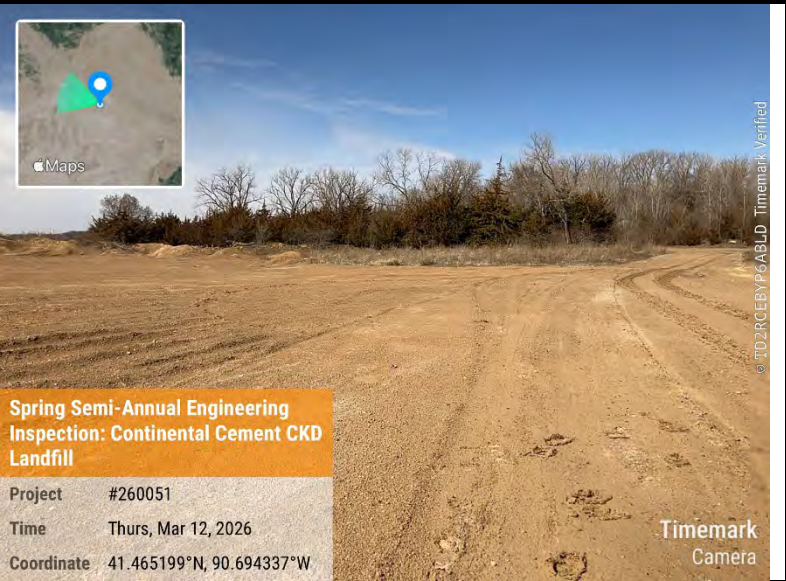
| <b>Photo No.</b><br>19 | <b>Date:</b><br>03/12/2026 | <div style="position: absolute; top: 10px; right: 10px; font-size: 8px;">© TD2RCEBYP6ABJD Timemark Verified</div> <div style="position: absolute; bottom: 10px; right: 10px; font-size: 10px;">Timemark<br/>Camera</div> |

| <b>Description:</b><br>View looking at the Phase II Active cell. | | |

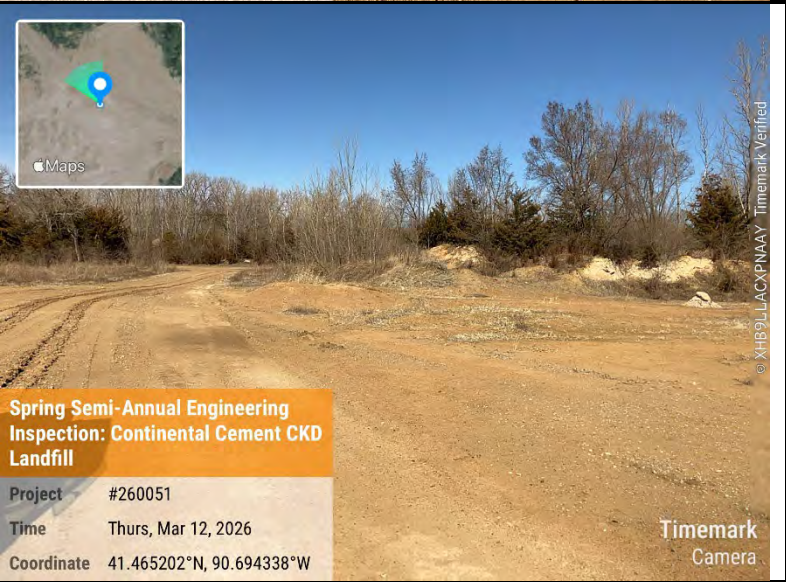
| <b>Photo No.</b><br>20 | <b>Date:</b><br>03/12/2026 | <div style="position: absolute; top: 10px; right: 10px; font-size: 8px;">© X4B9JLLACXNAAY Timemark Verified</div> <div style="position: absolute; bottom: 10px; right: 10px; font-size: 10px;">Timemark<br/>Camera</div> |

| <b>Description:</b><br>View looking at the Phase II Active cell. | | |

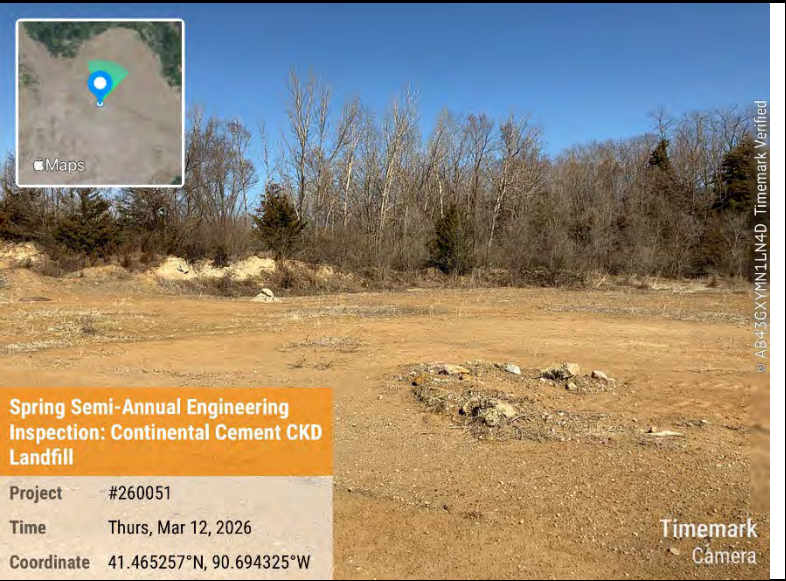
| <b>Photo No.</b><br>21 | <b>Date:</b><br>03/12/2026 | <div style="position: absolute; top: 10px; right: 10px; font-size: 8px;">© AB43CXYM1LN4D Timemark Verified</div> <div style="position: absolute; bottom: 10px; right: 10px; font-size: 10px;">Timemark<br/>Camera</div> |

| <b>Description:</b><br>View looking at the Phase II Active cell. | | |

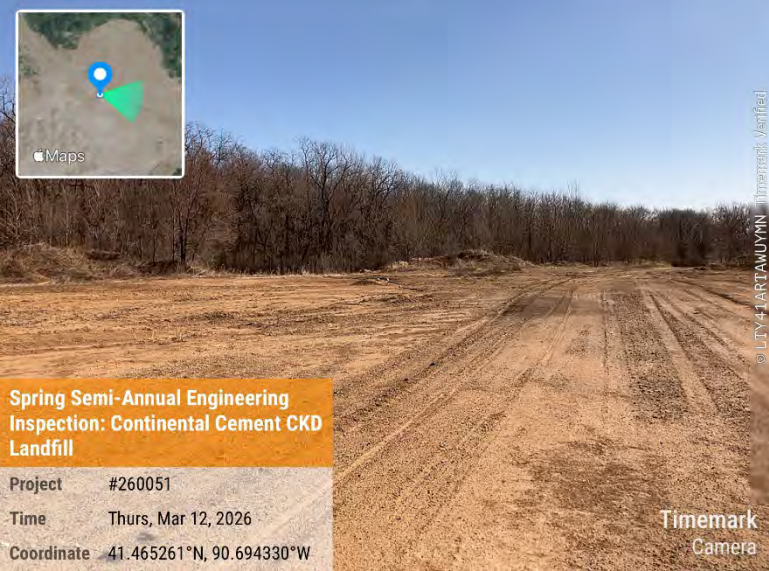
| <b>Photo No.</b><br>22 | <b>Date:</b><br>03/12/2026 | <div style="position: absolute; top: 10px; right: 10px; font-size: 8px;">© LTY4JARTAWUYN Timemark Verified</div> <div style="position: absolute; bottom: 10px; right: 10px; font-size: 10px;">Timemark<br/>Camera</div> |

| <b>Description:</b><br>View looking at the Phase II Active cell. | | |

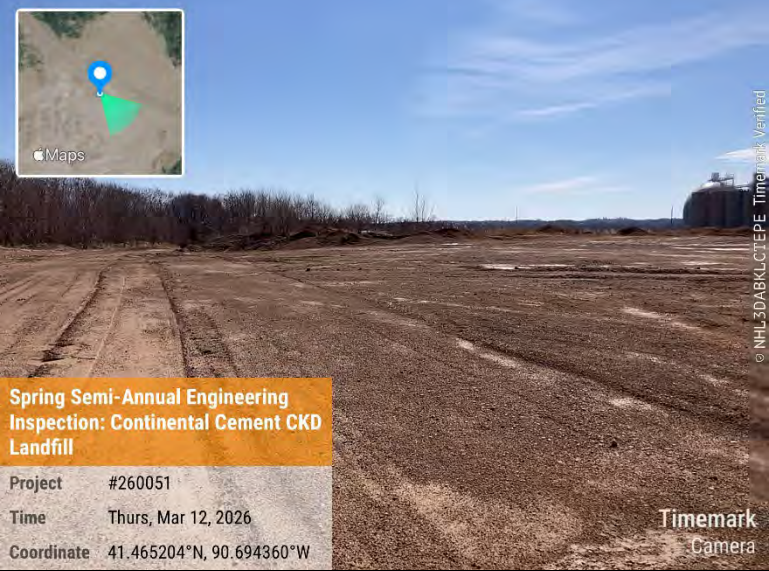
| <b>Photo No.</b><br>23 | <b>Date:</b><br>03/12/2026 | <div style="position: absolute; top: 10px; right: 10px; font-size: 8px;">© NHL3DABKLCCTEPE Timemark Verified</div> <div style="position: absolute; bottom: 10px; right: 10px; font-size: 10px;">Timemark<br/>Camera</div> |

| <b>Description:</b><br>View looking at the Phase II Active cell. | | |

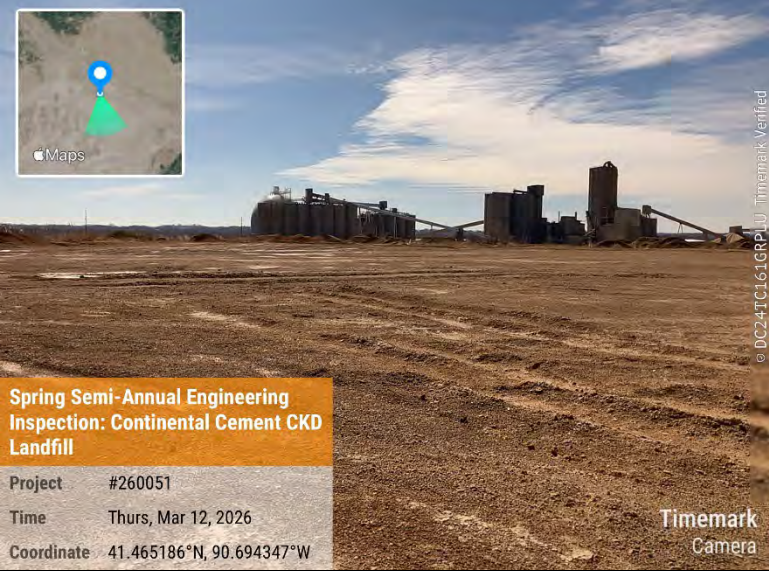
| <b>Photo No.</b><br>24 | <b>Date:</b><br>03/12/2026 | <div style="position: absolute; top: 10px; right: 10px; font-size: 8px;">© DC24TC161GRPU Timemark Verified</div> <div style="position: absolute; bottom: 10px; right: 10px; font-size: 10px;">Timemark<br/>Camera</div> |

| <b>Description:</b><br>View looking at the Phase II Active cell. | | |

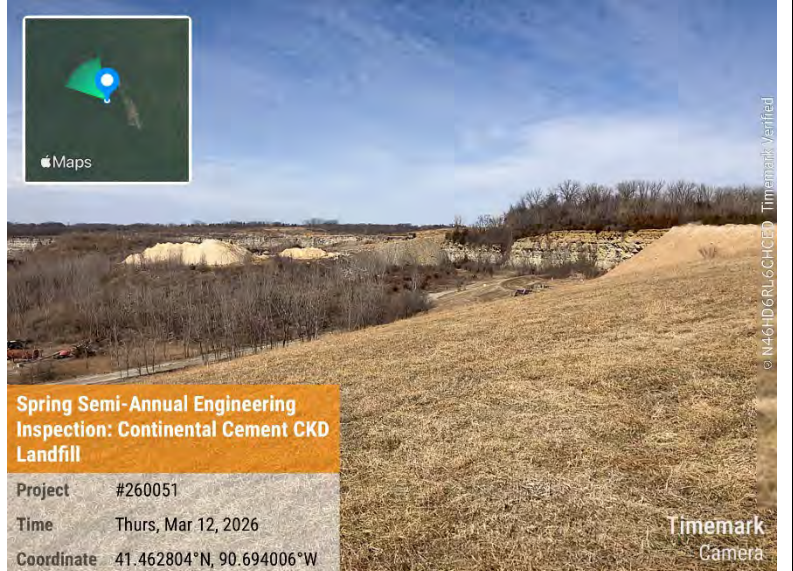
| <b>Photo No.</b><br><b>25</b> | <b>Date:</b><br>03/12/2026 |

**Description:**  
View looking at Phase I Closed cell with quarry operations in the background. No bare spots or pooling water observed.

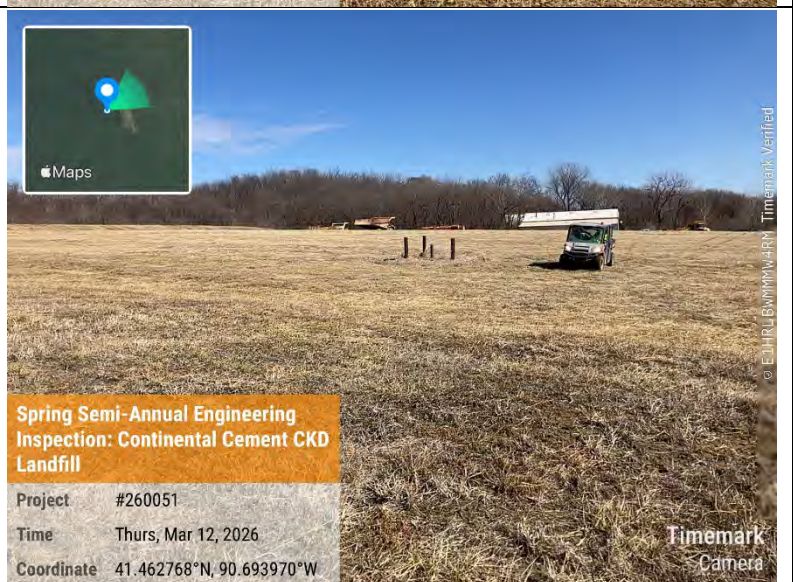
| <b>Photo No.</b><br><b>26</b> | <b>Date:</b><br>03/12/2026 |

**Description:**  
View looking at close cell with plant operations in the background. Monitoring well Mw-9 in view.

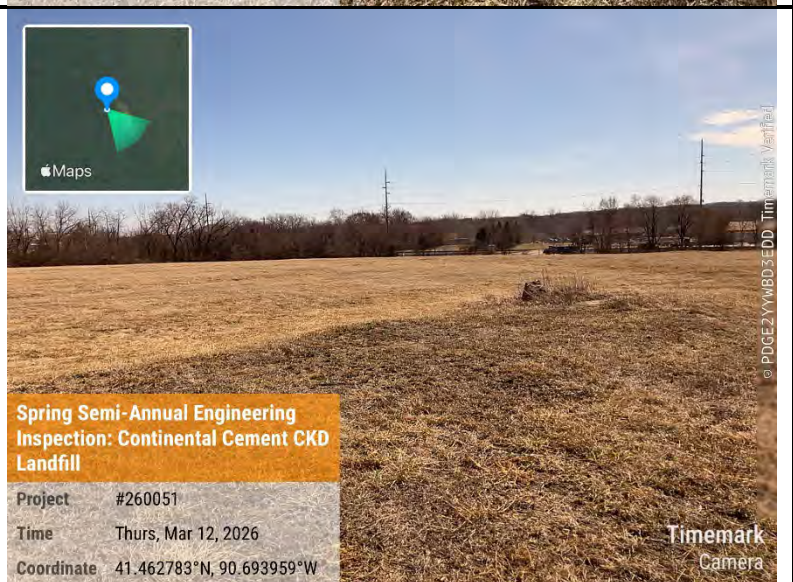
| <b>Photo No.</b><br><b>27</b> | <b>Date:</b><br>03/12/2026 |

**Description:**  
View looking at close cell with plant operation in the background. No bare spots or pooling water observed.

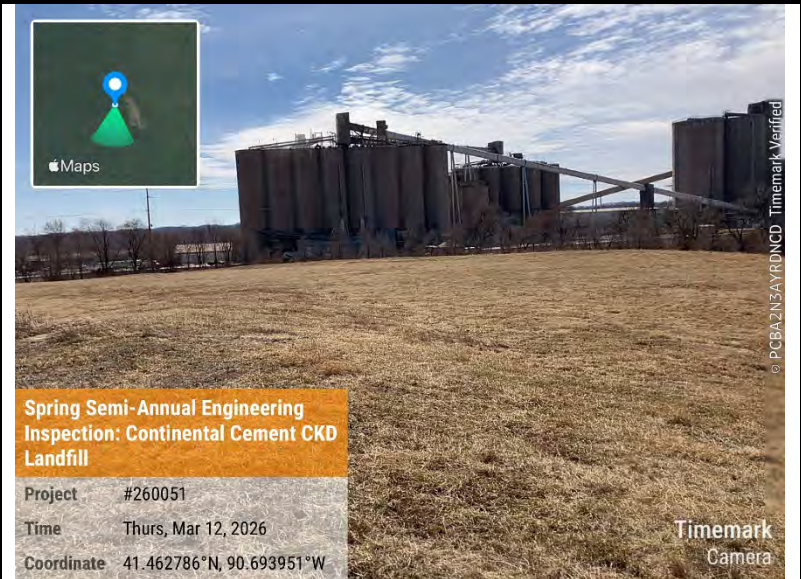
| <b>Photo No.</b><br>28 | <b>Date:</b><br>03/12/2026 |

**Description:**  
View looking at close cell with plant operation in the background. No bare spots or pooling water observed.

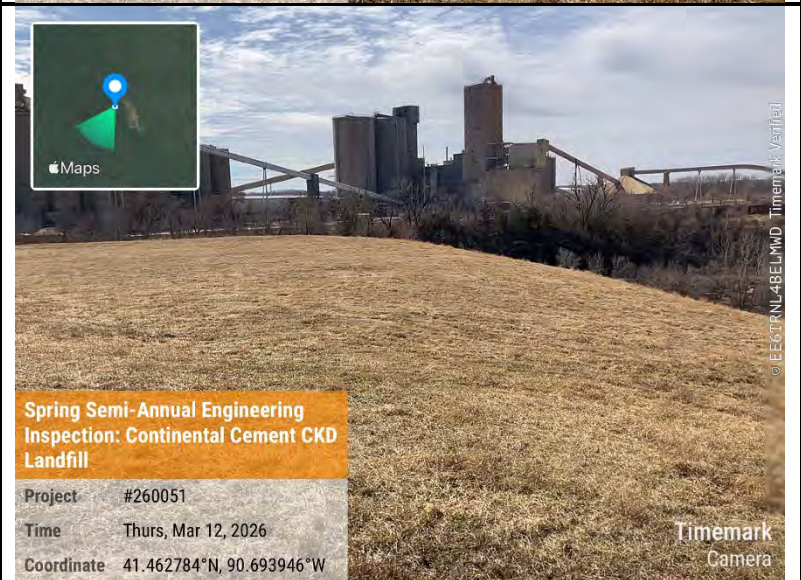
| <b>Photo No.</b><br>29 | <b>Date:</b><br>03/12/2026 |

**Description:**  
View looking at close cell with plant operation in the background. No bare spots or pooling water observed.

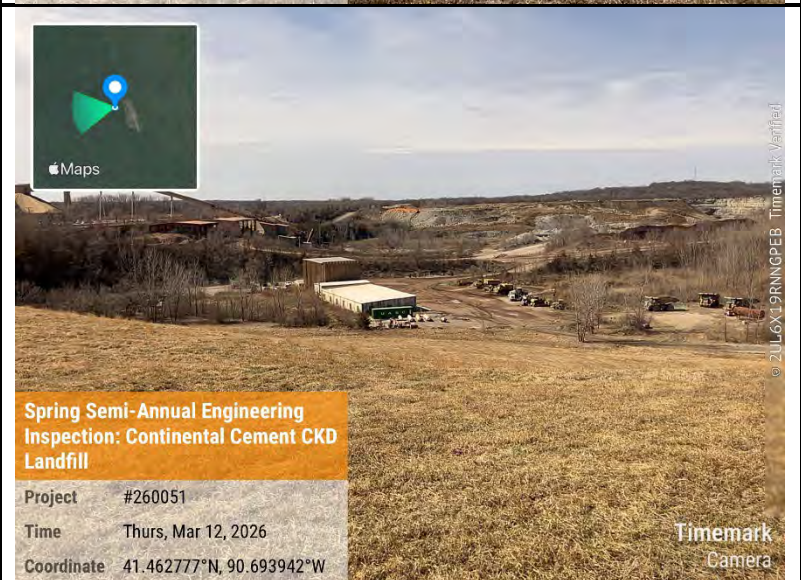
| <b>Photo No.</b><br>30 | <b>Date:</b><br>03/12/2026 |

**Description:**  
View looking at the west downgradient slope of the closed cell, with the Quarry Building in view.

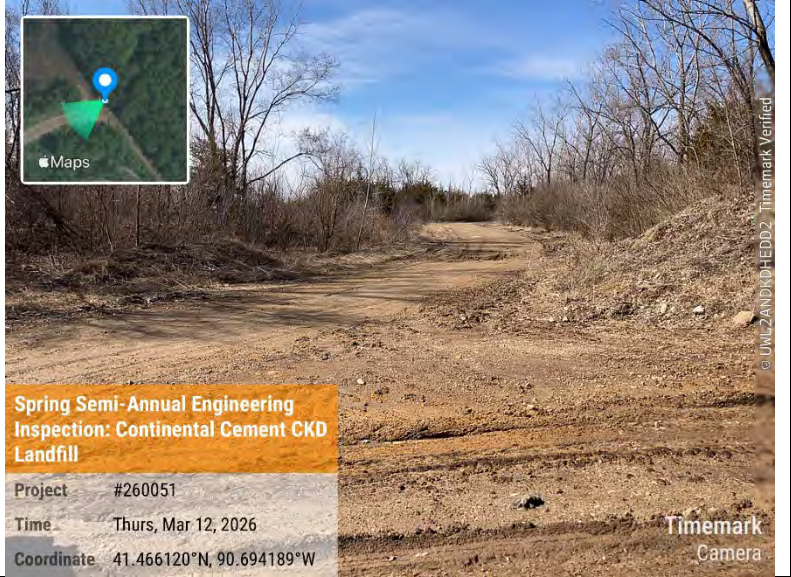
**Photo No.**  
31

**Description:**  
View of an access road leading to Phase II Active cell.

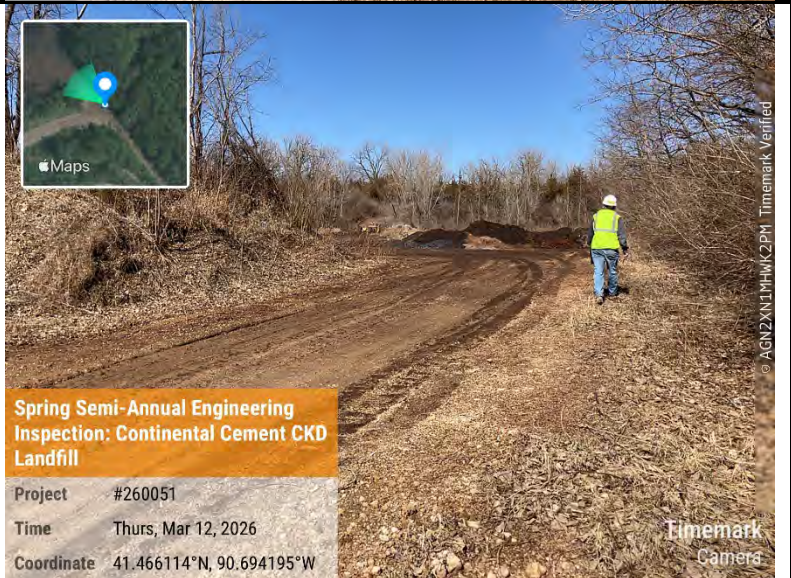
**Photo No.**  
32

**Description:**  
View of access road traveling north to Iron Mill, north of monitoring well MW-21.

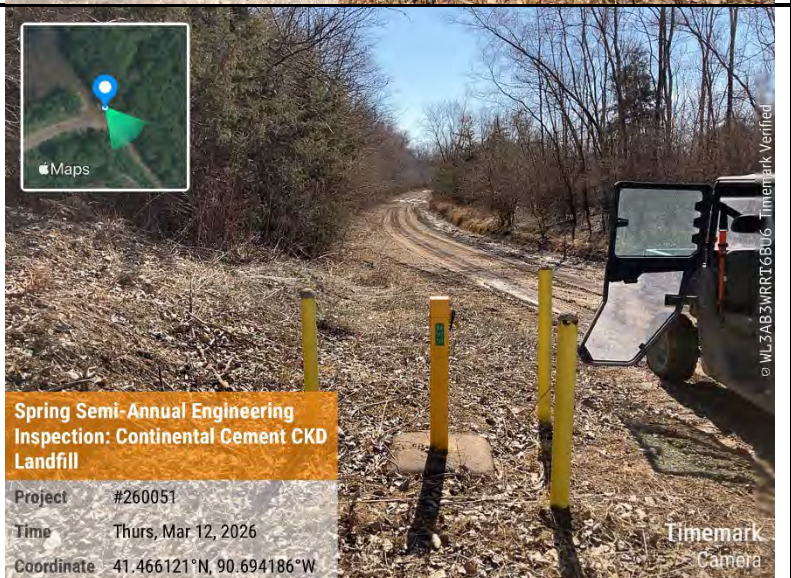
**Photo No.**  
33

**Description:**  
View of east access road next to monitoring well MW-21.

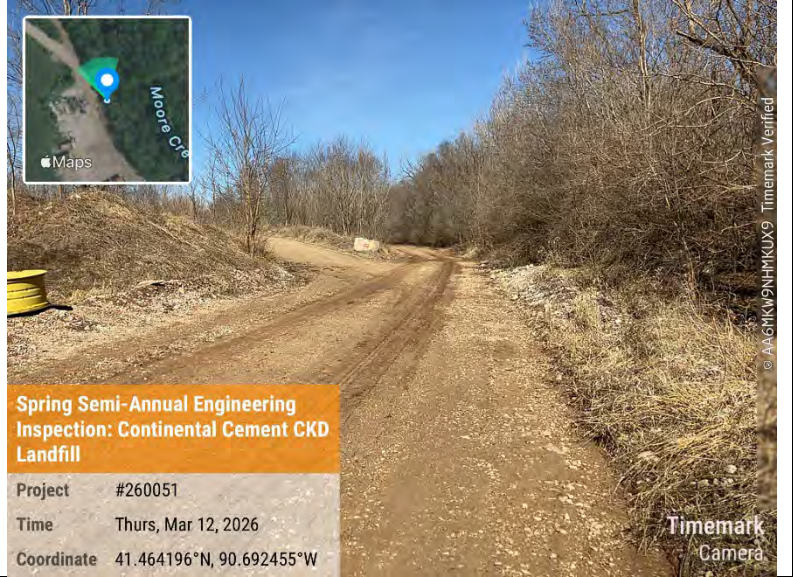
| <b>Photo No.</b><br><b>34</b> | <b>Date:</b><br>03/12/2026 |

**Description:**  
View of east access road north of the earthwork contractor area on east of the landfill.

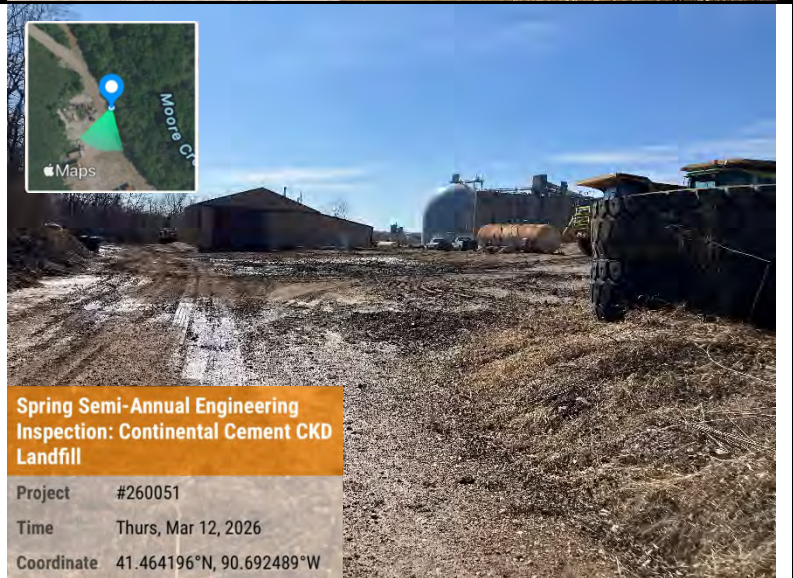
| <b>Photo No.</b><br><b>35</b> | <b>Date:</b><br>03/12/2026 |

**Description:**  
View of east access road traveling south with the earthwork contractor area and parking in view.

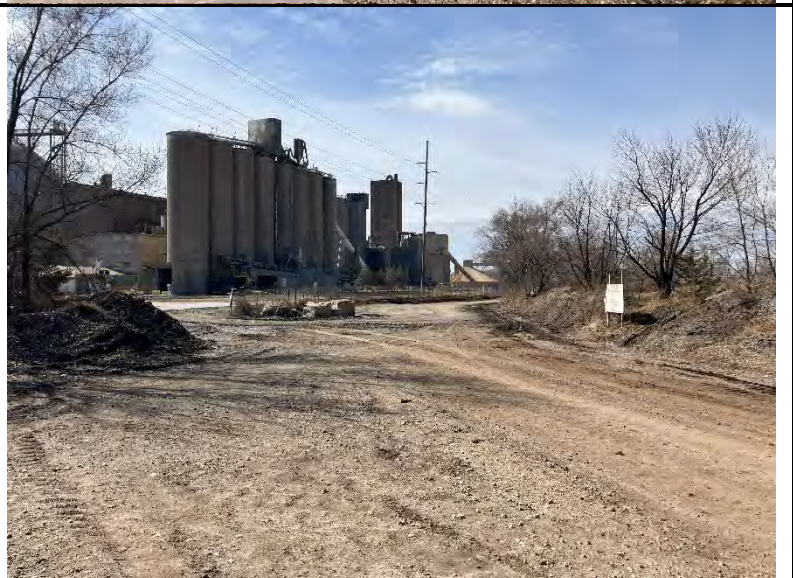
| <b>Photo No.</b><br><b>36</b> | <b>Date:</b><br>03/12/2026 |

**Description:**  
View of access road leading out of the landfill area.
