ANNUAL REVIEW
BLACK HAWK COUNTY SANITARY LANDFILL
BLACK HAWK COUNTY, IOWA
IDNR #7-SDP-1-75P
April 14, 2026

Attachment 2
Engineering Inspection Report Photo Log

Client's Name: Black Hawk County Solid Waste Commission	Site Location: Black Hawk County Sanitary Landfill	Project No. 26B009.00
---	--	---------------------------------

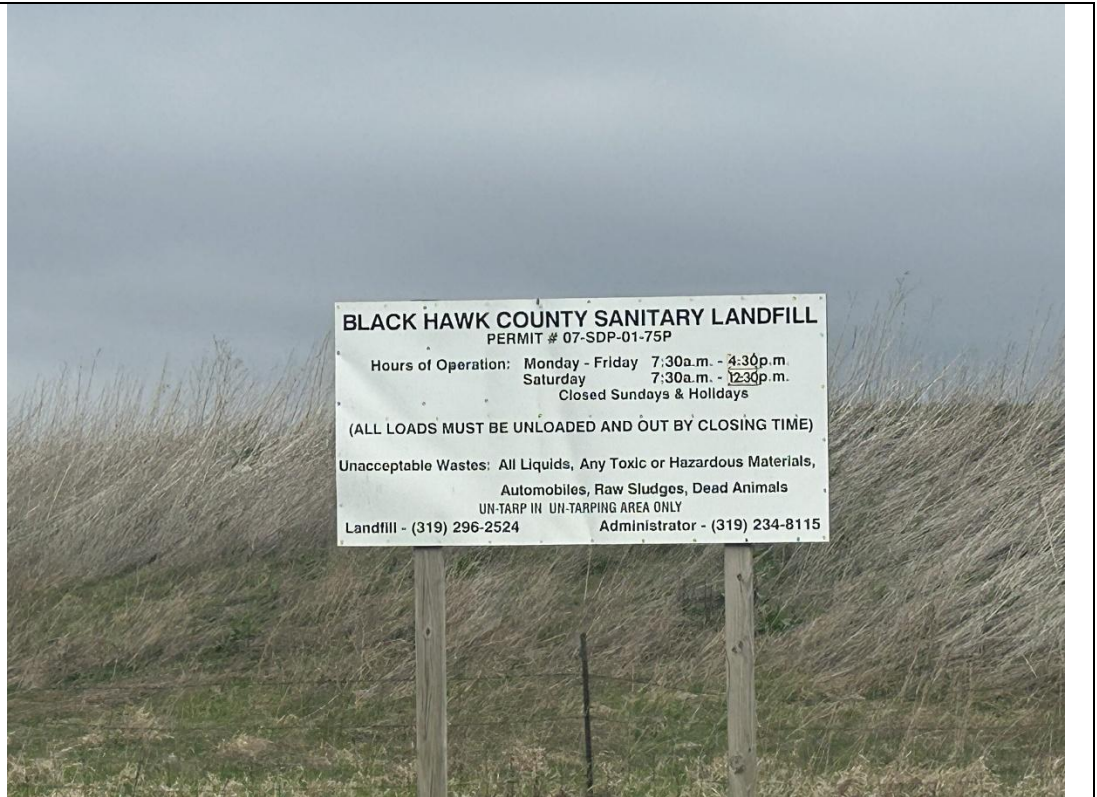
Photo No. 1	Date: 4/14/26
Direction Photo Taken: N/A	
Photo Taken By: CGO	
Description: Entrance sign.

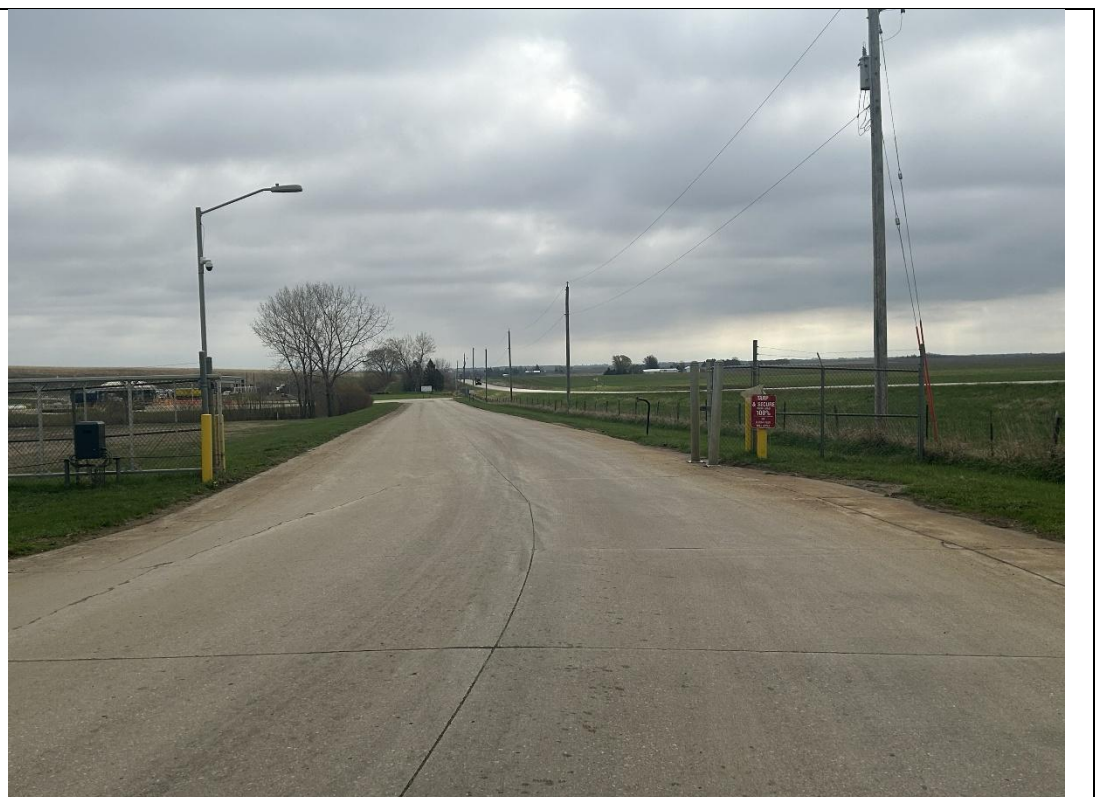
Photo No. 2	Date: 4/14/26
Direction Photo Taken: N/A	
Photo Taken By: CGO	
Description: Front gate.

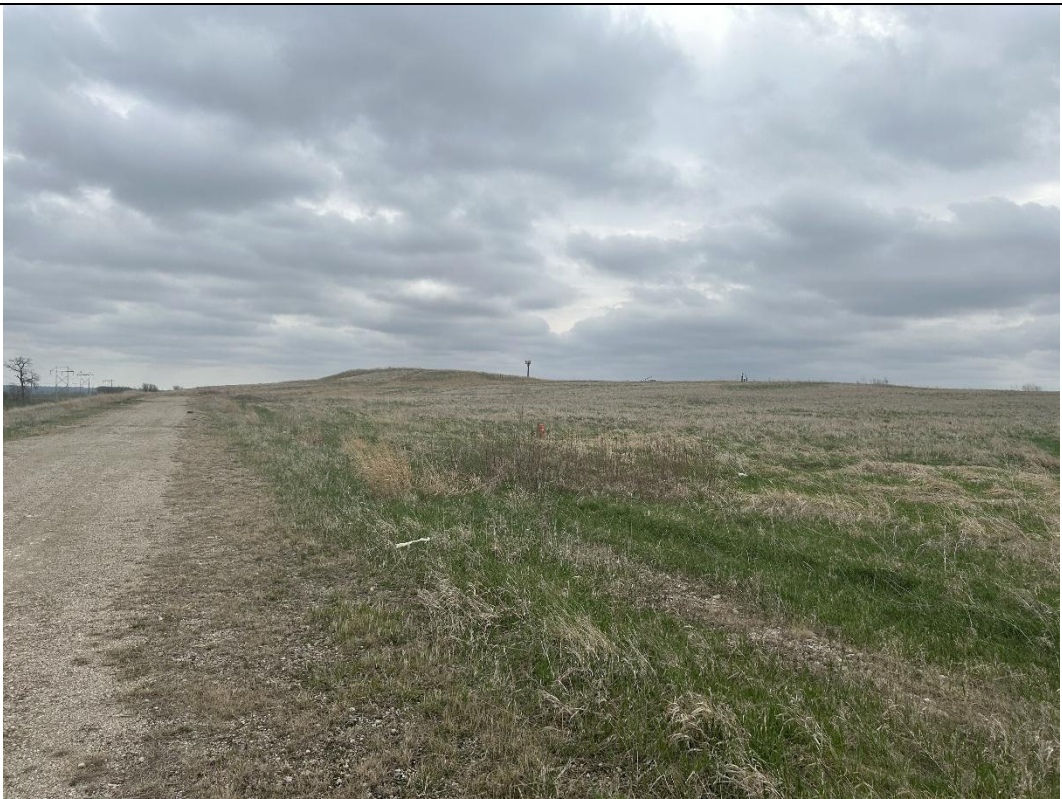
Photo No. 7	Date: 4/14/26

Area E looked good. Vegetation was thick. The access roads around this cell are in good condition. The final cover was mowed in fall 2024 and is planned to be mowed next in summer 2026.

Direction Photo Taken: N/A		
Photo Taken By: CGO		
Description: Area E final cover.

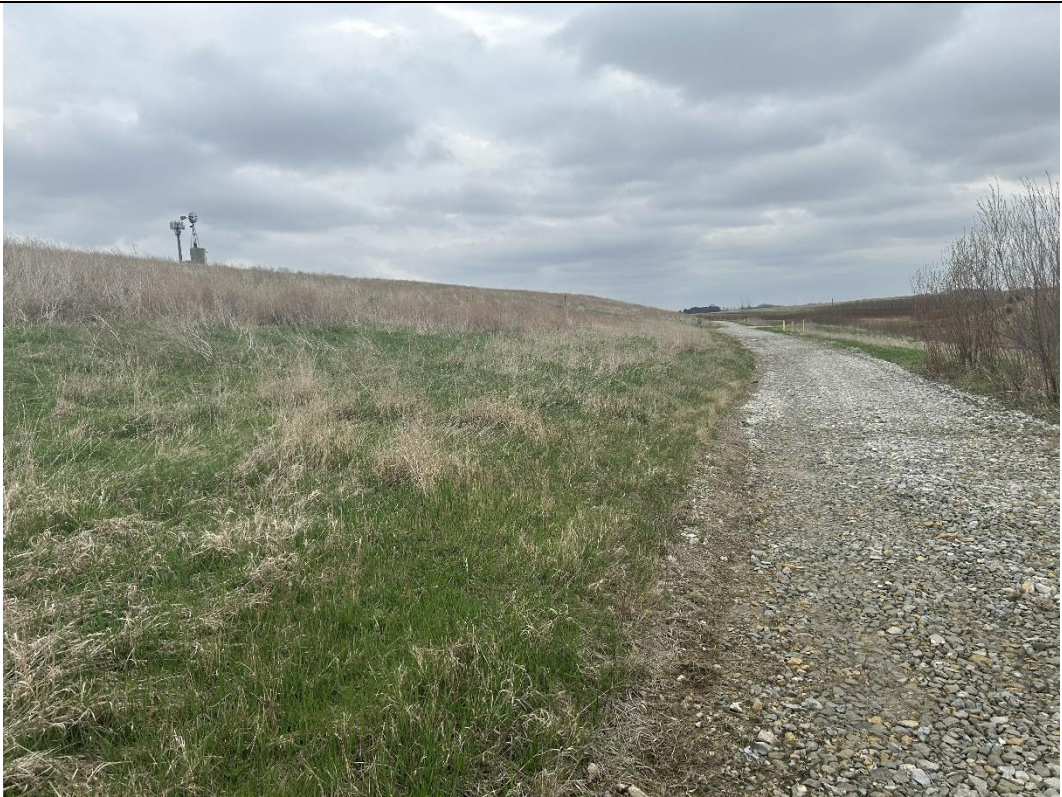
Photo No. 9	Date: 4/14/26

The overall condition of Cell X was good. Vegetation coverage was good, and erosion seemed to be minimal. The access roads around this cell are in good condition. The final cover was last mowed in fall 2024 and is planned to be mowed next in summer 2026.

Direction Photo Taken: N/A		
Photo Taken By: CGO		
Description: Cell X final cover.

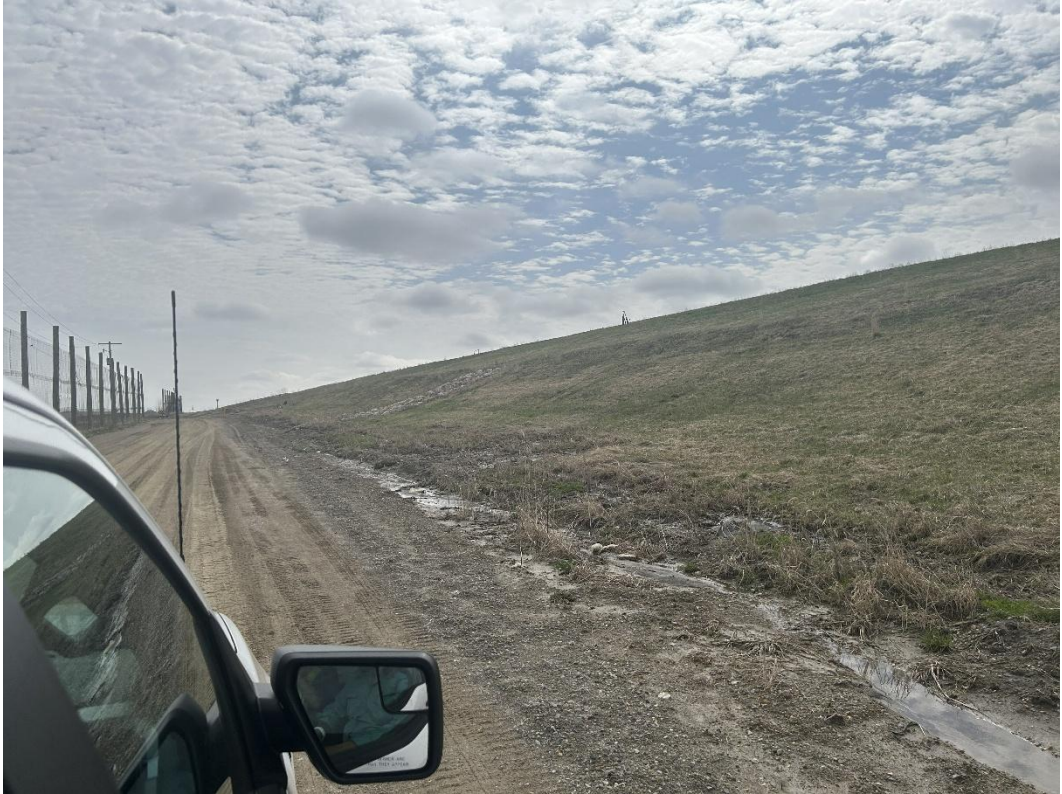
Photo No. 13	Date: 4/14/26

Cell W-2 has 8 ft of temporary cover and is in good condition.

Direction Photo Taken: N/A		
Photo Taken By: CGO		
Description: Cell W-2 temporary cover.
