Our ref.: 12666637-LTR-04

Spring 2026 Semi-Annual Engineering Inspection
Viking Pump Foundry Sand Landfill
Permit No. 7-SDP-12-89P-FSL

This letter serves as a semi-annual report of the engineering inspection, which follows the scope and format of previous reports. The spring 2026 semi-annual engineering inspection of the Viking Pump (Viking) Foundry Sand Landfill (landfill) located in Cedar Falls, Iowa was conducted by GHD Services Inc. (GHD) on April 21, 2026.

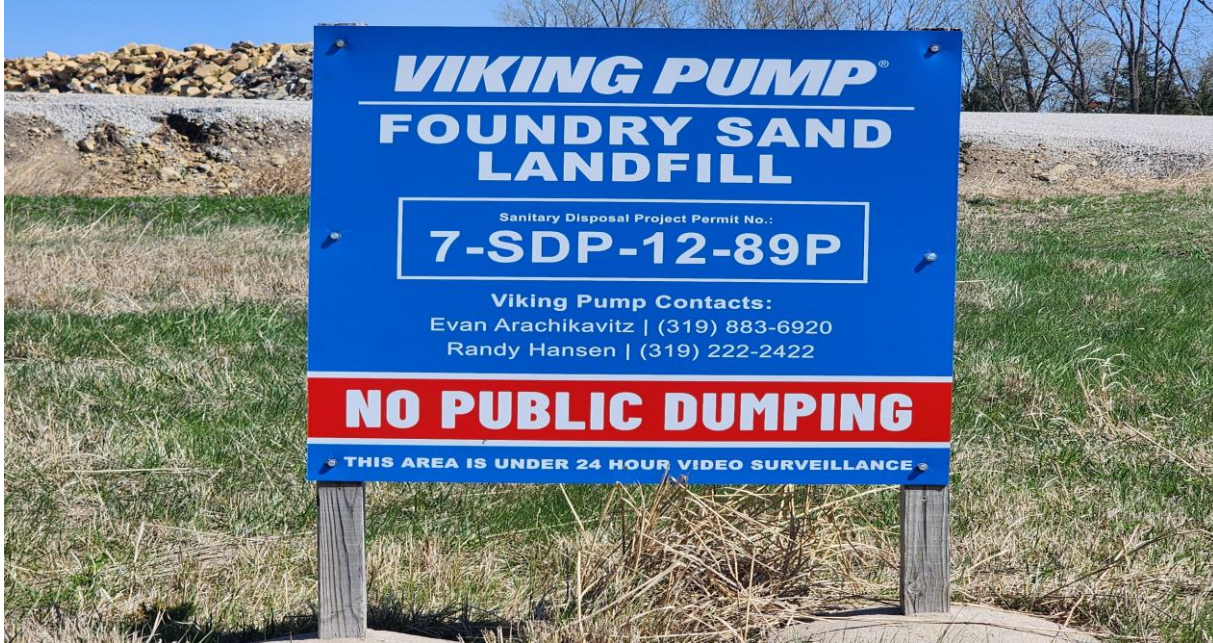
A new entrance sign was placed in 2026 (see photographic log included in Attachment 1).

Photo 1 New sign at entrance to the landfill.

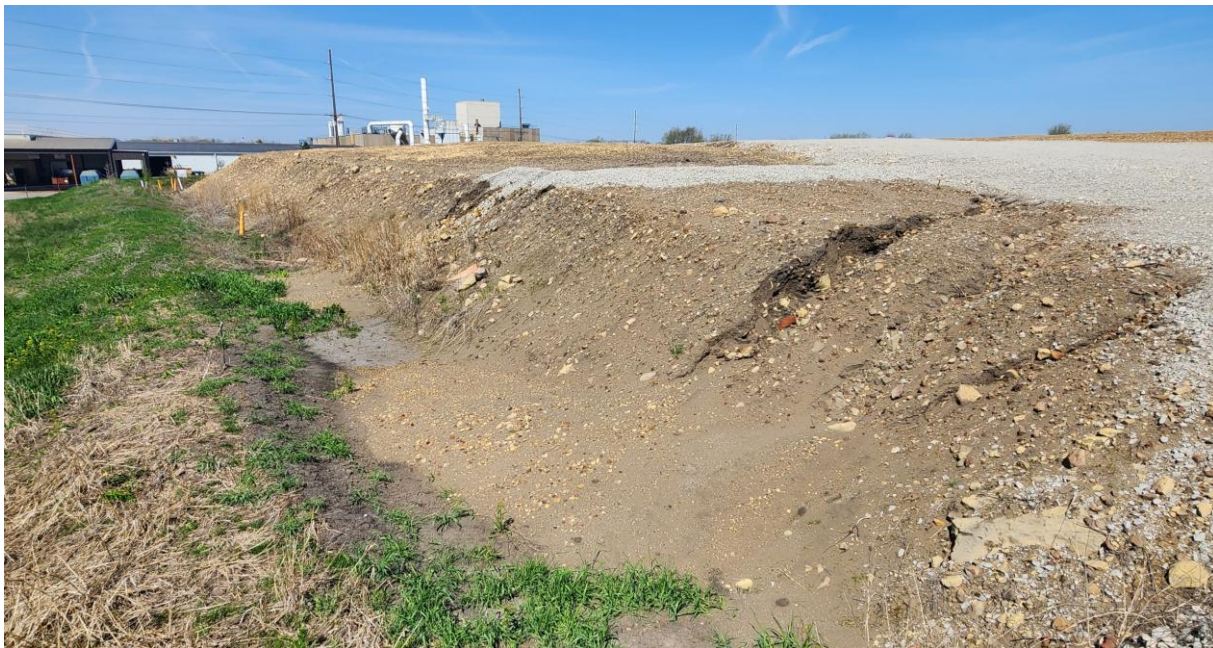
As specified in the approved Operations Plan, soil cover is not placed on the landfill. No problems with dust generation, runoff, or erosion outside the fill area were noted at the time of the inspection. Erosion of foundry sand into the low area inside the cell at the south perimeter was noted. This area was west of the access road. The eroded foundry sand was completely captured within the cell and minor regrading is planned to reduce run-off velocity and restore capacity at the toe of the slope to contain potential future erosion.

Photo 2 Area of foundry sand erosion into the low-lying perimeter of the cell. No evidence of a release outside the cell was observed.

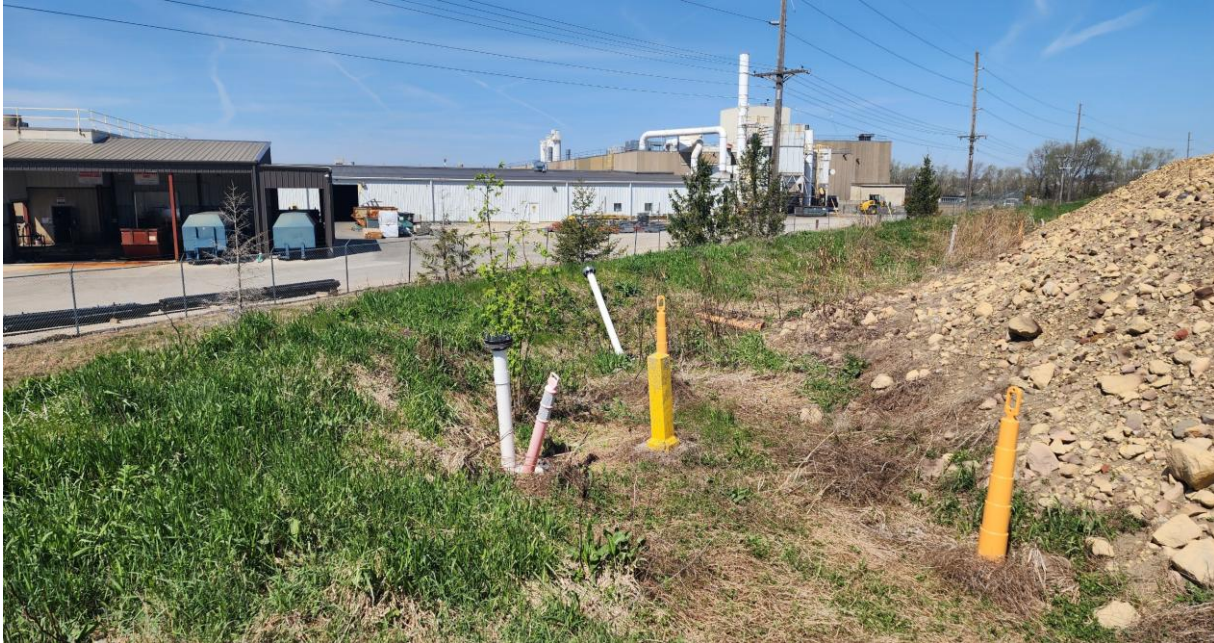
Two woody saplings were identified within the fill area and will be removed.

A leachate clean-out riser observed broken (no release of leachate) in fall 2025 was repaired.

Photo 3 The far white leachate clean-out riser was repaired since the October 2025 inspection. Photograph also shows one of the two woody saplings slated for removal.

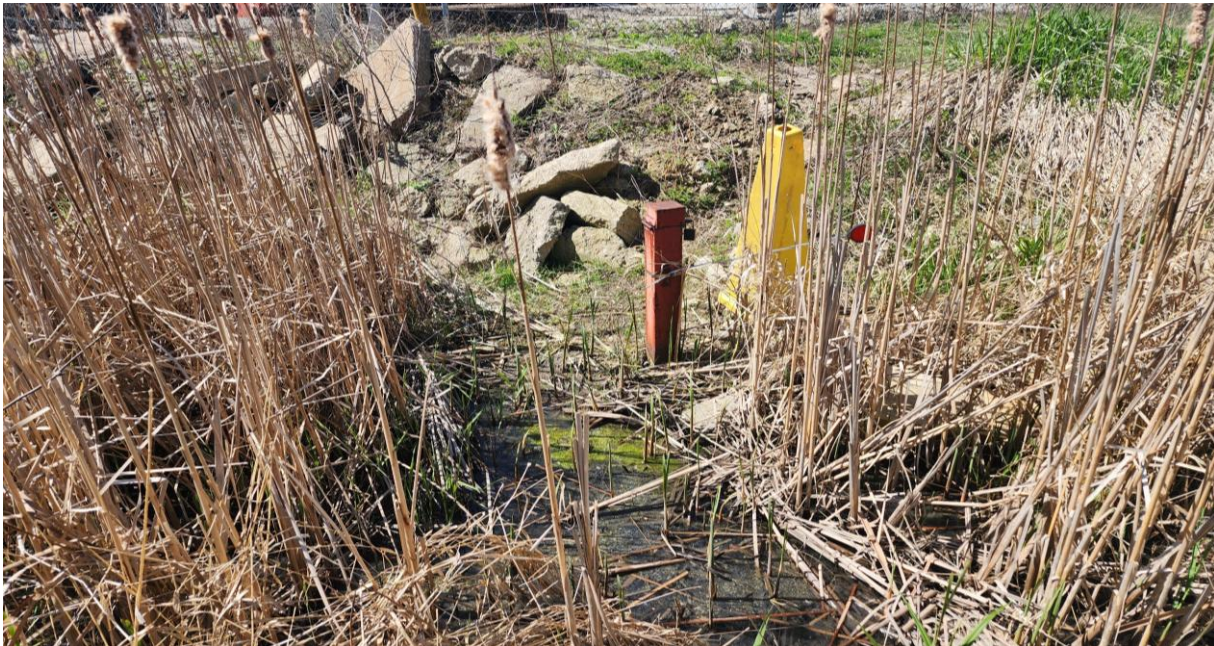
Photo 4 Standing water near monitoring well MW-15.

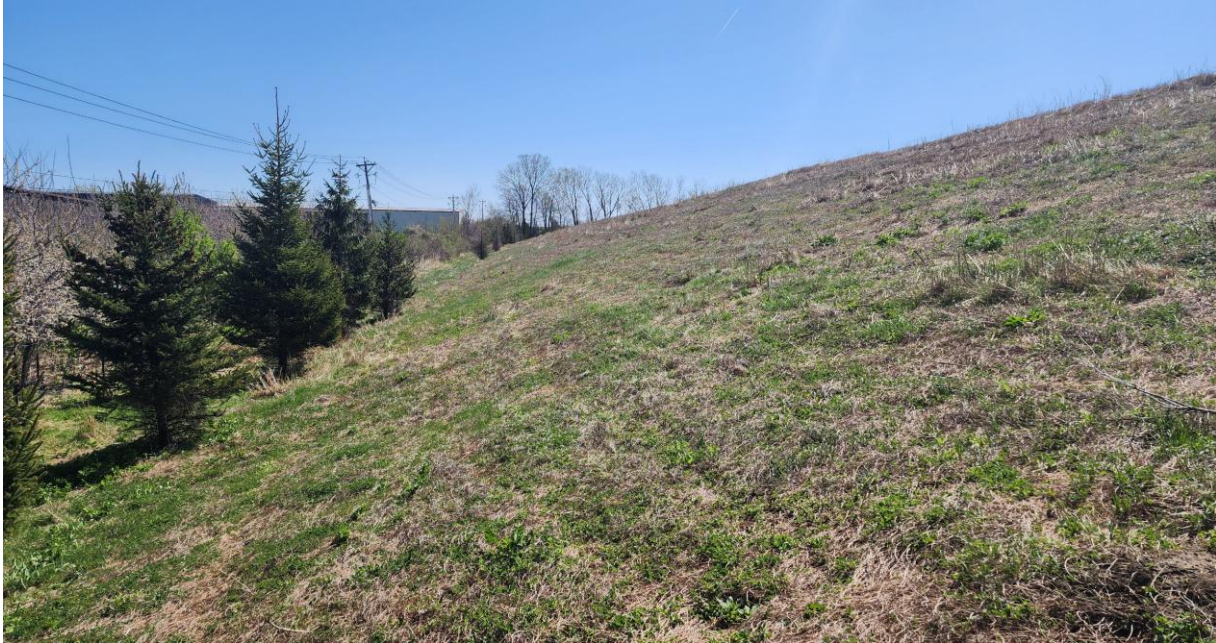
The landfill areas with final cover on the north and west sides of the landfill flow to the unnamed ditch west of the landfill. Surface water from the east flows to the south to a stormwater retention pond and leaves the Site at Viking Road and enters the City of Cedar Falls stormwater system. No erosion in drainage pathways was observed. Vegetation has been established and is in good condition.

Photo 5 Grass cover on north side of landfill, looking east.

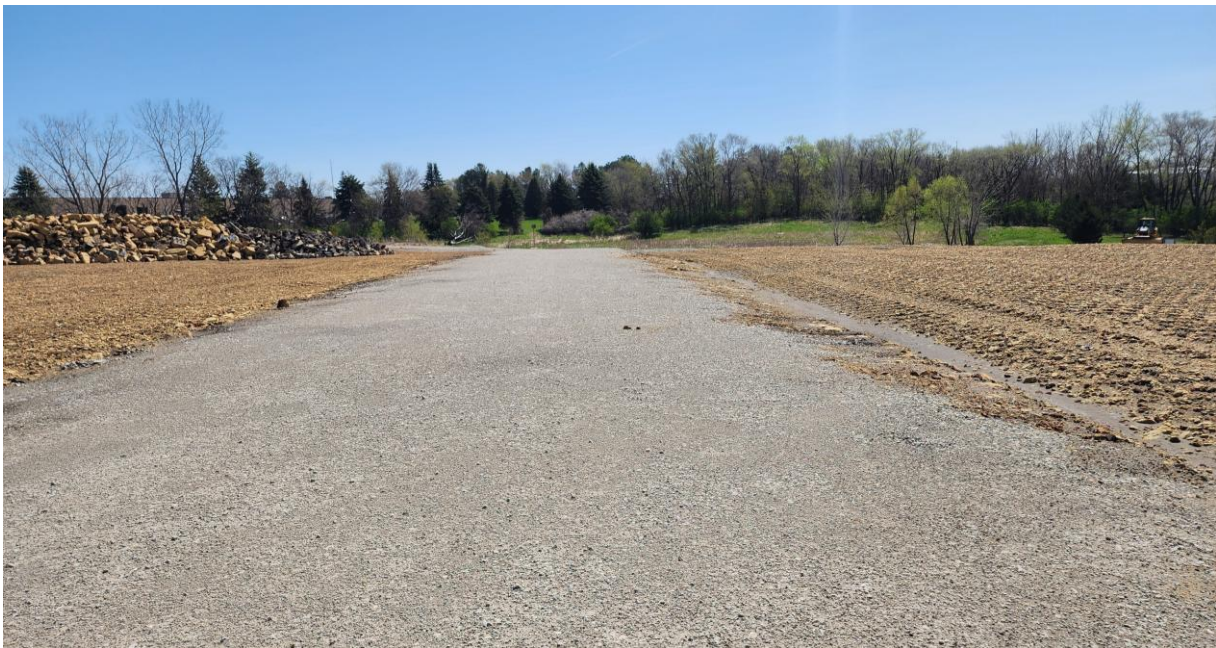
The gravel access roads within the landfill footprint, constructed in late 2023, remain in good condition. The access road into the Site remains free of foundry sand. The hammer head turnouts appear to be providing sufficient access for vehicle turning. As of the April 2026 inspection, crushed foundry sand has reached the level of the roads.

Photo 6 Gravel access road with crushed foundry sand near elevation of road surface. Staged blocks before brushing in the background. Looking east.
