RE: Follow-Up Inspection to the November 4, 2025 Annual Inspection – April 14, 2026 Site Inspection
Georgia-Pacific Gypsum North Recycle Pile; IDNR Permit #94-SDP-18-09;
Evergreen #9510

Georgia-Pacific Gypsum North Recycle Pile

Follow-Up Inspection to the Annual 2025 Inspection for the Georgia-Pacific Gypsum North Recycle Pile

Permit #94-SDP-18-09

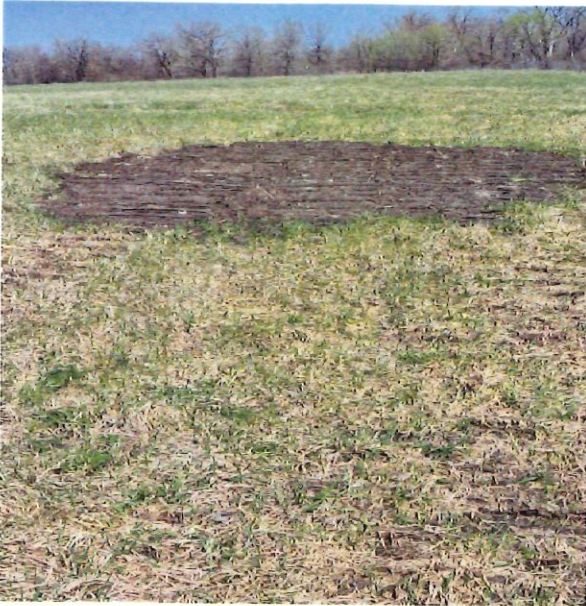
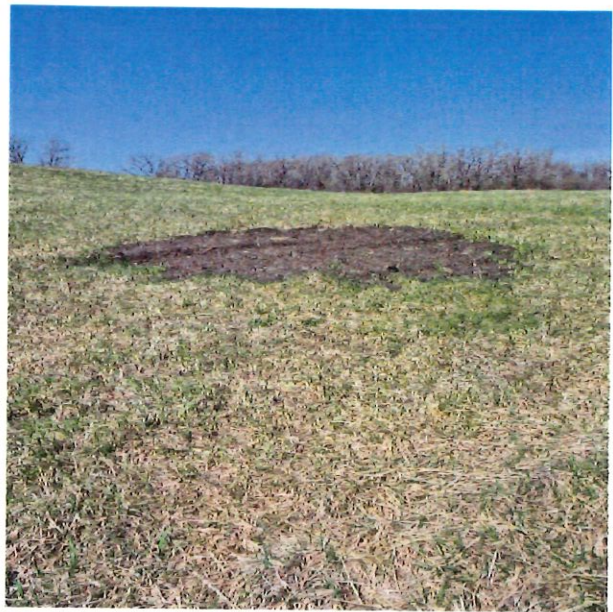
Sinkhole # 1

The cap and grass vegetation were found to be in excellent condition during this site visit. There were three sinkholes identified during the November 4, 2025, Annual Inspection. Georgia-Pacific completed repairs of these sinkholes on April 1, 2026. These sinkhole locations are shown on the April 14, 2026, Inspection Plat and labeled as sinkhole #1, #2, and #3. The sinkhole that was repaired in December 2023 showed no evidence of new settlement during this visit. Georgia-Pacific will continue to monitor these sinkhole locations for new settlement and repair when needed. There were no other areas of settlement or erosion noted during this site visit.

- There were three new sinkholes identified during the November 4, 2025, Annual Inspection. Georgia-Pacific completed repairs of these sinkholes on April 1, 2026. The sinkhole locations are shown on the April 14, 2026 Inspection Plat and labeled as sinkhole #1, #2, and #3. Photographic documentation of the repairs has been included for Department review. The sinkhole repaired in December 2023 showed no evidence of new settlement during this visit. There were no other areas of settlement or erosion noted during this site visit. The grass vegetation was thick, plush, green and growing. There were no areas of sparse vegetation or erosion noted.
- Drainage was positive, and there are no signs of storm water draining onto the site.

- Monitor and repair all settled areas or sinkholes as they occur and maintain site drainage per the final grading plan.
- Reseed when necessary to maintain dense vegetative cover.
- Mow site once annually.
