**RE: SEMI-ANNUAL INSPECTION – SPRING, 2026
RURAL IOWA SLF
IDNR PERMIT #42-SDP-1-72P
VERTICAL EXPANSION AREA - CLOSED
HORIZONTAL EXPANSION AREA - ACTIVE
HLW PN 6006-26A.750**

SPRING 2026 INSPECTION

RURAL IOWA SANITARY LANDFILL
ELDORA, IOWA

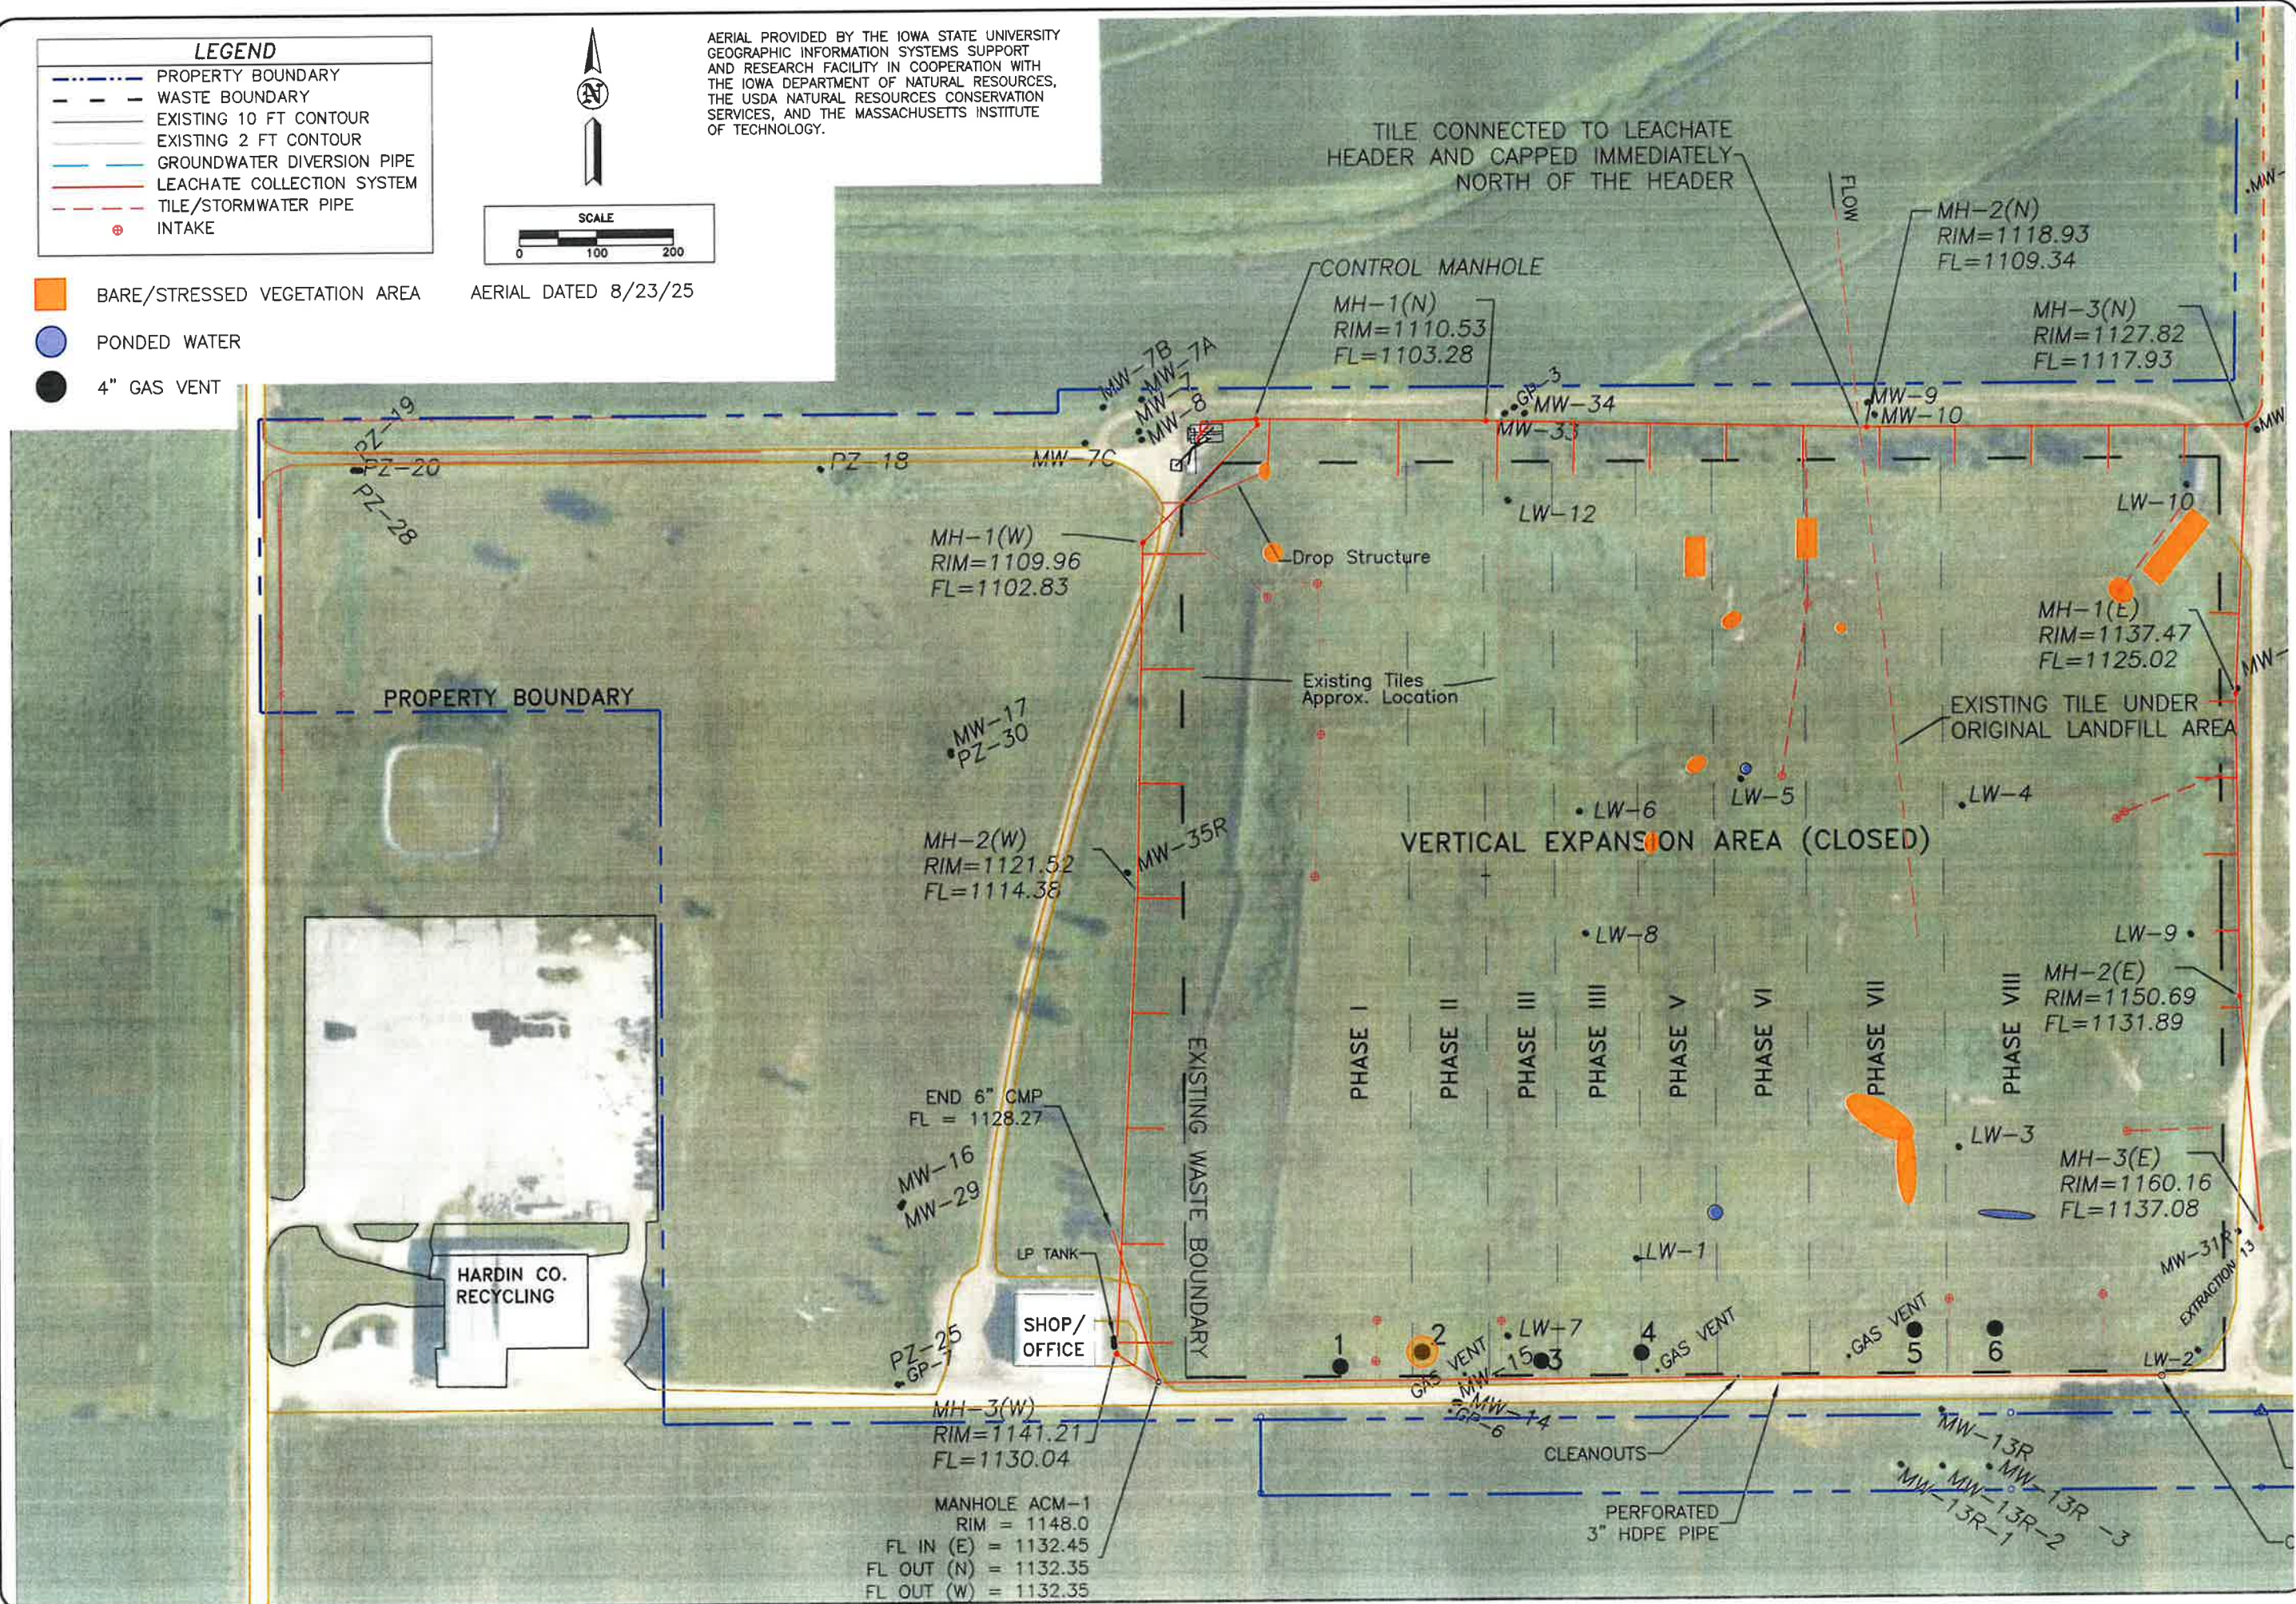
FIGURE: 1

Vegetation is established on the majority of the Original Landfilling Area; however, there are numerous areas on the cap where sparse vegetation/bare spots were noted. The approximate locations of the most significant stressed areas are shown on the attached figure.

Several areas of ponded water were noted in the closed area. The approximate locations of the ponded areas are shown on the attached figure.
