July 9, 2026

RE: Tire Processing Facility Inspection  
Liberty Tire Recycling, 1914 E. Euclid, Des Moines, IA  
Sanitary Disposal Project Permit #77-WTM-01-96P-PRT

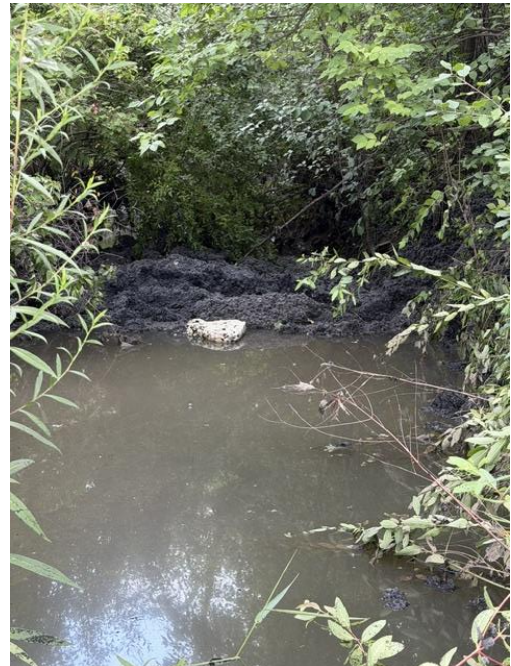
- Large piles of crumb rubber were visible in the stream east of the driveway. Additionally, small amounts of crumb rubber were observed along the stream where it goes underground on the northwest corner of Euclid Avenue and Delaware Avenue.

1. Immediately remove crumb rubber that has been deposited in the stream.
2. Replace the storm water pump that was located at the south west corner of the facility.
3. Ensure both storm water pumps are present and functioning, with filter bags in place, to discharge any stormwater from this site as required by your permit.
4. Ensure that the silt fence is in place and functional along the south and east perimeter as required by your permit.
