**Re: Continental Cement Company, LLC's Responses to the IDNR's Comment  
Letter Dated May 14, 2026**

We write this letter in response to the IDNR's comment letter on Continental Cement Company, LLC's ("Continental") 2025 Annual Water Quality Report, Leachate Collection System Performance Evaluation Report, and Update to the Remedial Action Mitigation Plan (Doc. 117124), and the IDNR's comments on Continental's Fall 2025 Engineering Inspection Report (Docs. 114687, 115273) and 2026 Spring Semi-Annual Engineering Inspection Report (Doc. 117132).

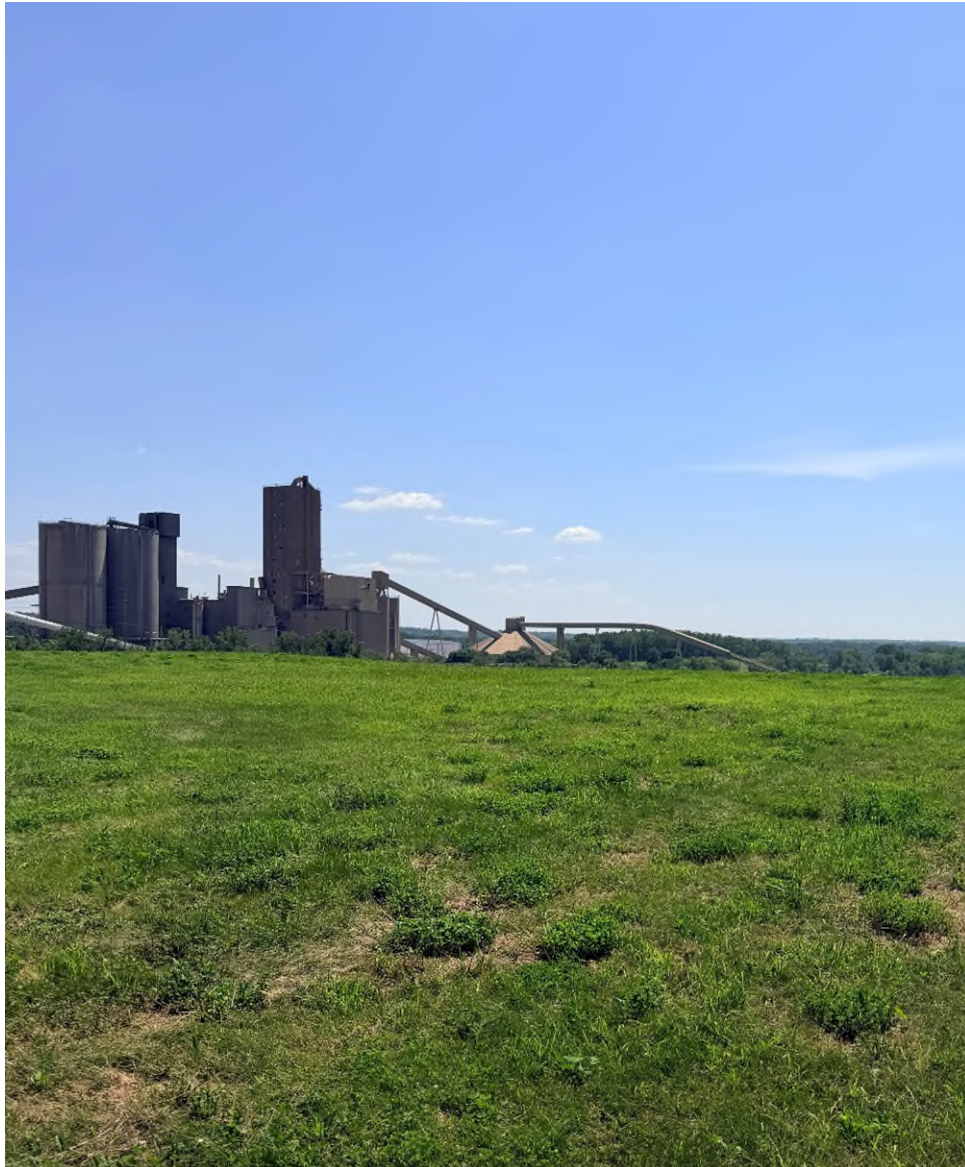
**Cap Area 1:** On January 12, 2026, Continental placed 60 tons of topsoil to fill the low area shown as Cap Area 1 in the Fall 2025 Engineering Inspection Report. Cap Area 1 was mowed and reseeded on May 22, 2026. The photograph below shows Cap Area 1 as of July 8, 2026.

**1. Regrade Cap Areas 1 and 2 to eliminate ponding and improve surface drainage.**

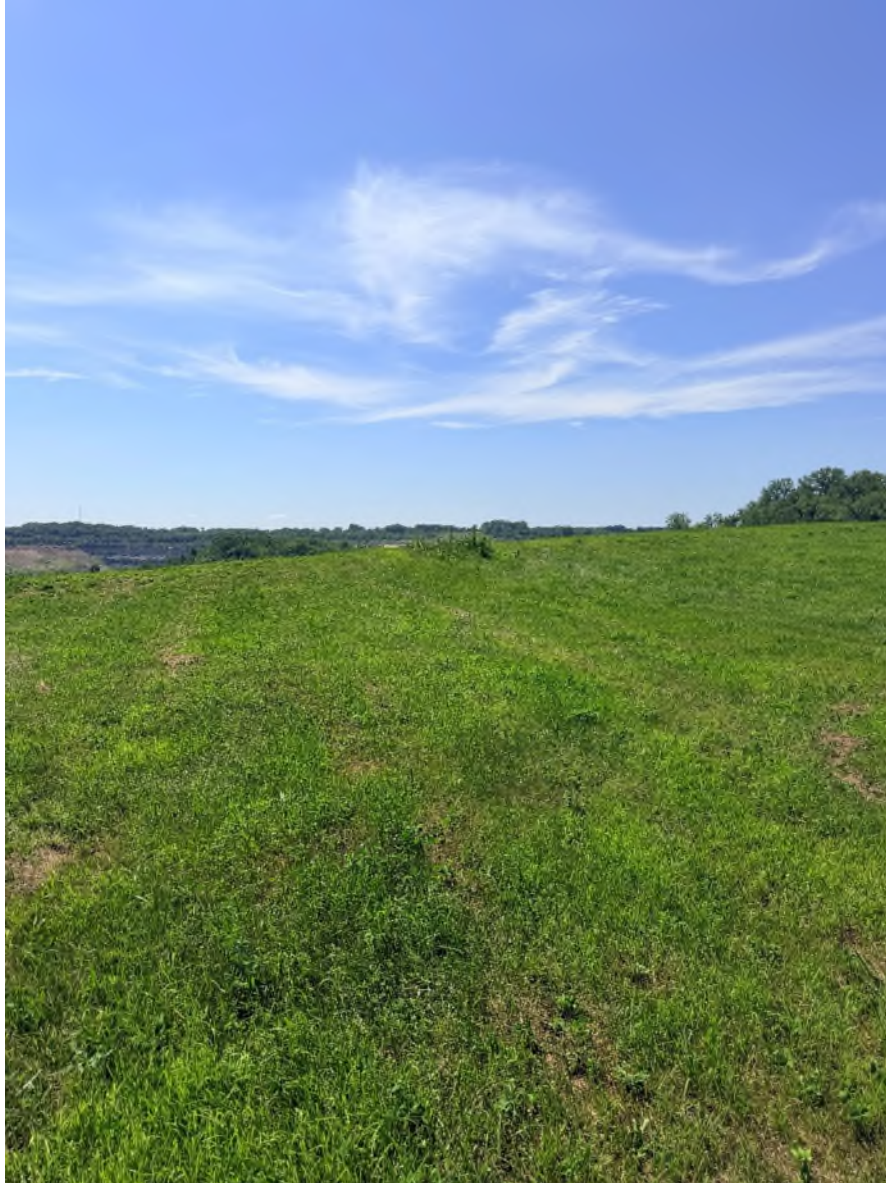
**Cap Area 2:** Ponding has not been observed at Cap Area 2. The photograph below shows Cap Area 2 as of July 8, 2026.

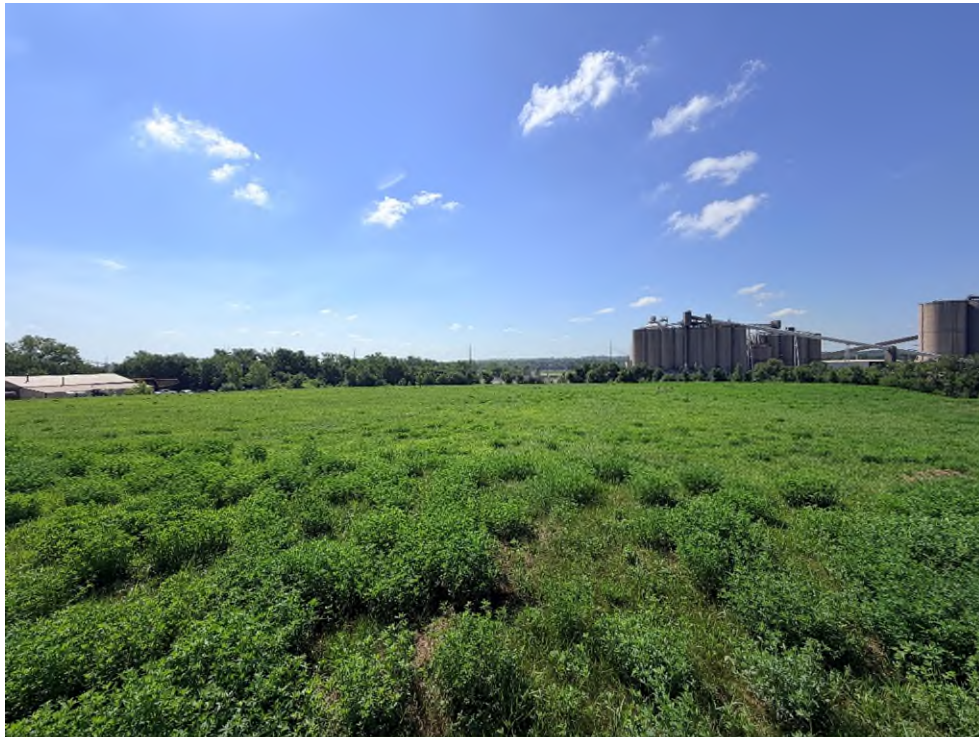
**Closed Cell**

Full cover is established. On May 22, 2026, Continental mowed and reseeded the capped landfill areas, referred to as the Phase I Closed Cell and Closed Cell on Figure 2 of the Fall 2025 Engineering Inspection Report, to prevent erosion and infiltration. The capped areas were mowed again on June 29, 2026. Mowing of the capped areas generally occurs quarterly. The photographs below show the capped landfill areas as of July 14, 2026.

**2. Continue vegetation maintenance on all capped areas until full cover is established.**

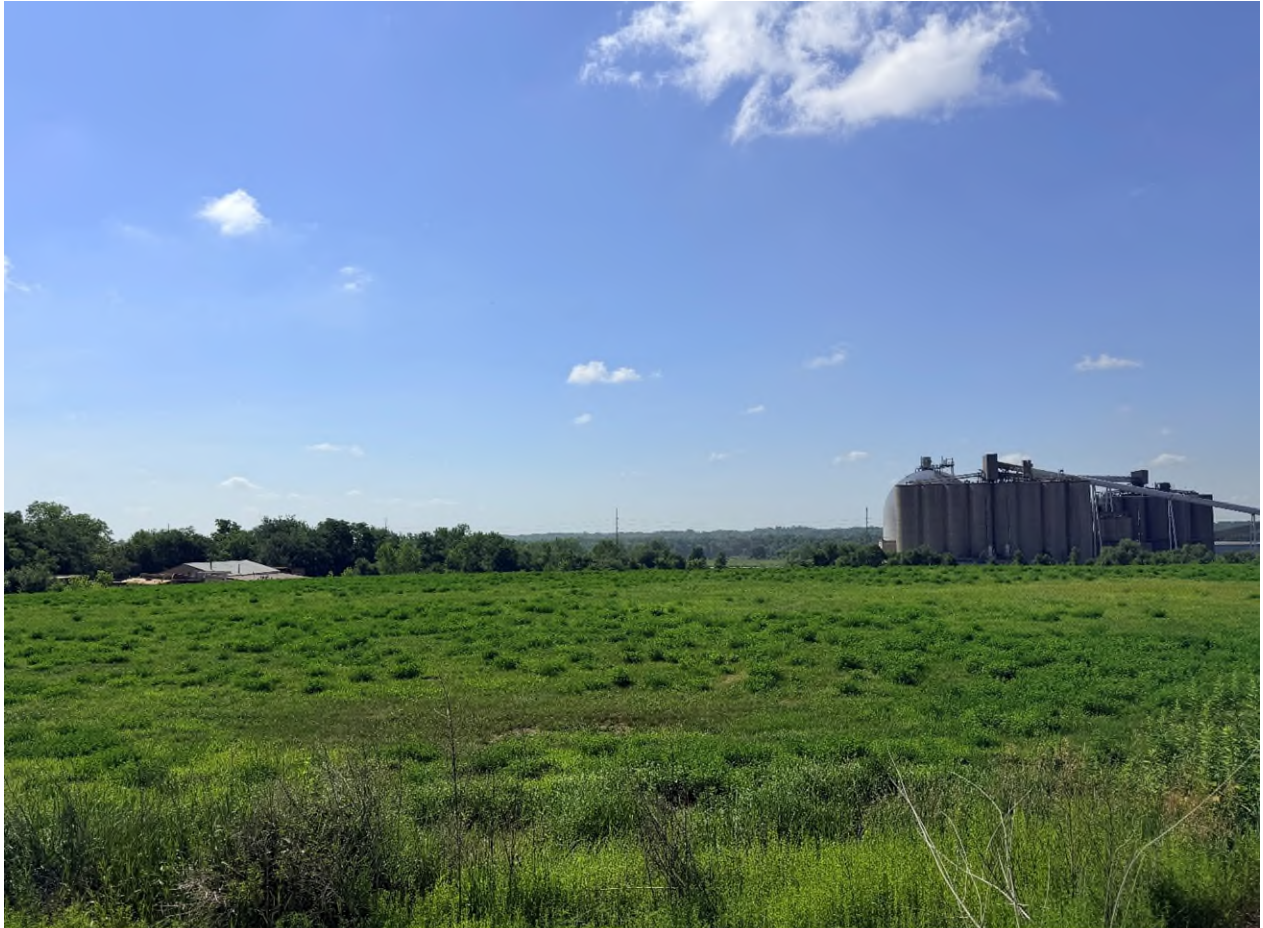
- 3. Photo 16 shows a bare area. However, Section 2.1 states there were no areas of bare or exposed soil. Please address this discrepancy.**

Photo 16, taken on March 12, 2026, shows topsoil that was placed on Cap Area 1 on January 12, 2026 (Doc. 117197). Photo 16 also shows dormant vegetation in the foreground (i.e., the planted vegetation is alive but not growing due to winter conditions). Cap Area 1 was mowed and reseeded on May 22, 2026 (Doc. 117197) and is no longer bare.

The following photograph, taken at roughly the same location as Photo 16, shows this area of the Phase I Closed Cell as of July 14, 2026.

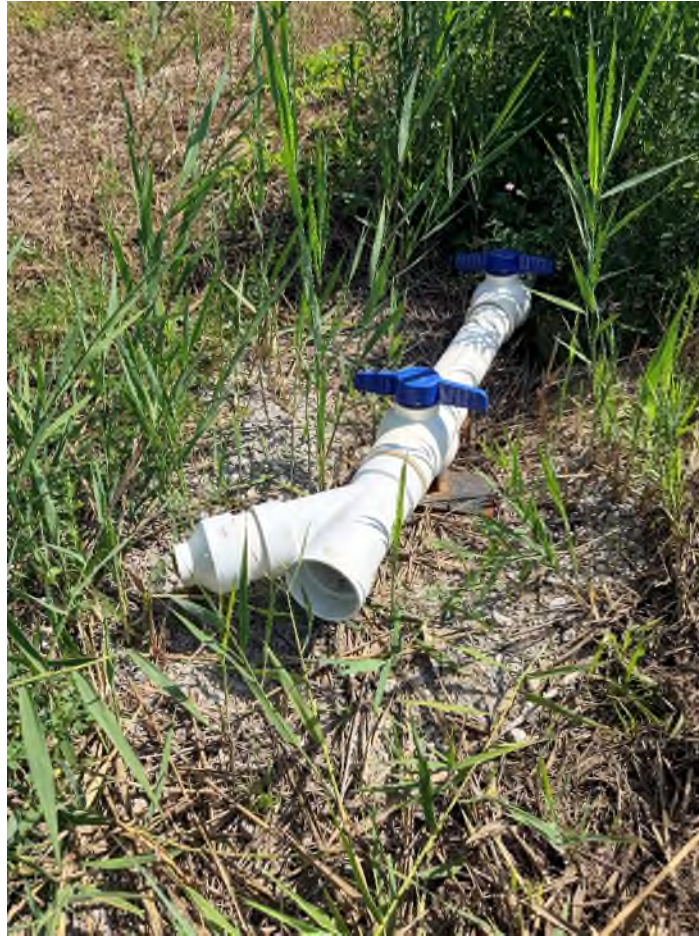
**1. Photos 5 and 6 show drainage pipes, and Photo 6 appears to have a missing cap. We assume these are cleanouts for the leachate collection system. Please confirm or correct the assumption and clarify whether the missing cap is a concern.**

Yes, Photos 5 and 6 show one of the cleanouts for the leachate collection system (the pipe with the yellow cap). The pipe on the left in Figure 6 is not a drainage pipe and is not connected to the leachate collection system, so it does not require a cap. Since the inspection, Continental removed this component and it is no longer present.

The photograph below shows how the drainage pipe appears as of July 14, 2026. The blue nozzles are used to close and open the pipe.
