**RE: CONSTRUCTION CERTIFICATION REPORT  
NW1 SUMP EXCAVATION  
SCISWA SLF  
IDNR PERMIT NO. 63-SDP-02-77P  
HLW PN 6009-26A.200**

This letter shall serve as notice to IDNR that excavation of the leachate collection sump in Cell NW1 at the SCISWA SLF in Marion County, Iowa has been completed. The following is intended to document the project.

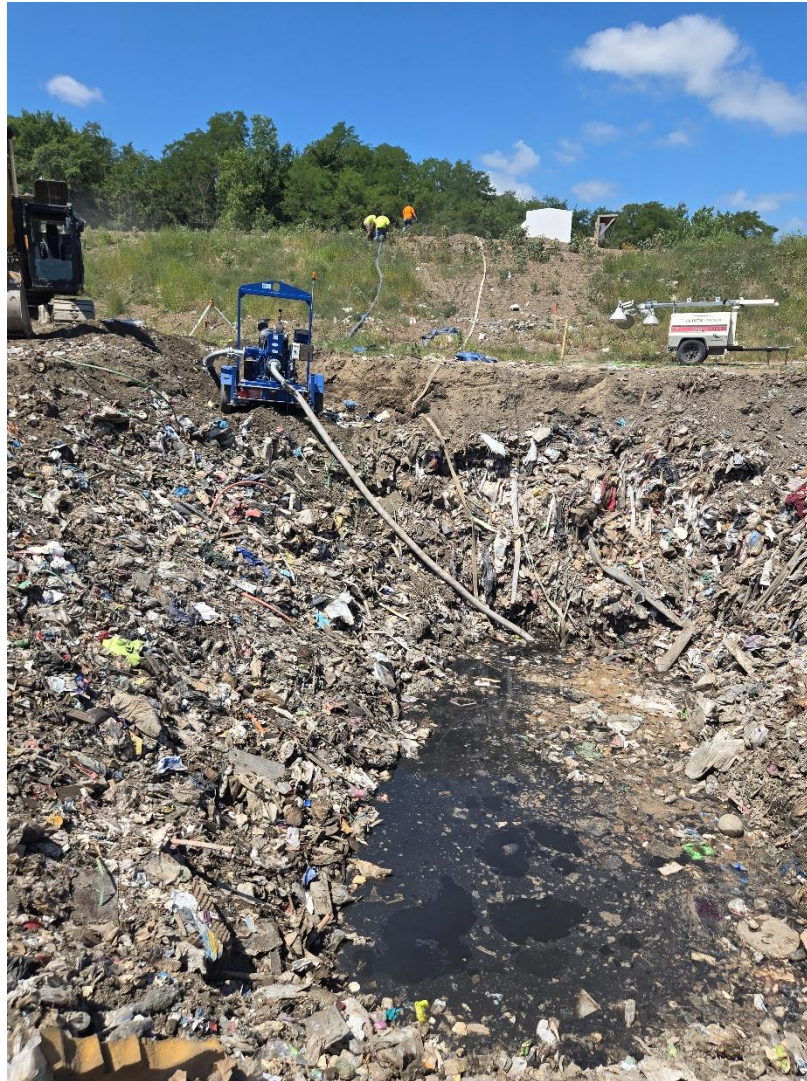
**Photo 1: Initial excavation showing leachate level, looking west, 07-14-26.**

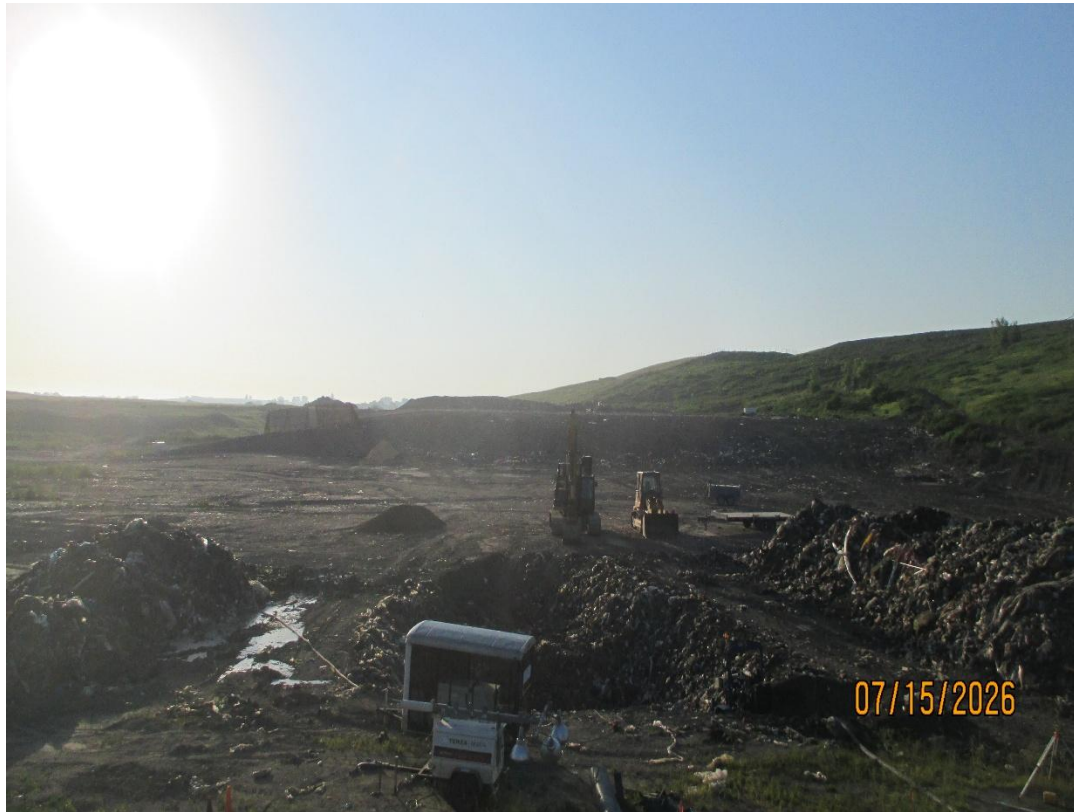
**Photo 2: Excavation area and stockpiled waste, looking east.**

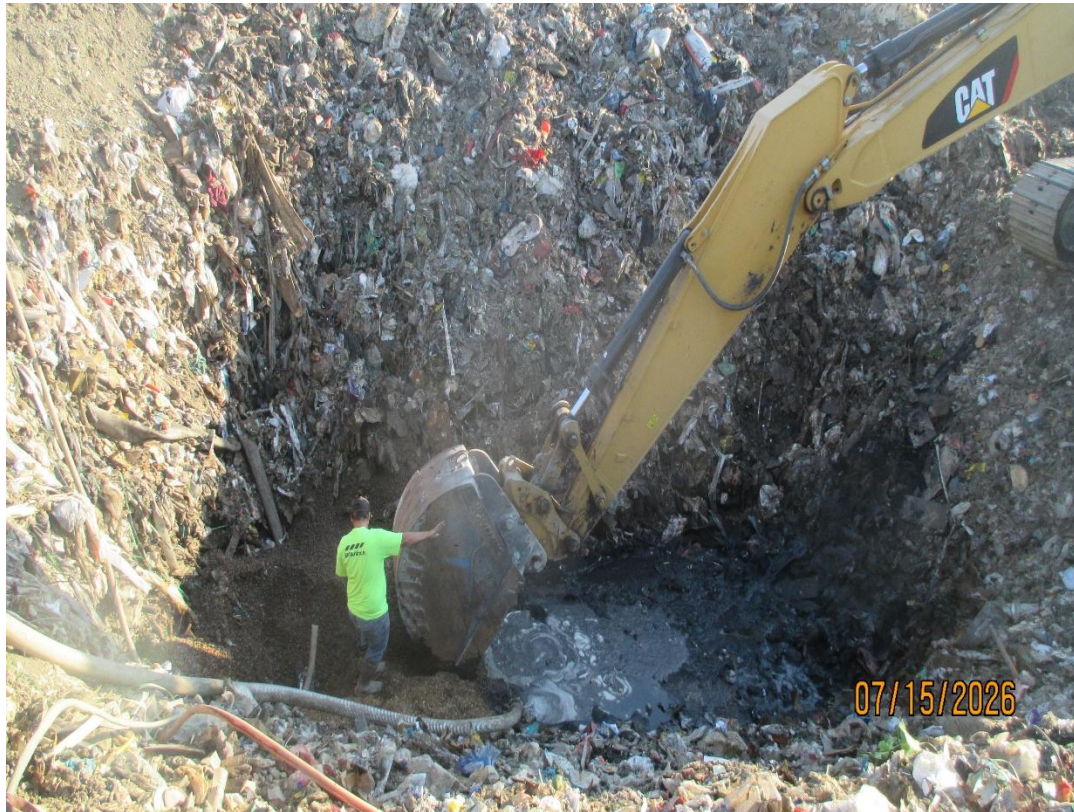
During excavation, leachate was pumped into the existing leachate forcemain west of Cell NW1 as needed for conveyance to the leachate storage lagoon. The excavation exposed the sand drainage layer, river rock backfill, and riser pipe in the leachate collection sump Cell NW1. Silt was noted in the sand drainage layer as well as in the river rock backfill during excavation which may have impeded leachate flow to the riser pipe.

**Photo 3: Exposing riser pipe, looking north.**

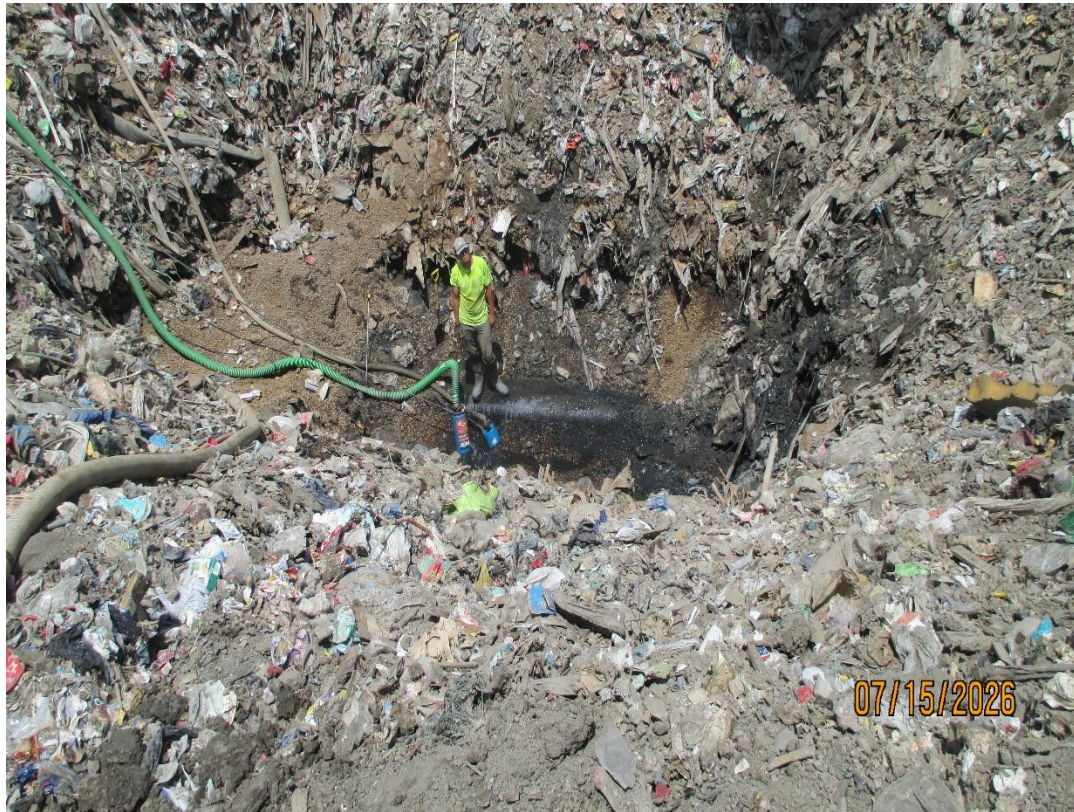
The existing river rock backfill was removed adjacent to the riser pipe to a level even with the bottom of the riser pipe. When the riser pipe was exposed the perforations in the riser pipe appeared to be open which indicated that flow to the perforations in the riser pipe had been impeded leading to the elevated leachate levels recorded in LHPZ-NW1. Even though the perforations in the riser pipe appeared to be clear, the Contractor added additional ½" diameter perforations in the riser pipe when it was exposed to increase the efficiency of leachate conveyance into the riser pipe.

**Photo 4: Exposed riser pipe, looking northwest.**

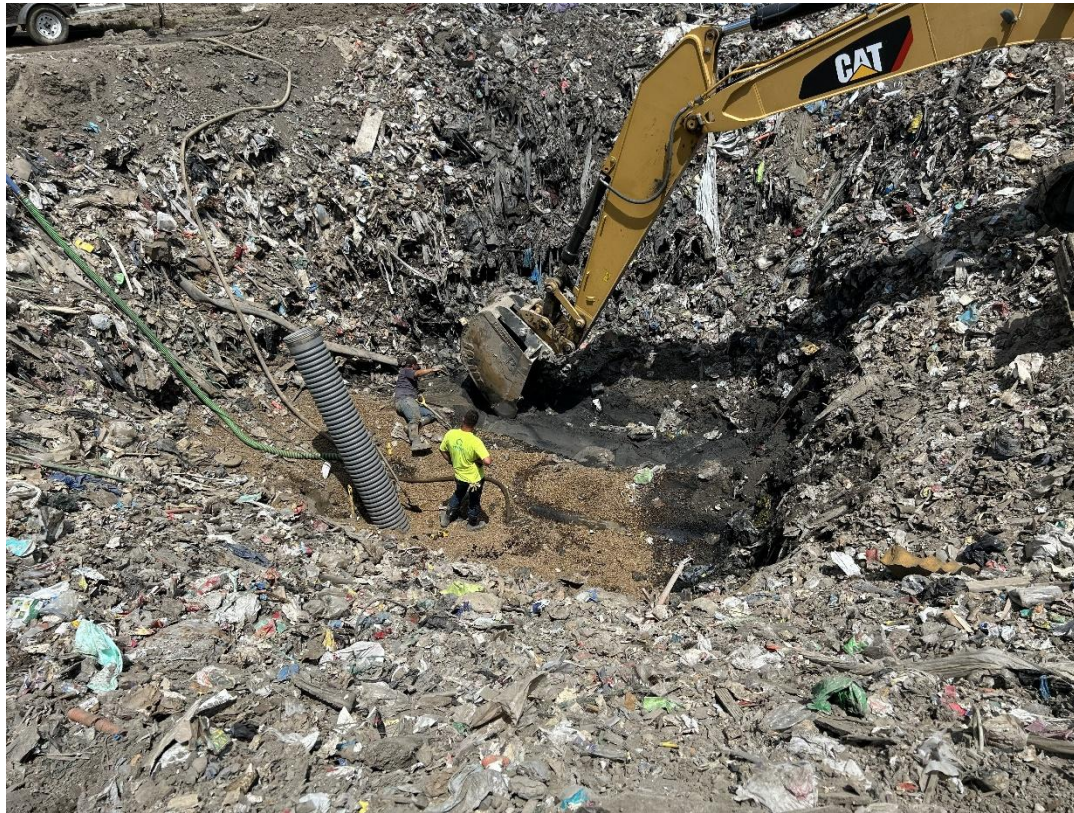
**Photo 5: Removing material adjacent to riser pipe, looking northwest, 07-16-26.**

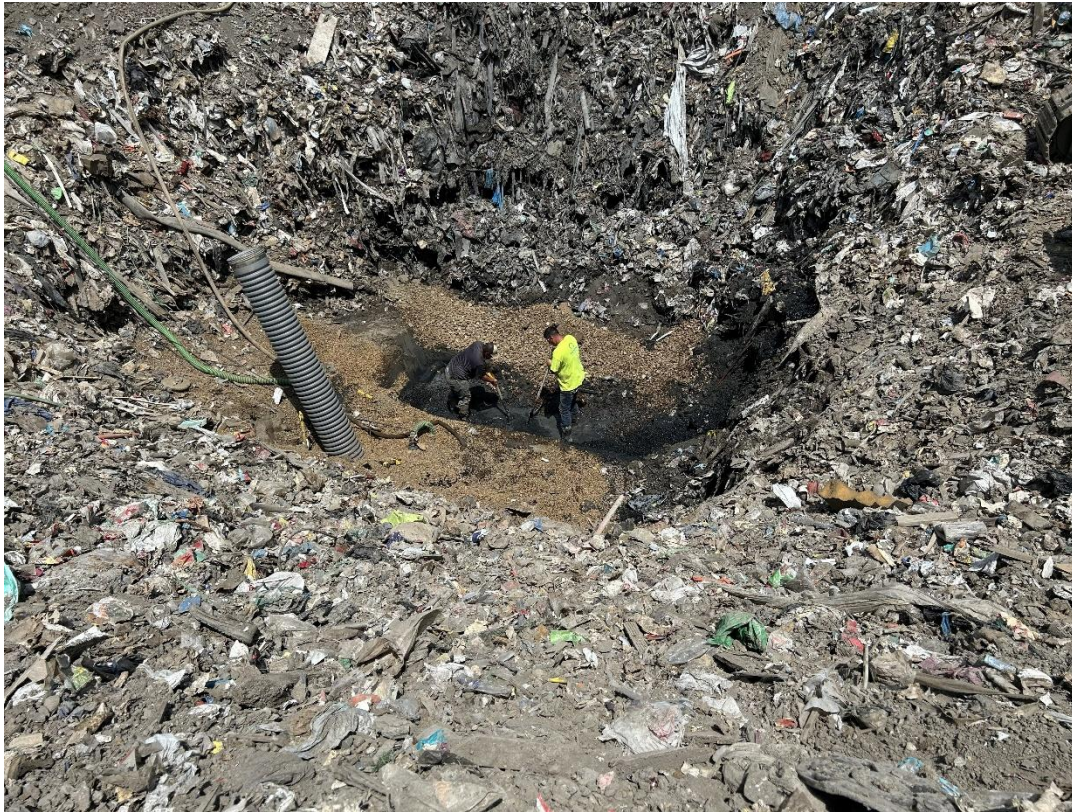
**Photo 6: Removing material adjacent to riser pipe, looking northwest, 07-16-26.**

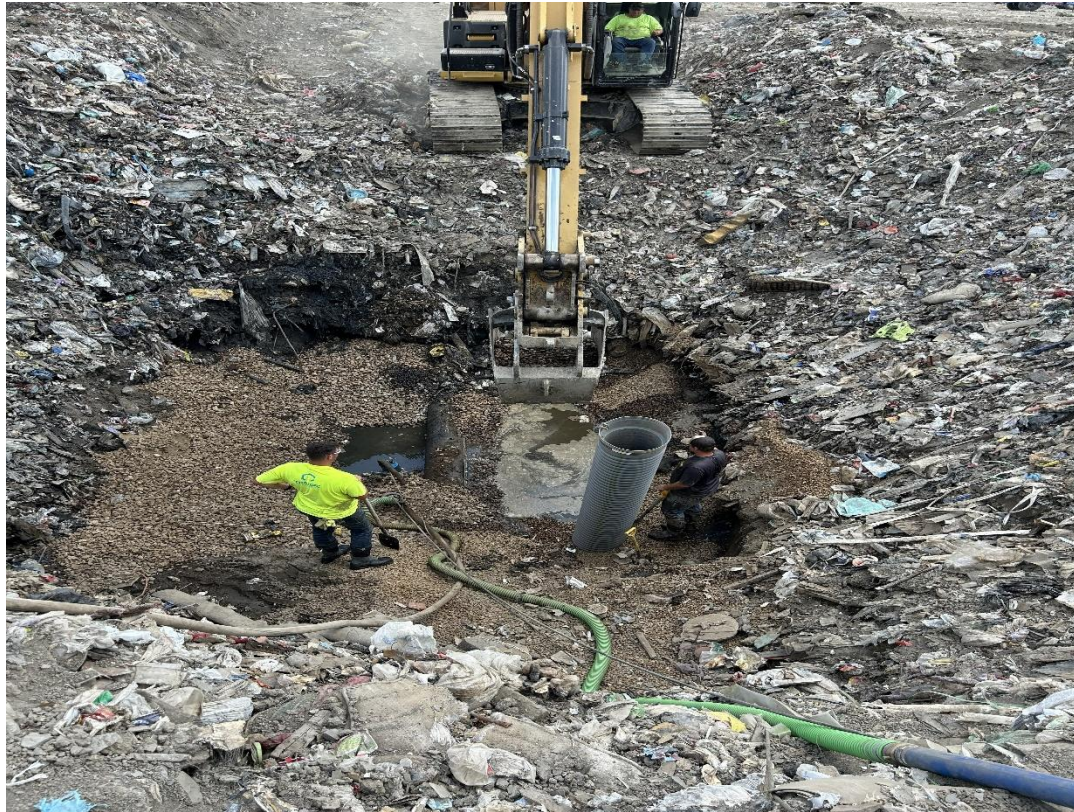
**Photo 7: Installing rock backfill next to pipe, looking east, 07-16-26.**

Once the additional perforations were placed in the riser pipe the excavation was backfilled to approximately elevation 776 with clean river rock to promote leachate movement to the riser pipe. The gradation of the river rock is included in Attachment A. A sacrificial corrugated plastic pipe was placed in the rock backfill for additional pumping from this area if needed.

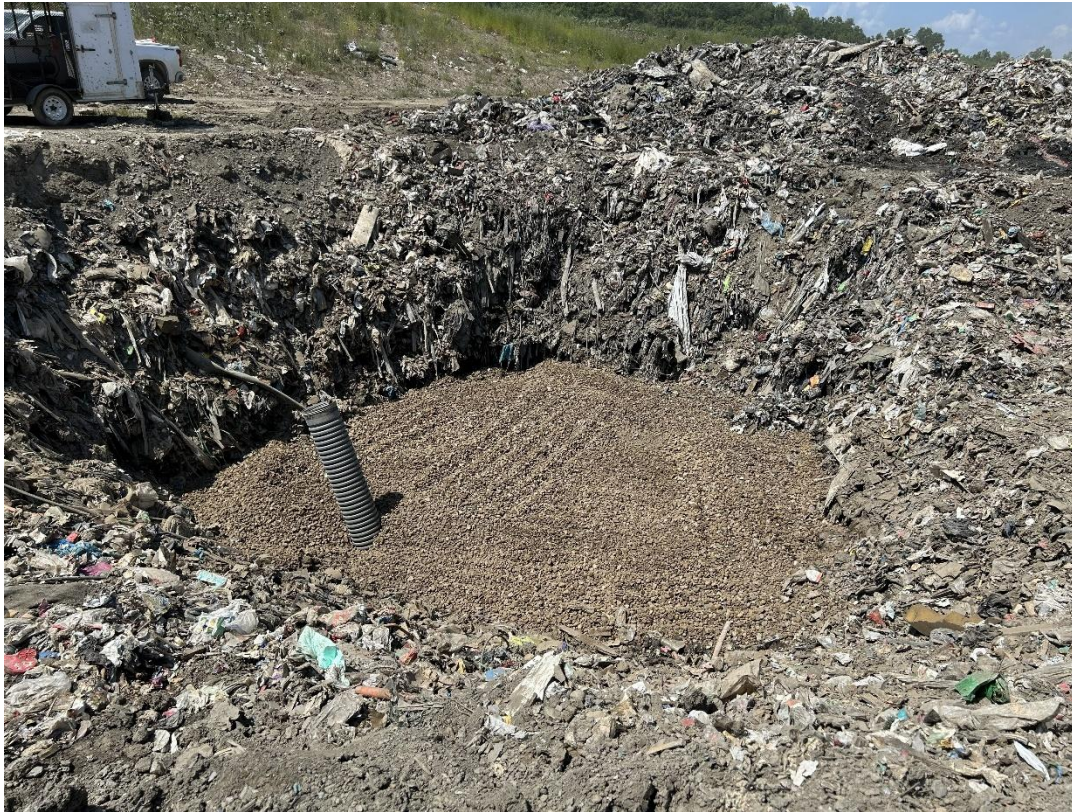
**Photo 8: Completed rock backfill showing dewatering pipe, looking northwest, 07-16-26.**
