# 2026 Fall Site Inspection

## Keokuk Ferro-Sil Monofill (Closed)

**Permit No. 56-SDP-17-91P**

Klingner & Associates, P.C.

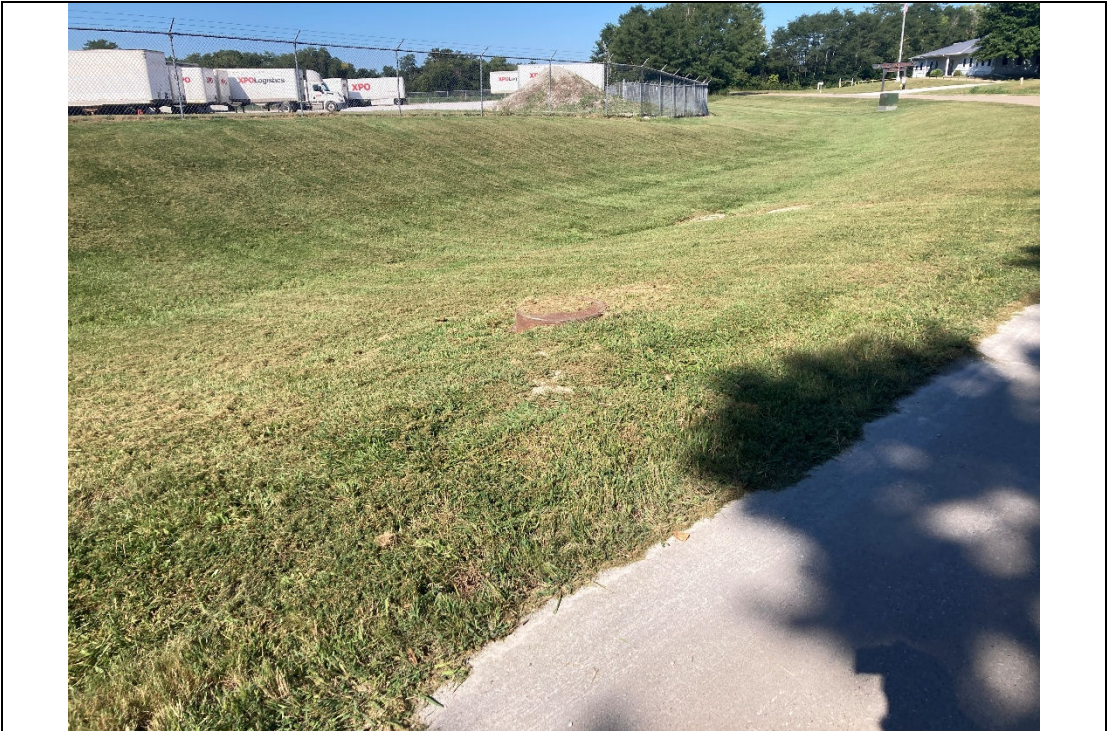
| Description | Manhole at Kindustry Park | 1 |

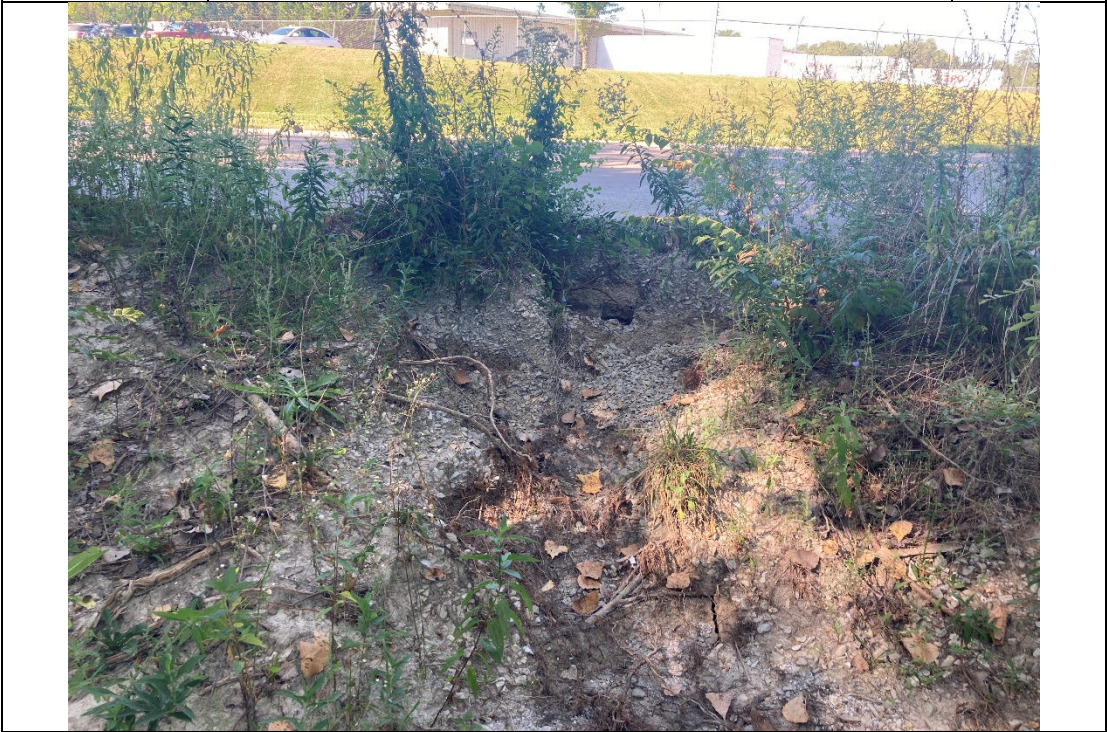
The leachate pond level appeared to be normal. The area of the leachate line repair (2023) was walked. Some erosion is starting in the City right-of-way along Kindustry Park Road where stormwater flows come off of the road. No other areas of erosion were noted. Thick vegetation is present in the areas which were previously disturbed.

| Description | Erosion at road where stormwater flows off of roadway at Kindustry Park | 2 |

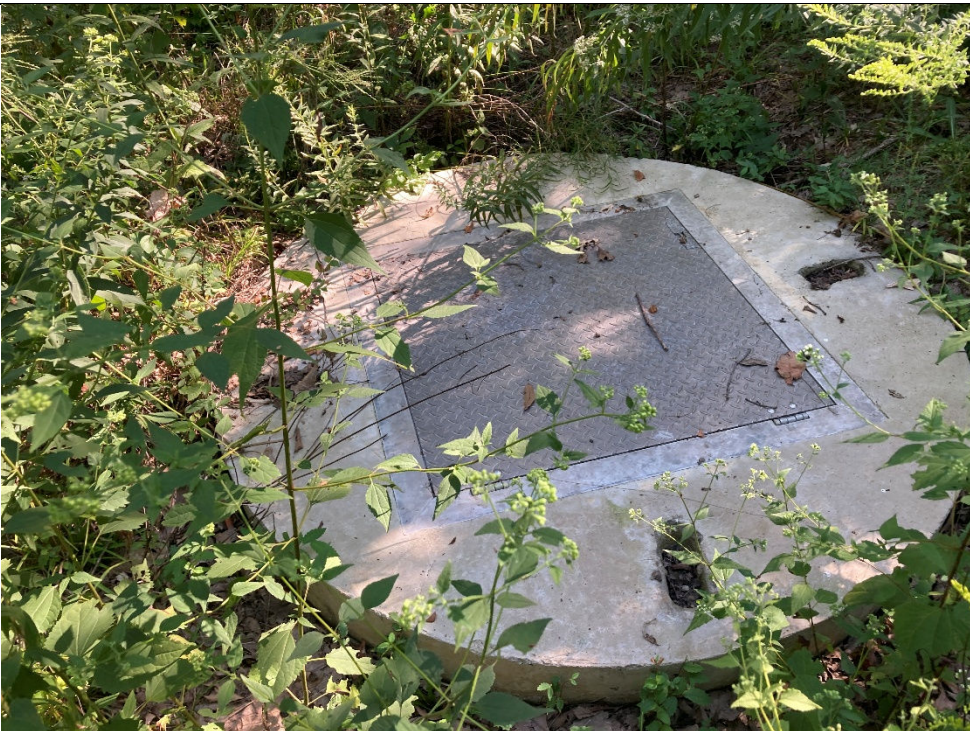
| Description | Air release manhole, north of Kindustry Park | 3 |

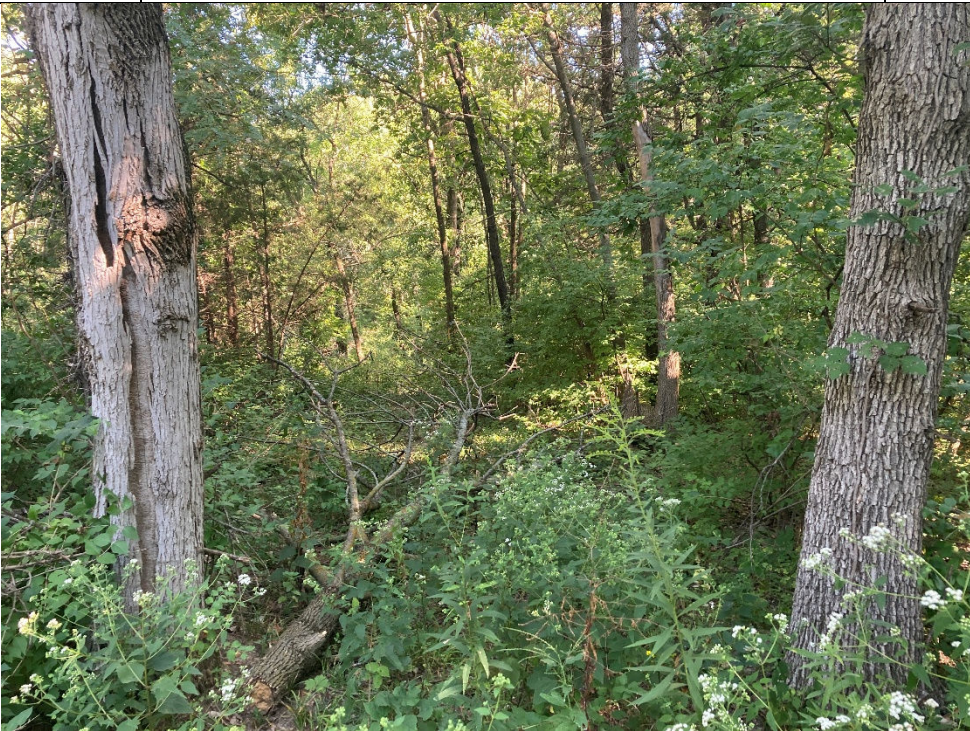
| Description | Looking north along force main alignment, north of air release | 4 |

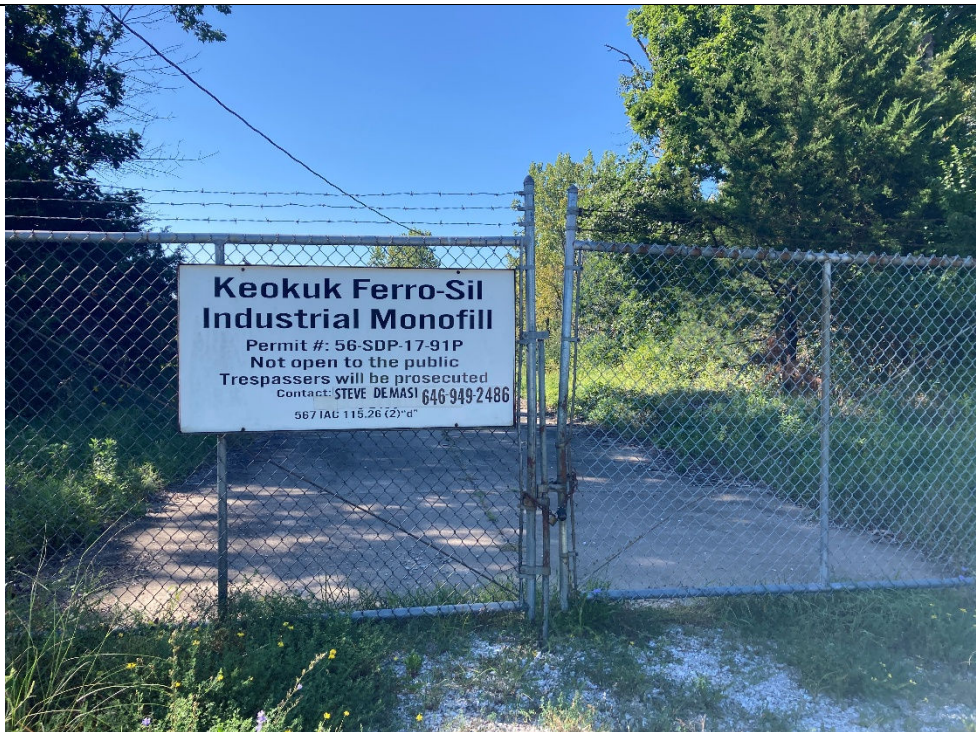
| Description | Landfill entrance | 5 |

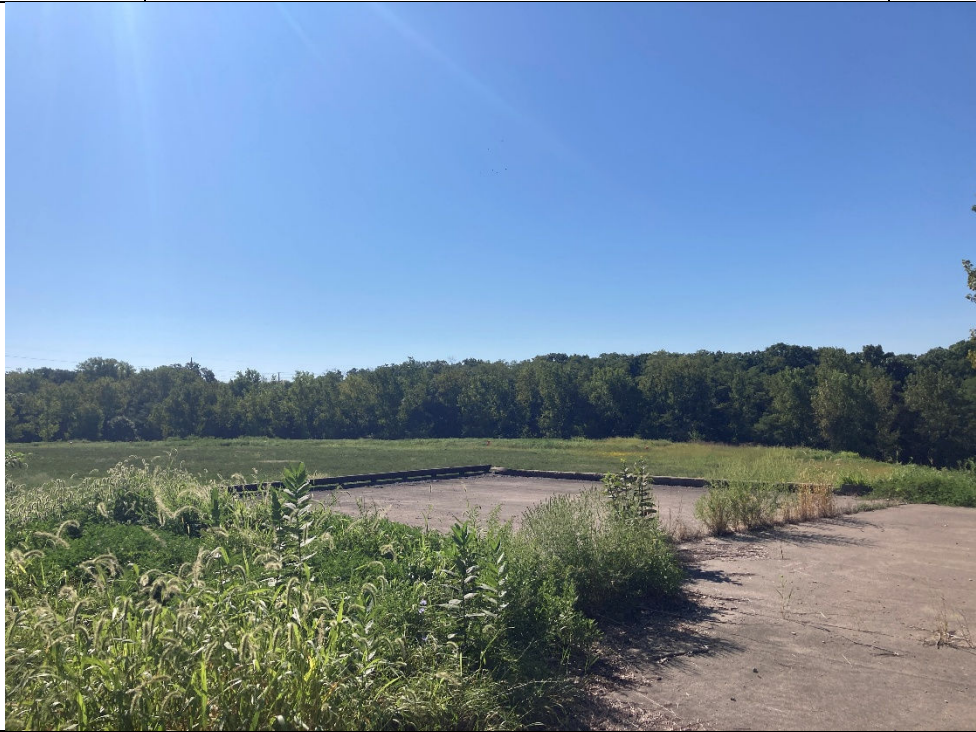
| Description | Former tipping pad area | 6 |

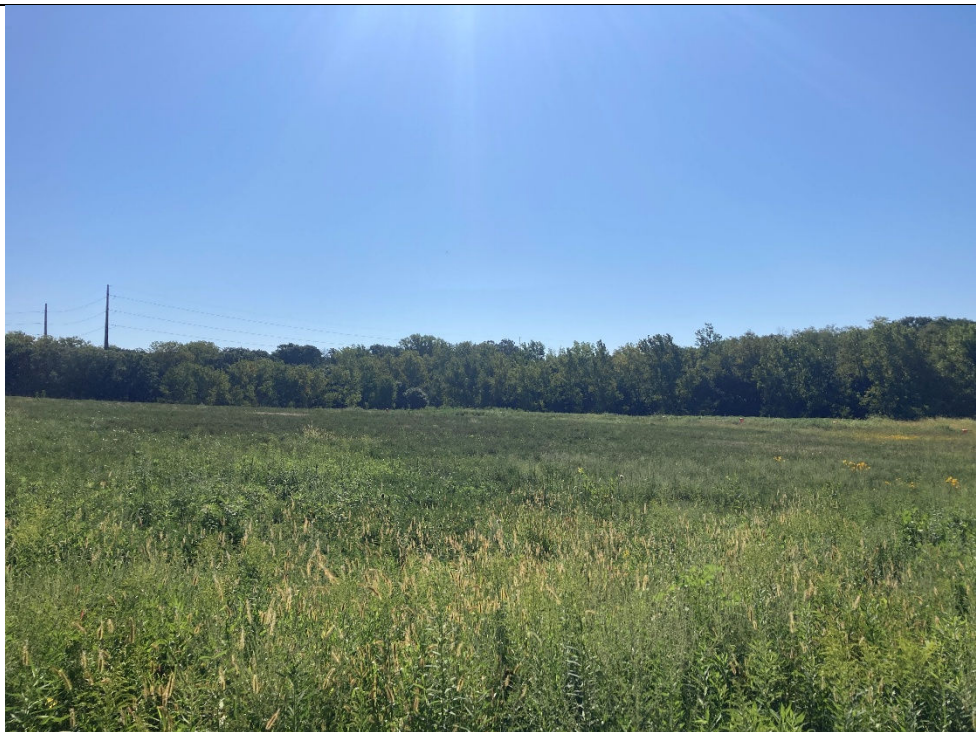
| Description | Looking east across landfill from west side | 7 |

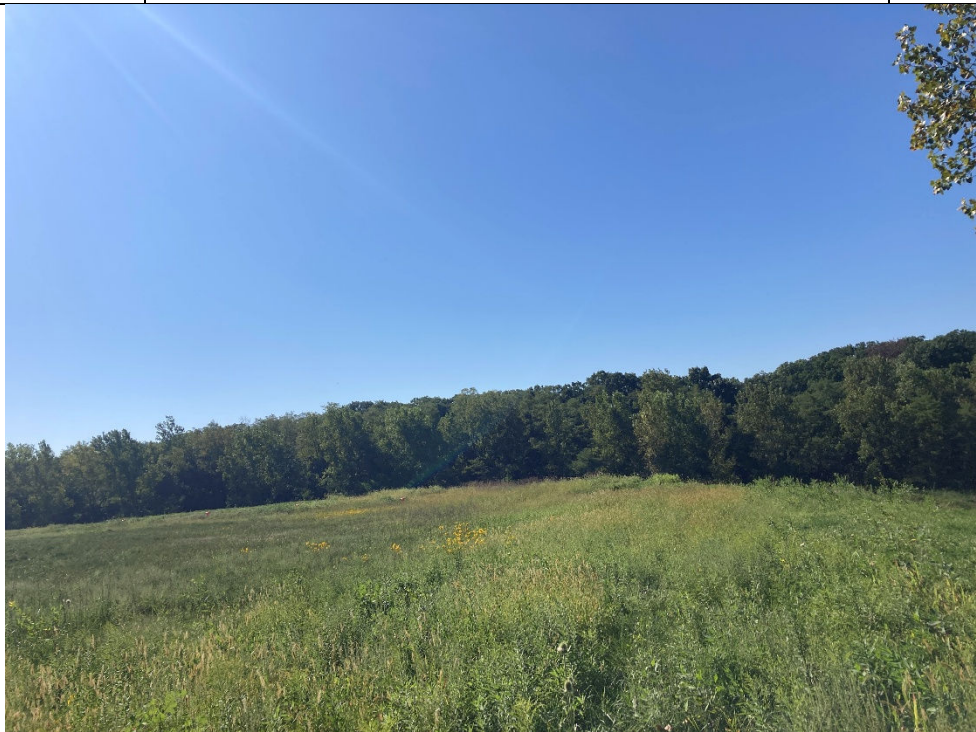
| Description | Looking east across southern end of landfill | 8 |

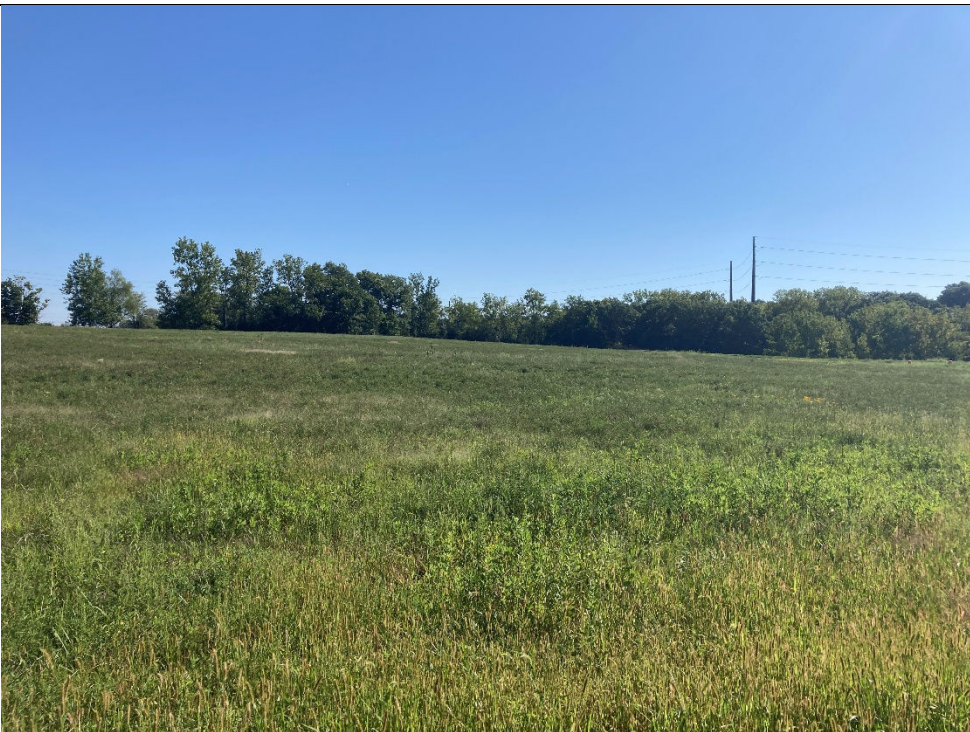
| Description | Looking north-northwest across landfill from south | 9 |

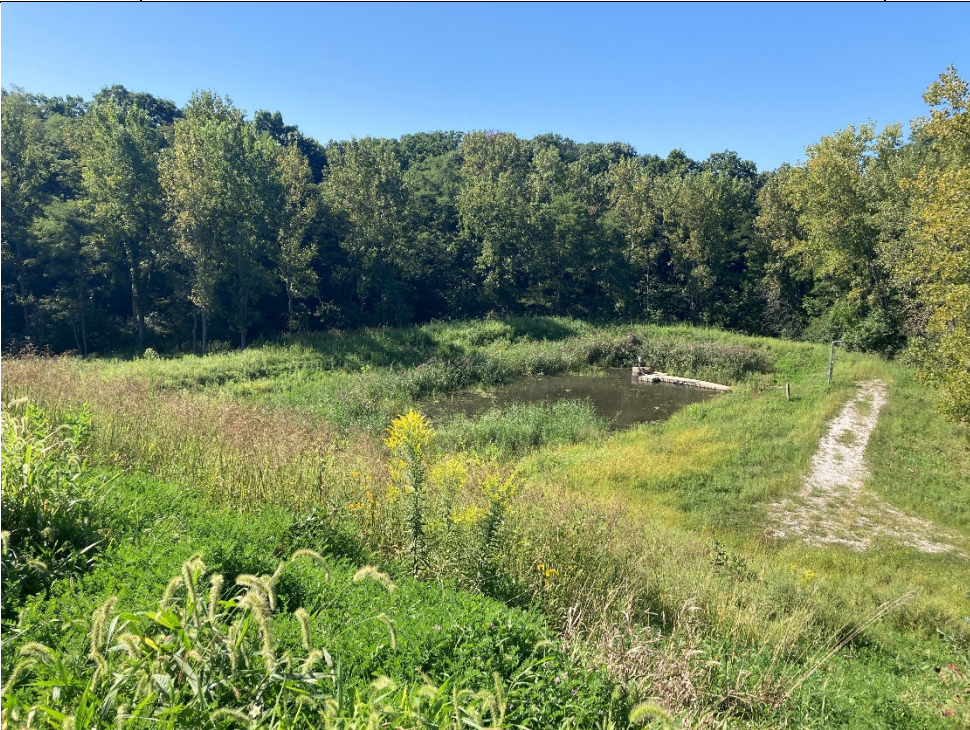
| Description | Leachate lagoon area | 10 |

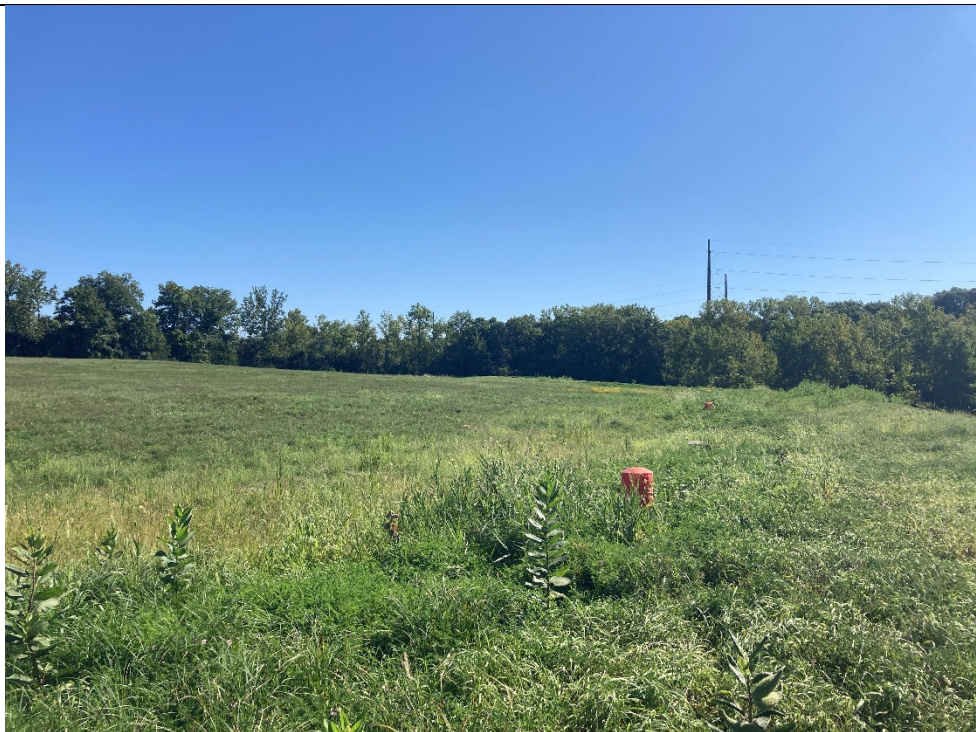
| Description | Stomrwater intakes near southeast side of landfill | 11 |

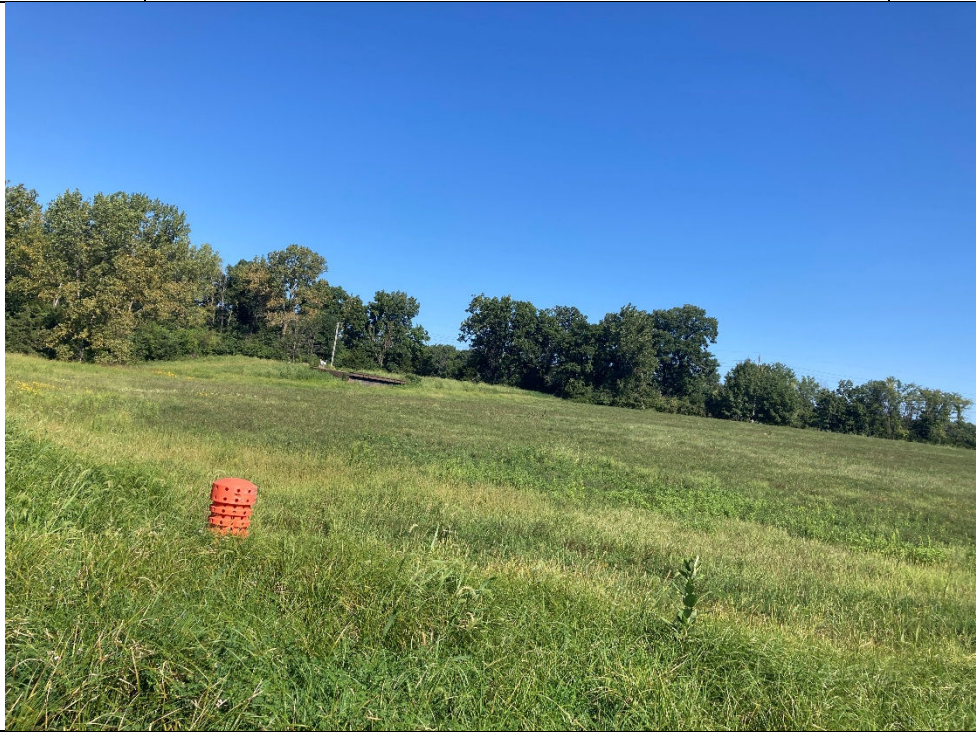
| Description | Looking northwest from south side of landfill | 12 |

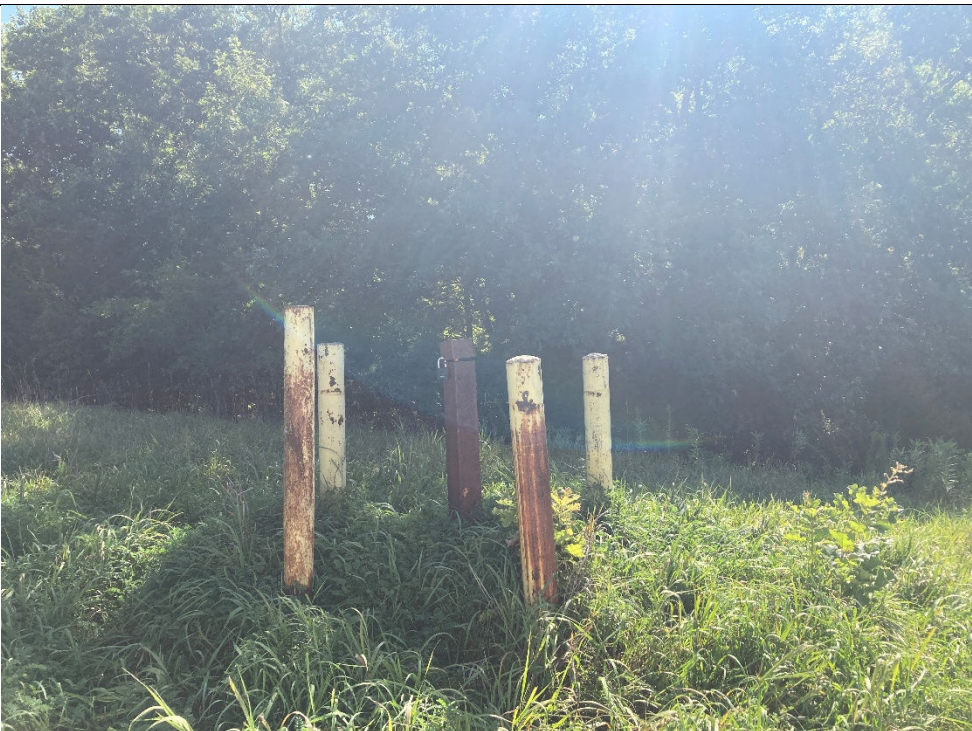
| Description | MW-11 | 13 |

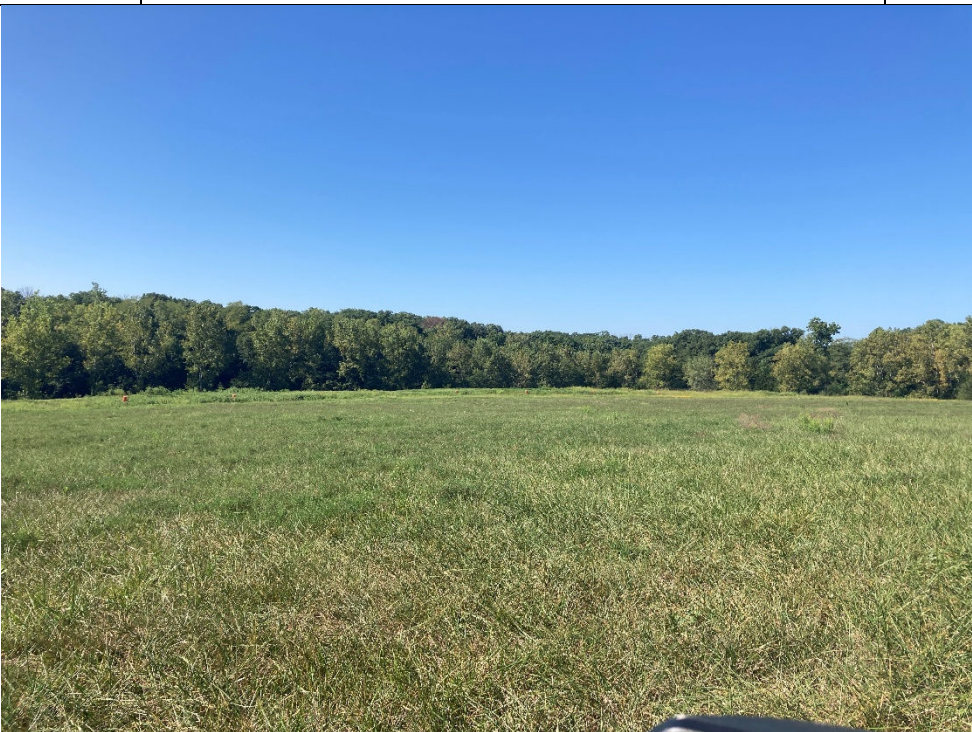
| Description | Looking south across landfill from north side | 14 |

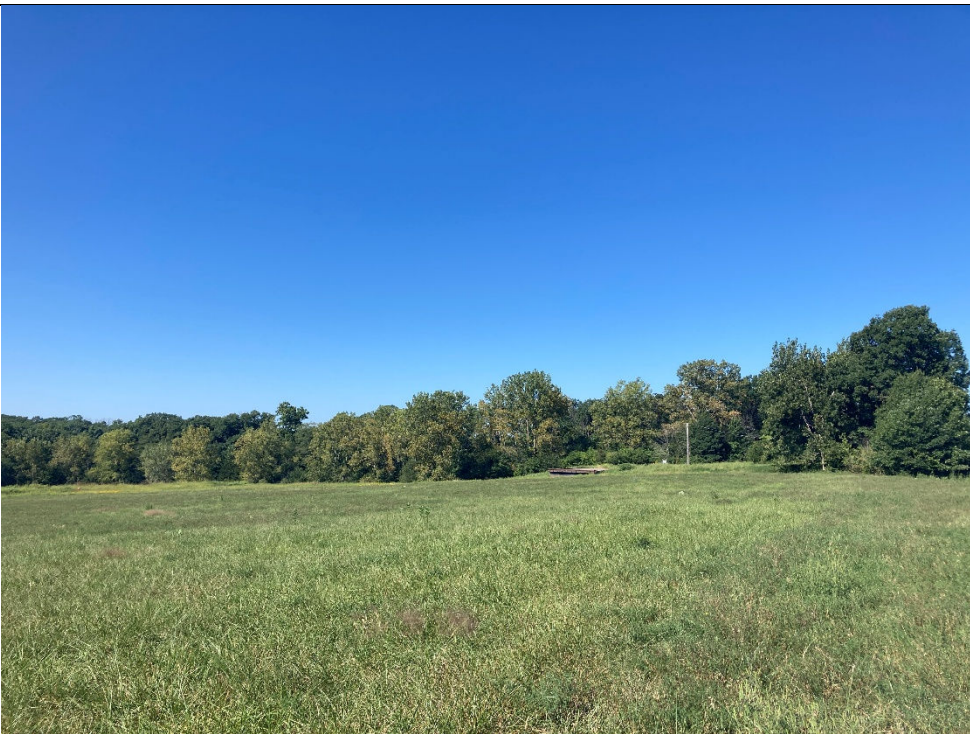
| Description | Looking towards west from north side of landfill | 15 |

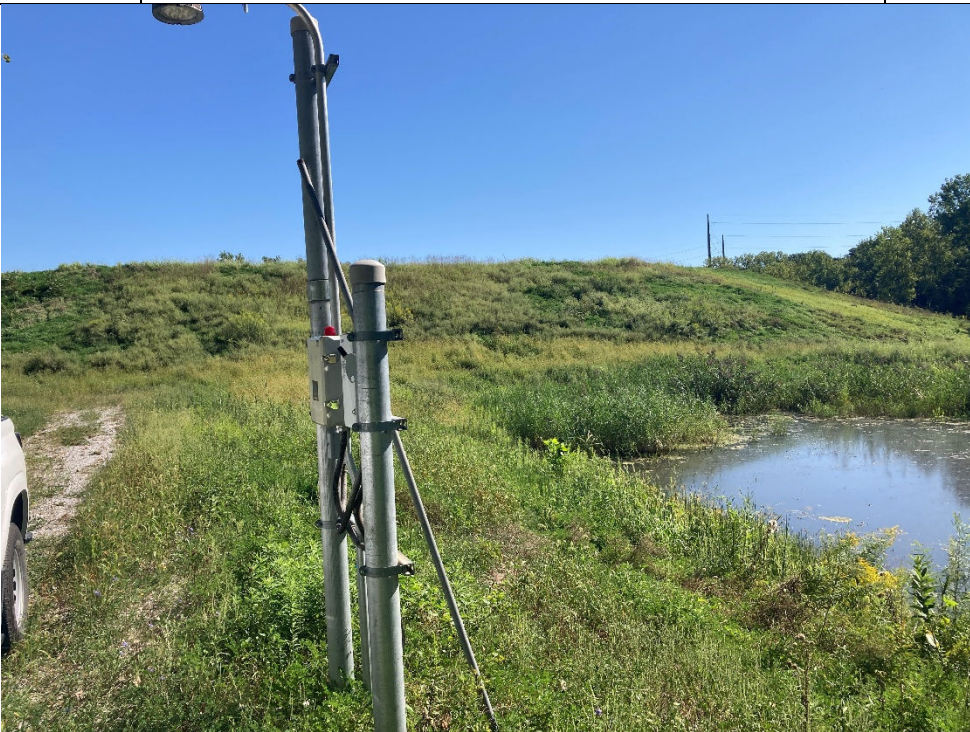
The run time during the September 4, 2026 (Fall Inspection) visit was 5023 hours and 39 minutes. The pump hours on March 13, 2026 (Spring Inspection) were recorded to be 4924 Hours and 39 Minutes.

| Description | Leachate lagoon pump controller | 16 |

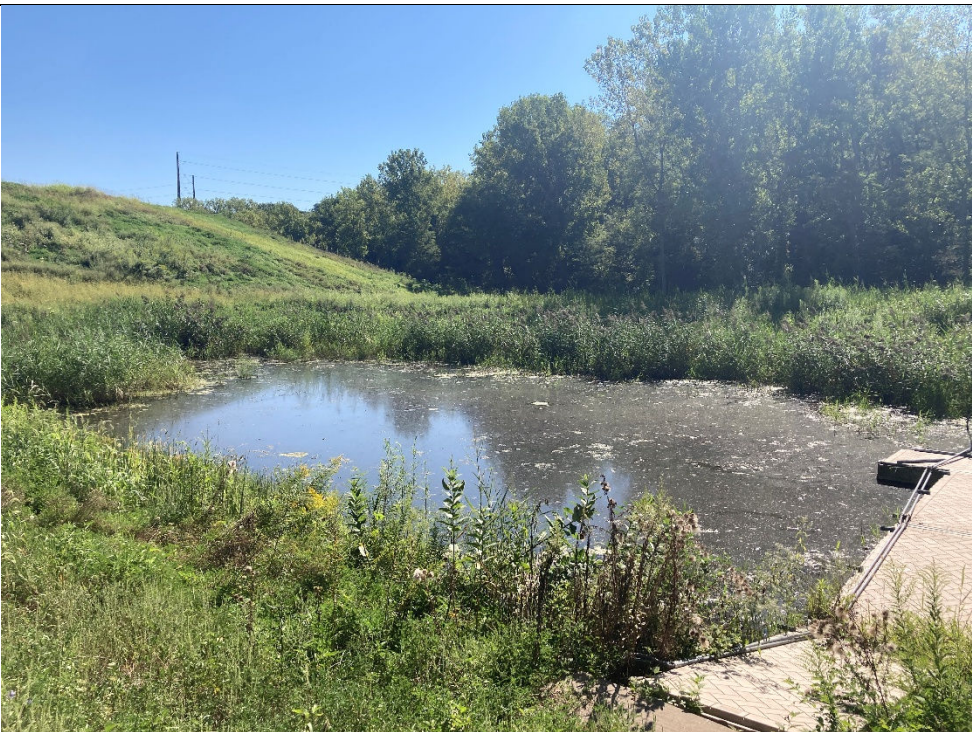
| Description | Leachate lagoon | 17 |

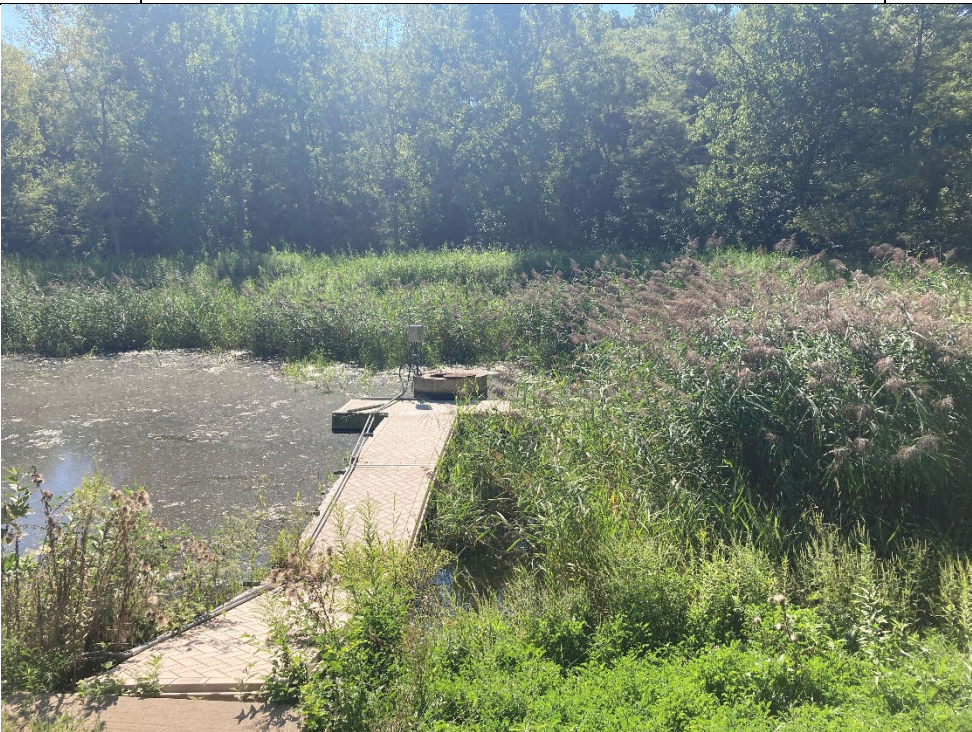
| Description | Dock and manhole at leachate lagoon | 18 |

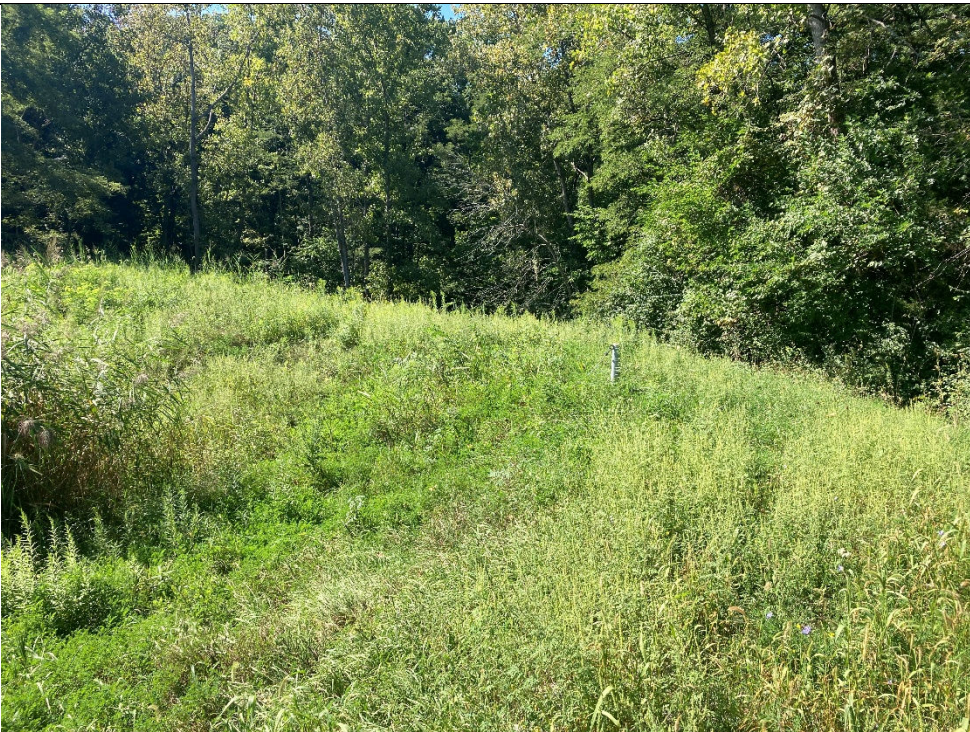
| Description | MW16, south of lagoon | 19 |

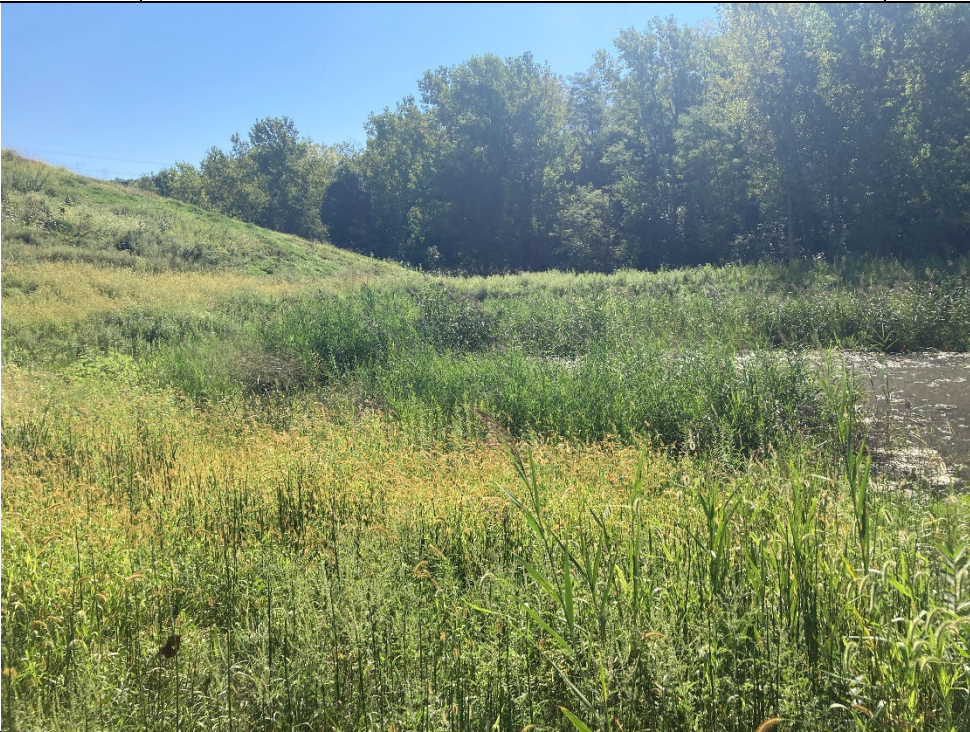
| Description | Looking southeast across edge of lagoon and bottom of landfill slope | 20 |
