RE: Sanitary Landfill Inspection  
Clarke County Sanitary Landfill, 2095 Leisure Drive, Osceola, IA  
Permit # 20-SDP-04-94C (closed site)

**REPORT OF INVESTIGATION****INVESTIGATION DATE****CURRENT:** 6/29/2026**LAST:** 9/28/2023**TO:** Dean Robins, Clarke County Landfill Commission  
Courthouse - 100 South Main, Osceola, IA 50213**SUBJECT:** Clarke County Sanitary Landfill Inspection (Closed)  
2095 Leisure Drive, Osceola, IA  
Permit #20-SDP-04-94C (South Site) [North Site #20-SDP-02-75C - rescinded]**PERSONS CONTACTED:** Justin Savage, Clarke County Engineer (vie email: ccsrd@clarkecountyia.org)**GENERAL:**

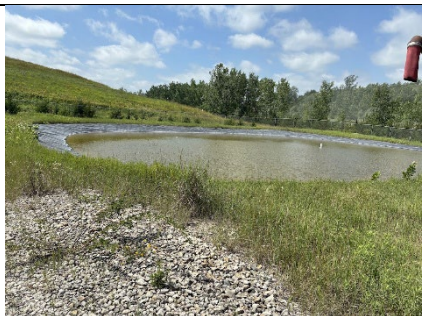
NE corner of lagoon

4. Physical access was fully achieved along the leachate storage lagoon embankment and perimeter fence. The lagoon perimeter fence remained in acceptable structural condition, aside from small cedar trees establishing in the fence line. Visual evaluation of the lagoon confirmed that the liquid level is maintained below the top of the liner slope/anchor trench, providing visible, operational freeboard. No active overtopping, structural slope distress, or surface seeps were observed. Facility

records show approximately 44,489 gallons of leachate were hauled to the Des Moines WRA facility in summer 2023, but no leachate had been removed or hauled from the site in 2024, 2025, or 2026. Available freeboard was measured at 1.15 feet in March 2026. While immediate liquid containment is adequate, current freeboard remains below the standard target buffer of 2.0 feet, indicating that leachate removal should be scheduled to ensure capacity before seasonal wet periods. Leachate conveyance lines were last cleaned on March 26–27, 2025. All leachate head piezometers (LPZ-1 through LPZ-6) continue to demonstrate acceptable head levels (generally under 1 foot).

- Replace the damaged sign at the entrance gate with one displaying the facility name, SDP permit number, and emergency contact number.
- Coordinate with the Des Moines WRA to haul leachate from the storage lagoon to restore standard freeboard (minimum 2.0 feet).
- Mow the vegetative cover on the landfill cap and clear brush/cedar trees from the lagoon perimeter fence and silt fences to control woody growth, mitigate terrain hazards, and allow safe pedestrian access for complete regulatory inspections.
- Inspect and stabilize the active erosion gullies outside the waste boundary near MW-17 and MW-34 once vegetation is managed to allow safe physical access.
- Submit the required 2026 Financial Assurance documentation to the Iowa DNR Land Quality Bureau upon completion of the FY25 audit.

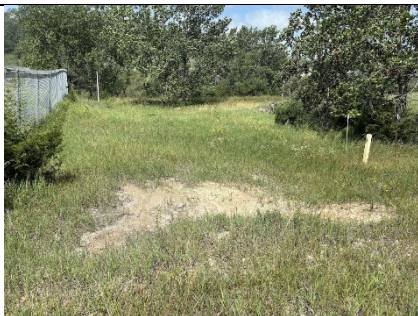
2. Where visible from accessible paths, the vegetative cover appeared dense across the majority of the cap. Historical bare spots on the upper cap crest and north-facing slopes previously repaired with topsoil remained largely vegetated. However, persistent woody vegetation and small cedar trees remained along the perimeter fence of the leachate lagoon and within the silt fence lines on the north-facing slope above MW-33.

north fence lagoon (small cedar trees)

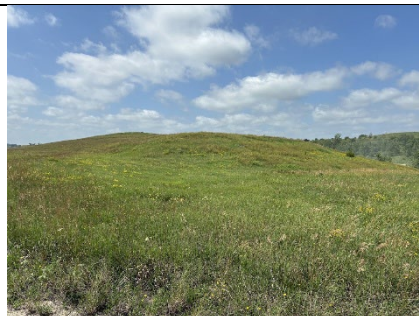
North slope of south unit

3. I entered via the access road to the north, traversed west toward the leachate lagoon, and then walked diagonally across the hillside/closed cell area back toward the main entrance gate. During this walk, dense and overgrown vegetative cover was observed across the landform. The thick vegetation obscured surface ground conditions, creating a high safety risk for due to the potential presence of historical trench-style landfilling hazards, unmapped drop-offs, and hidden erosion gullies. Consequently, physical traversal across the interior South Cell cap and its immediate surrounding terrain was restricted. Known feature areas previously highlighted in engineering reports—such as the emerging erosion gullies near MW-17 and MW-34—could not be physically inspected or re-evaluated during this visit due to these safety and access constraints.
