**RE: SEMI-ANNUAL INSPECTION – FALL, 2026  
AMES/STORY ENVIRONMENTAL LANDFILL  
IDNR PERMIT NO. 85-SDP-13-91  
HLW P.N. 6004-24A.750**

# SITE PLAN FALL 2026 INSPECTION AMES/STORY ENVIRONMENTAL LANDFILL AMES, IOWA

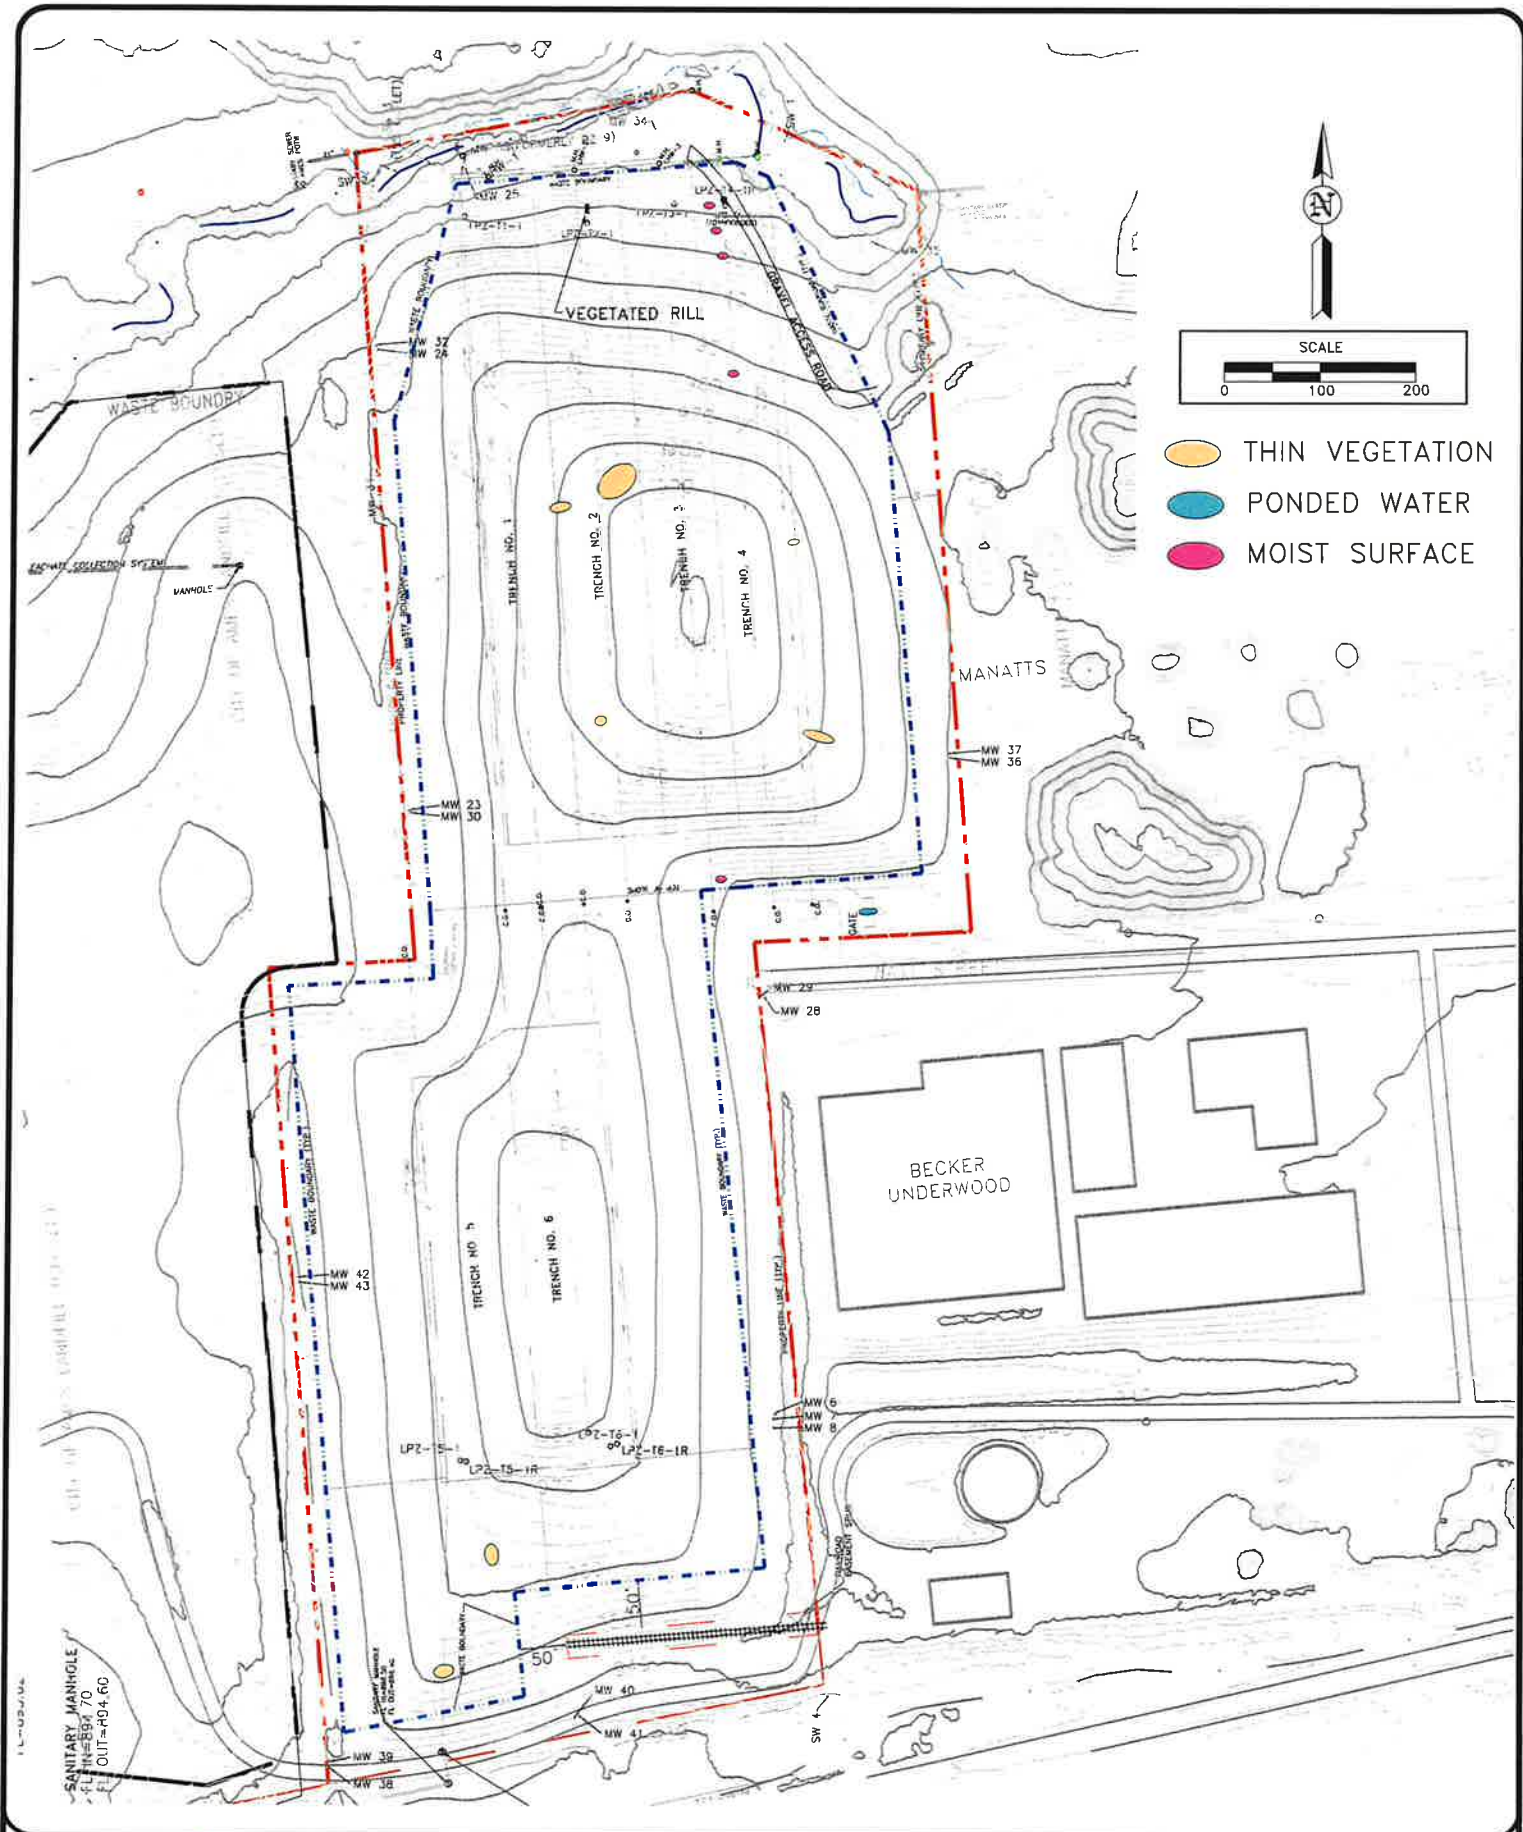
FIGURE: 1

The seeding on the south half of the site developed excellent coverage relatively quickly. As a result of the vegetation, there was minimal erosion noted on the south half of the site and the silt fence was removed prior to the Fall, 2017 inspection. Two small areas where vegetation was thin were noted during this inspection. No erosion was noted in these areas. The approximate locations of these areas is shown on the attached figure.

Vegetation is in excellent condition on the majority of the north half with the exception of a few areas where thin vegetation was noted during this inspection. No erosion was noted in the areas with thin vegetation. The approximate locations of these areas are shown on the attached figure.

No erosion was noted on cap with the exception of an erosion rill noted near LPZ-T2-1. The rill was referenced in past inspection reports. The rill is well vegetated and based on the condition of vegetation in this area, the rill does not appear to be active. No waste is exposed in the rill. The approximate location of the vegetated rill is shown on the attached figure.

Ponded water was observed in one area immediately north of the entrance gate. The area is within the former access road and outside the solid waste boundary; its approximate location is shown on the attached figure.

A moist surface was noted at several locations of the cap at the approximate locations shown on the attached figure. No standing or flowing water was noted at these locations during the inspection. The moisture is most likely the result of the above average rainfall in 2026 and the areas should be monitored.

1. Monitor streambank near MW-35.
2. Monitor the moist areas on the cap noted during the inspection.
3. Continue to remove trees from the landfill cap as needed.
4. Continue to monitor condition of vegetation, focusing on the areas with thin vegetation noted during this inspection, and reseed and control weeds as necessary.
5. Continue to monitor leachate levels in LPZ-T5-1R and discuss in the 2026 Annual Water Quality Report (AWQR).
6. Monitor the vegetated rill near LPZ-T2-1. Continue to monitor the remainder of the cap for erosion rills and repair as needed.
7. Monitor the sedimentation thickness at MW-34 and MW-8 during routine sampling events.
