**EnviroNET, Inc.**  
**Professional Environmental Services**  
**1225 East River Drive #101**  
**Davenport, IA 52803-5752**  
**WOSB, SBA, & BBB CERTIFIED**

**REFERENCE: 2026 FALL SEMI-ANNUAL ENGINEERING INSPECTION REPORT**  
**CONTINENTAL CEMENT – DAVENPORT CKD LANDFILL**  
**301 EAST FRONT STREET, BUFFALO, IA 52728**  
**PERMIT NOS. 82-SDP-16-97P AND 82-SDP-15-96C**

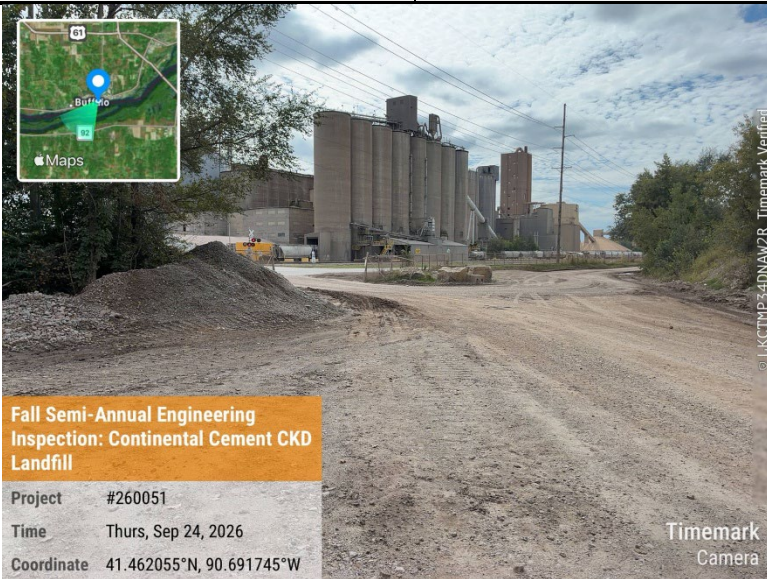
| Enviro <b>NET</b> Inc. | | PHOTOGRAPH LOG | |
|---|---|---|---|
| <b>Description:</b><br>View looking southwest at the main entrance to the mine and landfill areas. | | | |

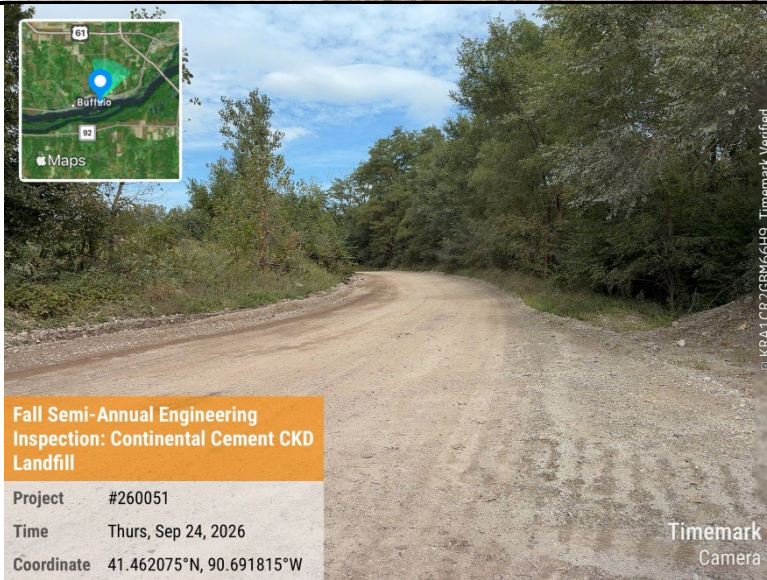
| Enviro <b>NET</b> Inc. | | PHOTOGRAPH LOG | |
|---|---|---|---|
| <b>Description:</b><br>View looking north at the access road on the eastern edge of the landfill. Nearby wells MW-3 & MW-3L appeared to be in good working condition with locks and nameplates. | | | |

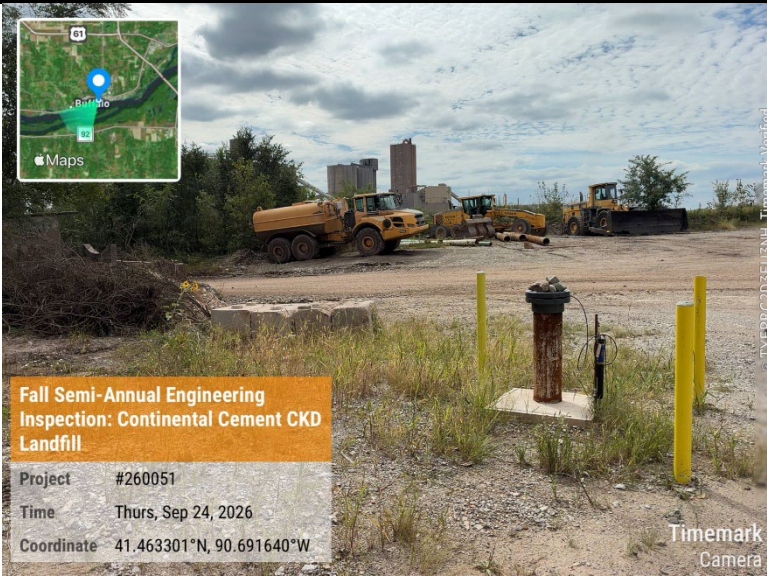
| Enviro <b>NET</b> Inc. | | PHOTOGRAPH LOG | |
|---|---|---|---|
| <b>Description:</b><br>View looking southwest at BMW-26-03, well was redrilled earlier this summer and missing a nameplate at time of inspection. Continental personnel confirmed nameplate will be installed after inspection. | | | |

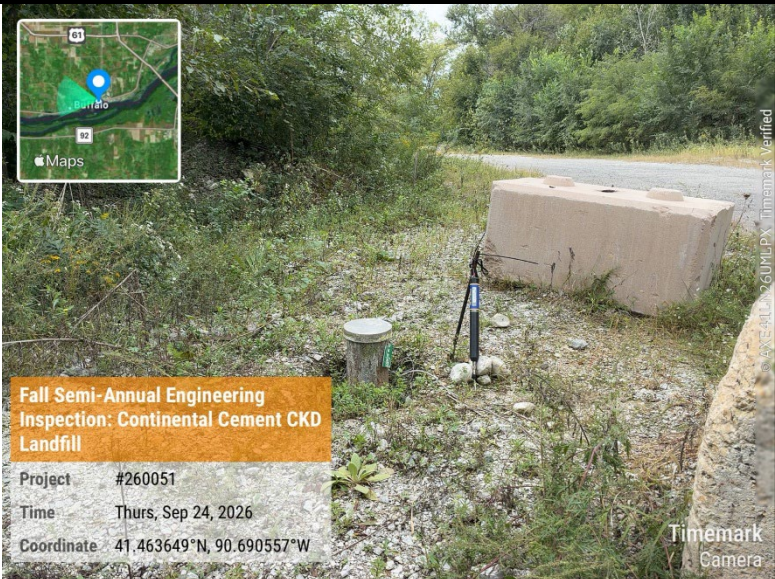
| Enviro <b>NET</b> Inc. | | PHOTOGRAPH LOG | |
|---|---|---|---|
| <b>Description:</b><br>View looking west at BMW-24-02, well appeared functional, locked and had a nameplate. | | | |

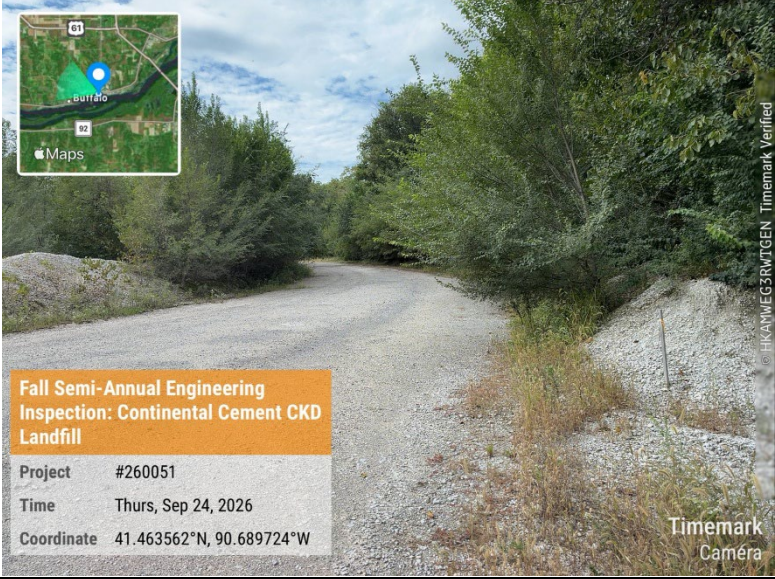
| Enviro <b>NET</b> Inc. | | PHOTOGRAPH LOG | |
|---|---|---|---|
| <b>Description:</b><br>View looking west at access road adjacent to wells BMW-24-02 & BMW-24-01 leading towards landfill area. | | | |

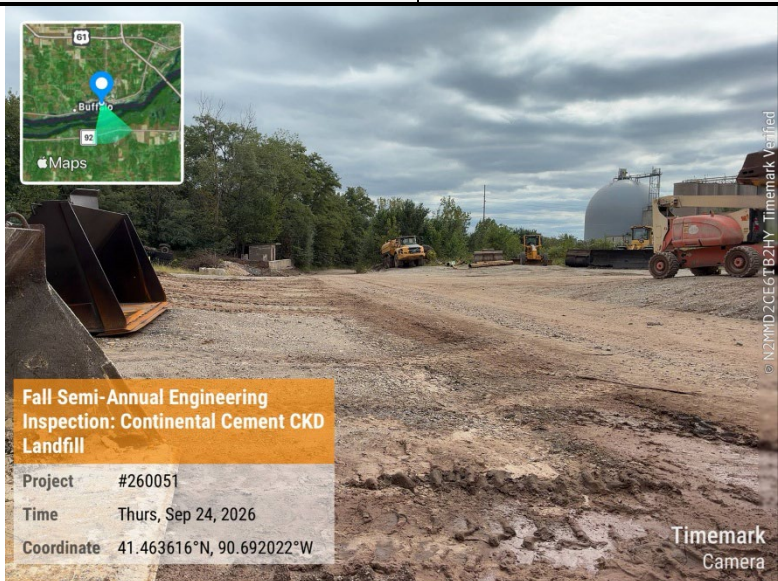
| Enviro <b>NET</b> Inc. | | PHOTOGRAPH LOG | |
|---|---|---|---|
| <b>Description:</b><br>View looking south at access road near newly redrilled well BMW-26-02CR. | | | |

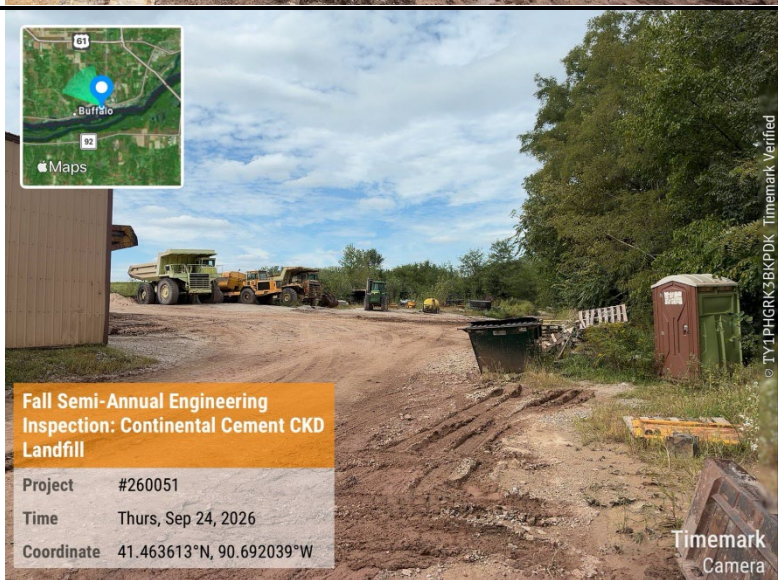
| Enviro <b>NET</b> Inc. | | PHOTOGRAPH LOG | |
|---|---|---|---|
| <b>Description:</b><br>View looking northwest at access road near newly redrilled well BMW-26-02CR. | | | |

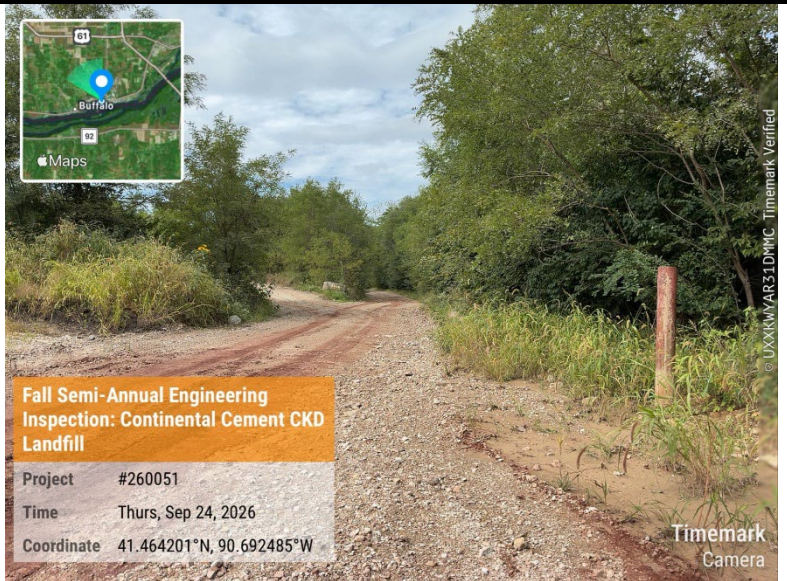
| Enviro <b>NET</b> Inc. | | PHOTOGRAPH LOG | |
|---|---|---|---|
| <b>Description:</b><br>View of east boundary access road looking north bound towards the Iron Mill Area (straight) and the Active Landfill Area (branch to the left). | | | |

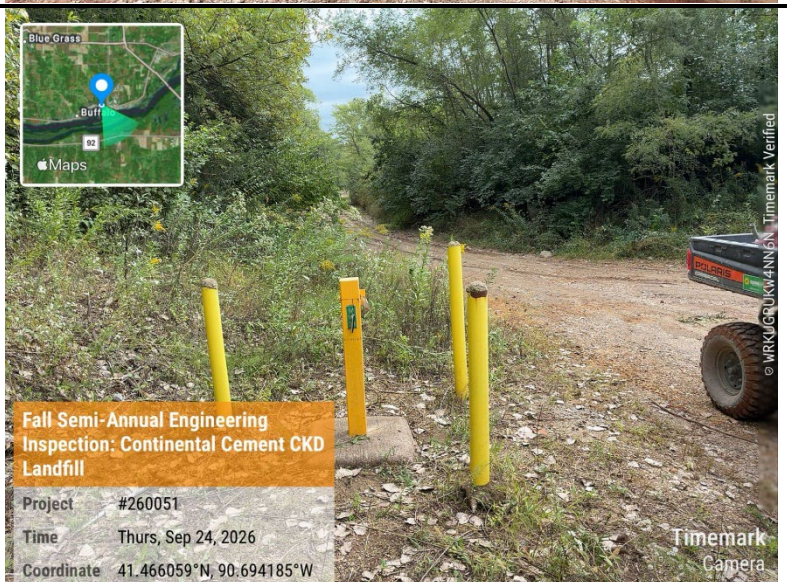
| Enviro <b>NET</b> Inc. | | PHOTOGRAPH LOG | |
|---|---|---|---|
| <b>Description:</b><br>View looking south at MW-21 and the east access road. | | | |

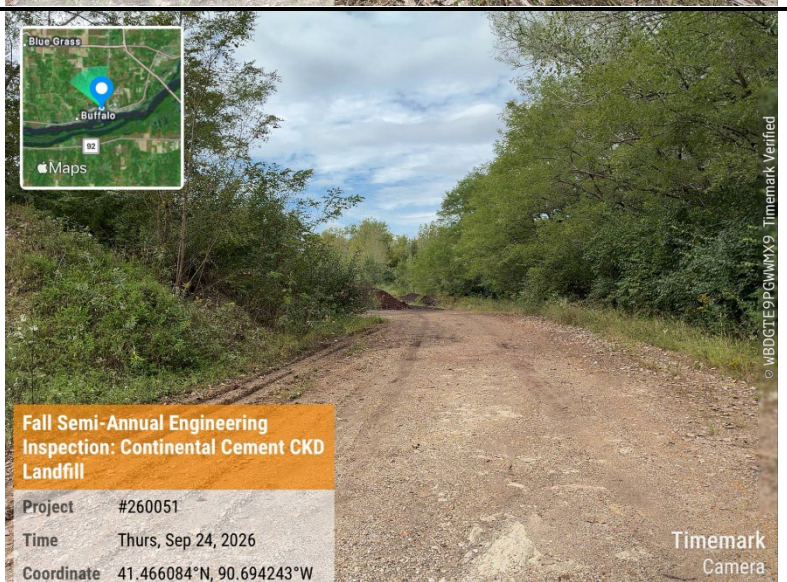
| Enviro <b>NET</b> Inc. | | PHOTOGRAPH LOG | |
|---|---|---|---|
| <b>Description:</b><br>View of east boundary access road looking north bound towards the Iron Mill Area. | | | |

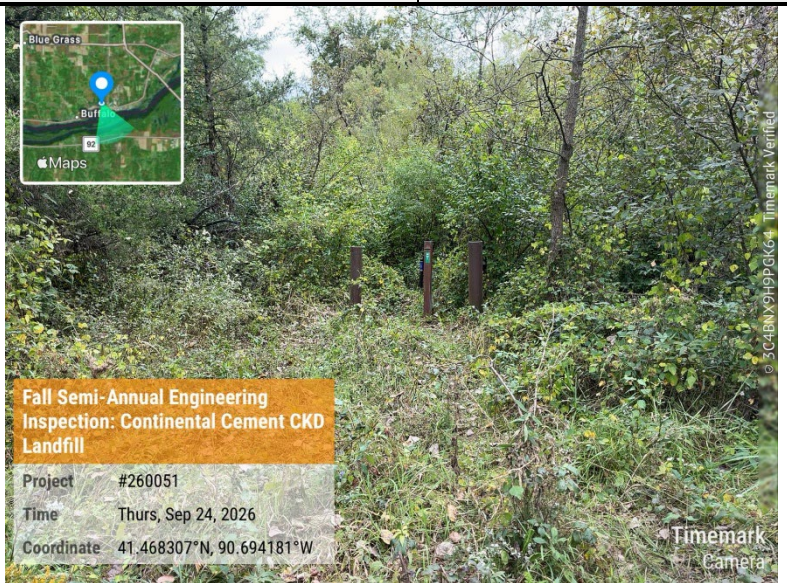
| Enviro <b>NET</b> Inc. | | PHOTOGRAPH LOG | |
|---|---|---|---|
| <b>Description:</b><br>View looking south at the northernmost well, MW-07. Well appeared functional, locked and appropriately labeled with a nameplate. | | | |

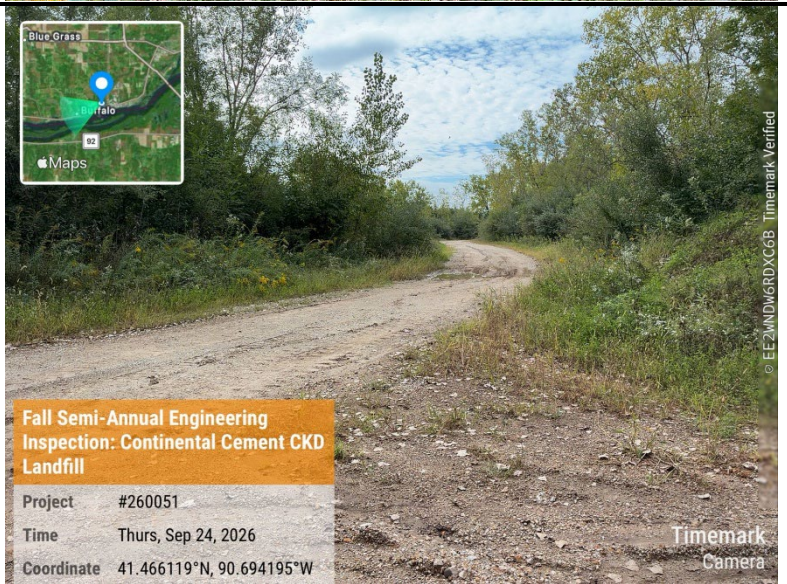
| Enviro <b>NET</b> Inc. | | PHOTOGRAPH LOG | |
|---|---|---|---|
| <b>Description:</b><br>View looking west along the access road on the north end of the landfill area. | | | |

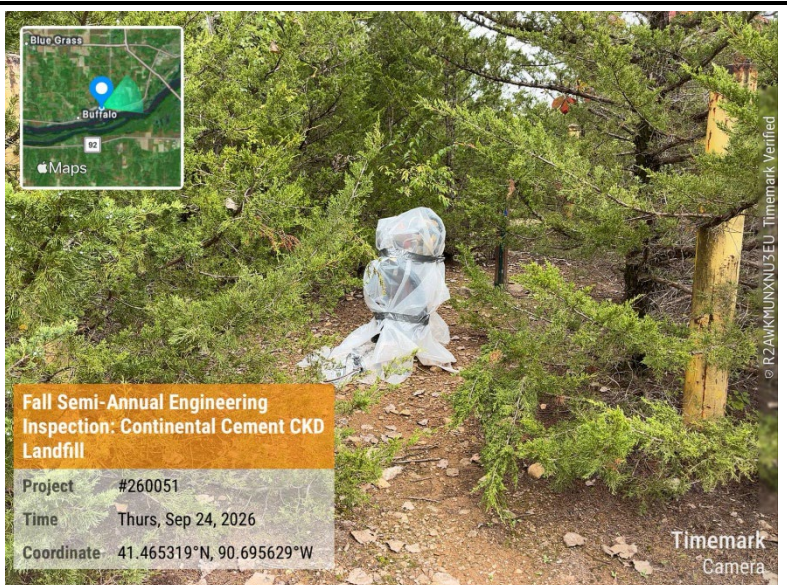
Monitoring wells near the landfill were located, observed, and appeared to be operational at time of inspection. The majority of monitoring wells had an intact nameplate and functioning lock. The newly redrilled monitoring wells, BMW-26-03 and BMW-26-02CR did not have installed nameplates at time of inspection. Continental representatives indicated nameplates for each well will be installed following this inspection. Monitoring well MW-1A was covered in plastic sheeting at time of inspection due to a sampling pump that got lodged during the September groundwater monitoring and sampling event. Continental personnel indicated that contractor mobilization for removal of the lodged equipment had been scheduled.

| Enviro <b>NET</b> Inc. | | PHOTOGRAPH LOG | |
|---|---|---|---|
| <b>Description:</b><br>View looking east at MW-1A and MW-1B. A sampling pump lodged in MW-1A during the fall groundwater sampling event was observed awaiting retrieval by contractor. The well was temporarily protected with plastic sheeting to prevent surface water intrusion. Continental personnel confirmed that contractor mobilization for equipment removal had been scheduled. The temporary condition was not considered a concern at the time of the inspection. | | | |

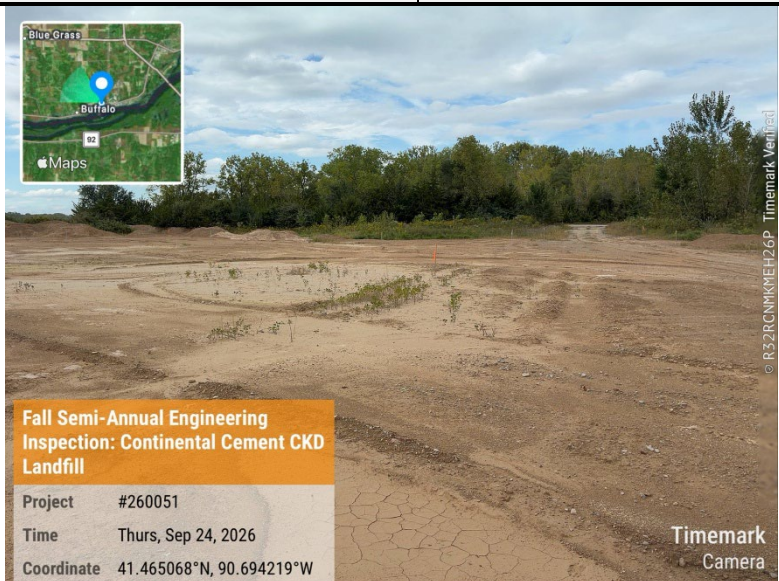
| Enviro <b>NET</b> Inc. | | PHOTOGRAPH LOG | |
|---|---|---|---|
| <b>Description:</b><br>View looking west at the Active Phase II Cell. No ponding water was observed. | | | |

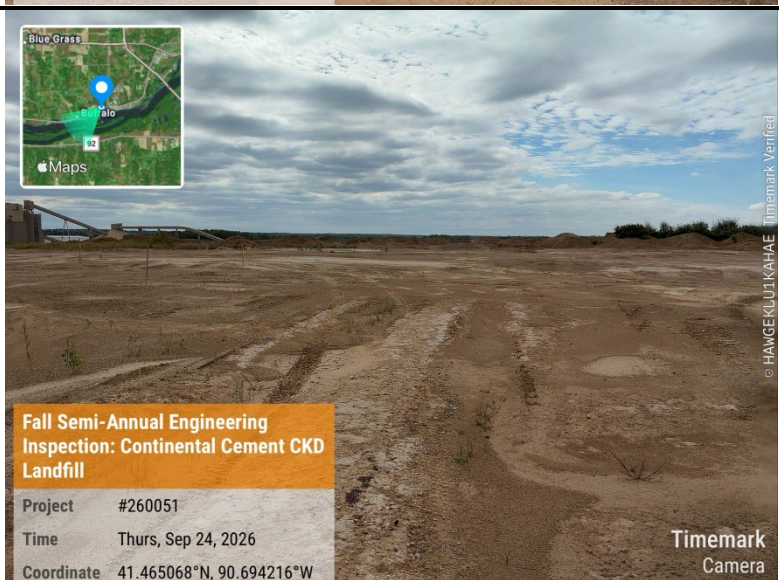
| Enviro <b>NET</b> Inc. | | PHOTOGRAPH LOG | |
|---|---|---|---|
| <b>Description:</b><br>View looking southwest at the Active Phase II Cell. No ponding water was observed. | | | |

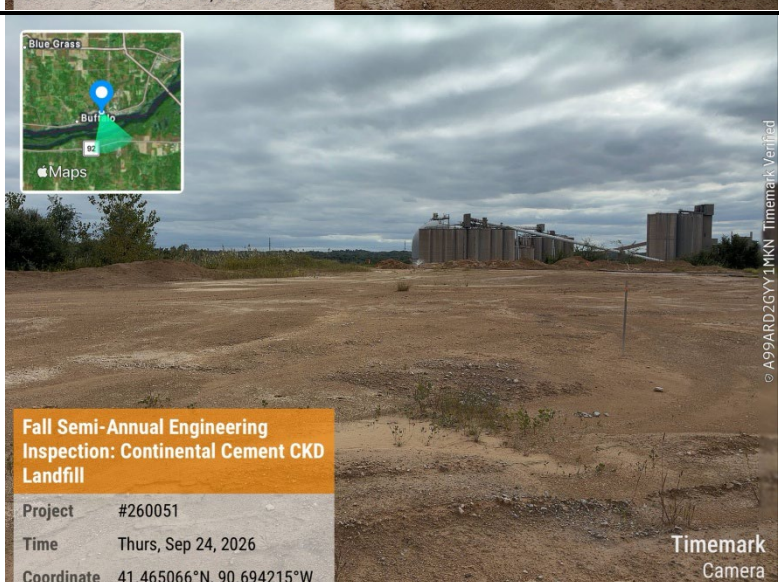
| Enviro <b>NET</b> Inc. | | PHOTOGRAPH LOG | |
|---|---|---|---|
| <b>Description:</b><br>View looking south-southeast at the Active Phase II Cell. No ponding water was observed. | | | |

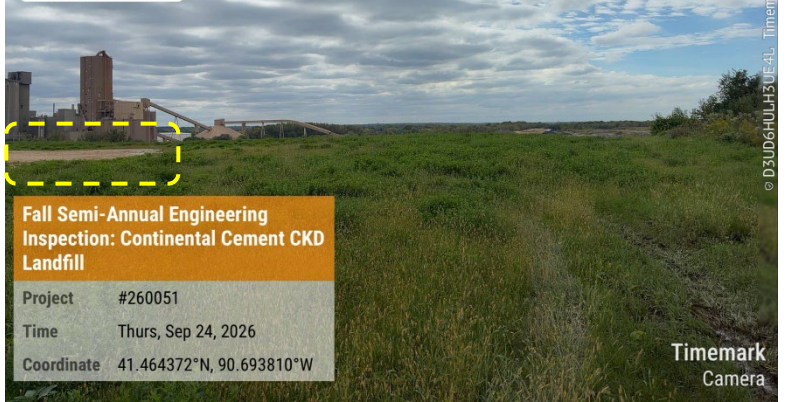
| Enviro <b>NET</b> Inc. | | PHOTOGRAPH LOG | |
|---|---|---|---|
| <b>Description:</b><br>View looking southwest at the Closed Phase I cell. The “bare” area in the yellow box, is further describe in Photo 20’s description. | | | |

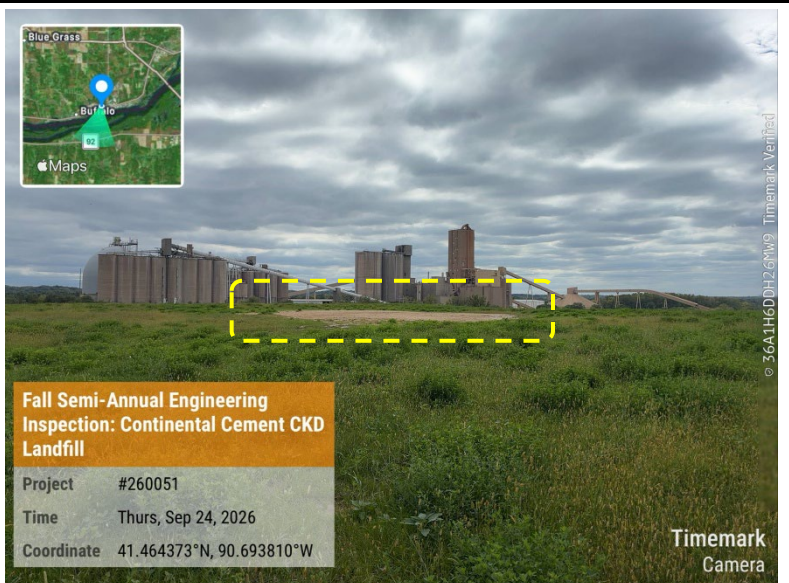
The northwest quadrant of the Phase I Closed Cell was previously identified during the 2025 October Engineering Inspection as being bare (Cap Area 1) with pooled/ponded water. Continual monitoring of this area along with routine seeding is recommended.

| Enviro <b>NET</b> Inc. | | PHOTOGRAPH LOG | |
|---|---|---|---|
| <b>Description:</b><br>View looking south at the Closed Phase I cell. Continental personnel identified a localized low area and placed approximately 153 tons of overburden/topsoil as a maintenance measure to improve drainage and prevent ponding. The recently placed soil remained unvegetated at the time of inspection; however, seeding is scheduled for Q4 to reestablish vegetative cover. The area appeared stable, and no ponding or evidence of cover system degradation was observed. | | | |

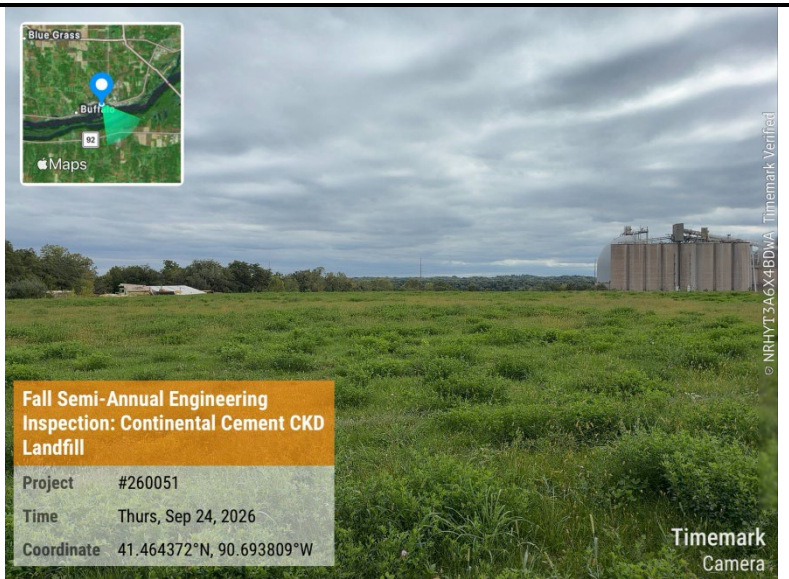
| Enviro <b>NET</b> Inc. | | PHOTOGRAPH LOG | |
|---|---|---|---|
| <b>Description:</b><br>View looking south-southeast at the Phase I Closed cell. Vegetation was intact and no ponding/pooling water was observed. | | | |

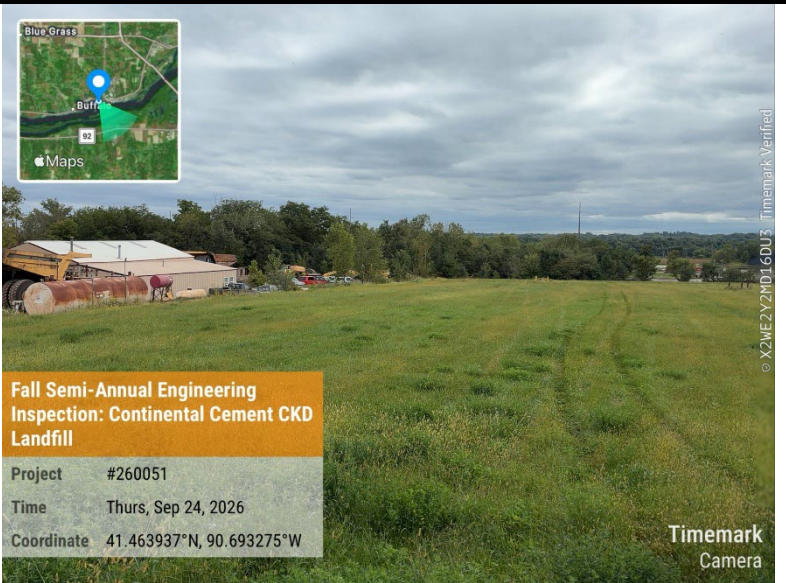
| Enviro <b>NET</b> Inc. | | PHOTOGRAPH LOG | |
|---|---|---|---|
| <b>Description:</b><br>View looking south-southeast at the Closed Cell. Vegetative cover was established and no ponding/pooling water was observed. | | | |

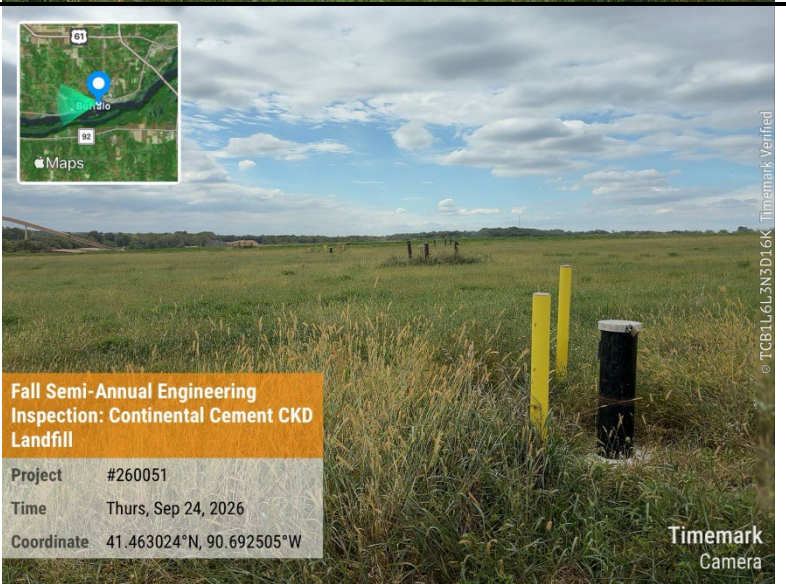
| Enviro <b>NET</b> Inc. | | PHOTOGRAPH LOG | |
|---|---|---|---|
| <b>Description:</b><br>View looking west at monitoring wells on the Closed Cell. Wells were locked and had nameplates at time of inspection. Vegetative cover was established and no pooling/ponding water was observed. | | | |

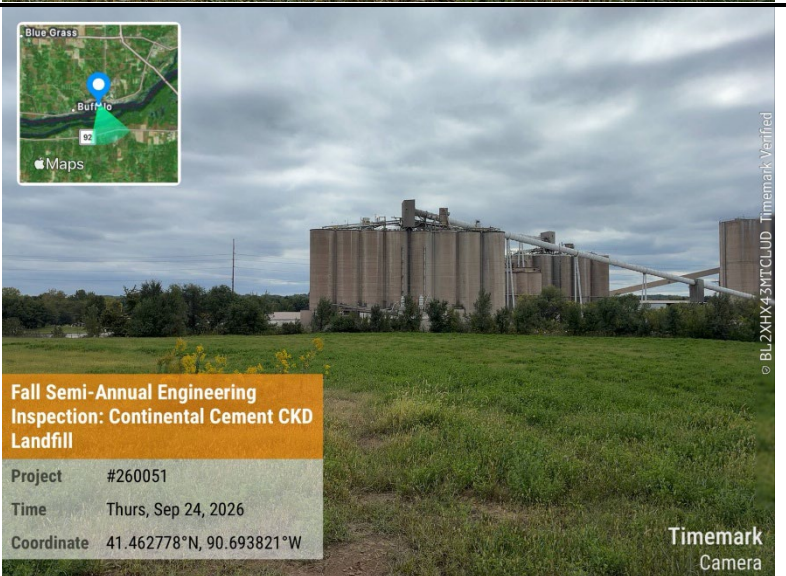
The clay cap over the Closed Cell appeared to be intact with a vegetative cover. The 2025 October Engineering inspection documented a bare area (Cap Area 2) with pooled/ponded water located southwest of MW-09. The previously identified bare area no longer appears to be present. Continual monitoring of this area along with routine seeding is still recommended to ensure established vegetation remains.

| Enviro <b>NET</b> Inc. | | PHOTOGRAPH LOG | |
|---|---|---|---|
| <b>Description:</b><br>View looking at the Closed Cell area, vegetative cover was established with no pooling/ponding water observed. Previous inspections identified this area in view as a problem area needing additional support. Continual monitoring and routine seeding is recommended to ensure vegetations remains established. | | | |

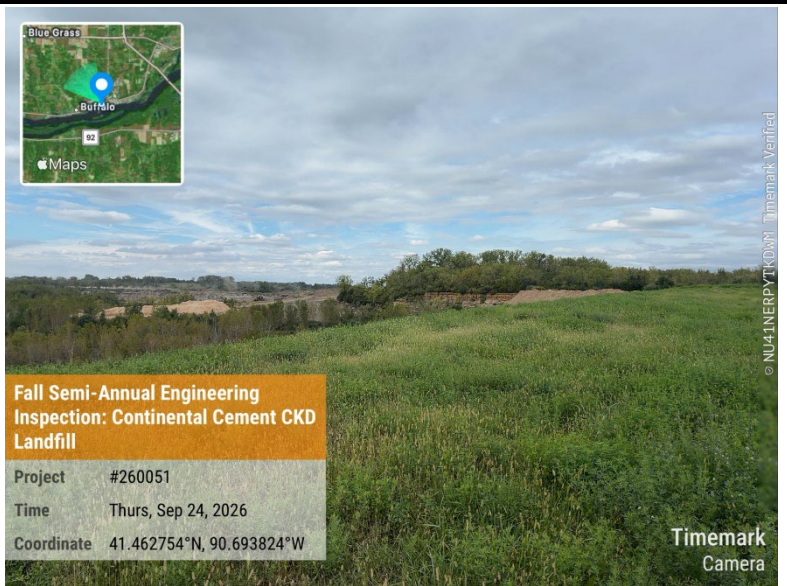
| Enviro <b>NET</b> Inc. | | PHOTOGRAPH LOG | |
|---|---|---|---|
| <b>Description:</b><br>View looking northwest at the west edge of the Closed Cell. Vegetative cover was established with no pooling/ponding water observed. Previous inspections identified this area in view as a problem area needing additional support. Continual monitoring and routine seeding is recommended to ensure vegetation remains established. | | | |

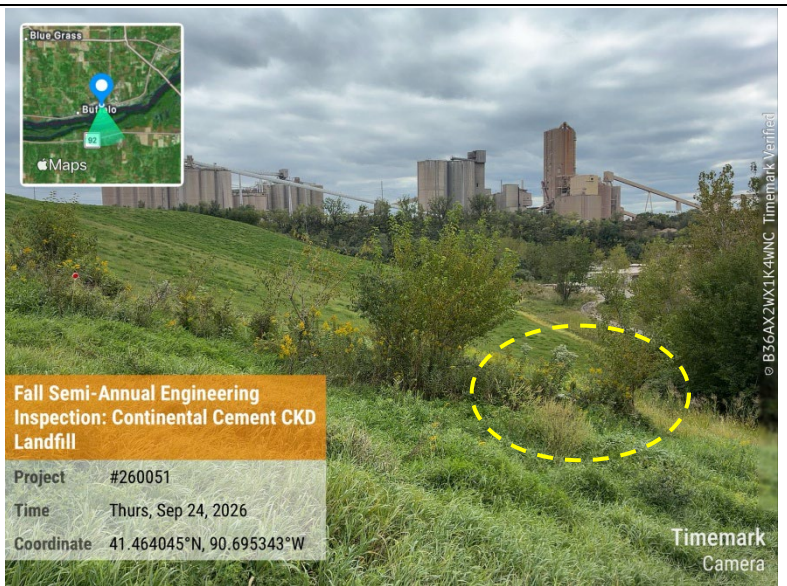
| Enviro <b>NET</b> Inc. | | PHOTOGRAPH LOG | |
|---|---|---|---|
| <b>Description:</b><br>View looking south at the west slope of the Closed Cell and L-Sump (yellow circle). Slope appeared stable with vegetative cover. | | | |

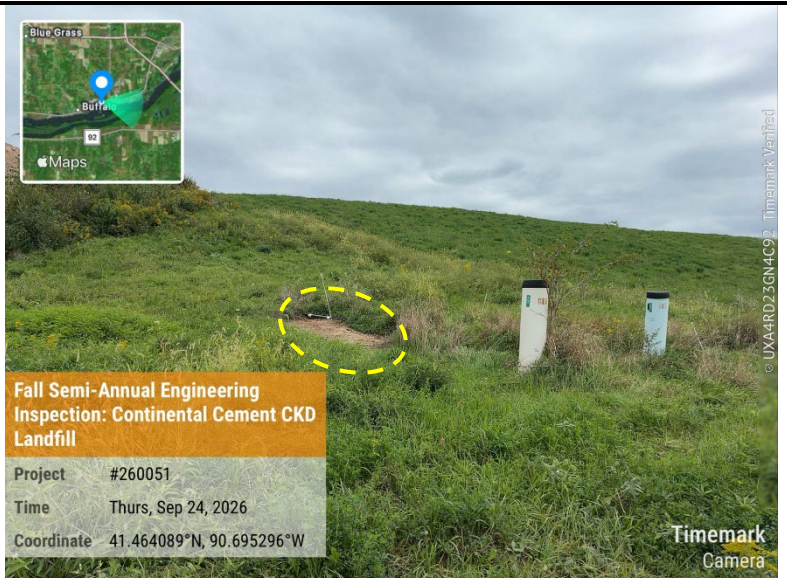
| Enviro <b>NET</b> Inc. | | PHOTOGRAPH LOG | |
|---|---|---|---|
| <b>Description:</b><br>View looking east at lysimeters UL-1 & LL-1. A small area upgradient of lysimeters had reduced vegetative cover downgradient of the leachate recirculation pipe. The surrounding vegetation remained well established, with no evidence of leachate breakout or erosion, was observed at time of inspection. | | | |

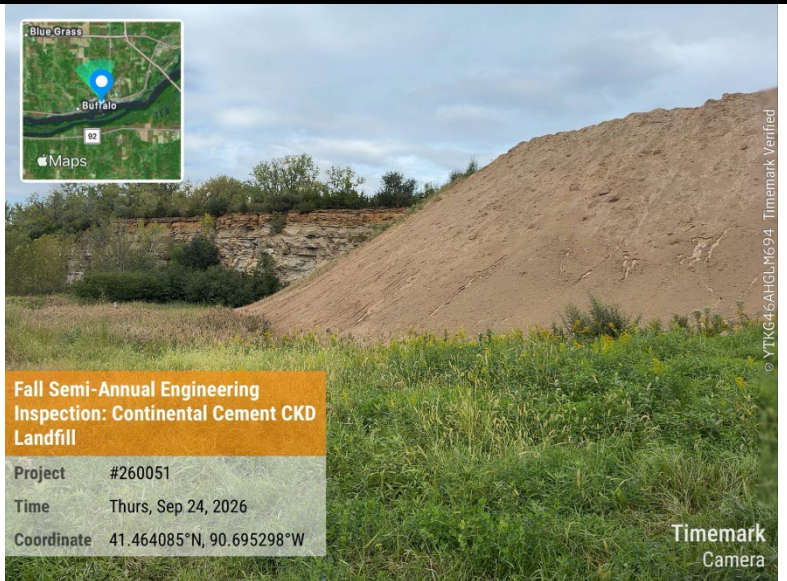
| Enviro <b>NET</b> Inc. | | PHOTOGRAPH LOG | |
|---|---|---|---|
| <b>Description:</b><br>View looking north along the working slope of the Active Phase II Cell. Pooled/ponded water at base of slope observed during the Spring inspection was not observed during this inspection due to dense vegetation growth. | | | |

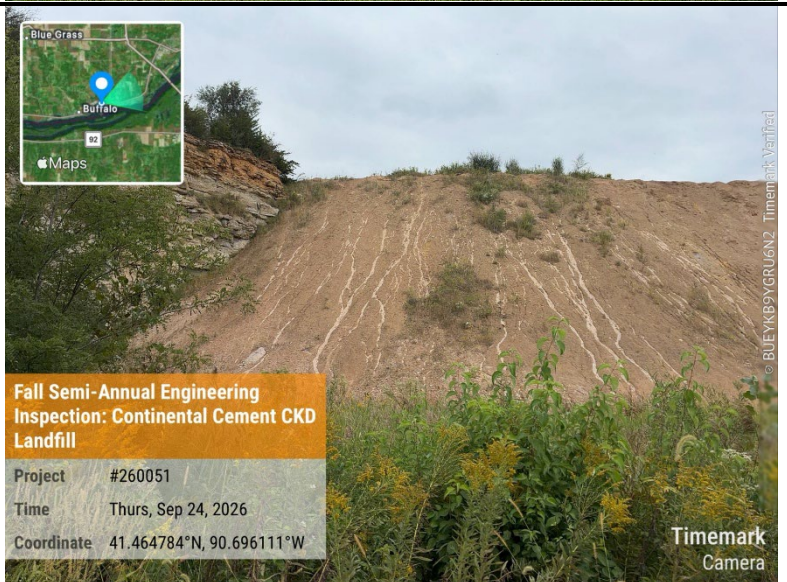
| Enviro <b>NET</b> Inc. | | PHOTOGRAPH LOG | |
|---|---|---|---|
| <b>Description:</b><br>View looking north of the working slope of the Active Phase II Cell, minor erosion rills were observed however slope appeared stable. | | | |

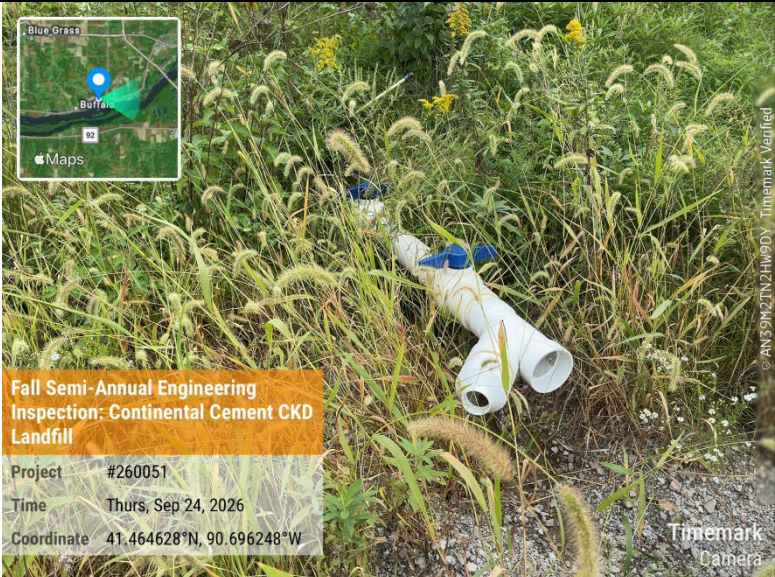
| Enviro <b>NET</b> Inc. | | PHOTOGRAPH LOG | |
|---|---|---|---|
| <b>Description:</b><br>View looking at the northern modified leachate drainage/jetting line. Pipe was in a closed position and not leaking at time of inspection. The area surrounding the discharge point was vegetated with no evidence of erosion. | | | |

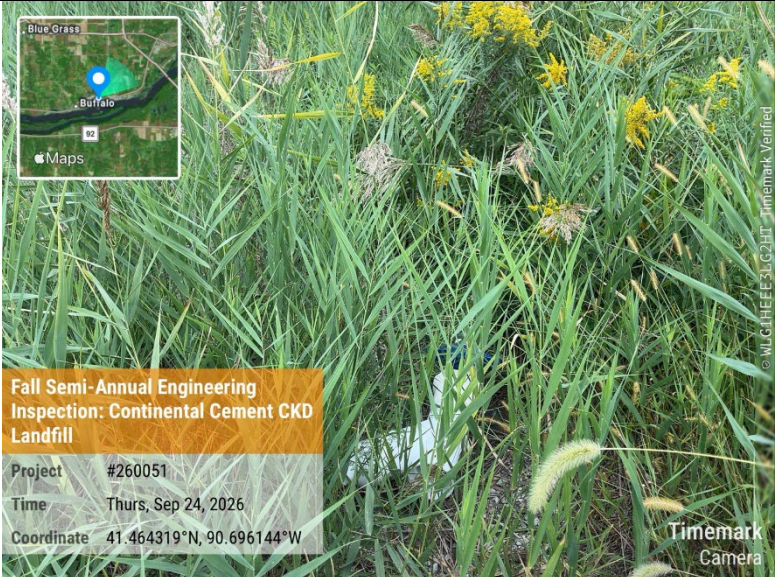
| Enviro <b>NET</b> Inc. | | PHOTOGRAPH LOG | |
|---|---|---|---|
| <b>Description:</b><br>View looking at the southern modified leachate drainage/jetting line. Pipe was in a closed position and not leaking at time of inspection. The area surrounding the discharge point was vegetated with no evidence of erosion. | | | |

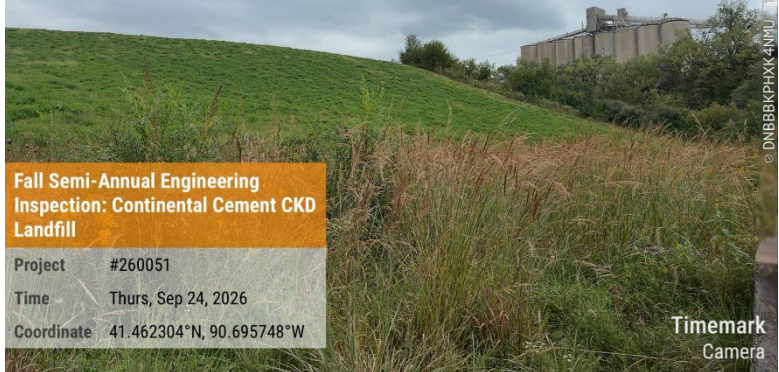
| Enviro <b>NET</b> Inc. | | PHOTOGRAPH LOG | |
|---|---|---|---|
| <b>Description:</b><br>View looking east at the western slope of the Closed Cell. Vegetative cover was intact with no evidence of erosion observed. | | | |

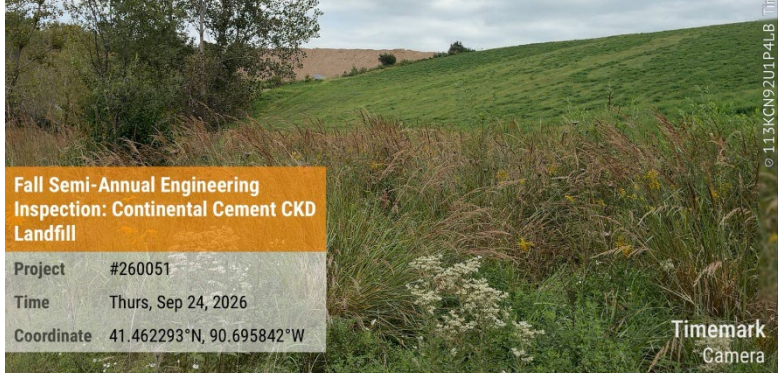
| Enviro <b>NET</b> Inc. | | PHOTOGRAPH LOG | |
|---|---|---|---|
| <b>Description:</b><br>View looking northeast at the western slope of the Closed Phase I cell. Vegetative cover was intact with no evidence of erosion observed. | | | |
