UNITED STATES ENVIRONMENTAL PROTECTION AGENCY

RE: Amazing Products Company
Mason City, Iowa
RCRA ID No.: none

SUBJECT: RCRA Complaint Investigation at Amazing Products Company,
Mason City, IA – Non-notifier

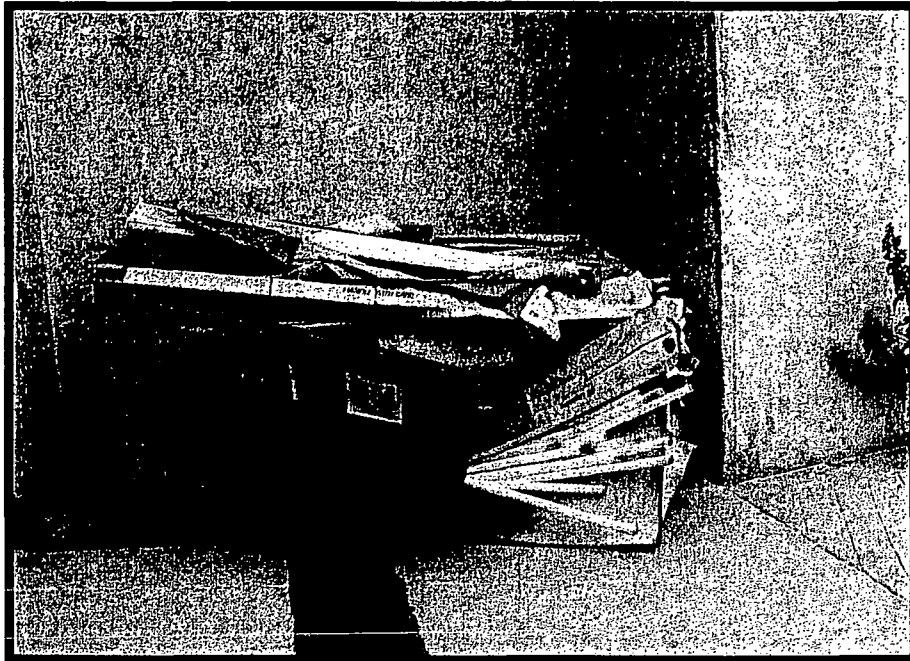
Photo 1

Amazing Products just outside entrance door – spent bulbs
being stored next to apparent storm drain.

On 7/1/05, I contacted Mr. Westcott to inform him of IDNR's sampling results. I told him that the sample from the machine residue contained high levels of mercury. He stated that he would make sure the equipment is covered more completely. He stated that he had also contacted the Iowa Waste Reduction Center to obtain recyclers for the spent fluorescent bulbs.

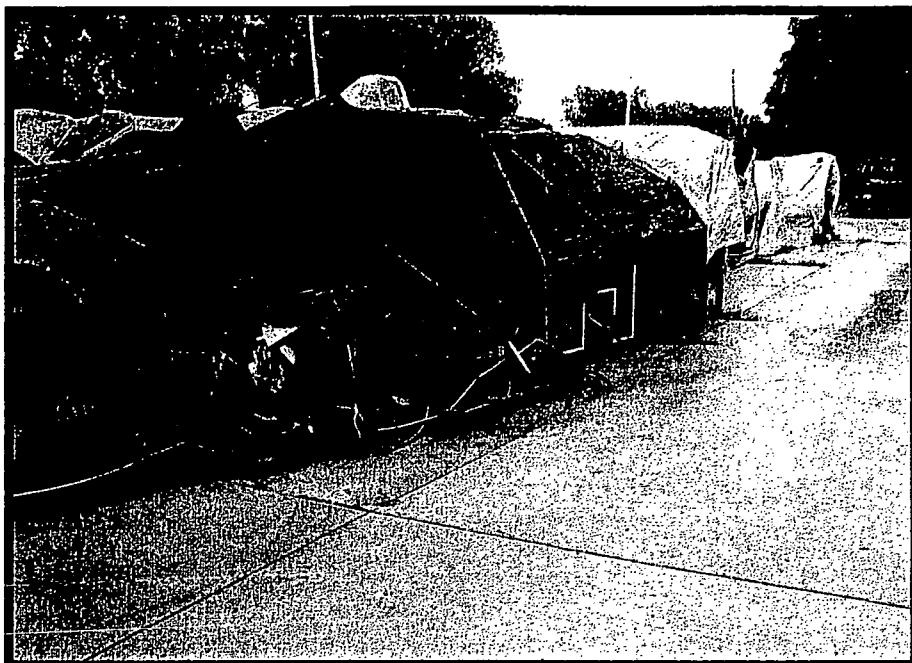
Photo 9

Northeast side of facility – Equipment belonging to Dick Westcott that was used in the production of mercury oxide batteries. It was partially covered with tarps.

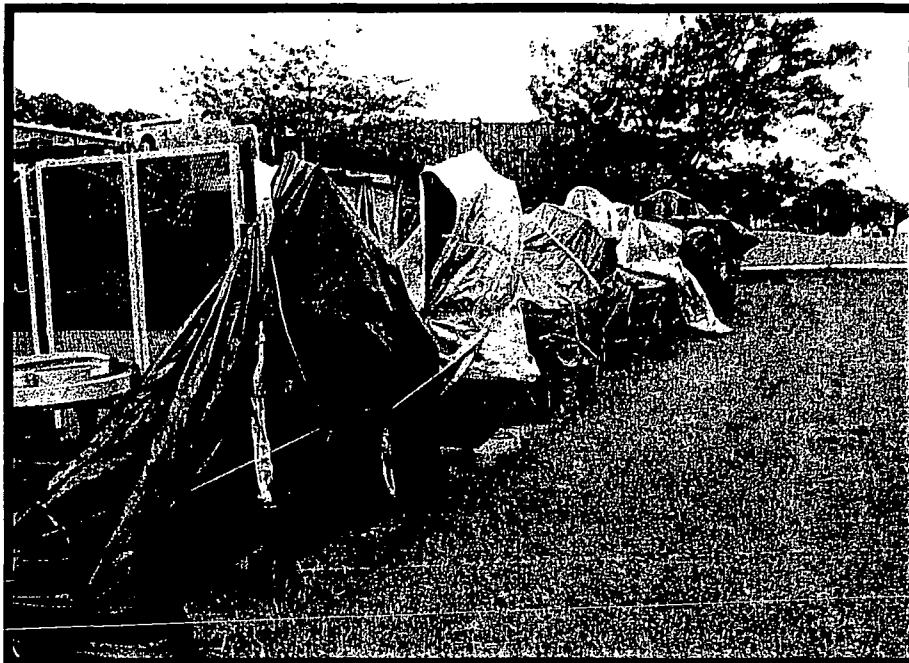
Photo 11

Northeast side of facility – Equipment belonging to Dick Westcott that was used in the production of mercury oxide batteries. It was partially covered with tarps.

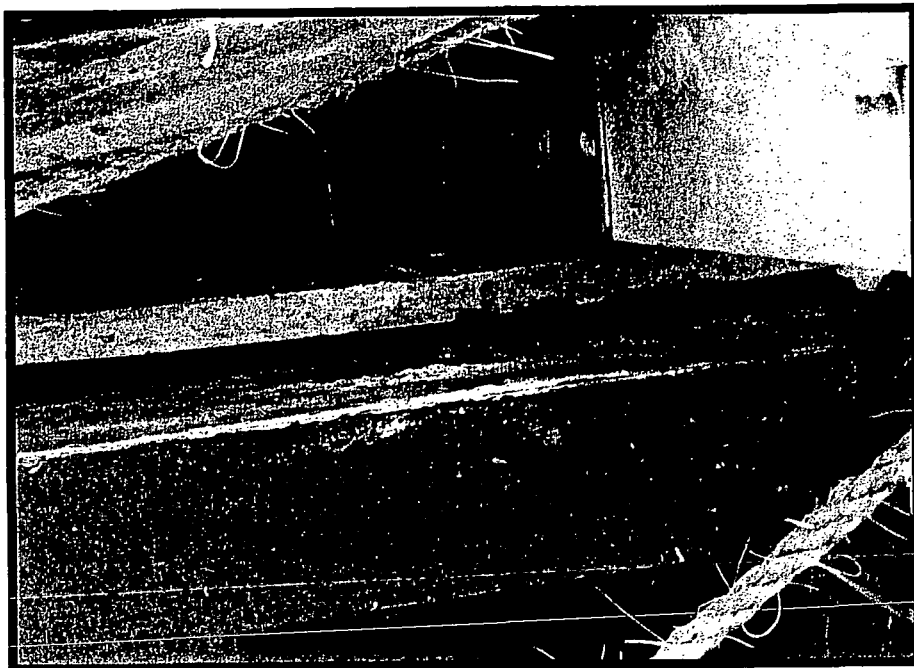
Photo 15

Northeast side of facility – Equipment belonging to Dick Westcott that was used in the production of mercury oxide batteries. It was partially covered with tarps. Exposed light grey powdery residue observed. Residue on this machine was part of composite sample analyzed by IDNR.
