**PHASE I ENVIRONMENTAL
SITE ASSESSMENT**

Oskaloosa Implement
2350 Highway 23 South
Oskaloosa, Iowa

WCEC Project No. 09-7331-60

September 23, 2009

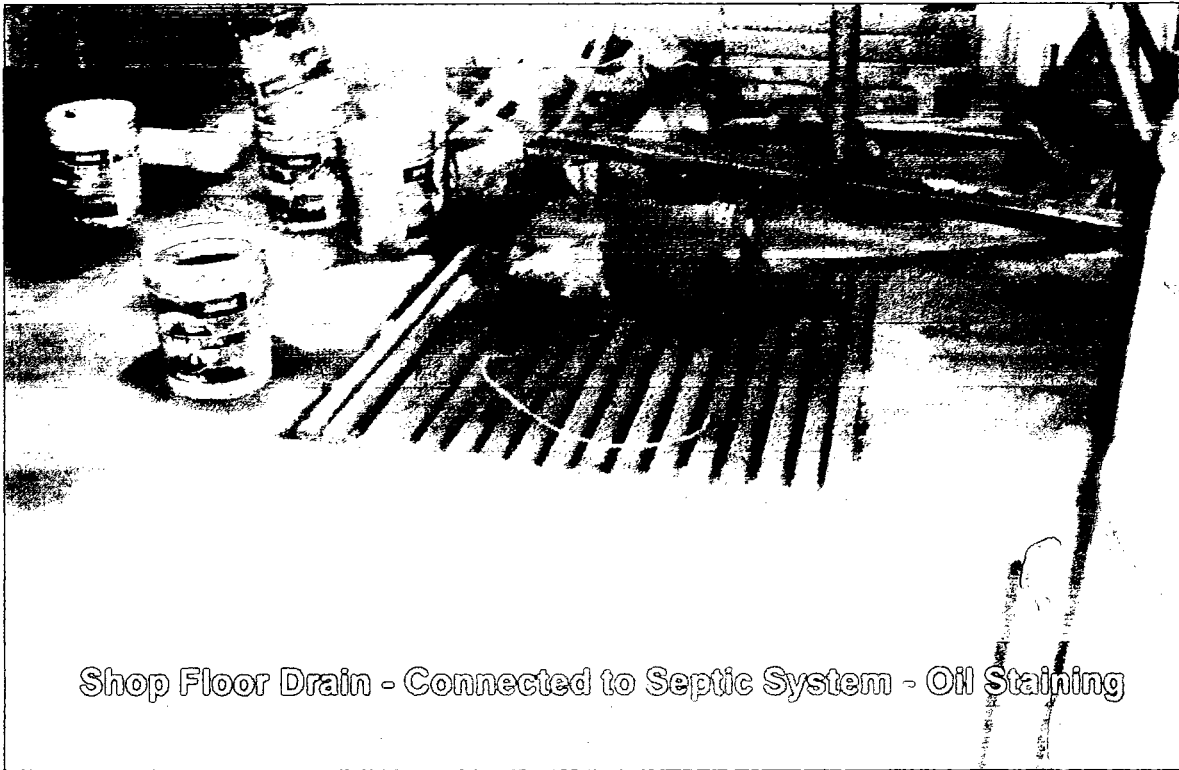
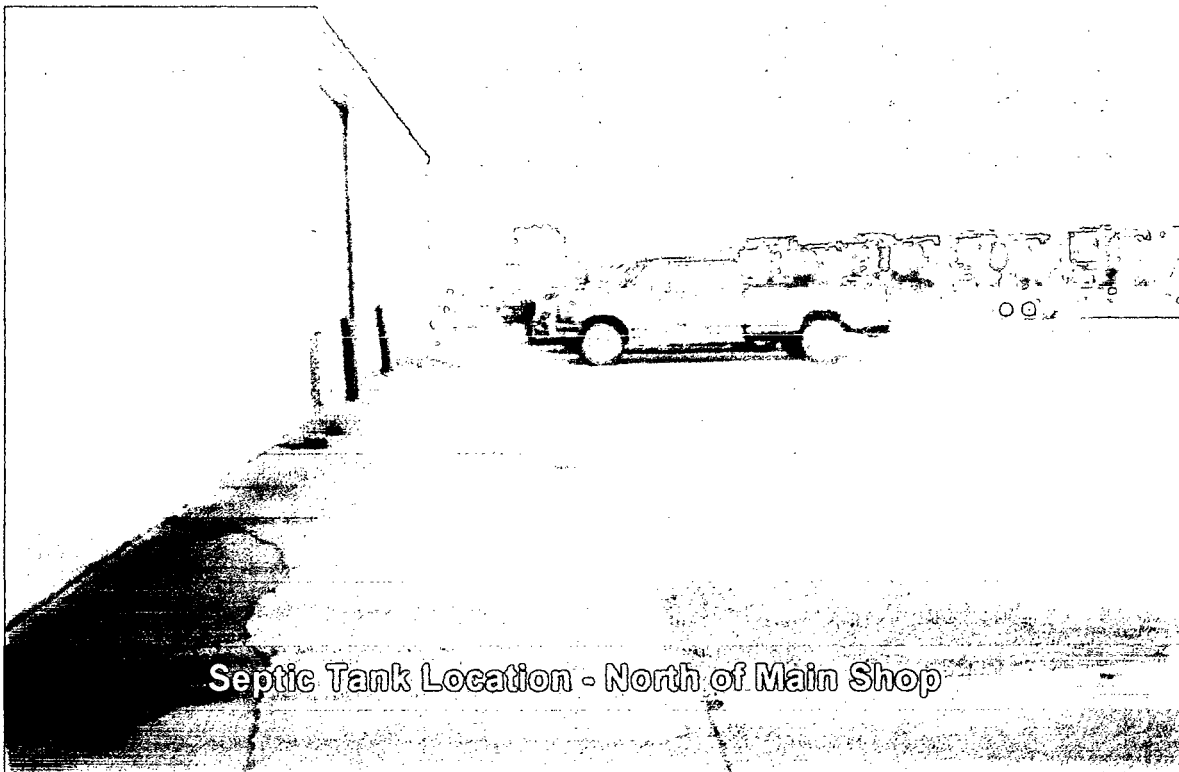
Former Fuel Pump, and Underground Tank

A former underground storage tank was removed from the subject property approximately 25-years ago. However, no laboratory data documenting the tank basin soils are available. In addition, a septic system, receiving waste from the shop floor drains, is located on the north side of the main shop. WCEC recommends a Phase II ESA to determine subgrade soil or groundwater impacts from the former bulk petroleum storage and existing septic drainfield. In addition, WCEC recommends installation of a holding tank for the shop floor drains.
