Site Name: Waterloo Greyhound Park, Waterloo

Initial Site Screening (ISS)

3931 - Phase II Assessment Review – Brownfield Funded

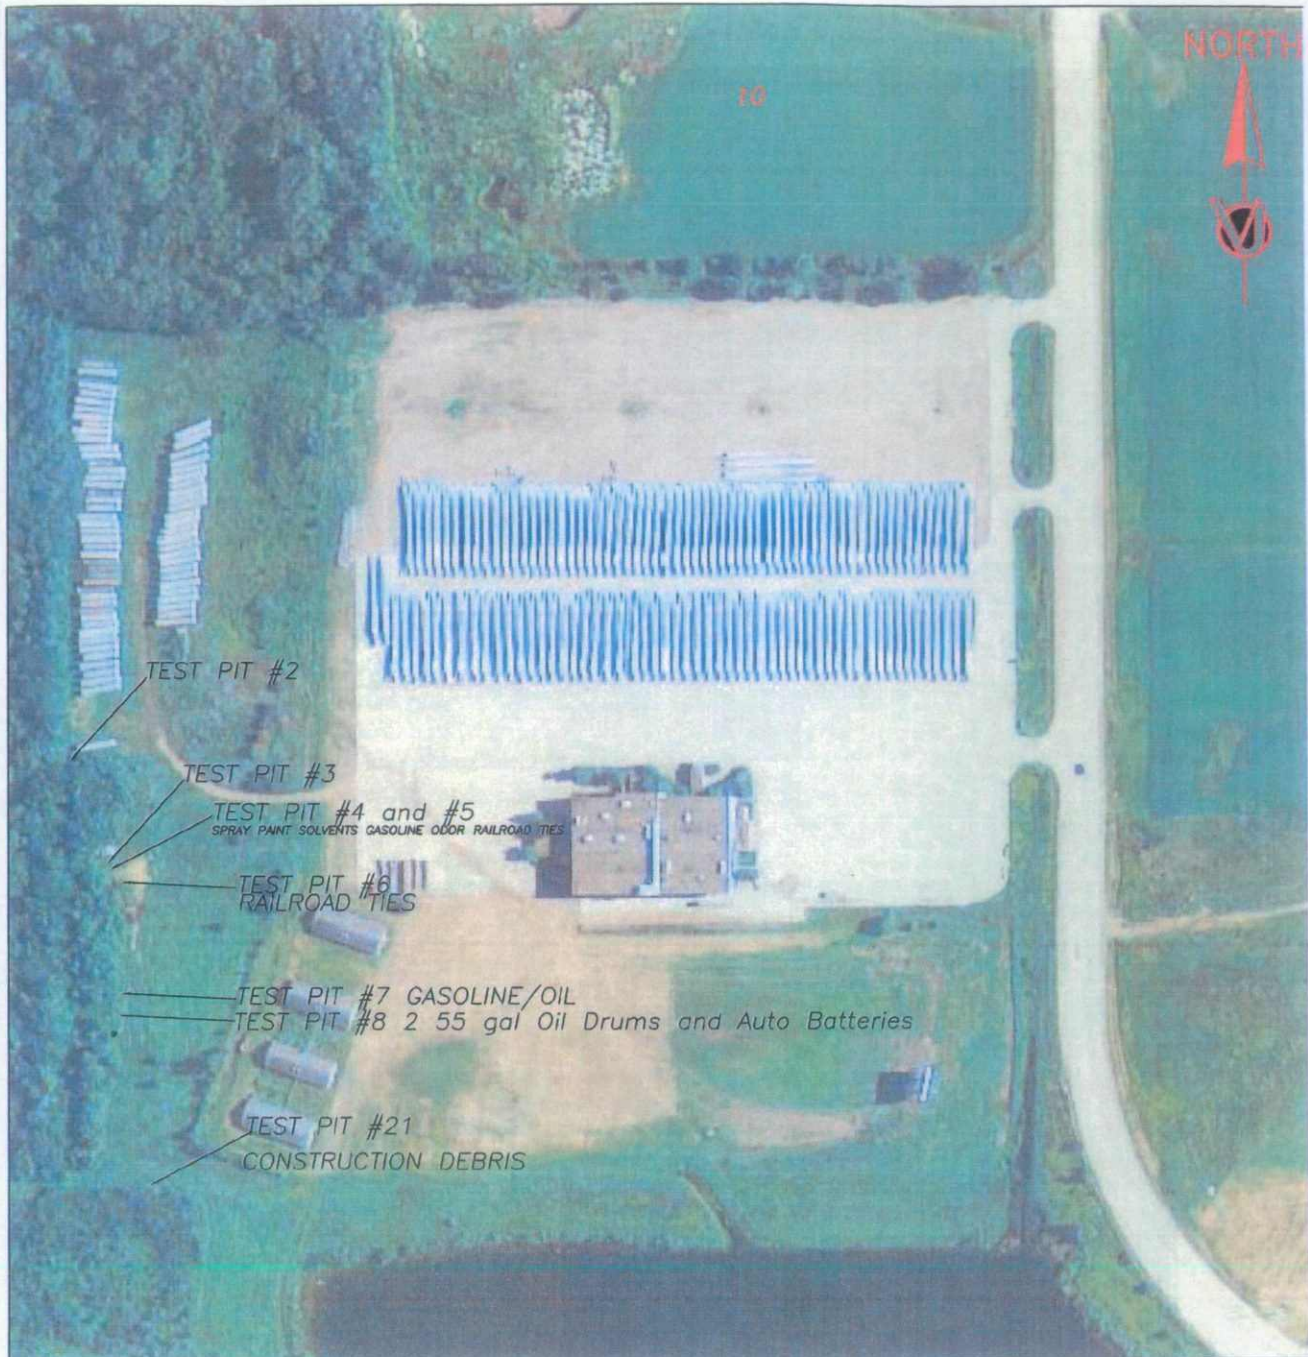
FIGURE 2: SITE PLAN MAP

TEST PIT #2 OIL DRUM mixed with garbage

TEST PIT #3 2-5 gallon paint containers (full) motor oil and paint thinner containers

TEST PIT #4 and #5 Spray Paint Cans and Railroad Ties

TEST PIT #6 Railroad Ties

TEST PIT #7 Gasoline/Solvents

TEST PIT #8 Gasoline Smell/55 gallon oil drum and car batteries

TEST PIT #21 Demolition Debris
