Subject: Spirit Lake Community Gardens, Spirit Lake, Iowa  
Summary of Surface Soil Sampling Results

The purpose of this letter is summarize the findings of the limited surface soil sampling conducted by the Iowa Department of Natural Resources (IDNR) at three locations in Spirit Lake that have been proposed as community gardens (Figures 1 and 2). The sampling and analyses were conducted to determine if there was evidence suggesting the existence of a hazardous condition. No previous environmental assessment documentation for this site was provided to IDNR. It is IDNR's understanding that the three locations are to be used for community gardens.

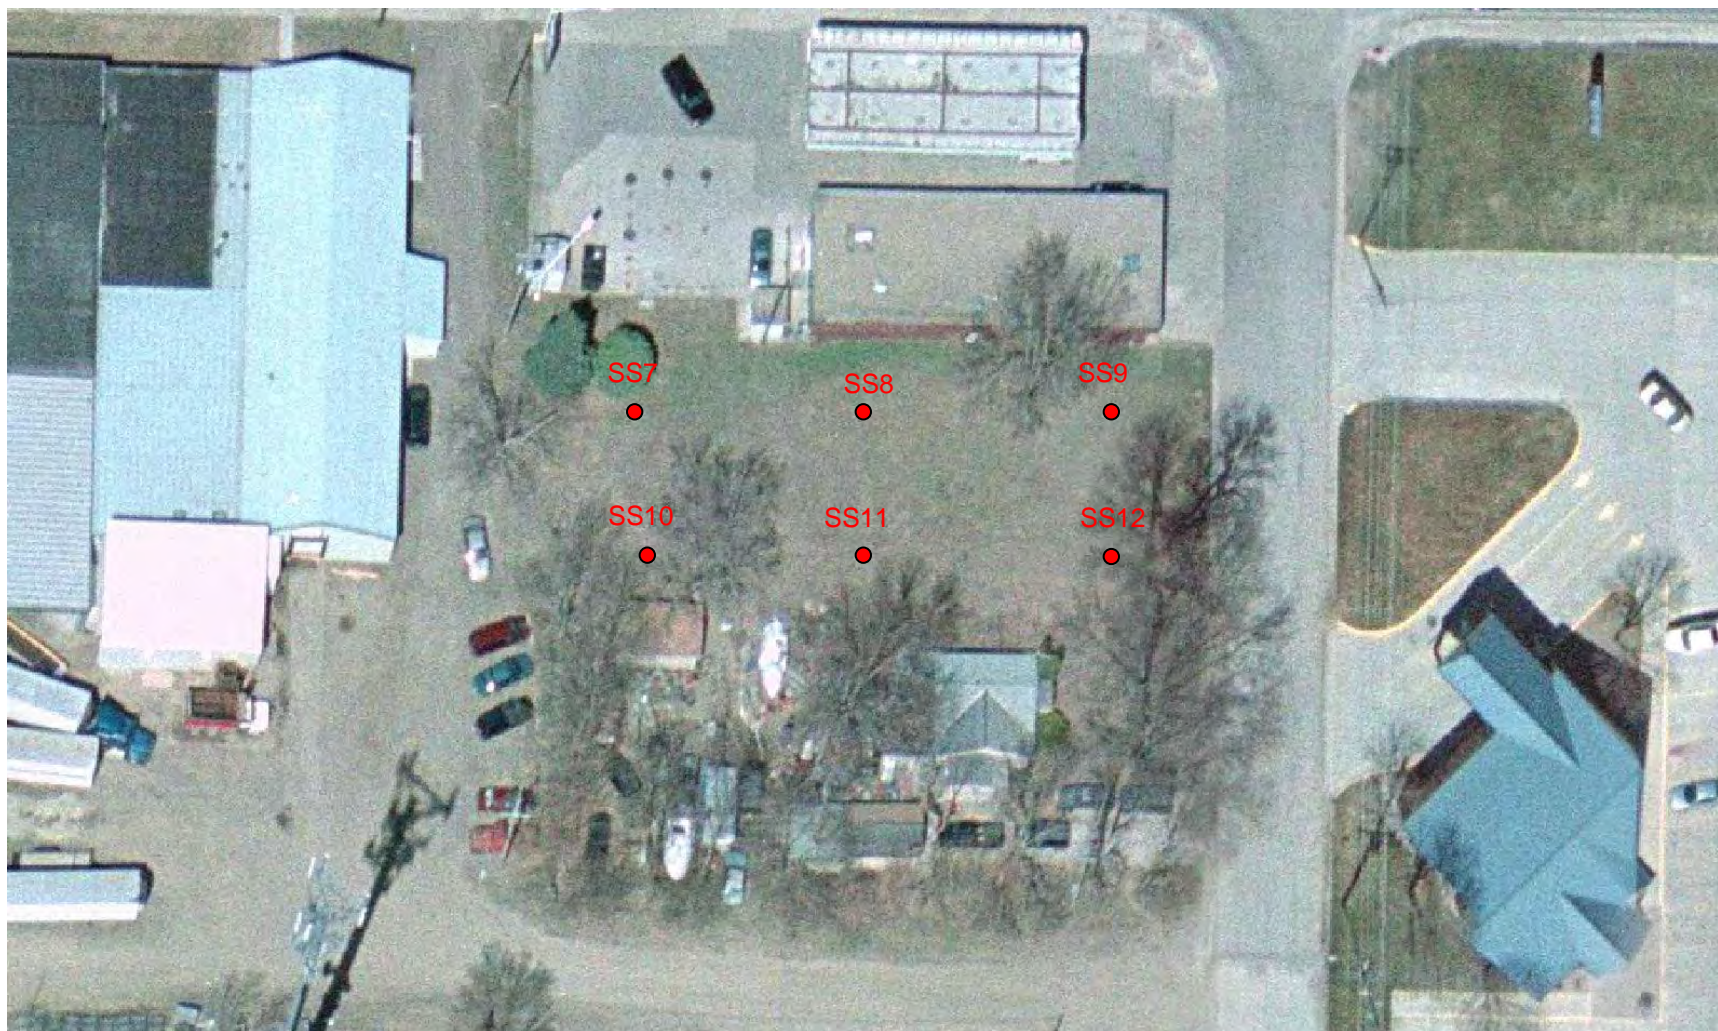
Figure 4 – Sample Locations, Site 2  
Spirit Lake Community Gardens  
Spirit Lake, Iowa

#### **Site 2 (SS7 – SS12), Dyno Oil Co., 18<sup>th</sup> & Lincoln Ave.**

Arsenic, cobalt, and lead were detected above their respective statewide standards for soil:

Arsenic (Statewide Standard: 17.0 mg/kg)

- 0-2" sample: SS11, 2.6 mg/kg
- 1-2' sample: SS11, 62.0 mg/kg

Cobalt (Statewide Standard: 23.0 mg/kg)

- 0-2" sample: SS9, 127 mg/kg
- 1-2' sample: SS11, 464 mg/kg

Lead (Statewide Standard: 400 mg/kg)

- 0-2" sample: SS9, 444 mg/kg
- 1-2' sample: SS11, 1,080 mg/kg

Sample locations are shown on Figure 4.

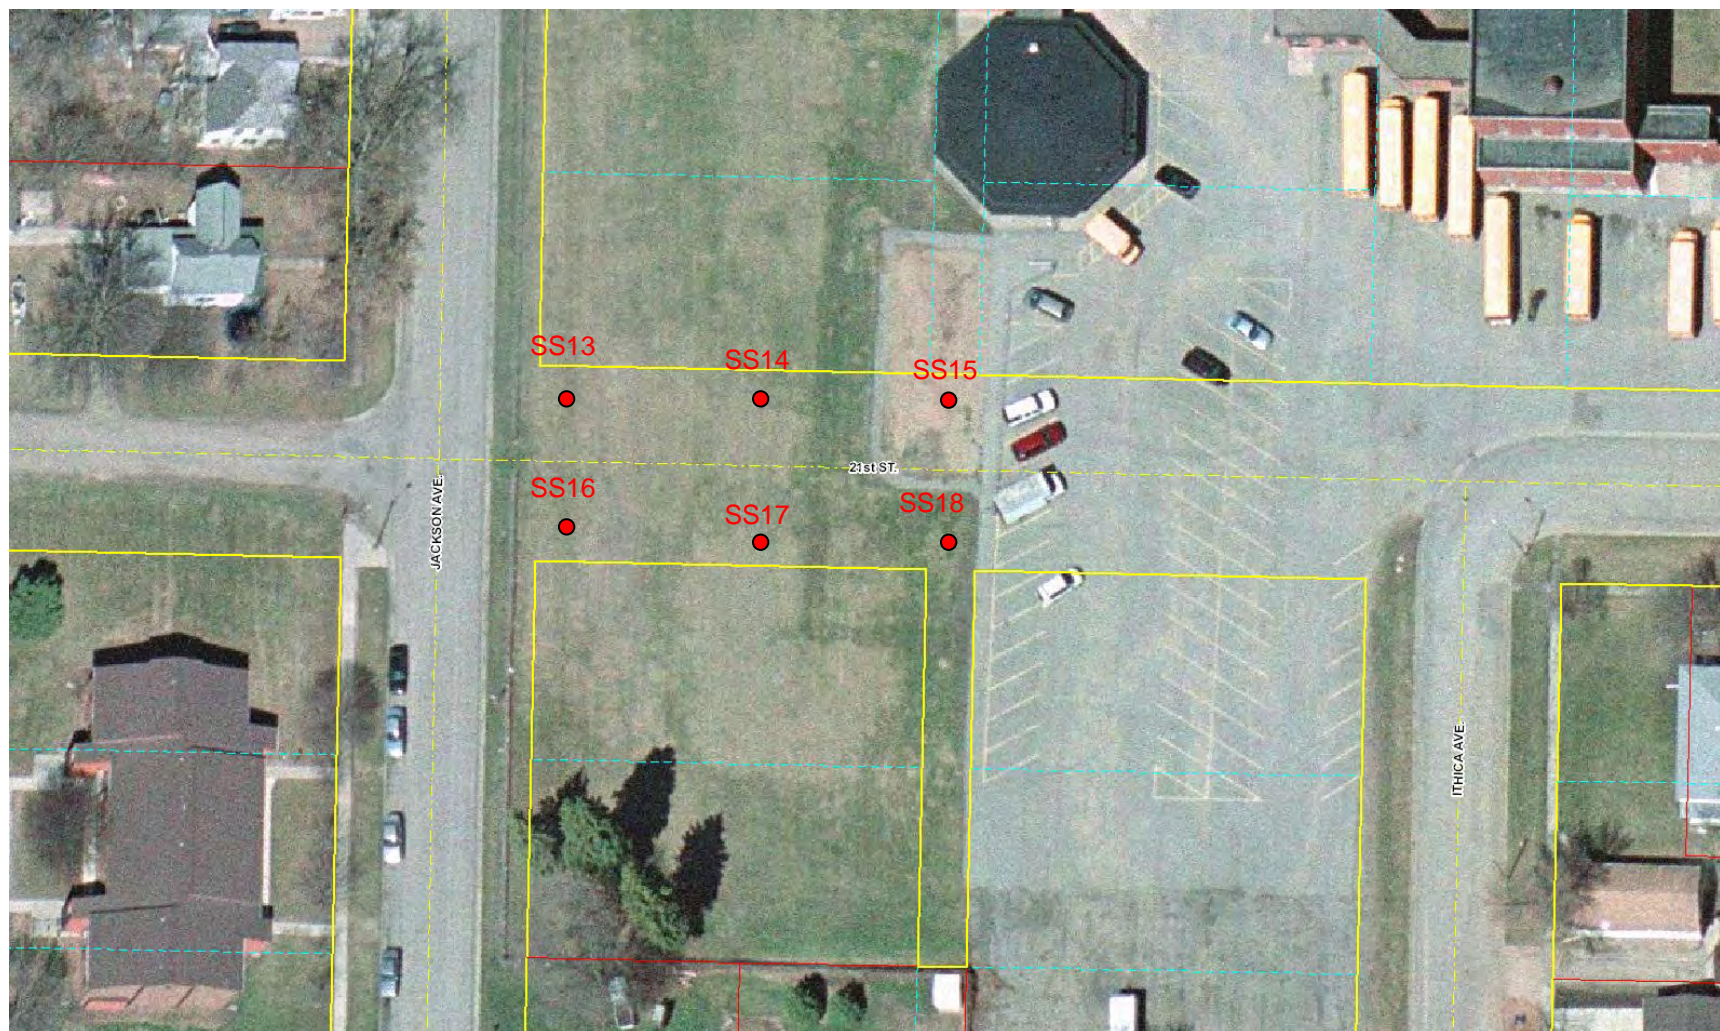
Figure 5 – Sample Locations, Site 3  
Spirit Lake Community Gardens  
Spirit Lake, Iowa

#### **Site 3 (SS13 – SS18), 21<sup>st</sup> St. Right-of-Way, between Ithica & Jackson on 21<sup>st</sup> alignment**

Antimony, cobalt, and lead were detected above their respective statewide standards for soil:

Antimony (Statewide Standard: 31.0 mg/kg)

- 0-2" sample: SS15, 55.5 mg/kg

Cobalt (Statewide Standard: 23.0 mg/kg)

- 0-2" sample: SS14 and SS18, average 123 mg/kg
- 1-2' sample: SS14, 136 mg/kg

Lead (Statewide Standard: 400 mg/kg)

- 1-2' sample: SS15, 537 mg/kg

Sample locations are shown on Figure 5.
