Environmental Site Investigation

TSL Companies
108 Avenue H
Carter Lake, Iowa

Report Dated: December 1, 2015

rdg Geoscience & Engineering, Inc.
10360 Sapp Brothers Drive, Omaha, Nebraska 68138
PH (402) 894-2678 FAX (402) 894-9043

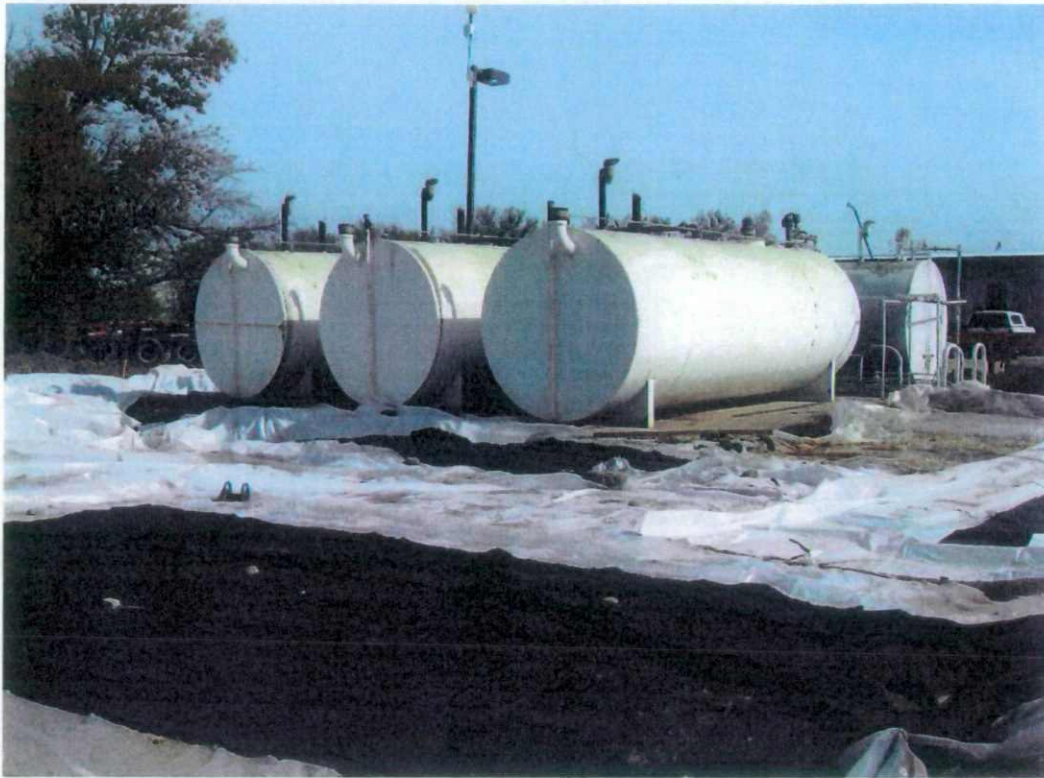
View is to the east of the above ground storage tanks (ASTs). Plastic cover was placed on the soil surrounding the concrete pad due to rain in the forecast.

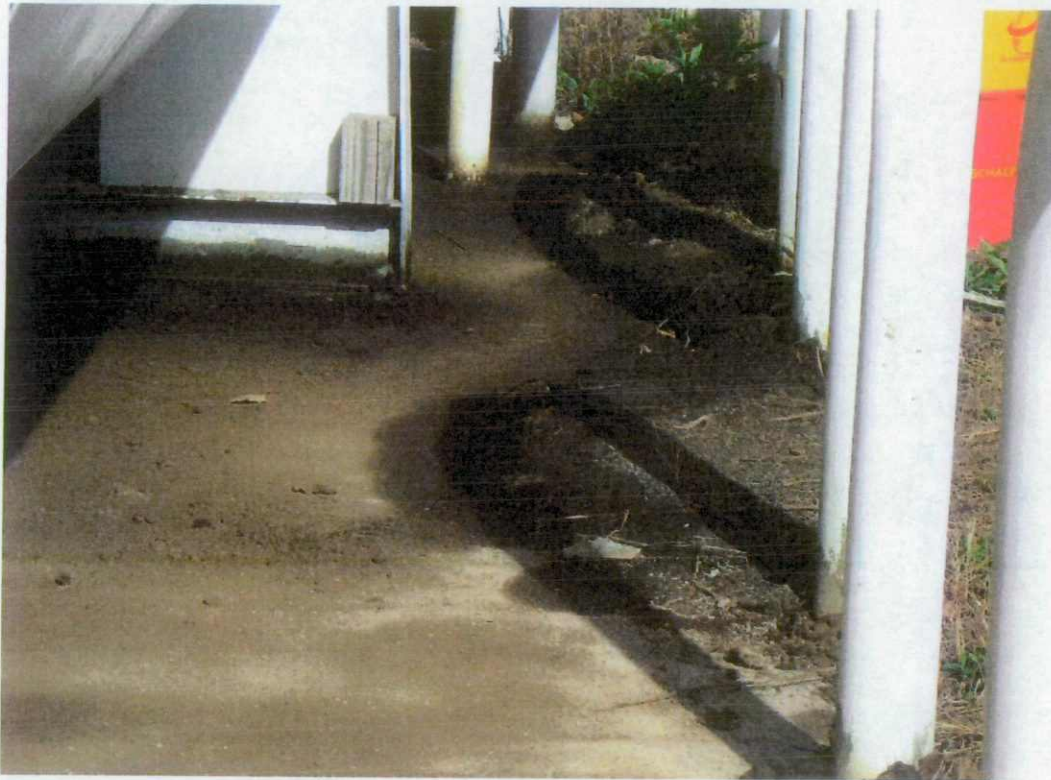
View is of the concrete pad and soil on the east side beneath the fueling station.

TSL employees had removed the stained soil on the east side of the three ASTs and from under the single AST. The valve at the north side of the fueling station had also been repaired.

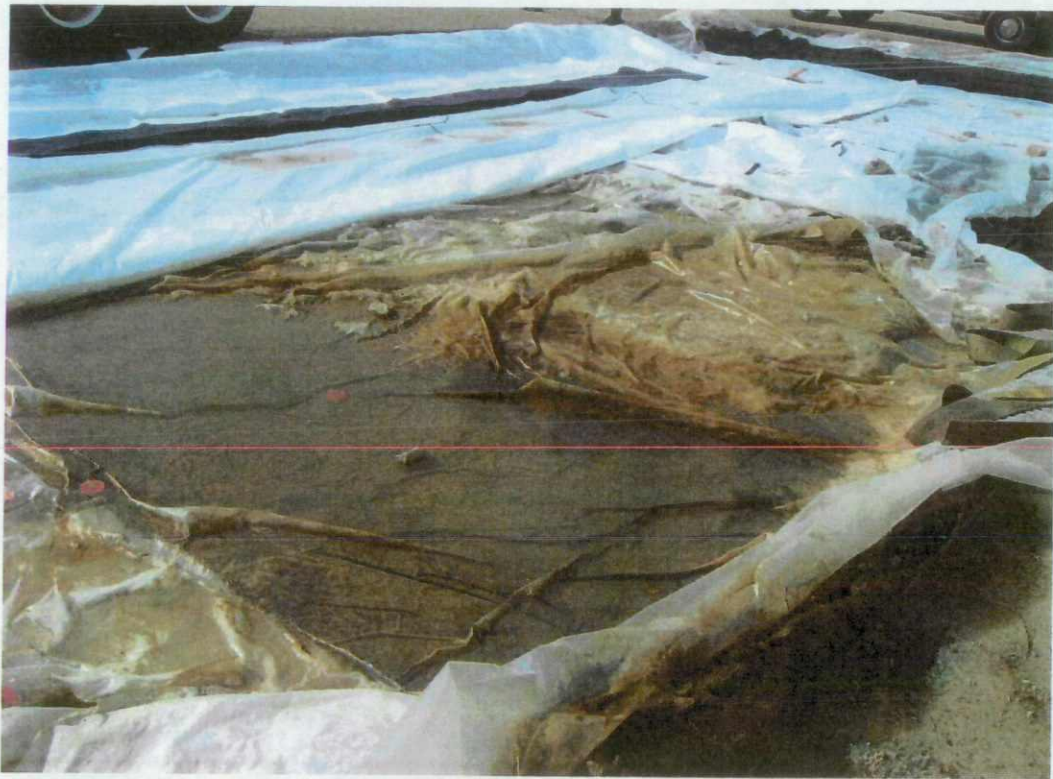
View is of the soil under the plastic on the south side of the tanks. The concrete pad is visible in the right portion of this photo.

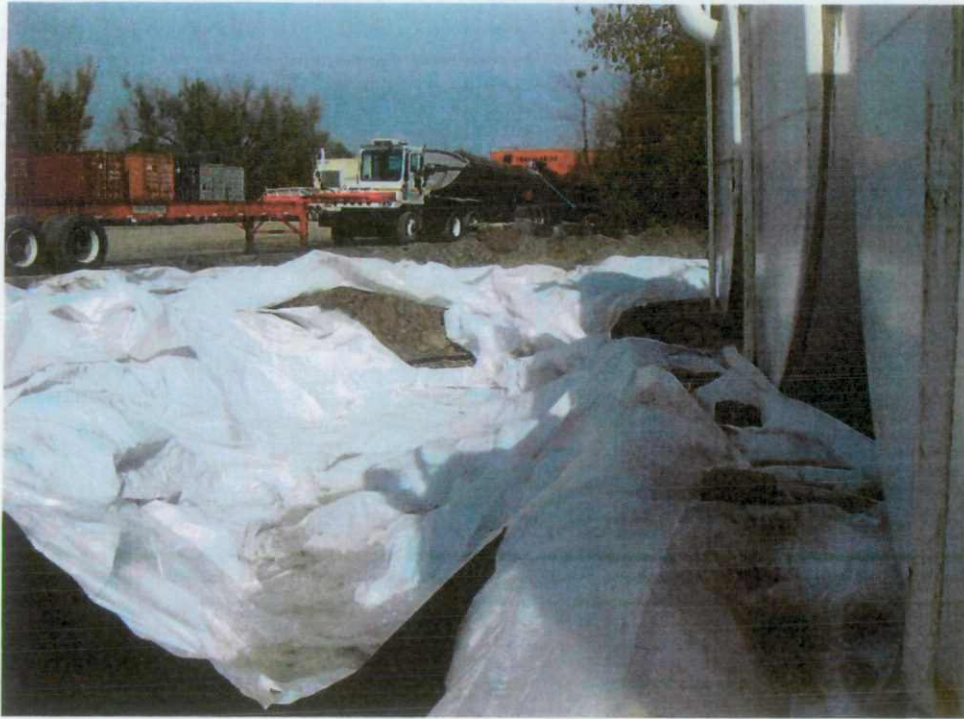
View is of the west side of the ASTs. Soil beneath the plastic was removed to approximately 3-feet at the edge of the concrete pad. The trucks holding the excavated soil can be seen in the background. The soil was eventually transported to the Pheasant Point Landfill in Douglas County.

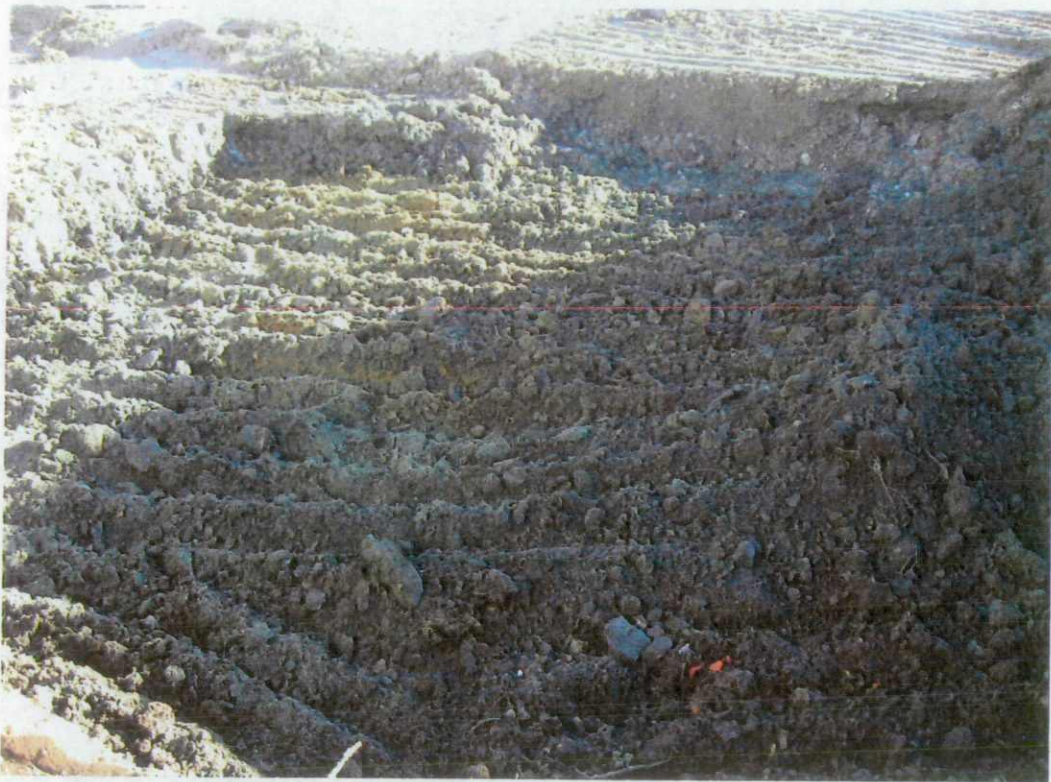
View is of the beginning of the excavation activities, as soil is removed in 2-foot increments.

Excavation began at the north side of the concrete pad at 2-foot deep increments; if visual and/or PID readings were detected above 50 relative response units (rru), additional soil was removed. Groundwater was encountered at approximately 7- to 7.5-feet below ground surface, and the soil removal did not extend under the water. A wood marker had been placed in the ground by TSL personnel to mark the lateral extent of the surface spill between the receptor trench and the concrete pad. As soil was removed on the north side toward the marker, logs, bottles, cans, and broken glass were encountered in the soil, and a sheen could be seen on the groundwater. Mr. Jordison was contacted via telephone and it was agreed the soil would be removed to groundwater and a groundwater sample would be collected for laboratory analysis. An area measuring 10-feet by 16-feet was removed and soil samples were collected at the north and east sidewalls for field head space analysis.

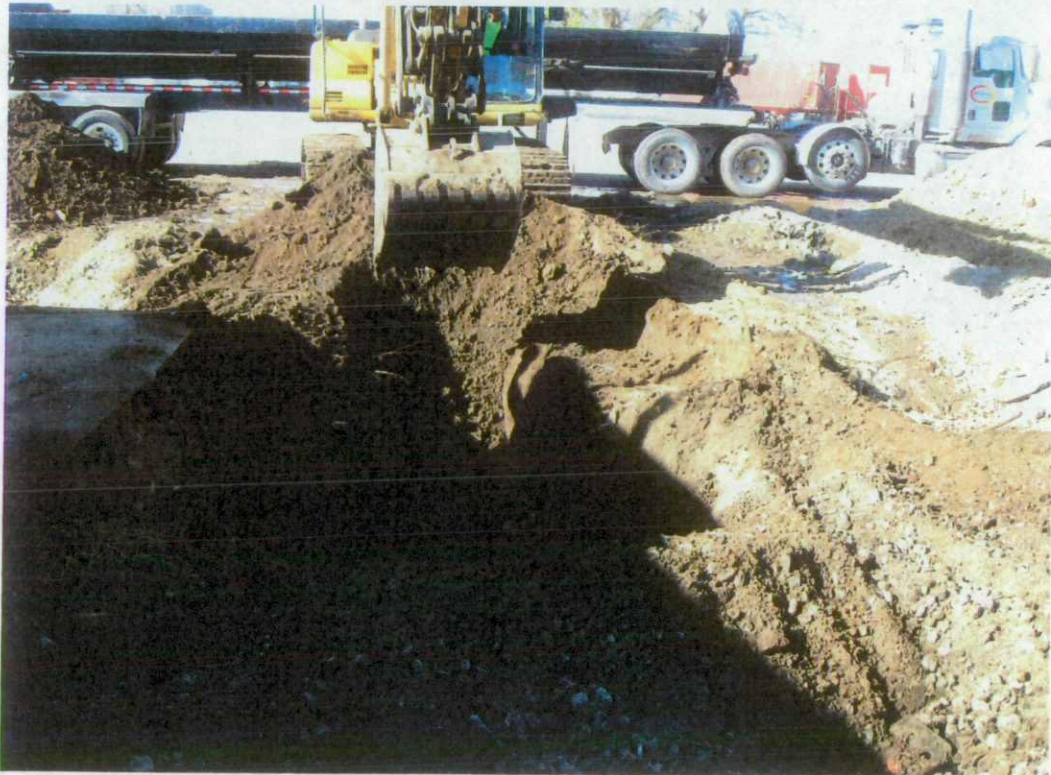
View is looking to the west as excavation continues on the north side of the tank system.

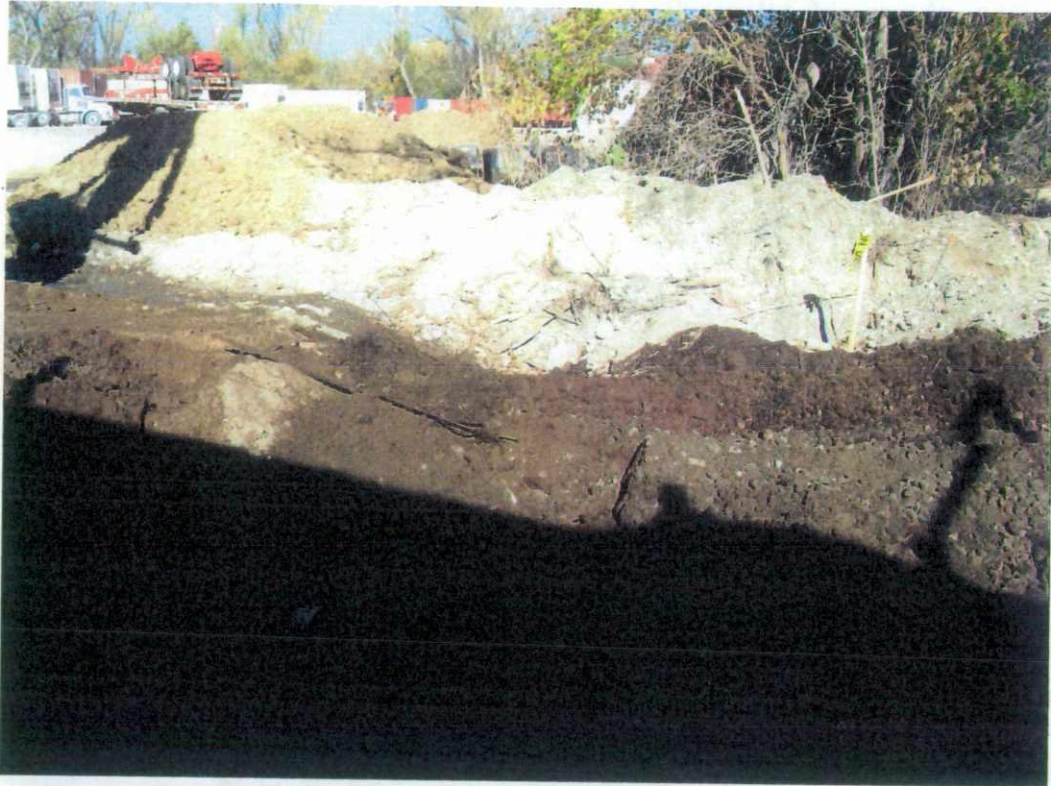
View is to the north as excavation continues. The marker showing the extent of the spill is seen in this photo. Piles of clean fill material can be seen in the upper left in this picture.

Clean fill material was hauled in from the Heimes Excavating yard located in Omaha, NE. The material was used to fill the void left by the over excavation of the contaminated soil, compacted using the backhoe, and gravel was placed on top of the clean soil.

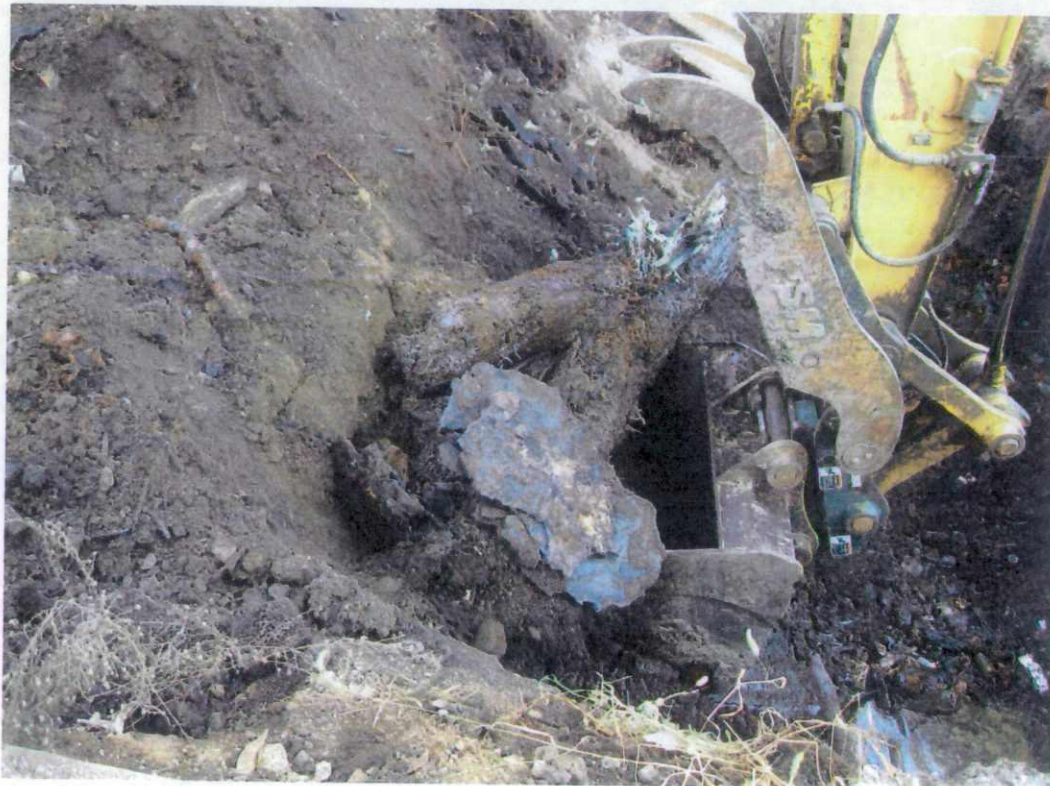
View is of the debris and logs being removed from the north side of the tanks. Broken glass, bottles, bricks, and plastic pieces can be seen at the bottom of the trench to the right in this photo.

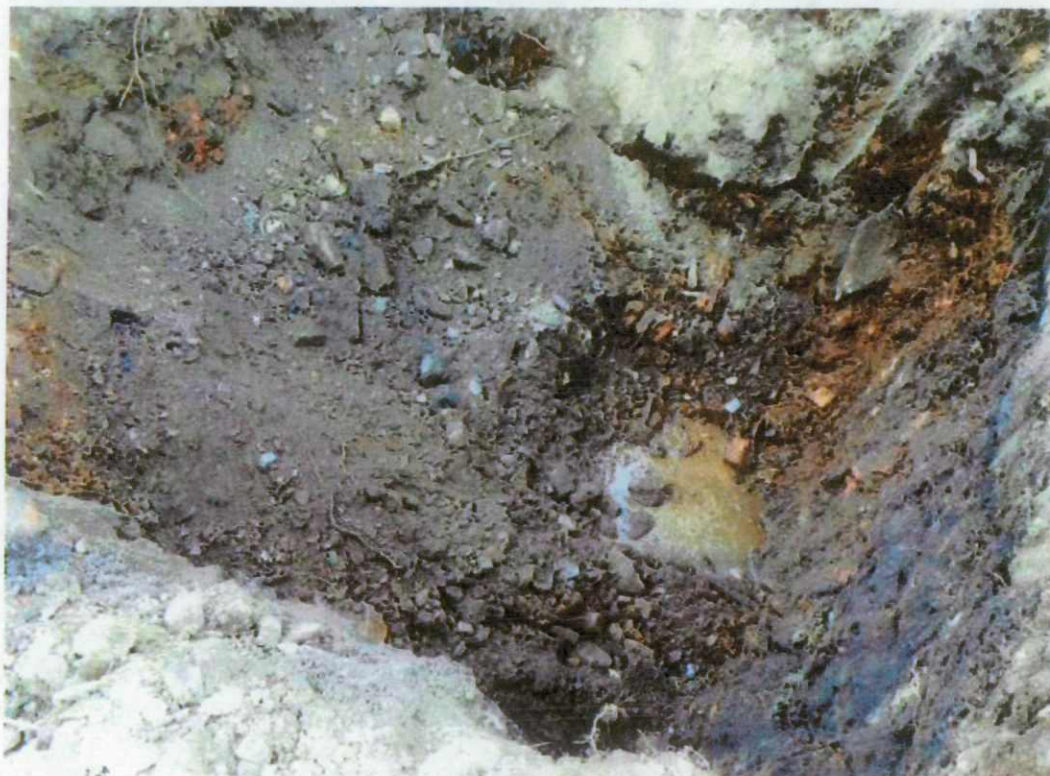
No measurable free product was observed on the groundwater surface or in the sample jar prior to submittal to the laboratory. The TEH-diesel concentration reported from the groundwater sample was 131,000 parts per billion (ppb).

View is of the sheen on the groundwater at the north side of the tanks. Soil removal continued from an area measuring 10'x16', and a groundwater sample was collected for laboratory analysis.

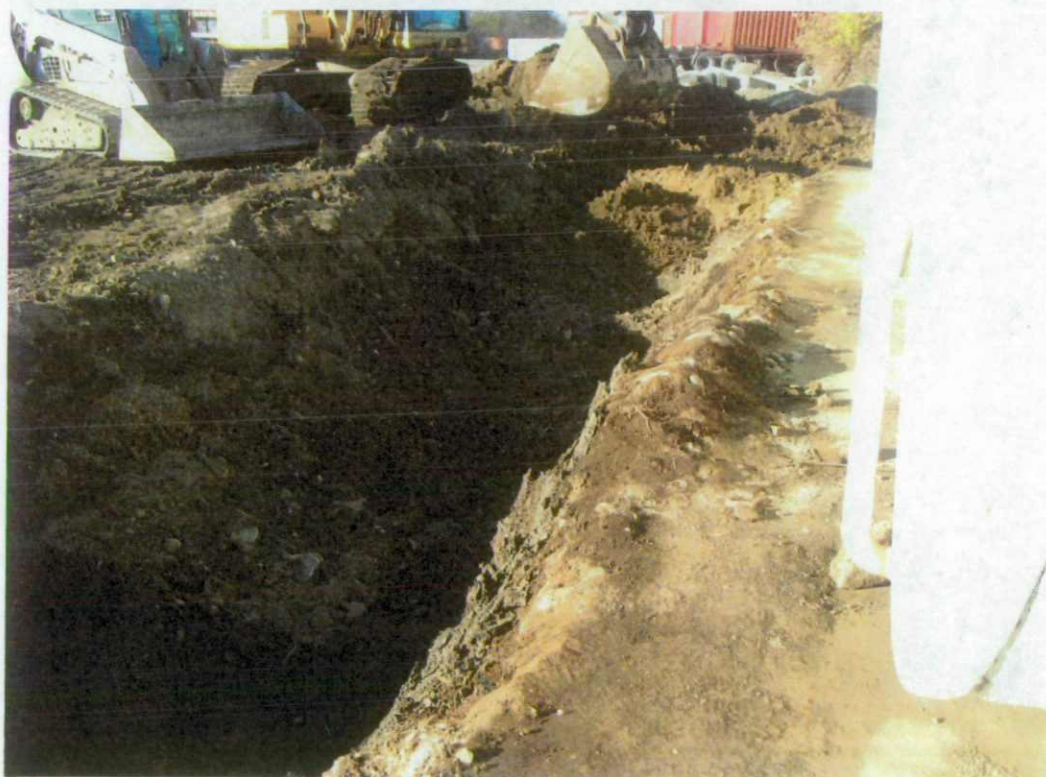
Clean fill material was placed in the excavation on the north side, and soil removal continued to the west side of the tank system. The north 20-feet of this trench was dug to 6.5-feet, and was deeper at the southwest end of the trench.

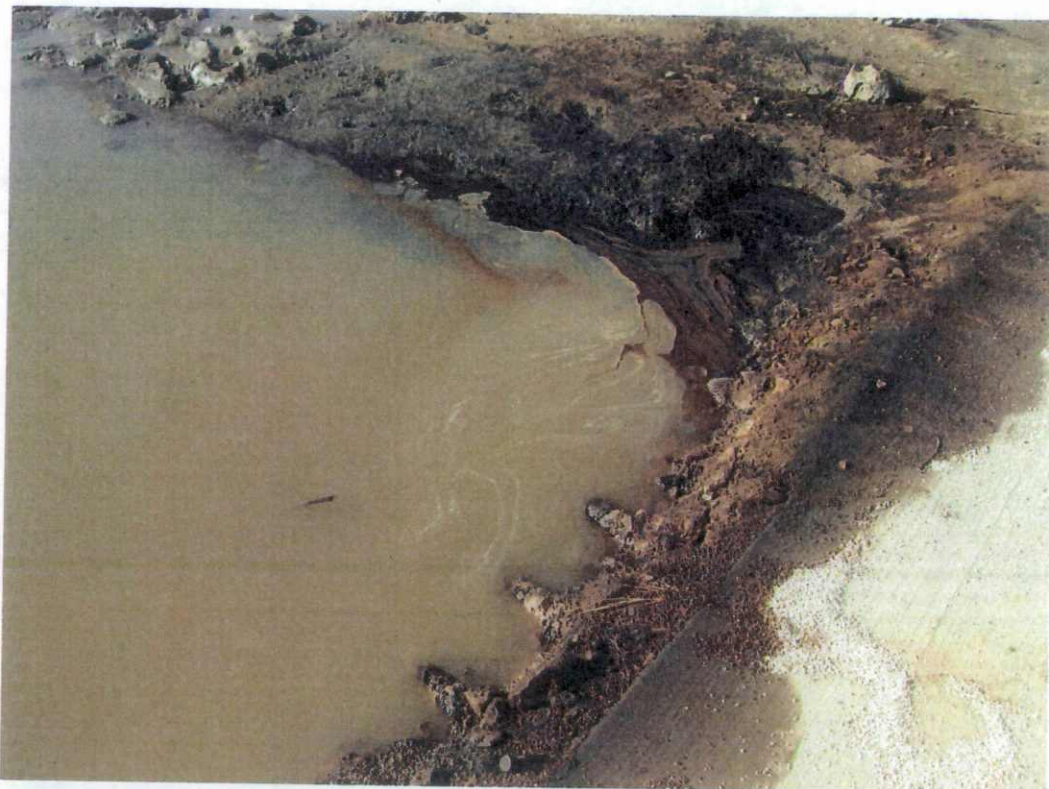
View is of the south side of the tank system after the plastic was removed. The concrete pad is visible to the right in this photo.

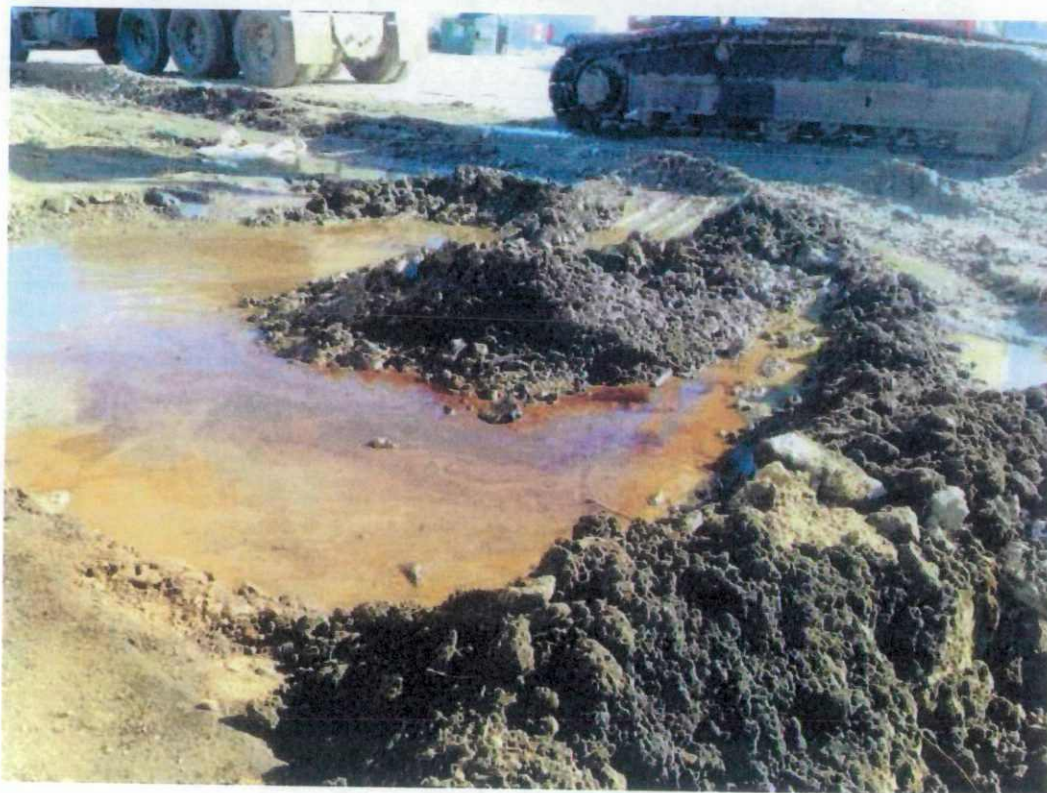
View is of the south side of the tank system. The berm soil was pushed into this area to absorb the fuel and water prior to removal.

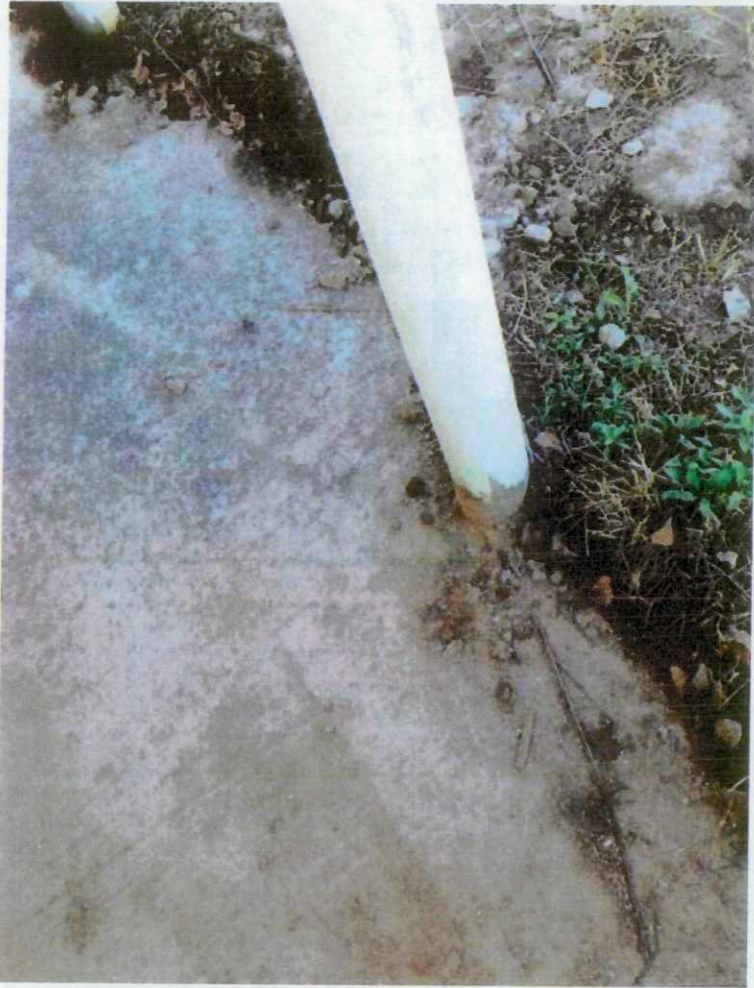
View is of the soil removed from under the fueling station.

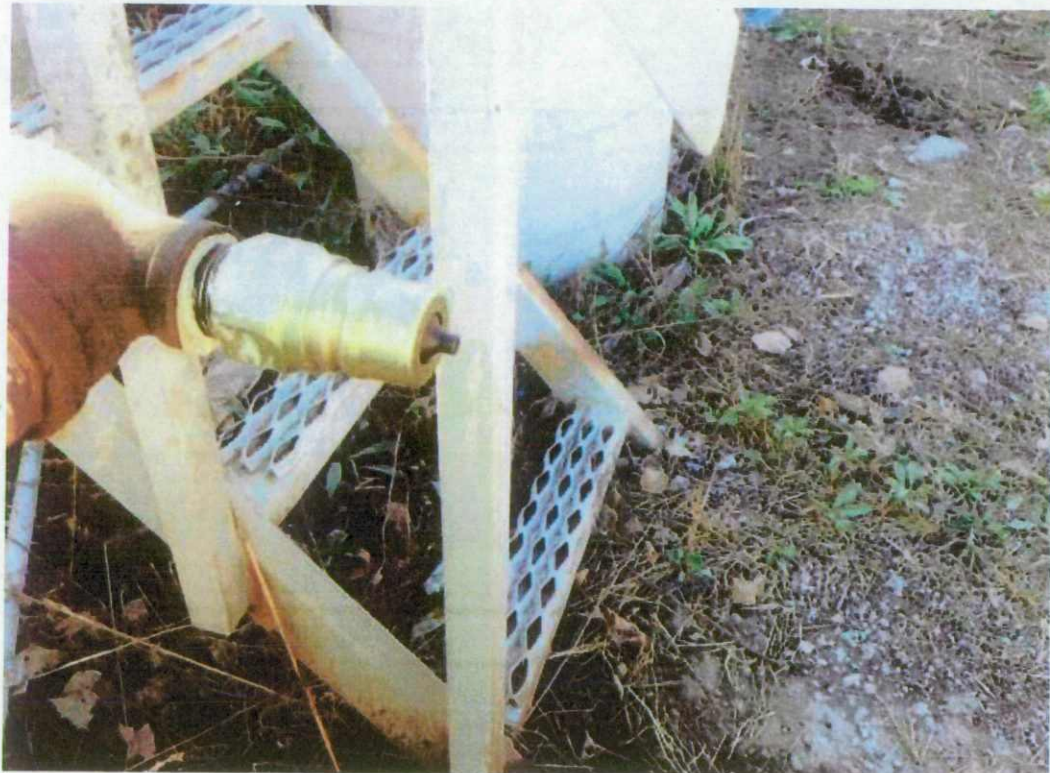
View is of the repaired pipe fitting at the fuel station.
