Site Name: VOC - HARALD LAMBERTS PROPERTY

3931 - Phase II Assessment Review – Brownfield Funded

PRE-CERCLIS SCREENING ASSESSMENT CHECKLIST/DECISION FORM

Harald Lamberts Property
7015-7021 and 7025 Douglas Avenue
Urbandale, Iowa

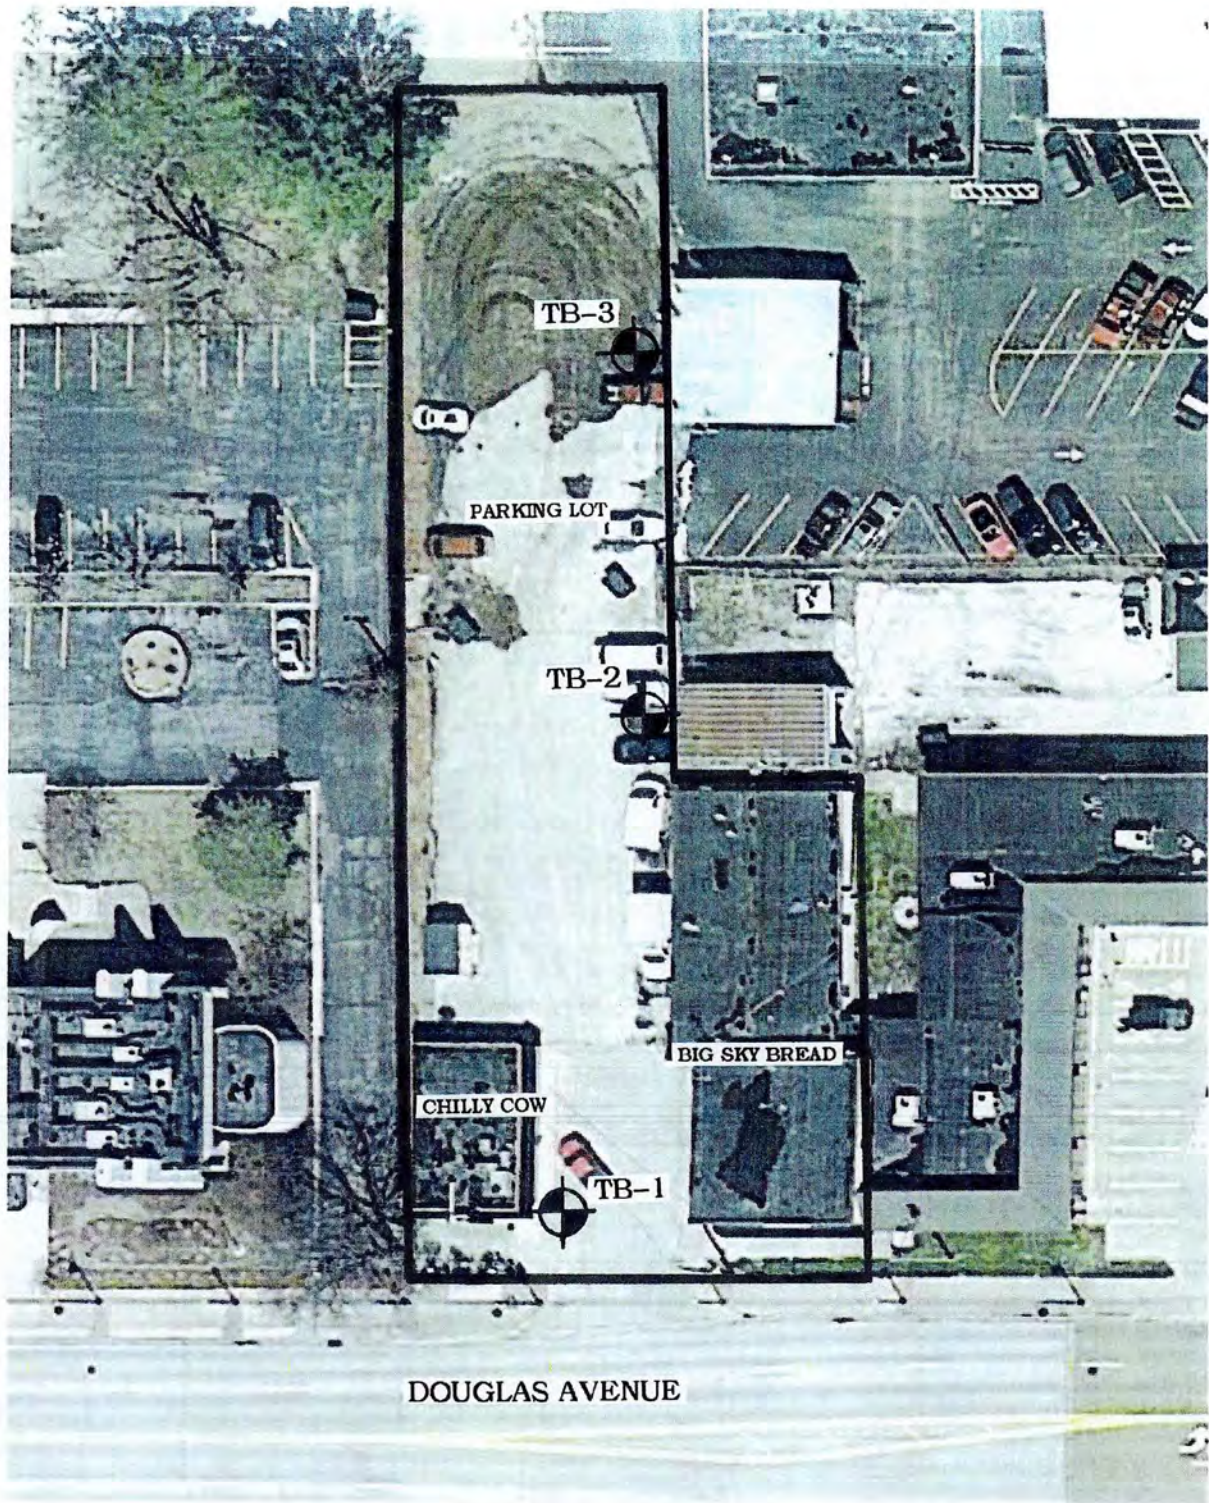
Site Map

Three soil borings (TB-1 T-B2 and TB-3) were completed to a depth of 20 feet (Soil borings logs are attached). Test boring TB-1 was drilled at the south end of the property between the buildings, TB-2 was drilled midway along the east side of the property, and TB-3 was drilled near the northeast corner (See Site Map). Soils were field screened using a photoionization detector (PID). No discoloration, unusual odors, or elevated PID measurements were detected in soil. Soil samples for the analysis of metals were collected from a depth of one foot in each test boring. Soil samples for petroleum hydrocarbon analysis were collected from a depth of twelve feet in test borings TB-1 and TB-2 and from a depth of ten feet in TB-3. These depths were approximately equivalent to the water table as estimated during drilling. Soil and groundwater samples were analyzed for volatile organic compounds (VOCs) by EPA Method 8260B, total extractable hydrocarbons (TEH) by Iowa Method OA-2, and metals by EPA Methods 601 OB and 7471A. Groundwater samples were analyzed for VOCs by EPA Method 8260B and for TEH by Iowa Method OA-2.

Arsenic, Barium, Cadmium, Chromium, and Lead were detected in soil. The concentrations were less than Iowa Land Recycling Program (LRP) statewide standards (SWS). Tetrachloroethylene (PCE) was detected at a concentration of 0.004 ppm in soil from TB-2. This concentration is less than the ILRP statewide standard of 1,500 ppm.

PCE was also detected in groundwater at a concentration of 6.5 ppb at soil boring TB-2. This concentration exceeds the LRP statewide standard of 5.0 ppb. TEH as Waste Oil was also detected at a concentration of 100 ppb in groundwater from TB-1. This concentration is less than the IDNR action level of 400 ppb. No other petroleum hydrocarbons or VOCs were detected in groundwater.

There are no reported On-site potential sources or receptors. Off-site sources include several registered UST sites, LUST sites and dry cleaners located in the surrounding vicinity. PCE is commonly associated with dry cleaners. The PCE observed in groundwater at this site may have originated from Plaza Cleaners located at 3816 70th Street located up-gradient and adjacent to the east of TB-2.
