**LIMITED SUBSURFACE INVESTIGATION**

**Baker Property  
Near Hubbell Avenue and NE 44<sup>th</sup> Drive  
Des Moines, Iowa 50317**

**May 3, 2019**

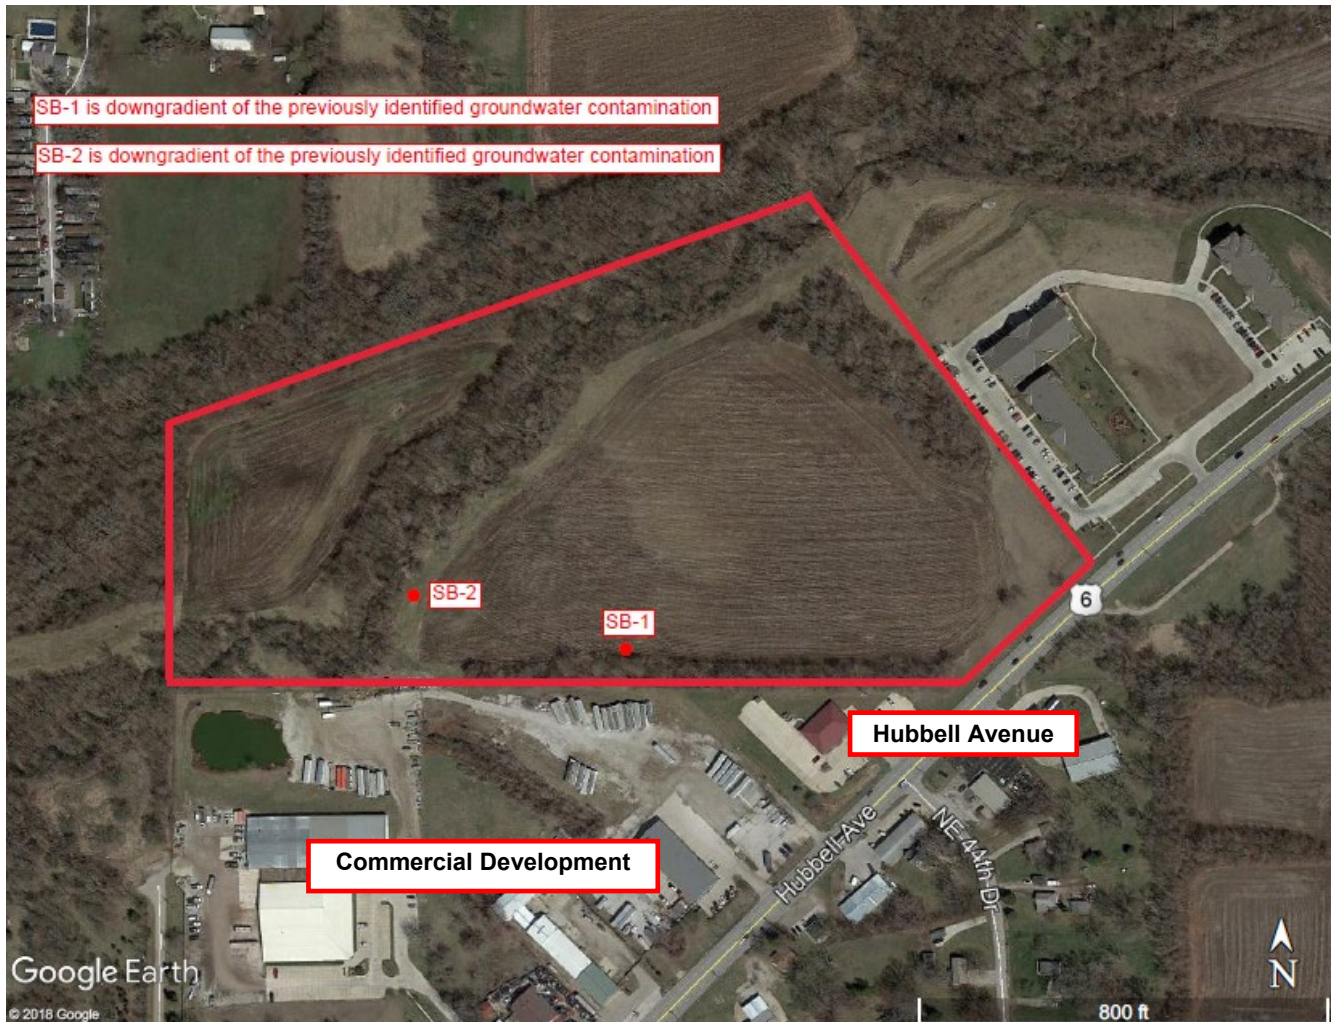
**FIGURE 2 - SAMPLE LOCATION MAP**

On April 11, 2019, two (2) borings (SB-1 and SB-2) were advanced using a track mounted, direct push Geoprobe® drill rig. The two borings were placed downgradient of a nearby, up-gradient State/Tribal Brownfields site with identified groundwater contamination (See Figure 2 in Appendix B).

Soils encountered in the borings generally consisted of silt, sand, and clay. Boring SB-1 was drilled to a depth of 20 feet bgs and boring SB-2 was drilled to a depth of 35 feet bgs. No petroleum odors were detected, no visible staining was observed, and PID readings were <10 ppm in all borings. Soil samples were collected from the 12-26 foot depth range, which was the interval above the perceived water table. All samples were analyzed for BTEX (Iowa Method OA-1) and TEHs (Iowa Method OA-2). Soil sample locations are shown on Figure 2 in Appendix B. Borelogs are provided in Appendix D.

1. Boring SB-2 was moved from the proposed location. During drilling at the proposed location, it appeared as though the soil was fill and not native soil. Boring SB-2 was moved to a location with native soil.
