Phase II Environmental Site Assessment

Canadian Pacific Railway
East of the Intersection of Farson Road and the Railroad Tracks
Farson, Iowa

October 21, 2019

Project B1812348.01

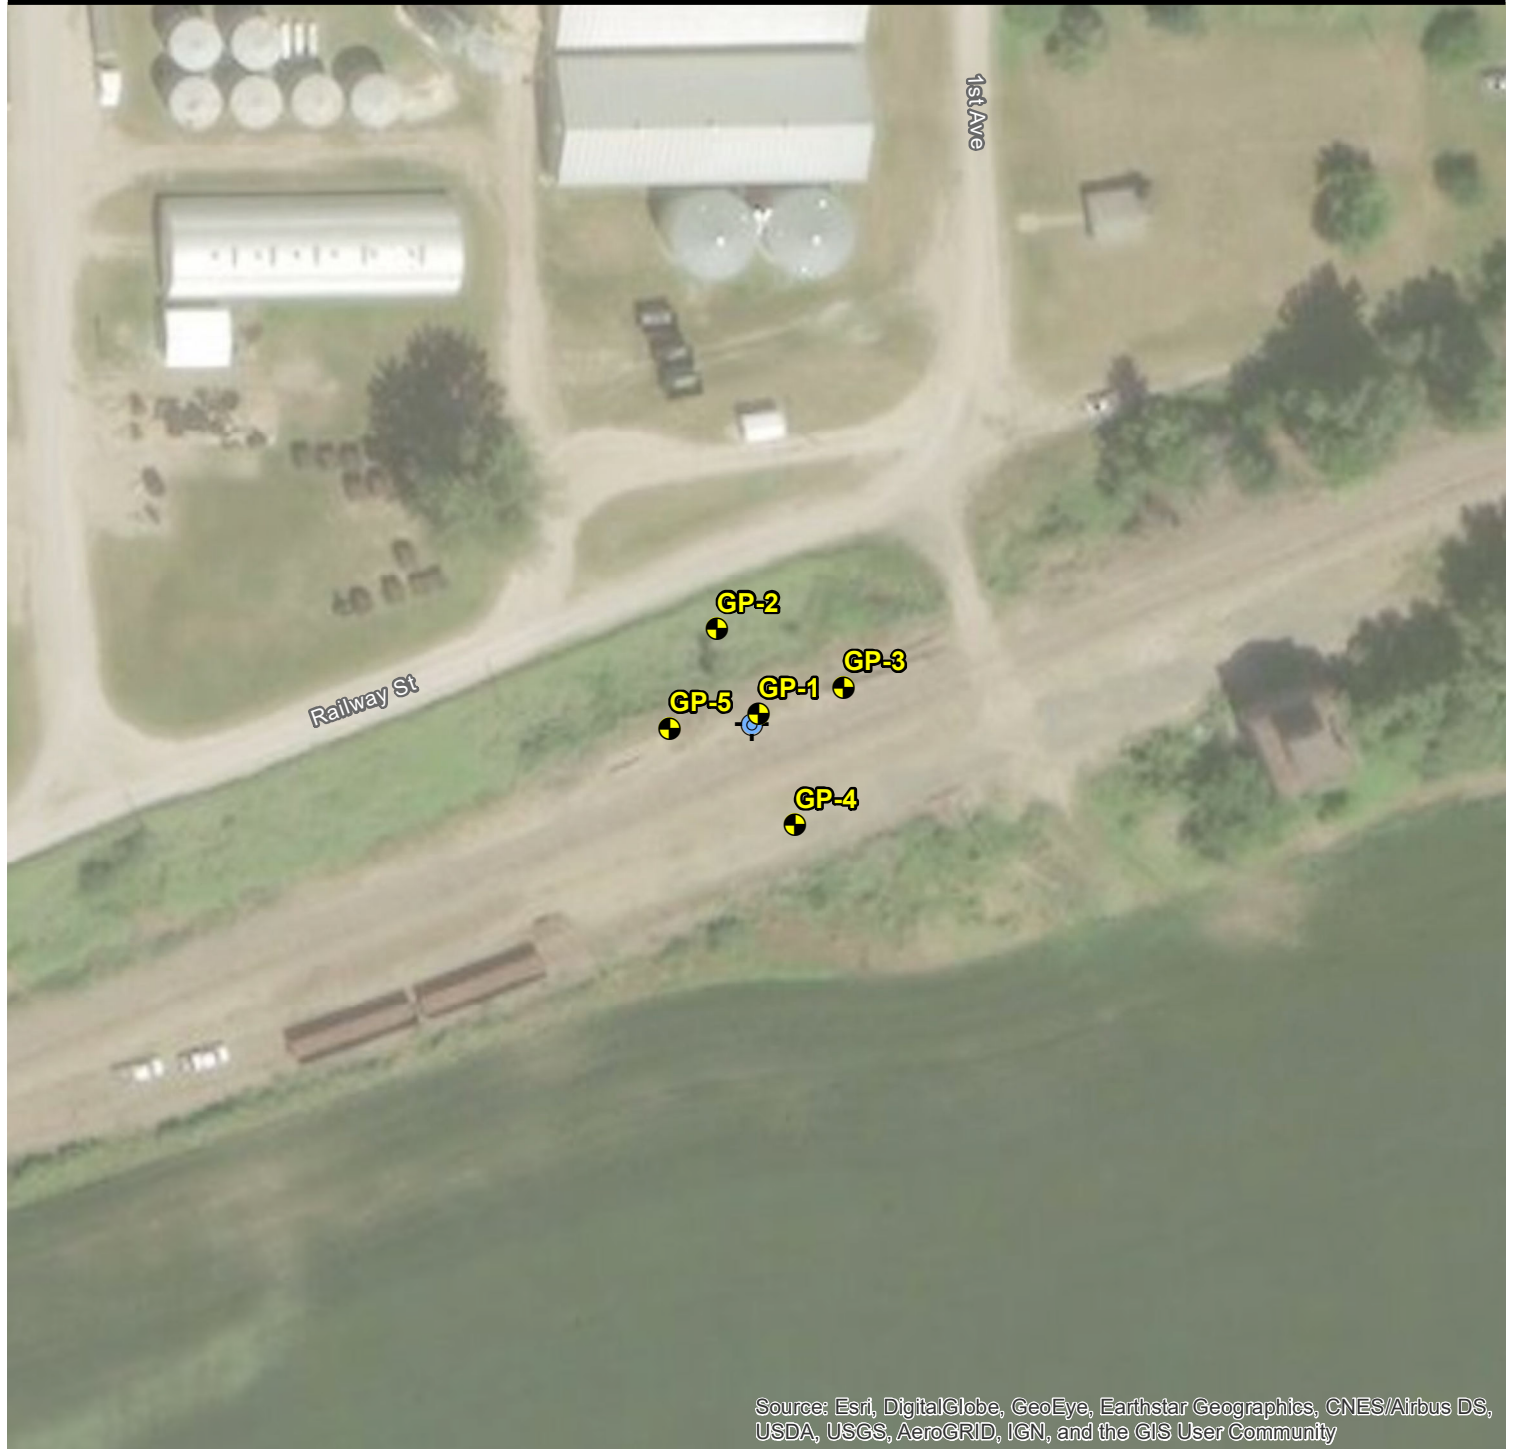
Approximate Soil Boring Location

The Site area was formerly a railroad depot. No structures remained at the Site. A Site Diagram is included as Figure 2.

Five push-probe soil borings, designated GP-1 through GP-5, were advanced at the Site. The soil borings were advanced as follows and are shown on Figure 2:

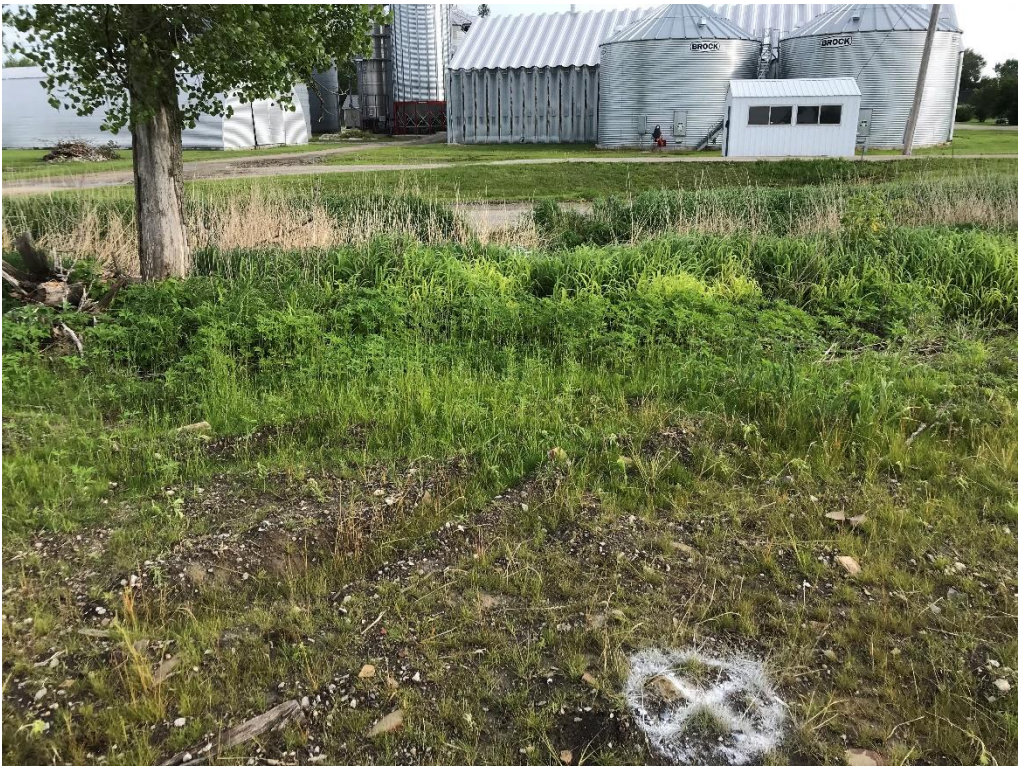
Photograph #1	Farson, IA Phase II ESA	B1812348.01
Date:	June 3, 2019

Direction:	Facing north	
Subject:	Location of boring GP-2 marked.

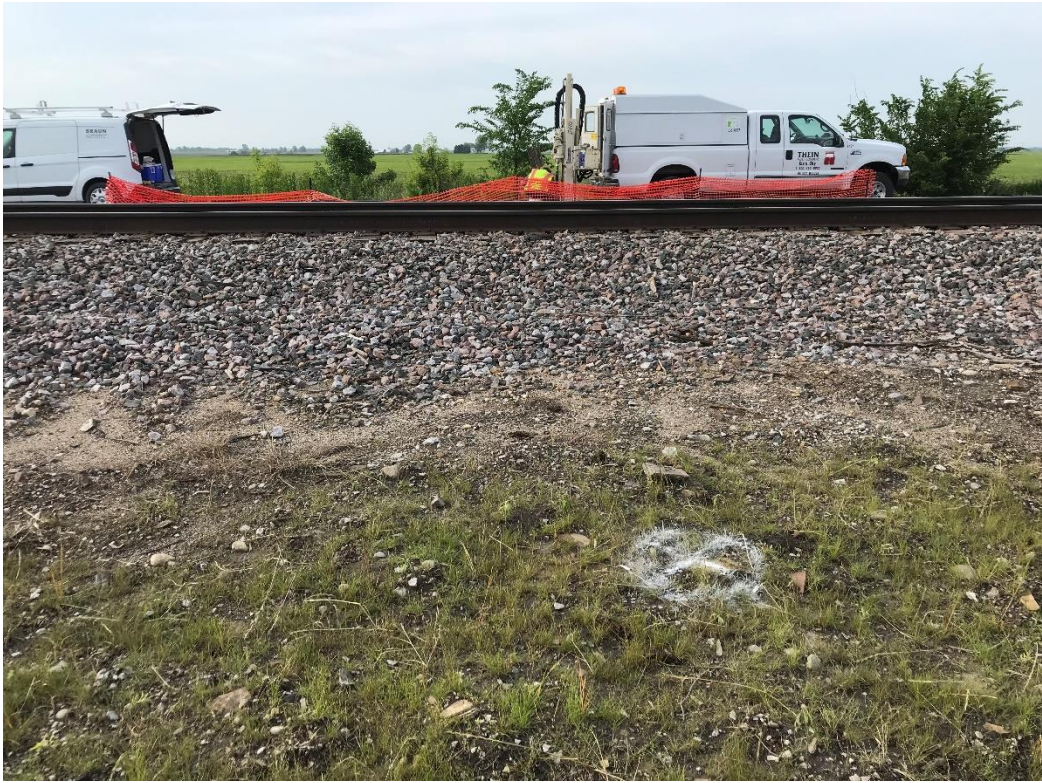
Photograph #2	Farson, IA Phase II ESA	B181234.01
Date:	June 4, 2019

Direction:	Facing south	
Subject:	Location of boring GP-1 marked in foreground, working on boring GP-4.

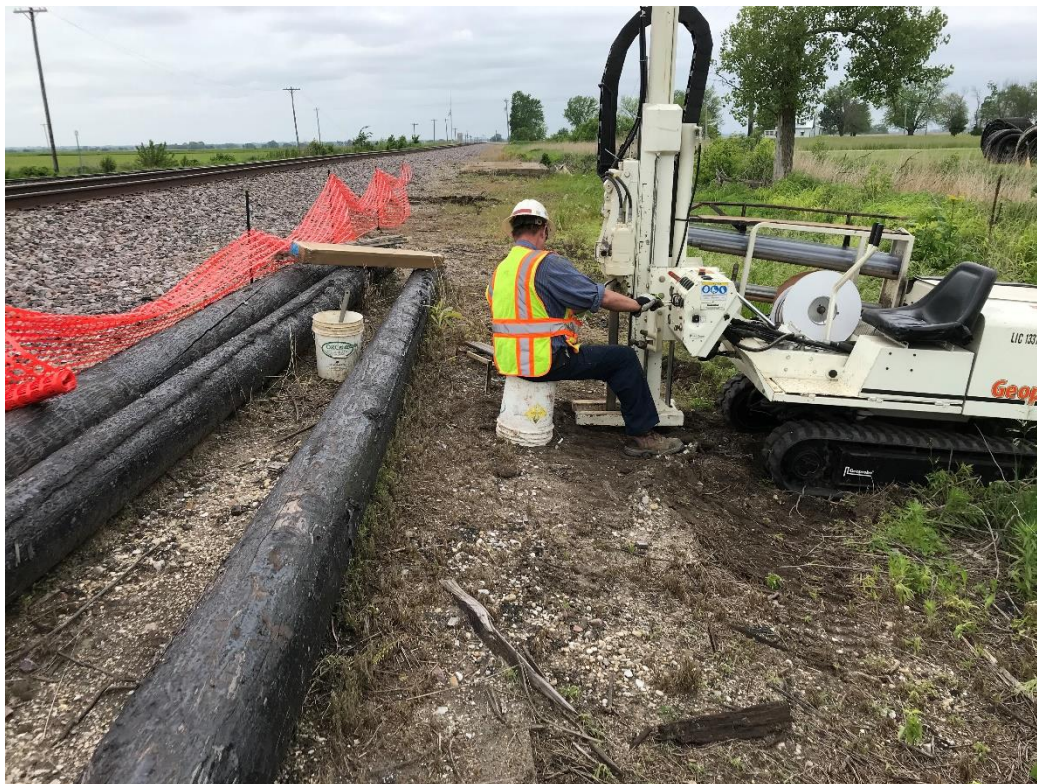
Photograph #3	Farson, IA Phase II ESA	B181348.01
Date:	June 4, 2019	BRAUN INTERTEC
Direction:	Facing west	
Subject:	Working on boring GP-3.

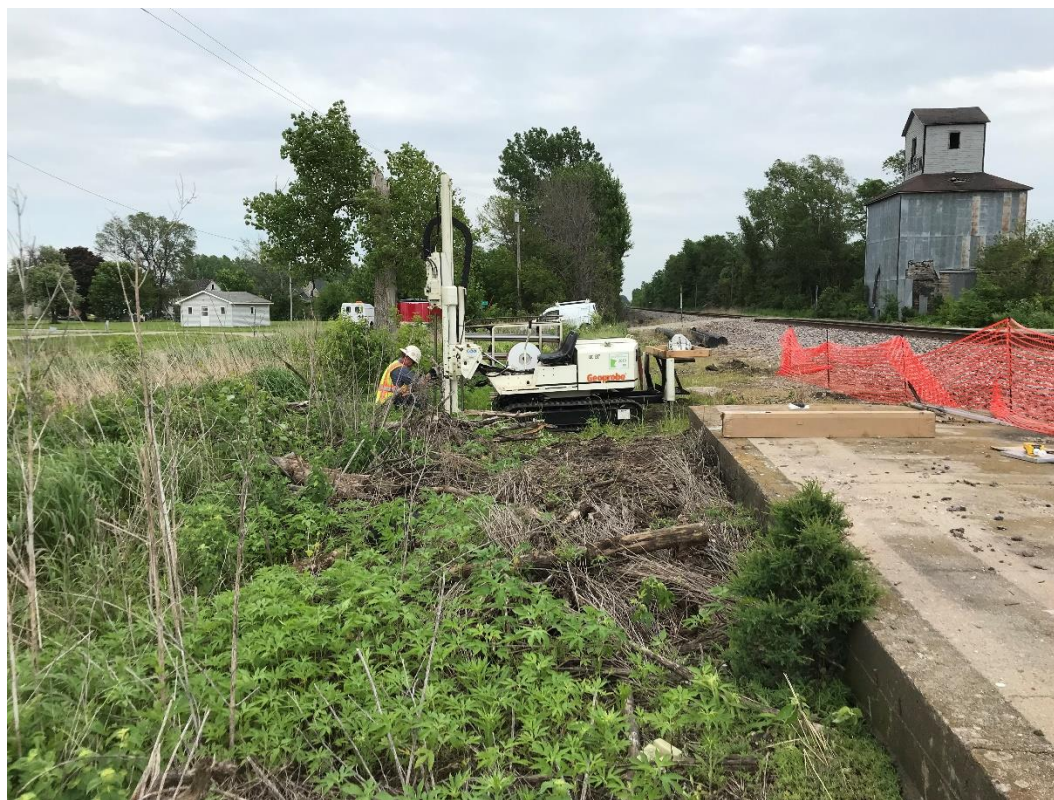
Photograph #4	Farson, IA Phase II ESA	B1812348.01
Date:	June 4, 2019	BRAUN INTERTEC
Direction:	Facing east	
Subject:	Working on Boring GP5. The former depot footing is visible in the foreground.
