ARCONIC-DAVENPORT WORKS SITE VAPOR INTRUSION INVESTIGATION REPORT

Arconic-Davenports Work Site
4879 State Street
Riverdale, Iowa

Project Number: MR1503

January 2020

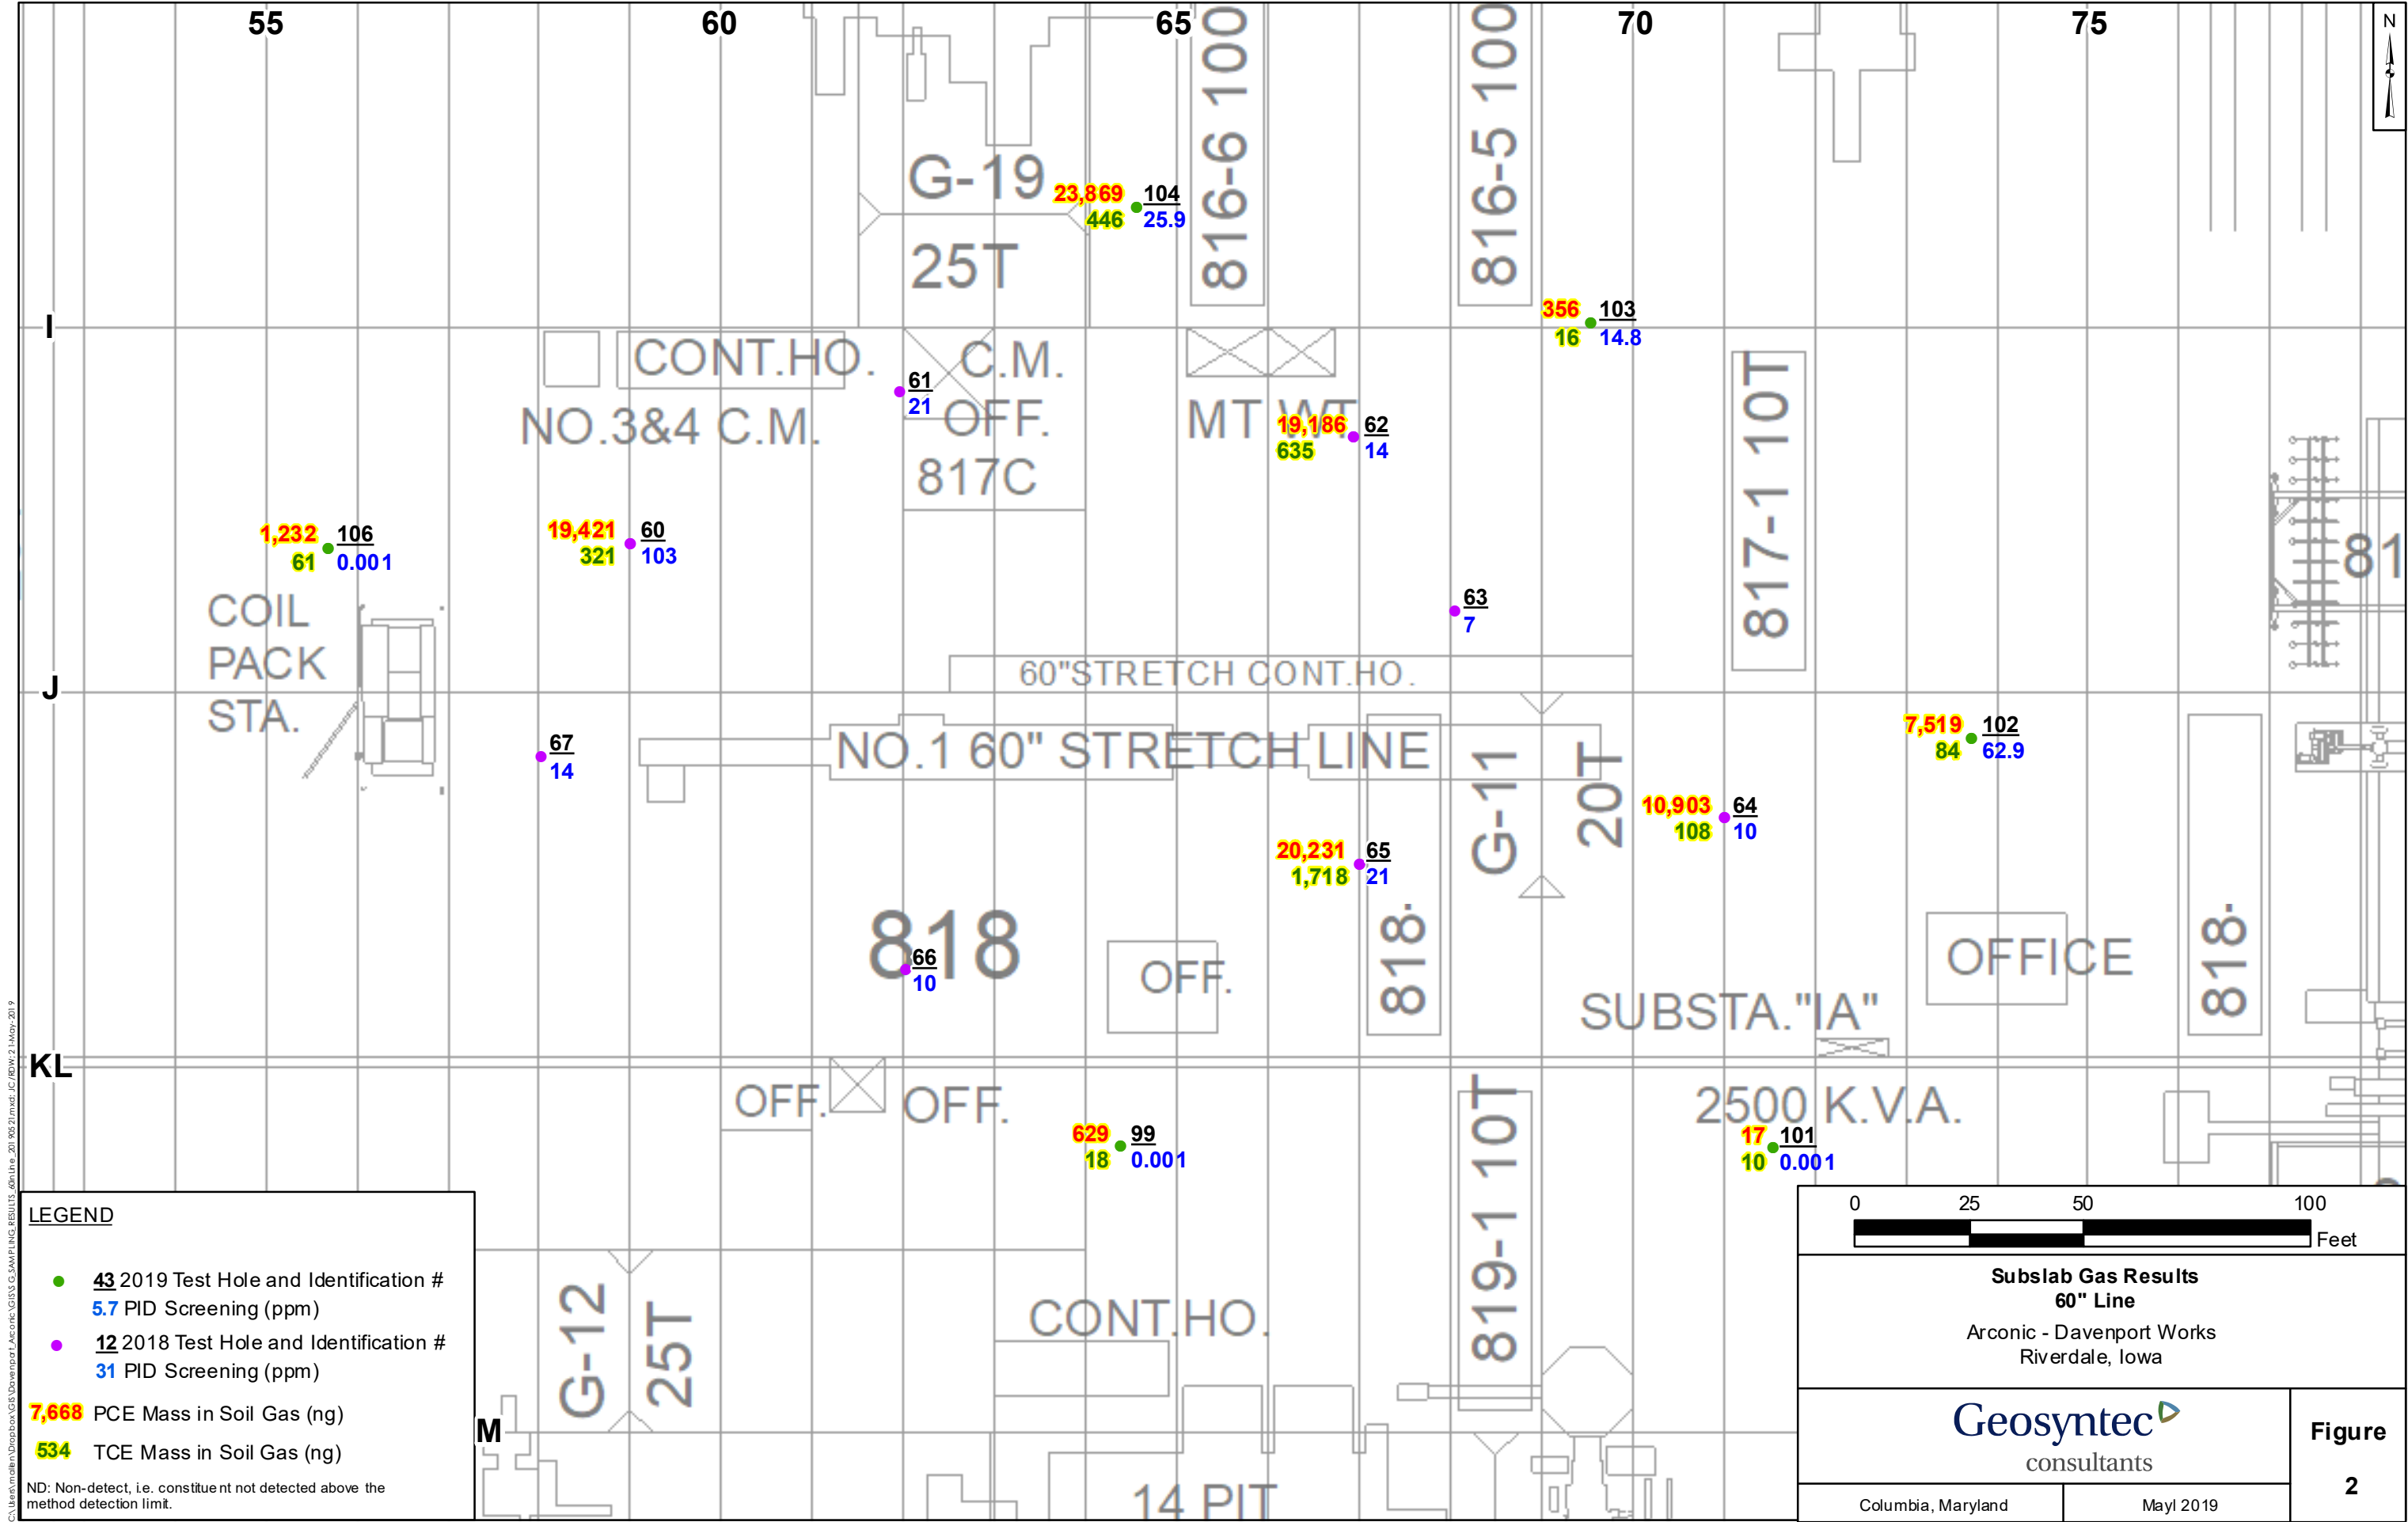
PID and subslab vapor results from the 2018 investigation for the 84" and 86" Lines, 60" Line, and Store Room are indicated with purple dots on **Figures 1, 2 and 3**, respectively. The passive subslab vapor samplers detected PCE, TCE, and *cis*-1,2-DCE at masses ranging from 11 to 65,945; 6 to 59,627; and 6 to 100,281 nanograms (ng), respectively. VC was occasionally detected, but at

lower masses than the other CVOCs. The presence of TCE, cis-1,2-DCE and VC in the subslab vapor indicates the underlying groundwater as the source (these compounds are generated during the degradation of PCE in groundwater). The greatest CVOC mass in subslab vapor occurred near the northwestern portion of the 86" Line, consistent with trends in groundwater data collected in previous years. The subslab vapor results did not fully delineate the extent of CVOC mass to the northwest and northeast of the 86" Line or around the 60" Line. Additional passive subslab vapor sampling was proposed to address this data gap. The Store Room had very little VOC mass and therefore no further testing was recommended in this area.

From 27 March through 9 April 2019, Arconic's consultants collected an additional 24 passive subslab vapor samples northeast and northwest of the 86" Line (**Figure 1**) and in the general area of the 60" Line (**Figure 2**). Prior to sampling, subslab vapor was extracted from each proposed sampling point and screened using either a PID or GASTEC's short-term Gas Detector Tube System (detector tube) affixed to a gas sampling pump. GASTEC detector tubes were intended to guide the placement of the Beacon passive samplers in place of a PID, whose results in the initial Phase I activities did not correlate well with the measured CVOC masses. Unfortunately, the detector tubes were not sensitive enough to approximate concentrations of total CVOCs at the advertised levels. Unable to confidently identify select locations with elevated CVOC field concentrations using the detector tubes, passive samplers were deployed in all proposed sampling locations.

Results for the additional 24 passive subslab vapor samples, as well as those from fall 2018, are presented in **Table 2**. The passive subslab vapor samplers detected PCE, TCE, and cis-1,2-DCE at masses ranging from 17 to 63,280; 16 to 101,798; and 62 to 253,687 ng, respectively. VC was only detected in 18 locations at masses ranging up to only 2,003 ng. The 2019 PCE and TCE results for the 84" and 86" Lines and 60" Line are indicated with green dots on **Figures 1 and 2**, respectively. On average, the masses of PCE and TCE detected in the April 2019 sampling locations were generally similar to those detected in previous events. The greatest masses for PCE and TCE were encountered southwest of the 84" Line (sampling location 50) and northwest of the 86" Line (sampling location 93). Relatively high masses were also observed north of the 60" Line (sampling location 104).
