**Subject: Integrated Site Assessment and Removal Site Evaluation Report
regarding Sunshine Laundry Site, Fort Dodge, Iowa
EPA SEMS Identification No. IAN000706520
U.S. EPA Region 7, START 5, Contract No. 68HE0719D0001
Task Order No. 19F0086.008
Task Monitor: Todd Davis, EPA Site Assessment Manager**

**INTEGRATED SITE ASSESSMENT AND
REMOVAL SITE EVALUATION REPORT**

**SUNSHINE LAUNDRY SITE
FORT DODGE, IOWA**

EPA SEMS ID – IAN000706520

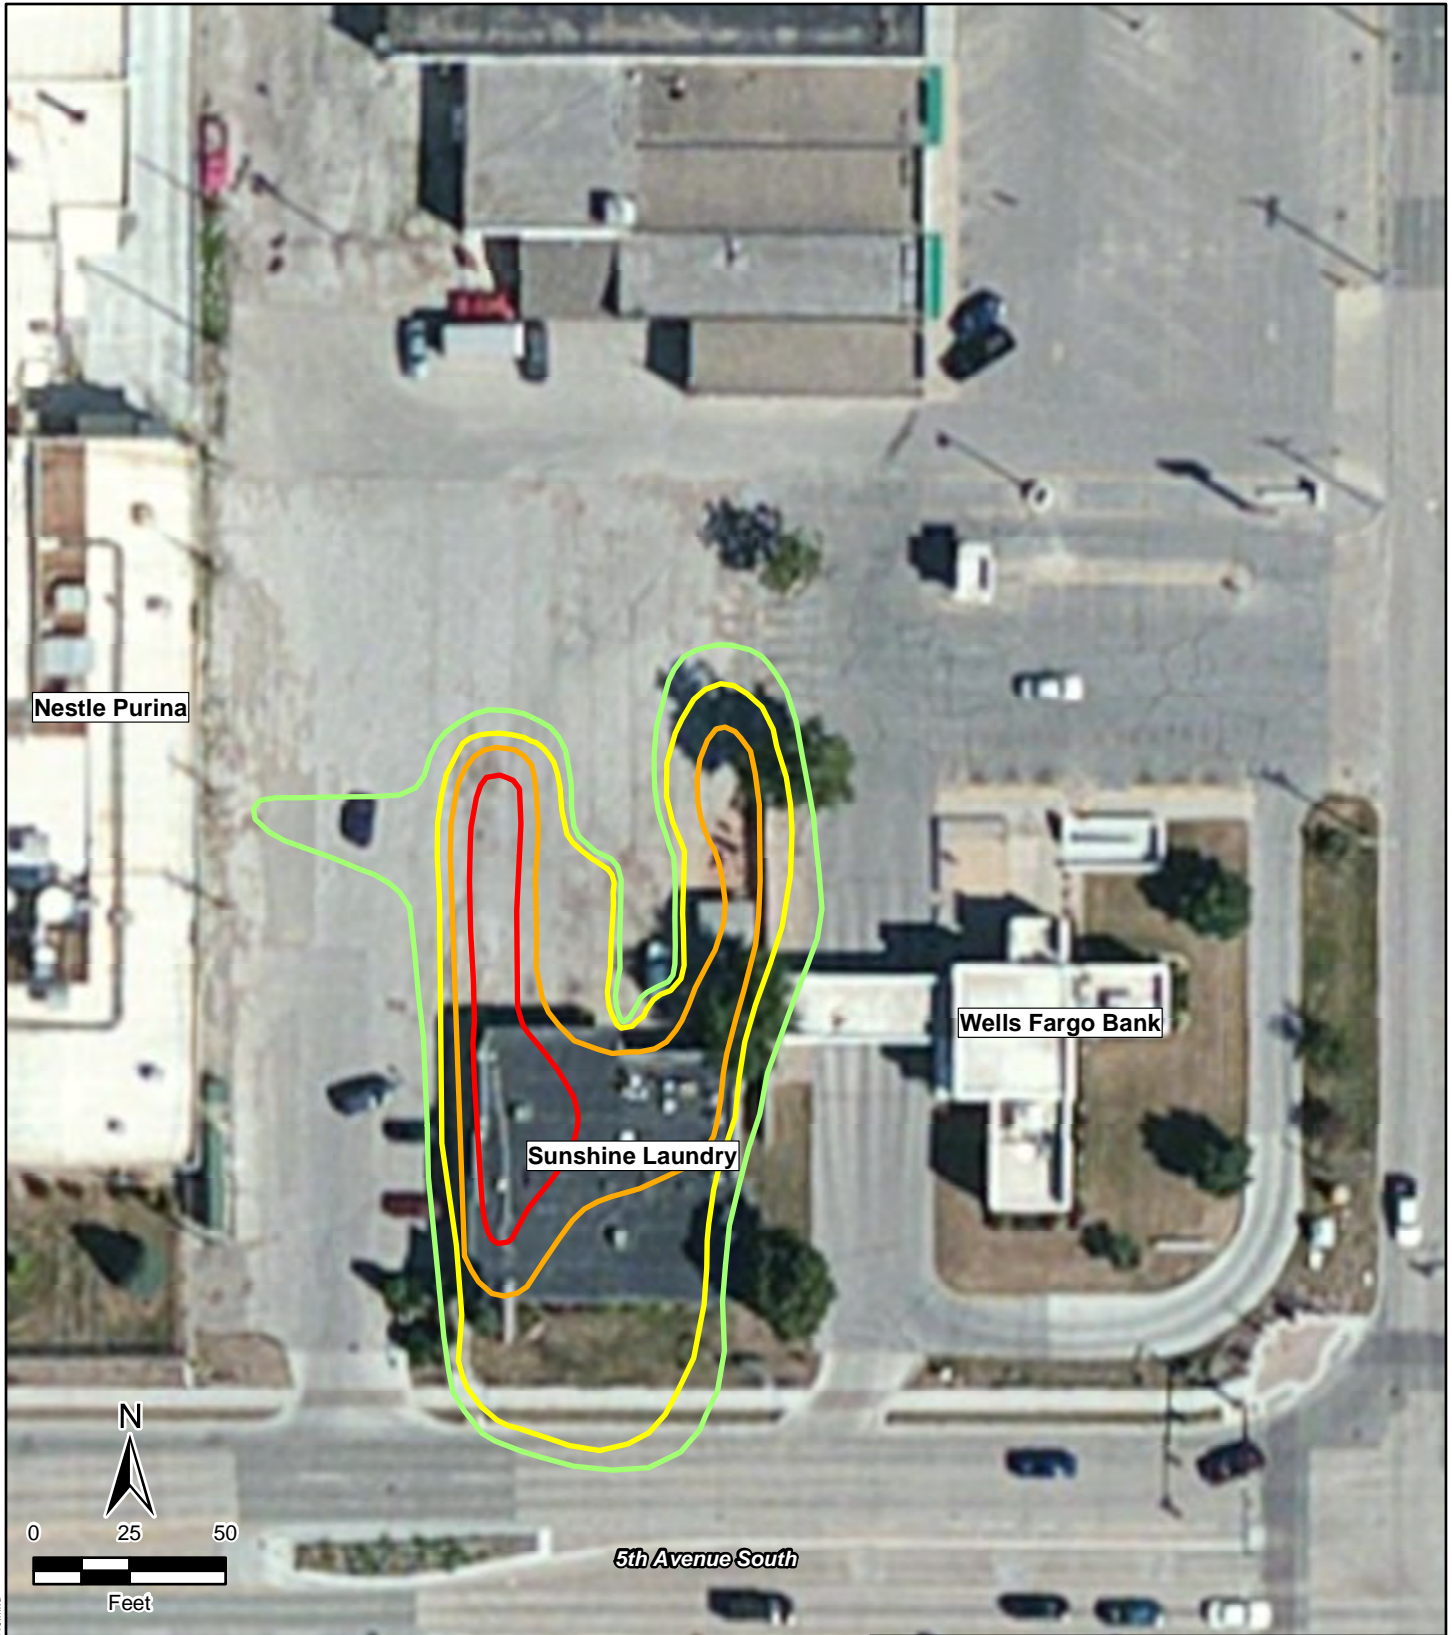
Figure 11
 Groundwater Results Map

Table 4 lists VOCs detected in the MW samples, and these results are shown on Figure 11 in Appendix A. PCE was detected at 3,700 µg/L in the groundwater sample from MW-3, and at 23 µg/L in the sample from MW-6—both exceeding the 5 µg/L MCL. The sample collected from MW-3, north of the building, also contained an estimated 250 µg/L of TCE (estimated), 880 µg/L of *cis*-1,2-DCE, and 140 µg/L of *trans*-1,2-DCE, which also exceeded their respective MCLs. PCE, TCE, and *cis*-1,2-DCE concentrations in MW-3 also exceeded the ISS for a nonprotected groundwater source (the federal MCLs are used for the protected groundwater standards).

Table 6 below lists the VOCs detected in the 14 groundwater samples, and Figure 11 indicates these results. Site-related VOCs were detected at seven locations. PCE was detected in six of the groundwater samples at concentrations between 28 and 2,500 µg/L. Because of the high concentrations previously detected at the site, a 5 µg/L detection limit (the MCL) was applied for this analysis; consequently, lower levels of VOCs may be present where indicated as “undetected” in Table 6. The 2 µg/L MCL for vinyl chloride was below the detection limit. Vinyl chloride detections at TW-11 (11 µg/L) and TW-12 (31 µg/L) exceeded the MCL.

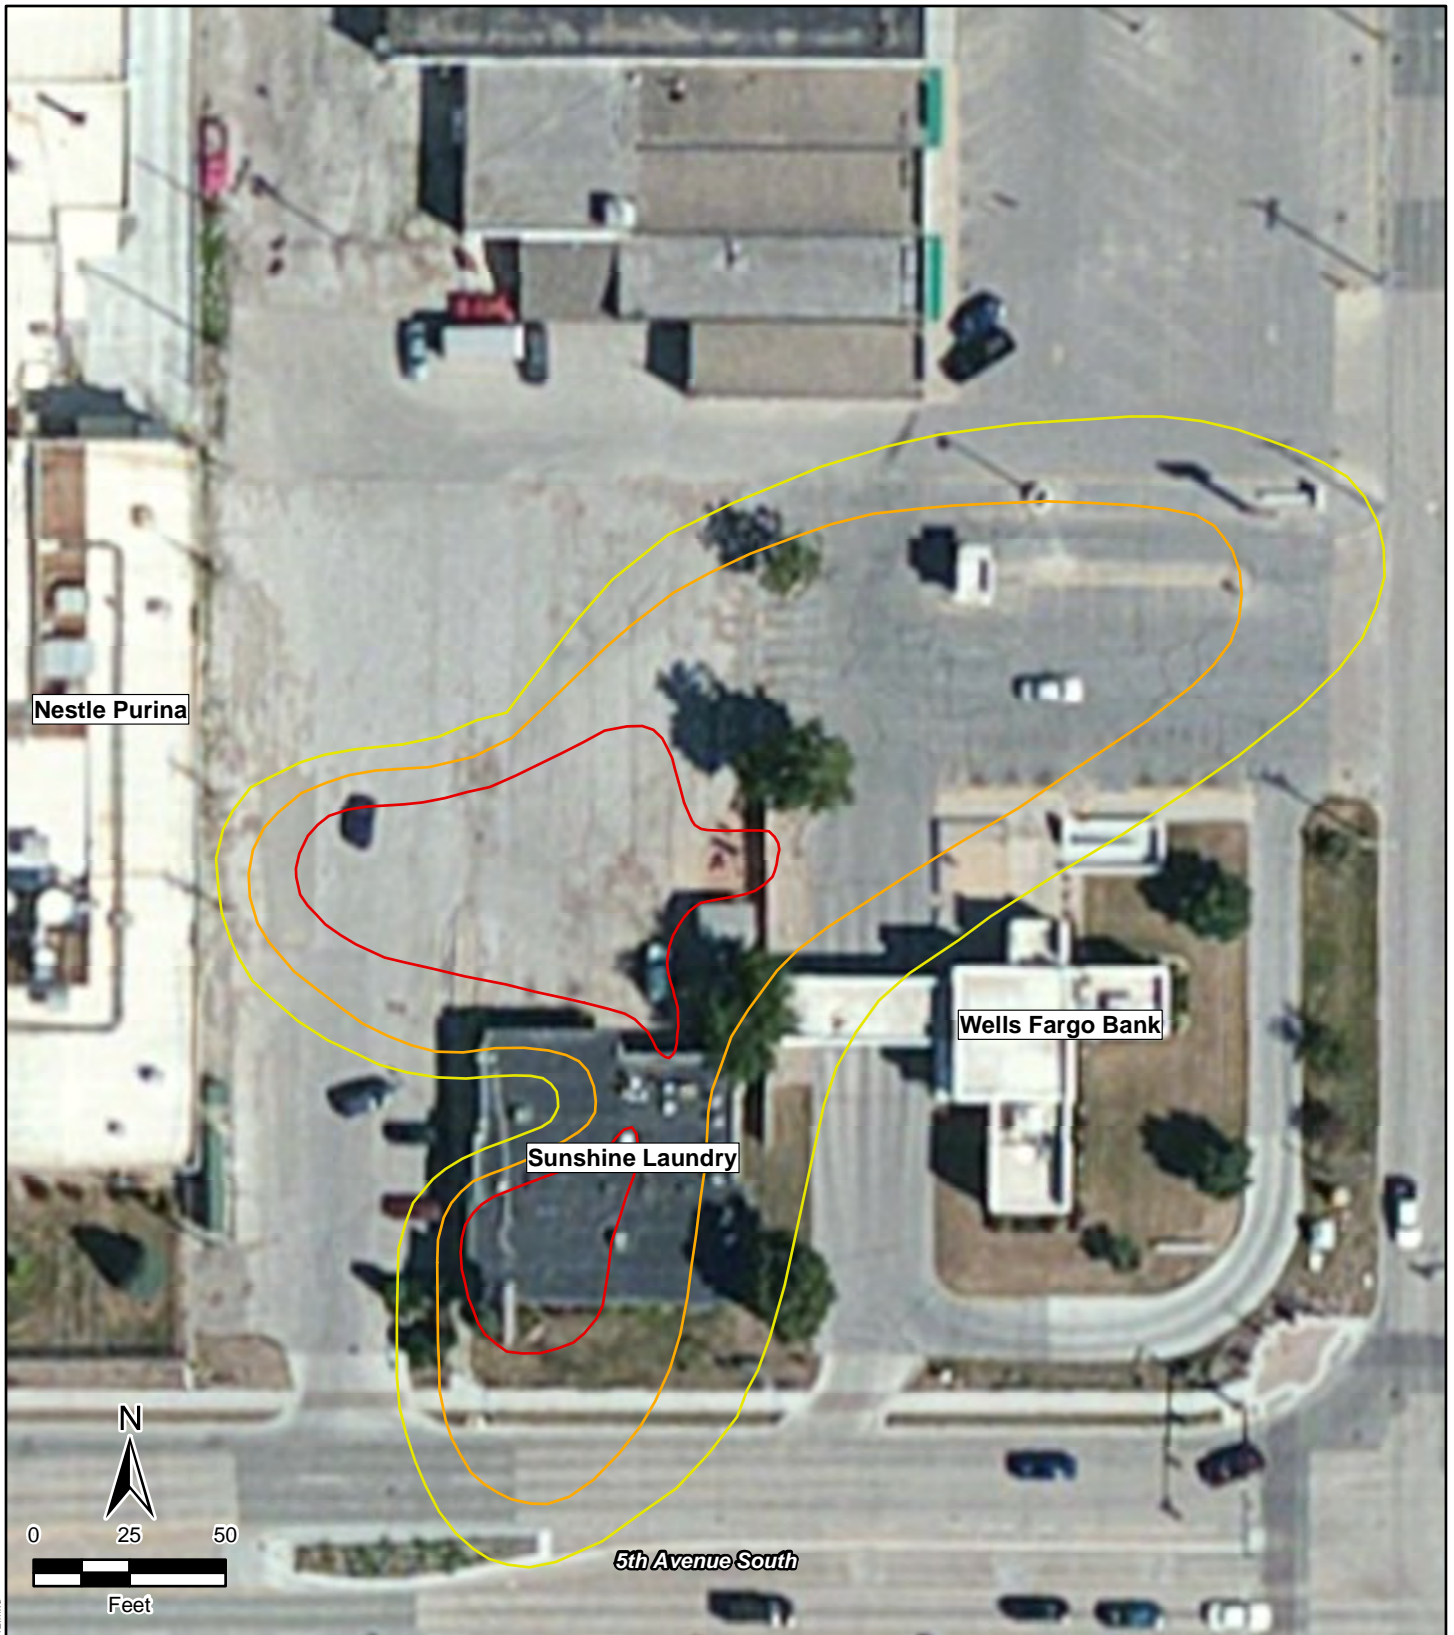
Figure 12
 2008-2021 PCE Isoconcentration Map

Figures 12 and 13 are PCE and TCE isoconcentration maps for groundwater based on concentrations detected since 2008. Vinyl chloride was detected only in groundwater samples from TW-11 and -12 at the distal end of the groundwater plume, south and north, respectively, of the bank's east entrance.

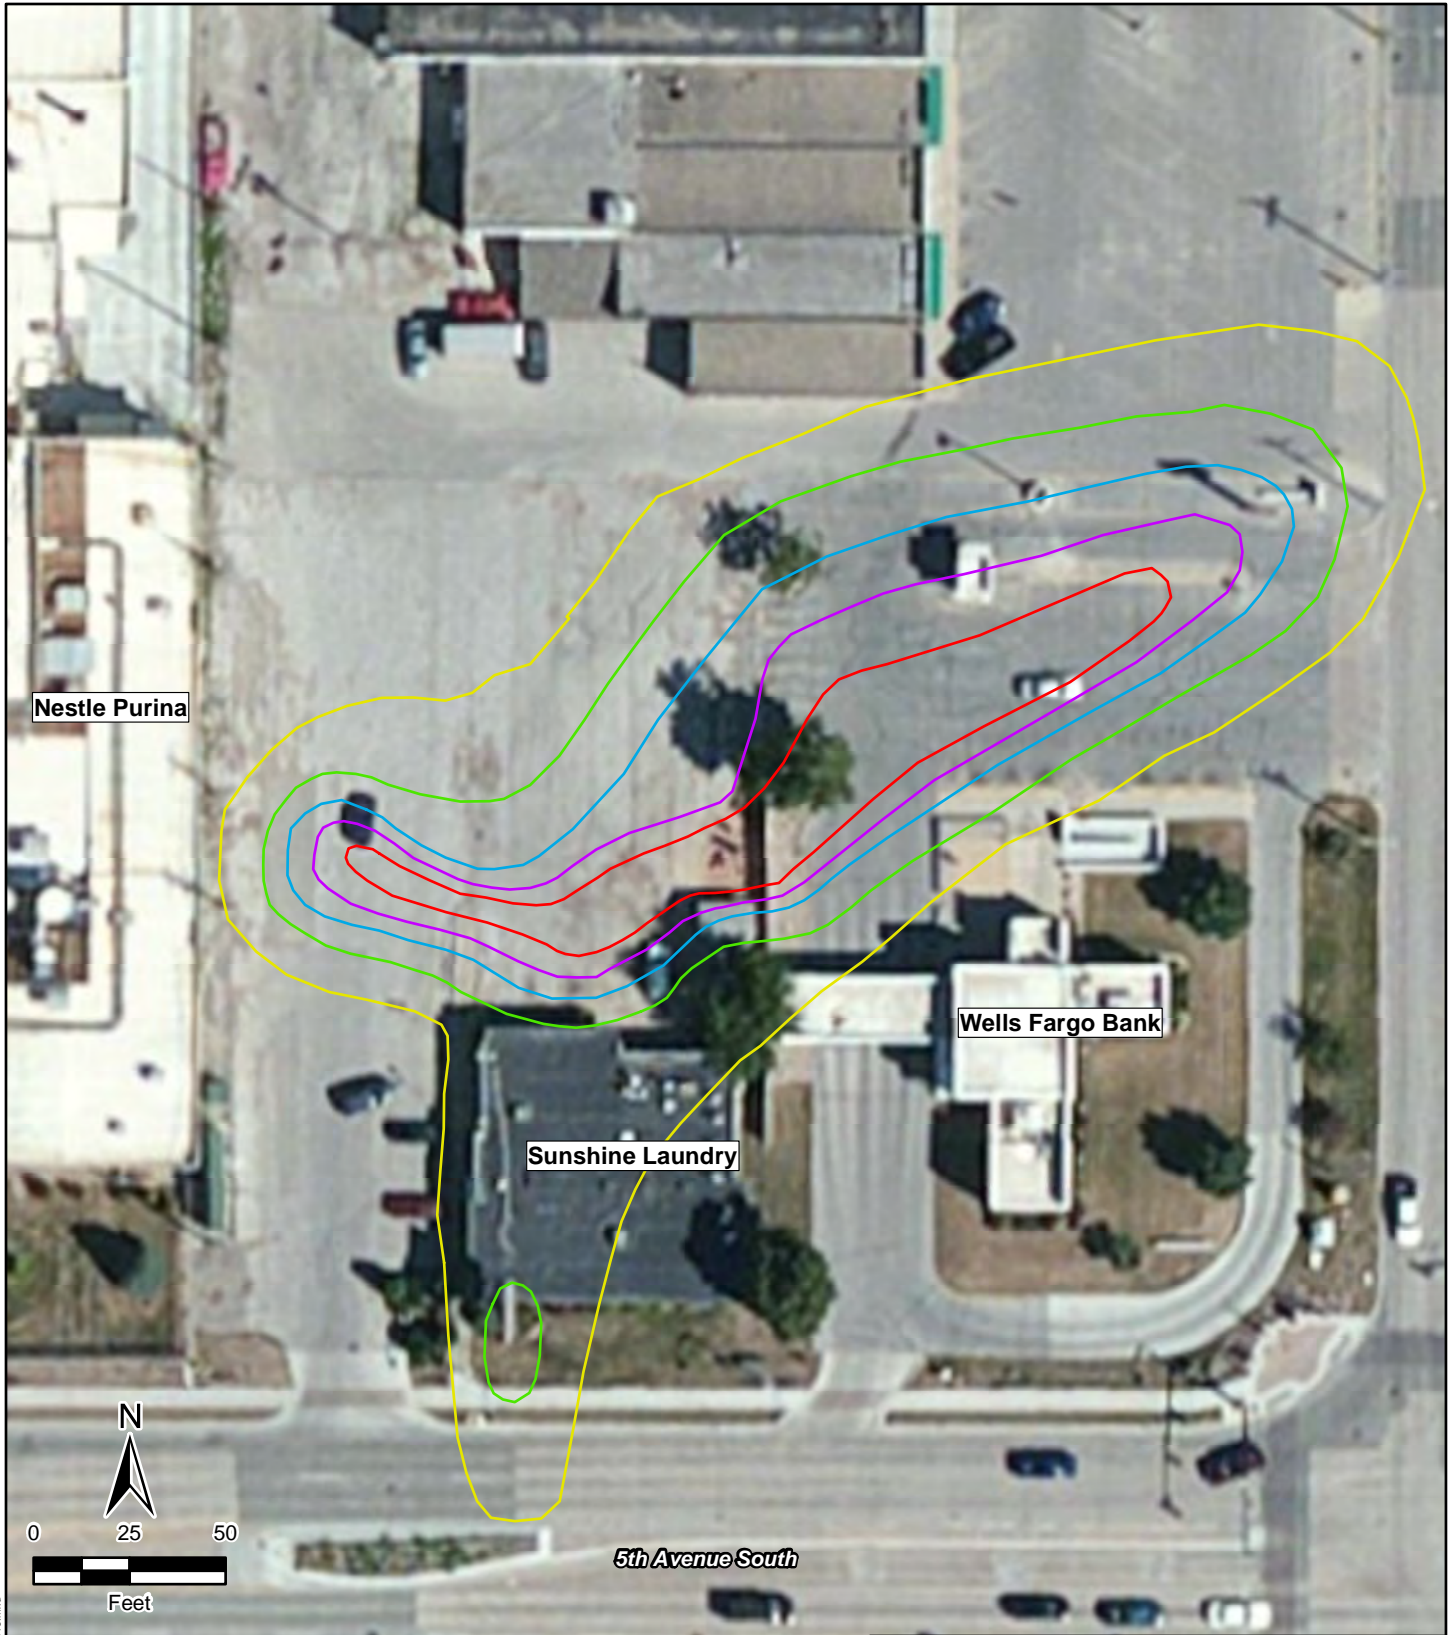
TCE isoconcentration plume		100 µg/L
		5 µg/L
		50 µg/L
		200 µg/L
		300 µg/L
µg/L		Micrograms per liter
TCE		Trichloroethene

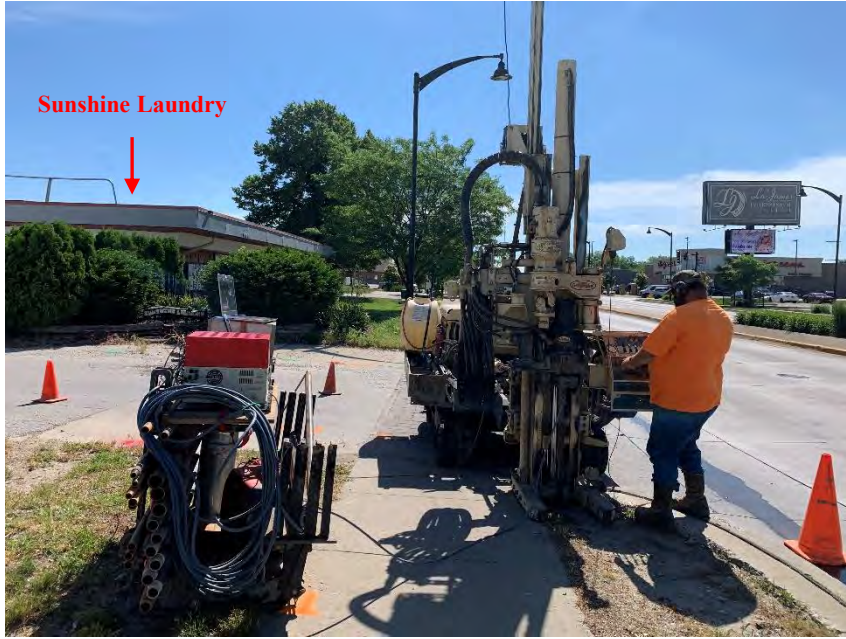
TETRA TECH PROJECT NO. X9030..19F.0086.008 DIRECTION: East	DESCRIPTION	This photograph shows Membrane Interface Probe (MIP)-1 location; collocated with Soil Boring (SB)-5 and Temporary Well (TW)-6.	1
	CLIENT	Environmental Protection Agency - Region 7	DATE
	PHOTOGRAPHER	Jenna Mead	6/7/2021

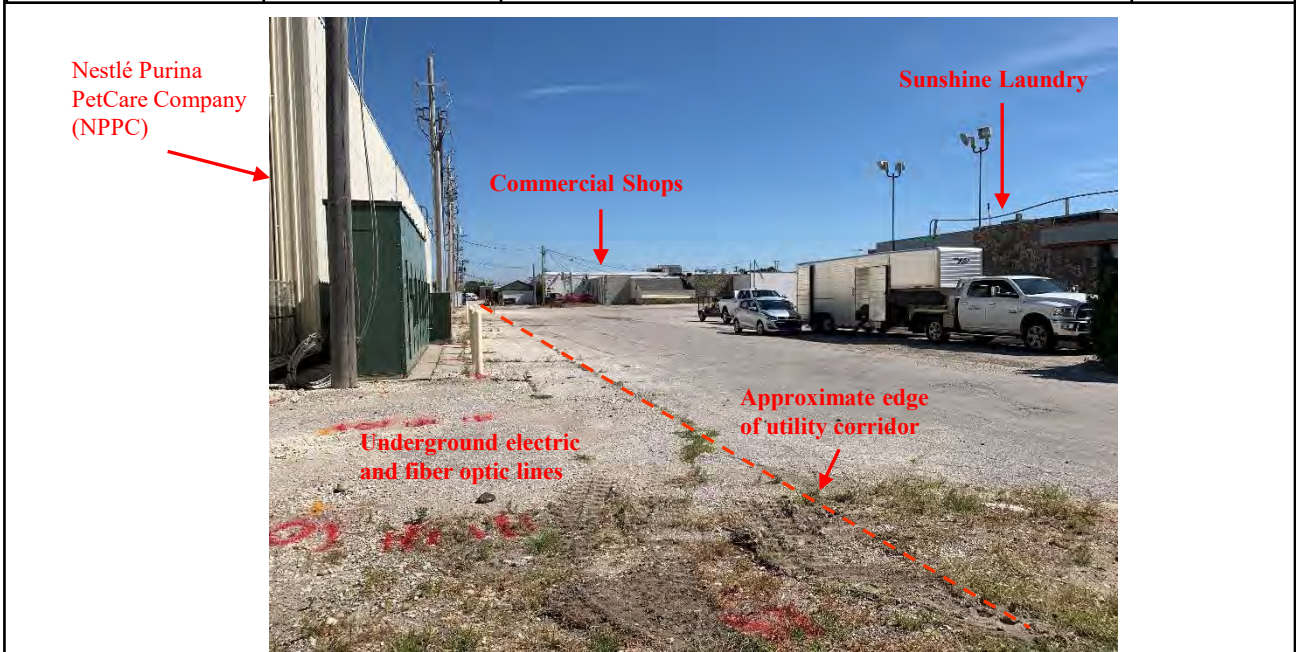
TETRA TECH PROJECT NO. X9030.19F.0086.008 DIRECTION: North	DESCRIPTION	This photograph shows power and communications utility easement at west side of Sunshine Laundry.	2
	CLIENT	Environmental Protection Agency - Region 7	DATE
	PHOTOGRAPHER	Jenna Mead	6/7/2021

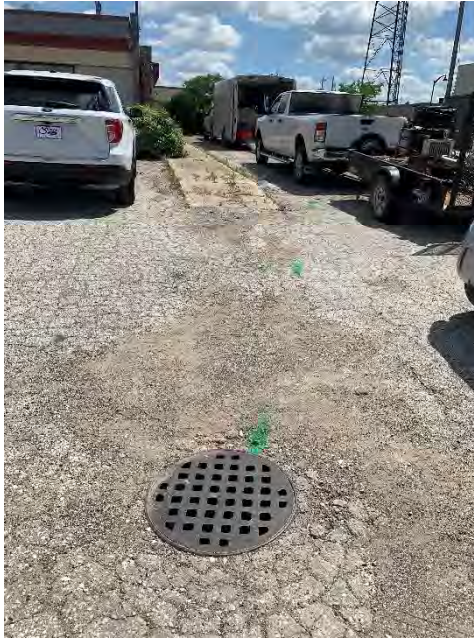
TETRA TECH PROJECT NO. X9030..19F.0086.008 DIRECTION: South	DESCRIPTION	This photograph shows the storm sewer drain in parking lot north of Sunshine Laundry.	3
	CLIENT	Environmental Protection Agency - Region 7	DATE 6/7/2021
	PHOTOGRAPHER	Jenna Mead

PCE was detected in 17 samples at concentrations as high as an estimated 31,000 $\mu\text{g}/\text{kg}$ in a sample collected at 12-13 feet bgs near a stormwater drain about 50 feet north of the former dry cleaner building. TCE and other PCE degradation compounds were detected in 11 soil samples, generally in the north central portion of the site. The fuel-related VOCs benzene and toluene were also detected in one sample collected in this area. Fuel-related VOCs are known to enhance PCE and TCE degradation (EPA 1998).

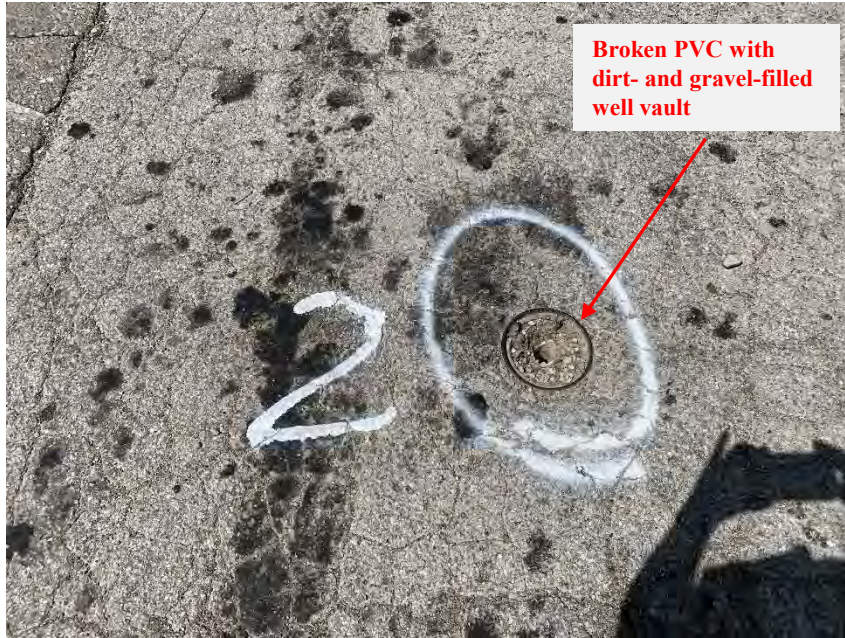
TETRA TECH PROJECT NO. X9030..19F.0086.008 DIRECTION: -	DESCRIPTION	This photograph shows open PVC with no well cap or vault cover at MW-2; not sampled.	5
	CLIENT	Environmental Protection Agency - Region 7	DATE 6/7/2021
	PHOTOGRAPHER	Jenna Mead

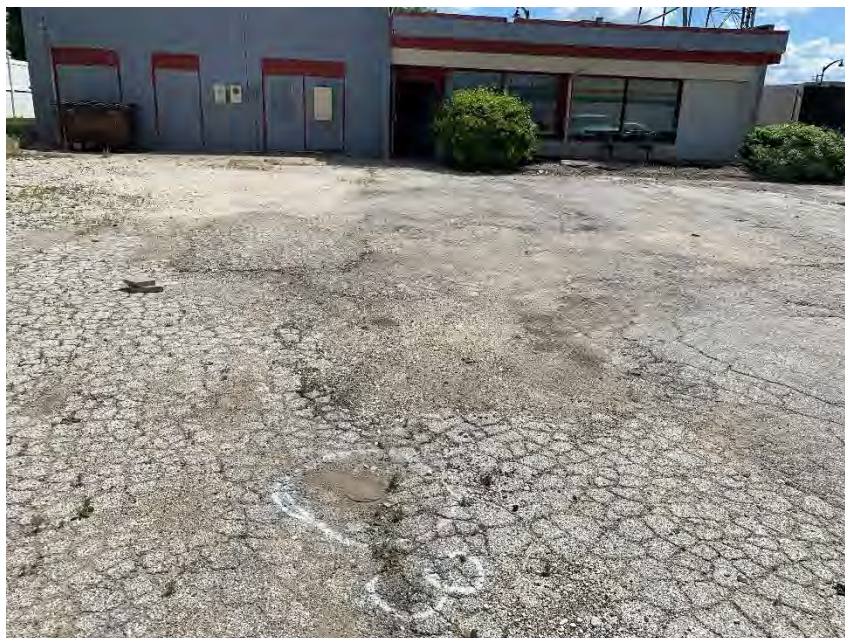
TETRA TECH PROJECT NO. X9030.19F.0086.008 DIRECTION: South	DESCRIPTION	This photograph shows MW-3 with vault cover in place, north of Sunshine Laundry building.	6
	CLIENT	Environmental Protection Agency - Region 7	DATE 6/7/2021
	PHOTOGRAPHER	Jenna Mead

that MW-6 may have been damaged or broken during line installation. At MW-3, the shallower bottom (18.7 feet bgs) is likely due to siltation.

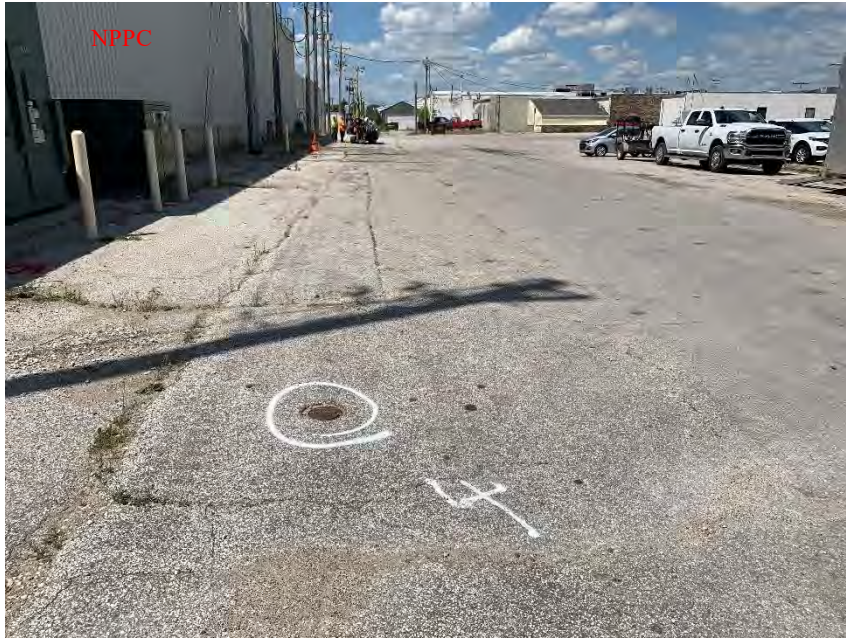
TETRA TECH PROJECT NO. X9030..19F.0086.008 DIRECTION: North	DESCRIPTION	This photograph shows MW-4 with 4-inch vault cover in place.	7
	CLIENT	Environmental Protection Agency - Region 7	DATE 6/7/2021
	PHOTOGRAPHER	Jenna Mead

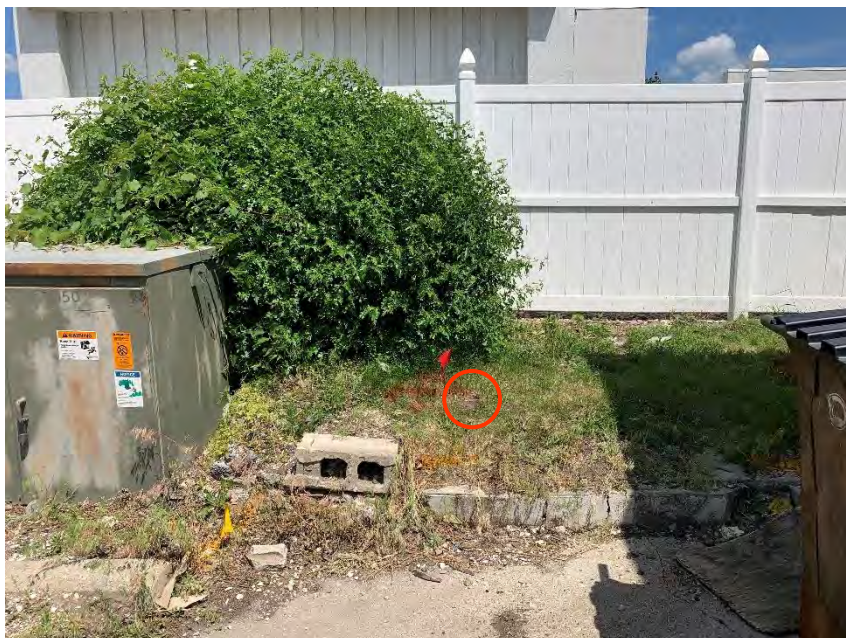
TETRA TECH PROJECT NO. X9030.19F.0086.008 DIRECTION: East	DESCRIPTION	This photograph shows MW-6 location just northeast of Sunshine Laundry building. Note underground electrical flag and markings.	8
	CLIENT	Environmental Protection Agency - Region 7	DATE 6/7/2021
	PHOTOGRAPHER	Jenna Mead

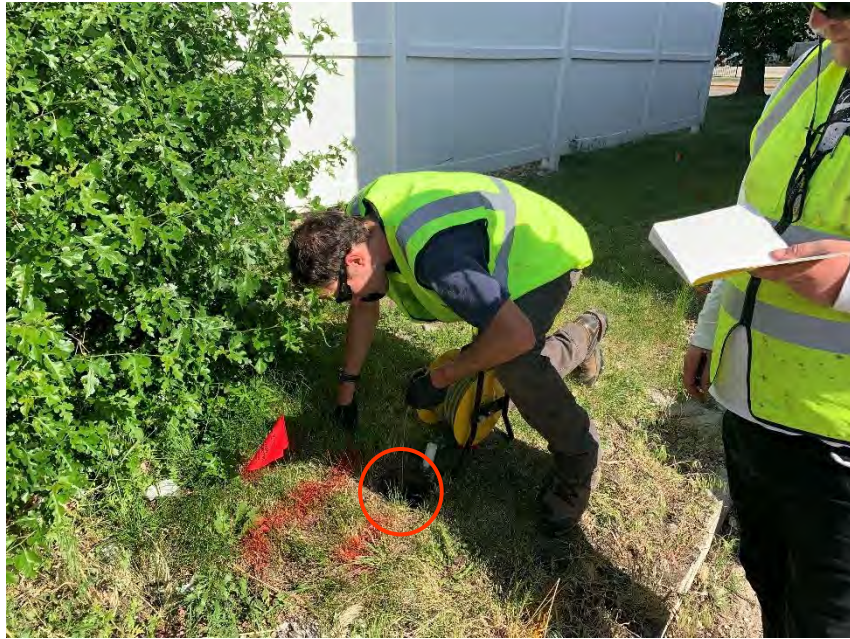
<p style="text-align: center;">TETRA TECH PROJECT NO. X9030..19F.0086.008 DIRECTION: Southeast</p>	DESCRIPTION	This photograph shows water level measurement at MW-6. Note: the subsurface electrical post-dates installation of MW-6.	9
	CLIENT	Environmental Protection Agency - Region 7	DATE 6/7/2021
	PHOTOGRAPHER	Jenna Mead

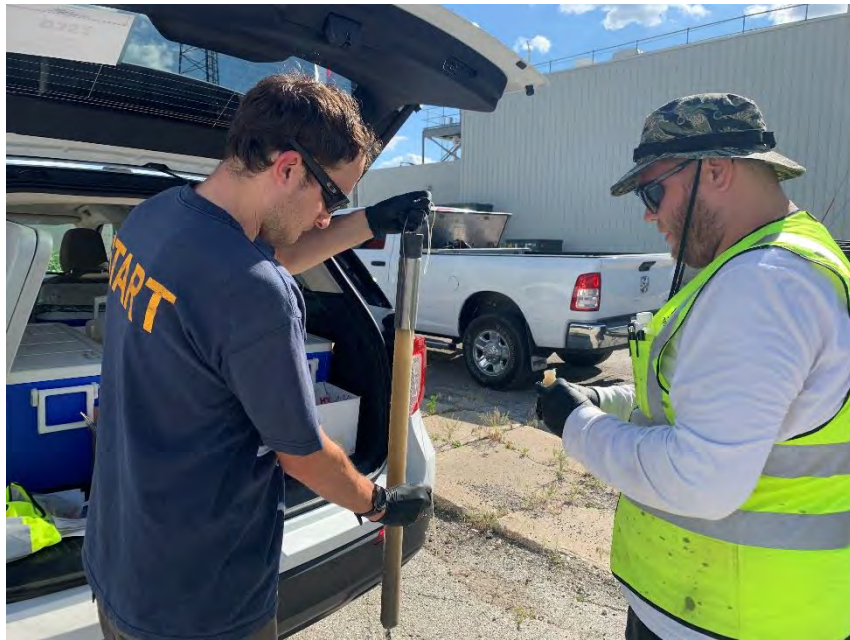
<p style="text-align: center;">TETRA TECH PROJECT NO. X9030.19F.0086.008 DIRECTION: Southwest</p>	DESCRIPTION	This photograph shows groundwater sample collected at MW-3 by use of a HydraSleeve™ sampling device.	10
	CLIENT	Environmental Protection Agency - Region 7	DATE 6/7/2021
	PHOTOGRAPHER	Jenna Mead

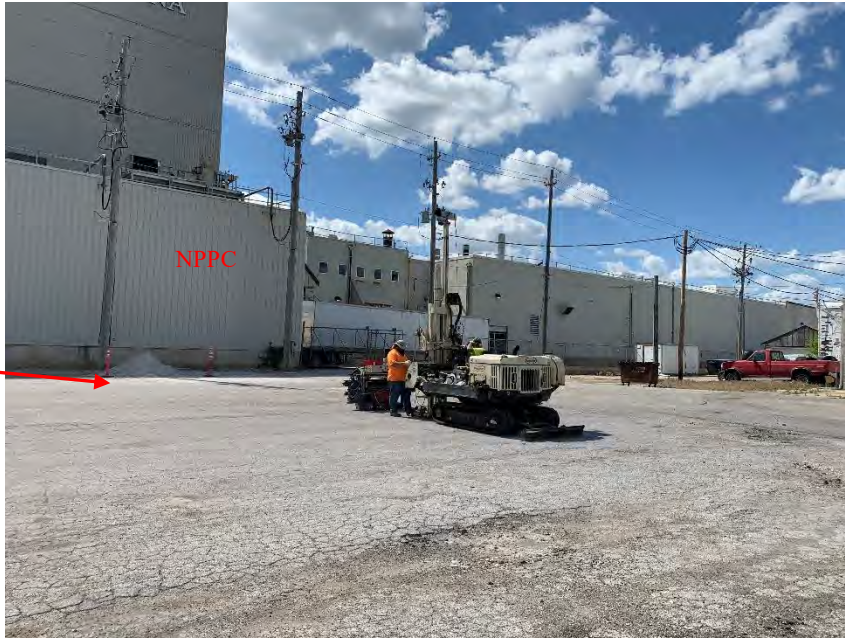
Approximate
location of
MIP-5

TETRA TECH PROJECT NO. X9030..19F.0086.008 DIRECTION: Northwest	DESCRIPTION	This photograph shows MIP-6 location.	11
	CLIENT	Environmental Protection Agency - Region 7	DATE
	PHOTOGRAPHER	Jenna Mead	6/7/2021

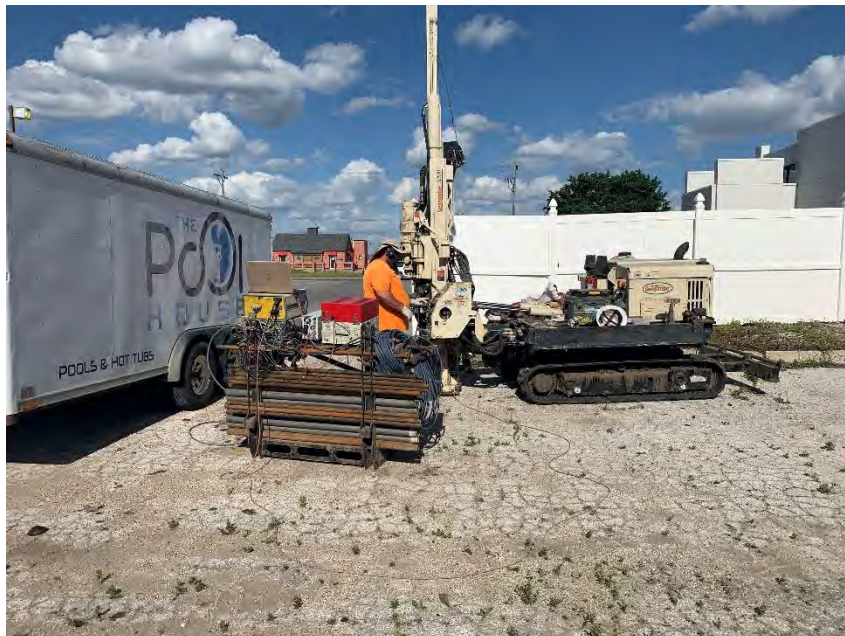
TETRA TECH PROJECT NO. X9030.19F.0086.008 DIRECTION: East	DESCRIPTION	This photograph shows MIP-8 location. Collocated with SB-9 and TW-9.	12
	CLIENT	Environmental Protection Agency - Region 7	DATE
	PHOTOGRAPHER	Jenna Mead	6/7/2021

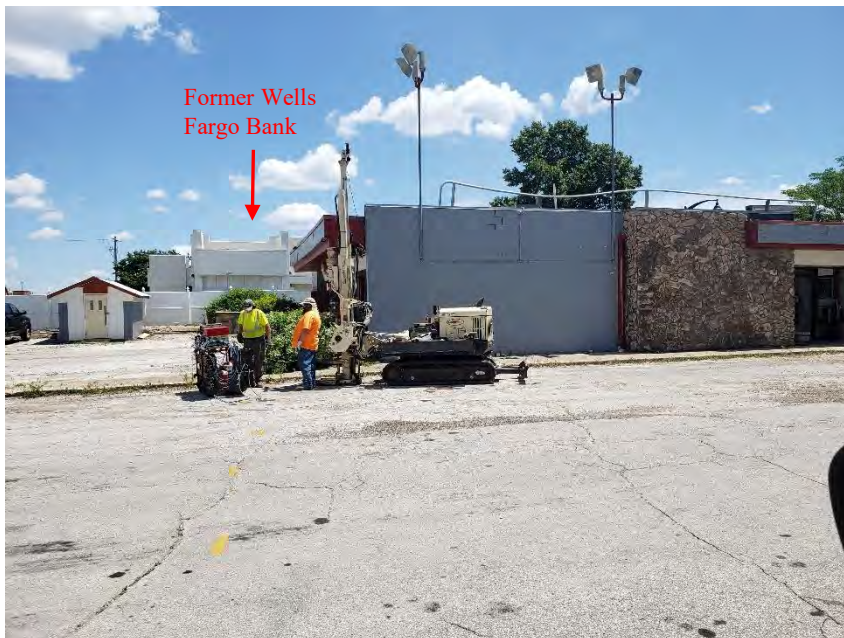
TETRA TECH PROJECT NO. X9030.19F.0086.008 DIRECTION: East	DESCRIPTION	This photograph shows MIP-13 near northwest corner of the Sunshine Laundry building; collocated with SB-15.	14
	CLIENT	Environmental Protection Agency - Region 7	DATE 6/8/2021
	PHOTOGRAPHER	Jenna Mead

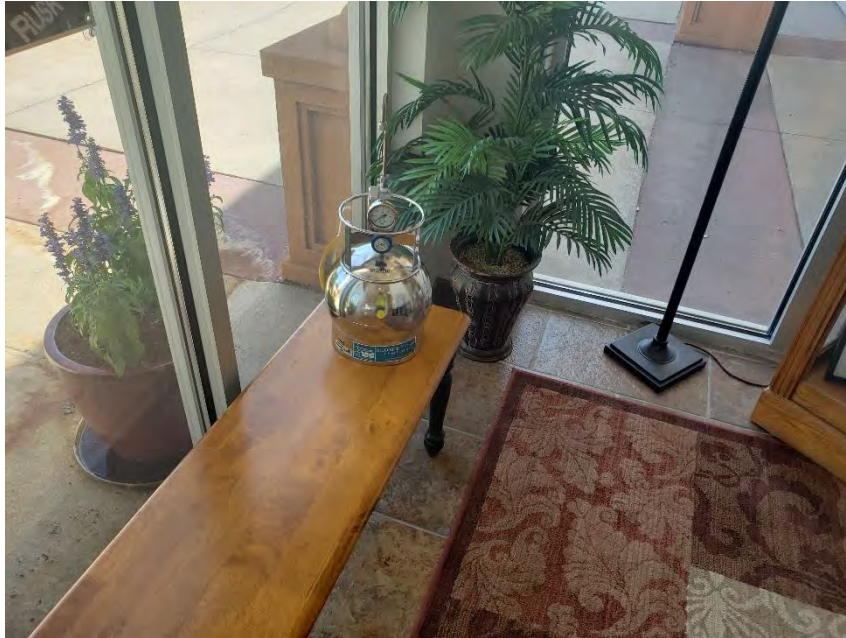
TETRA TECH PROJECT NO. X9030..19F.0086.008 DIRECTION: East	DESCRIPTION	This photograph shows indoor air sample collection at 2419 5 th Avenue South.	15
	CLIENT	Environmental Protection Agency - Region 7	DATE 6/8/2021
	PHOTOGRAPHER	Tim Barbeau

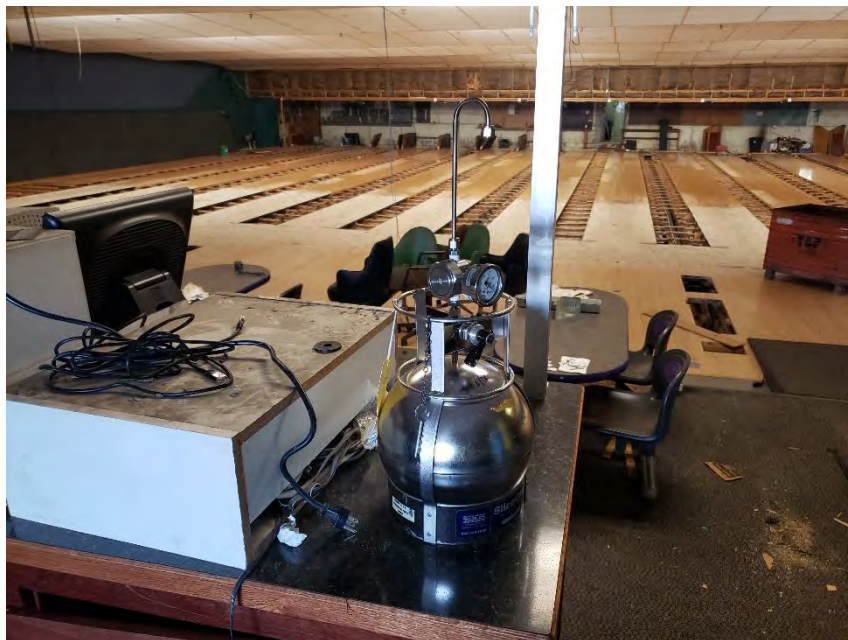
TETRA TECH PROJECT NO. X9030.19F.0086.008 DIRECTION: -	DESCRIPTION	This photograph shows indoor air sample location at vacant bowling alley at 326 S. 25 th Street.	16
	CLIENT	Environmental Protection Agency - Region 7	DATE 6/8/2021
	PHOTOGRAPHER	Tim Barbeau

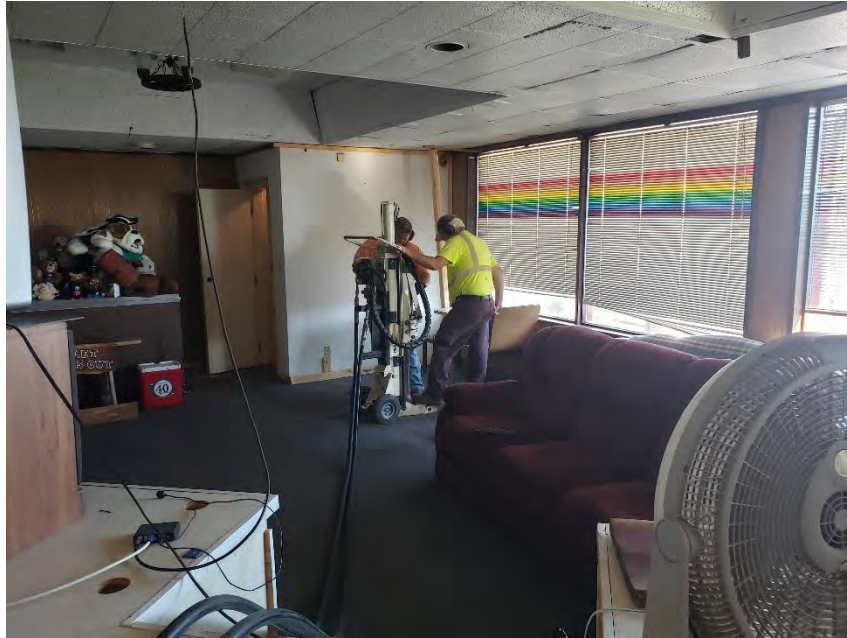
TETRA TECH PROJECT NO. X9030..19F.0086.008 DIRECTION: Northwest	DESCRIPTION	This photograph shows SB-1/TW-1 at northwest quadrant inside Sunshine Laundry near former dry cleaning machine's location.	17
	CLIENT	Environmental Protection Agency - Region 7	DATE 6/9/2021
	PHOTOGRAPHER	Tim Barbeau

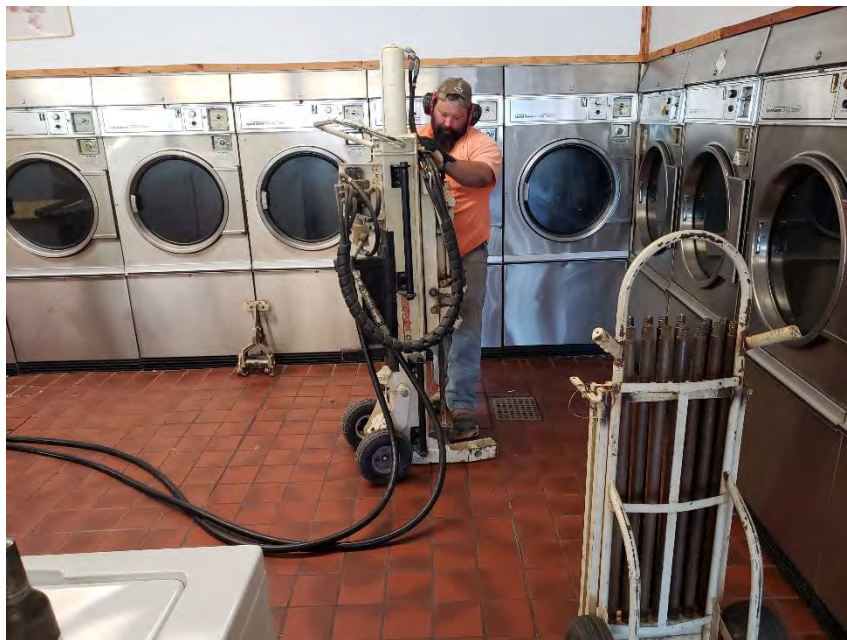
TETRA TECH PROJECT NO. X9030.19F.0086.008 DIRECTION: North	DESCRIPTION	This photograph shows SB-2 location in northeast quadrant of the Sunshine Laundry building.	18
	CLIENT	Environmental Protection Agency - Region 7	DATE 6/9/2021
	PHOTOGRAPHER	Tim Barbeau

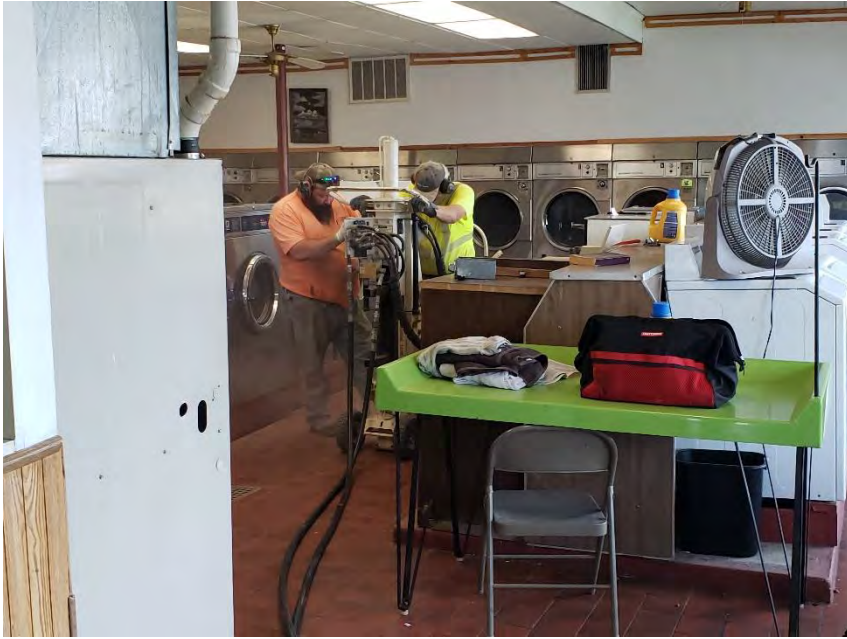
<p>TETRA TECH PROJECT NO. X9030..19F.0086.008 DIRECTION: Northeast</p>	DESCRIPTION	This photograph shows SB-3 location in southeastern quadrant within the Sunshine Laundry building.	19
	CLIENT	Environmental Protection Agency - Region 7	DATE 6/9/2021
	PHOTOGRAPHER	Tim Barbeau

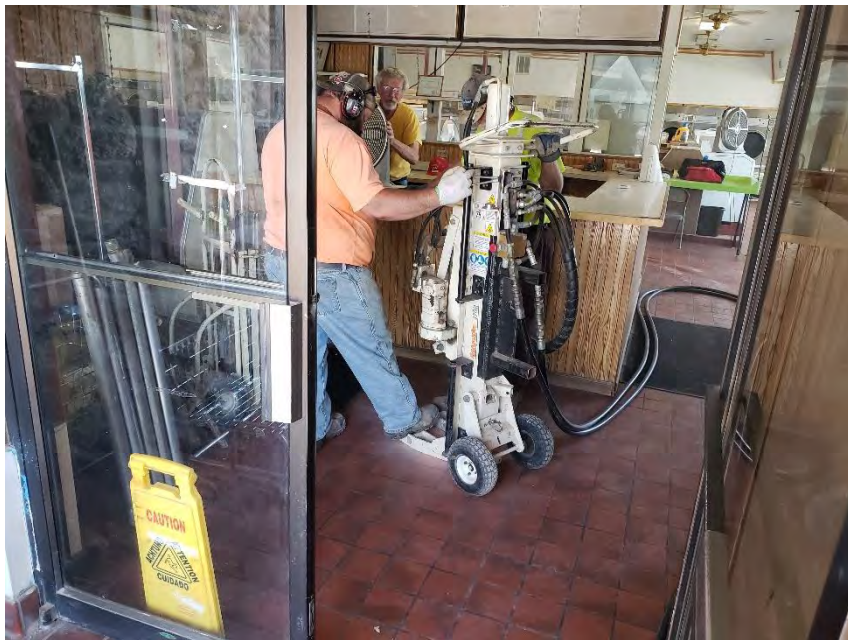
<p>TETRA TECH PROJECT NO. X9030.19F.0086.008 DIRECTION: East</p>	DESCRIPTION	This photograph shows SB-4/TW-2 location inside west entrance at southwest quadrant of the Sunshine Laundry building.	20
	CLIENT	Environmental Protection Agency - Region 7	DATE 6/9/2021
	PHOTOGRAPHER	Tim Barbeau

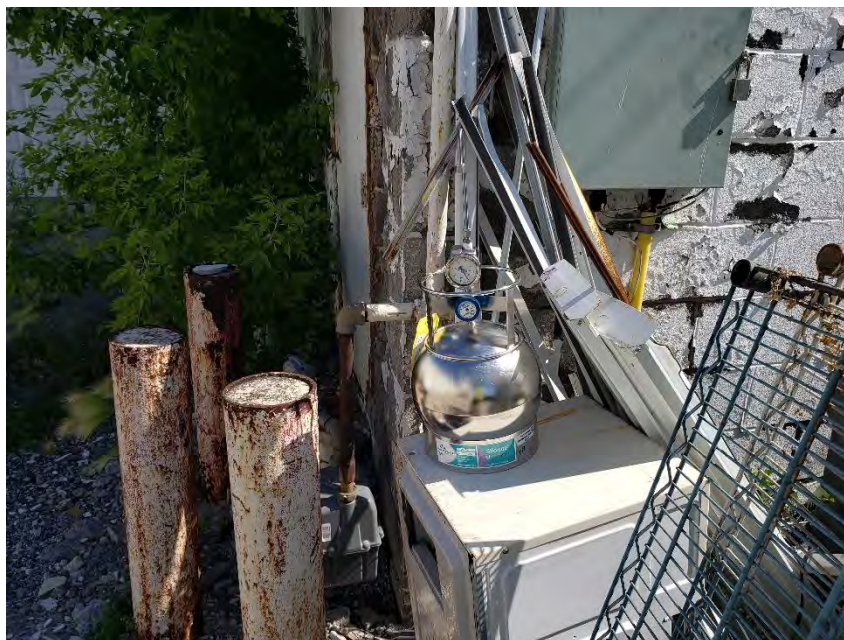
<p>TETRA TECH PROJECT NO. X9030..19F.0086.008 DIRECTION: NA</p>	DESCRIPTION	This photograph shows ambient air sample collection behind building at 330 S. 25 th Street, north of Sunshine Laundry.	21
	CLIENT	Environmental Protection Agency - Region 7	DATE
	PHOTOGRAPHER	Tim Barbeau	6/9/2021

An ambient air sample was collected north of the site during the June sampling event. Neither PCE nor its degradation products were detected in the sample. Other than small, landscaped areas or grassy easements, the area is largely covered by asphalt, concrete, or buildings—rendering documentation of an observed release to air unlikely. The air migration pathway is not considered a viable exposure pathway at the site and was not scored.

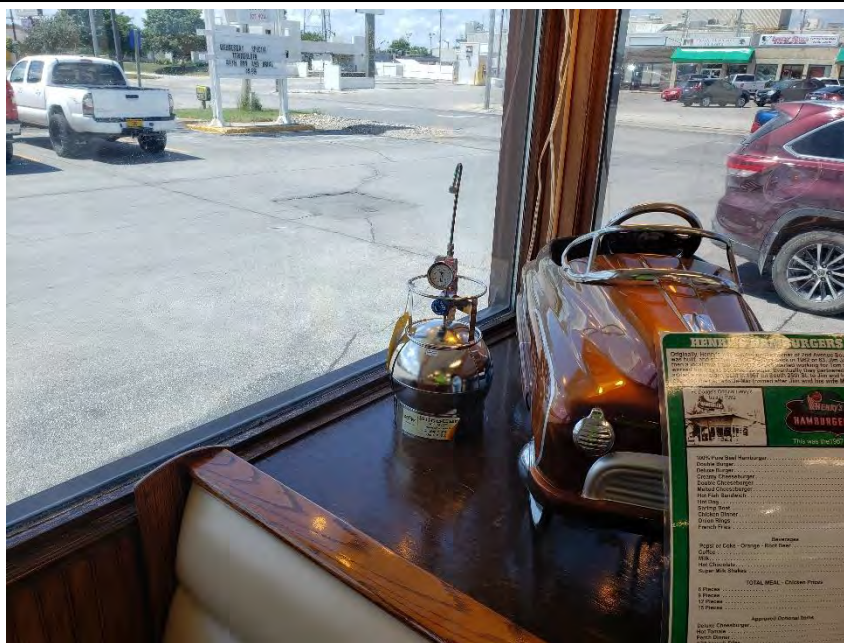
<p>TETRA TECH PROJECT NO. X9030.19F.0086.008 DIRECTION: NA</p>	DESCRIPTION	This photograph shows indoor air sample collection at 325 S. 25 th Street.	22
	CLIENT	Environmental Protection Agency - Region 7	DATE
	PHOTOGRAPHER	Tim Barbeau	6/9/2021

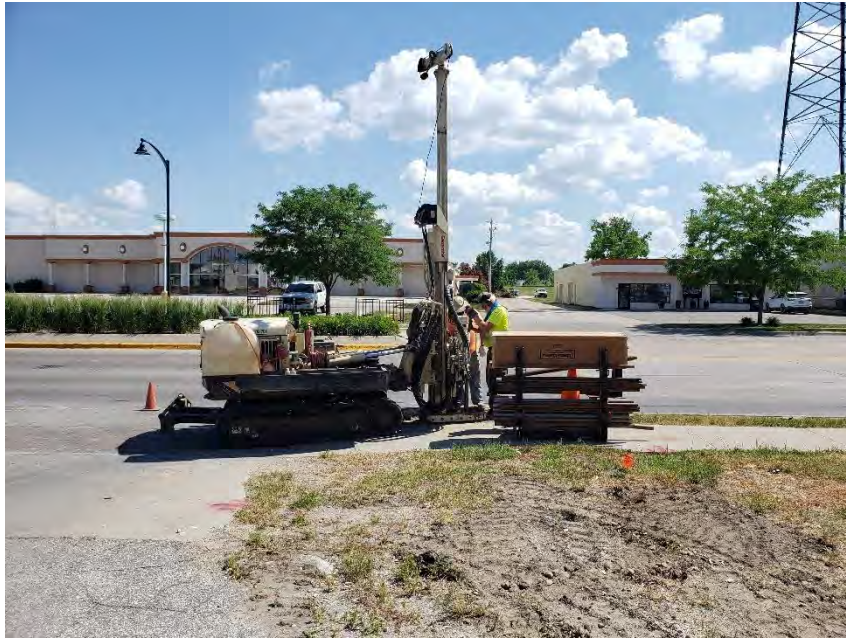
<p>TETRA TECH PROJECT NO. X9030..19F.0086.008 DIRECTION: South</p>	DESCRIPTION	This photograph shows SB-5 near southwest corner of Sunshine Laundry property; collocated with MIP-1 and TW-6.	23
	CLIENT	Environmental Protection Agency - Region 7	DATE 6/9/2021
	PHOTOGRAPHER	Tim Barbeau

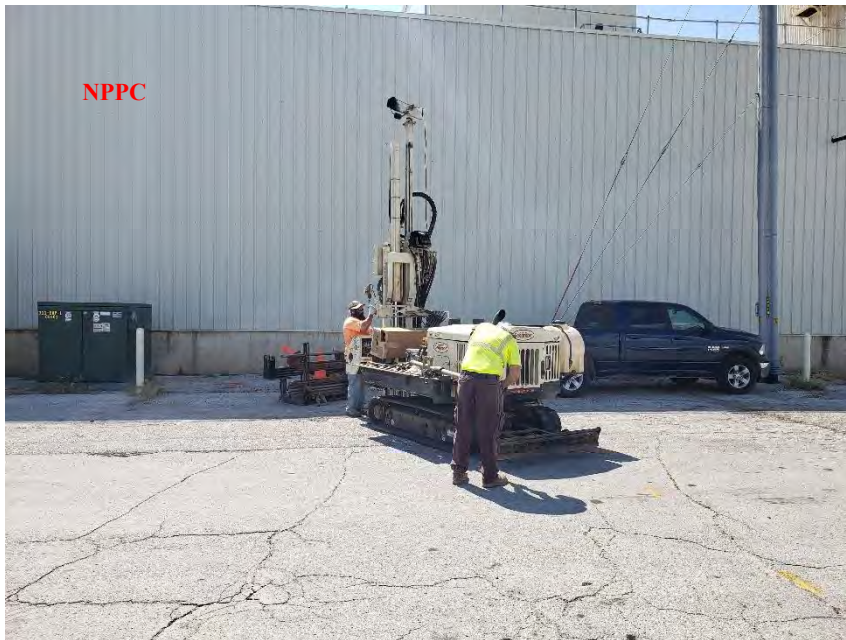
<p>TETRA TECH PROJECT NO. X9030.19F.0086.008 DIRECTION: West</p>	DESCRIPTION	This photograph shows SB-6 location; collocated with MIP-3, TW-7, and Soil Gas (SG)-2.	24
	CLIENT	Environmental Protection Agency - Region 7	DATE 6/9/2021
	PHOTOGRAPHER	Tim Barbeau

Site-related CVOCs detected in the two SG samples are listed in Table 8 below and shown on Figure 15 in Appendix A. Results are compared to VISLs and EPA Region 7 screening levels for exterior soil-gas. Because a utility corridor is immediately east of the NPPC facility building, SG samples were collected about 12 to 15 feet from the building rather than within 10 feet, as specified for comparison to these VISLs. In addition, samples were collected at about 4-4.5 feet bgs—rather than the recommended depth of greater than 5 feet bgs—because an initial sample attempt at 6 feet bgs encountered groundwater.

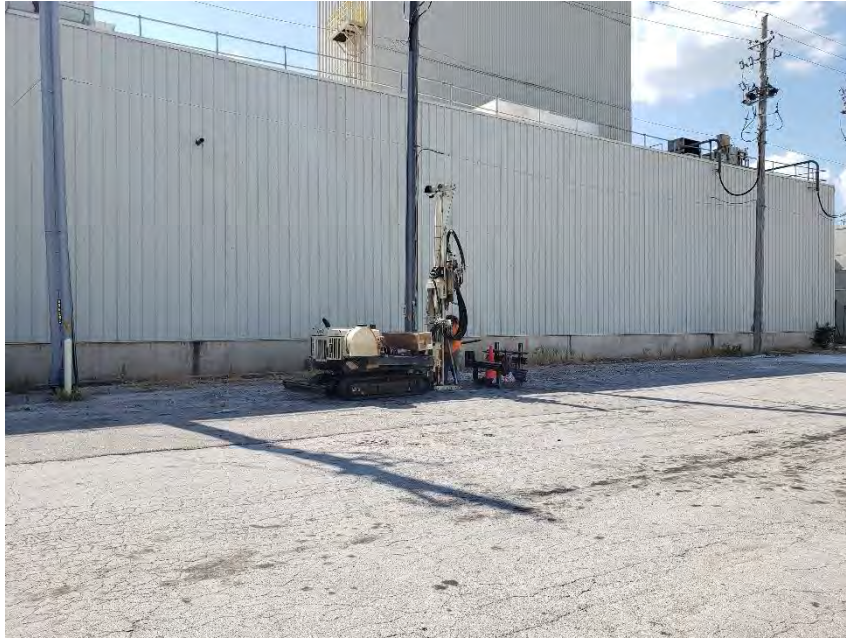
<p>TETRA TECH PROJECT NO. X9030.19F.0086.008 DIRECTION: Northwest</p>	DESCRIPTION	This photograph shows SB-7 location; collocated with MIP-4 and SG-1.	25
	CLIENT	Environmental Protection Agency - Region 7	DATE 6/9/2021
	PHOTOGRAPHER	Tim Barbeau

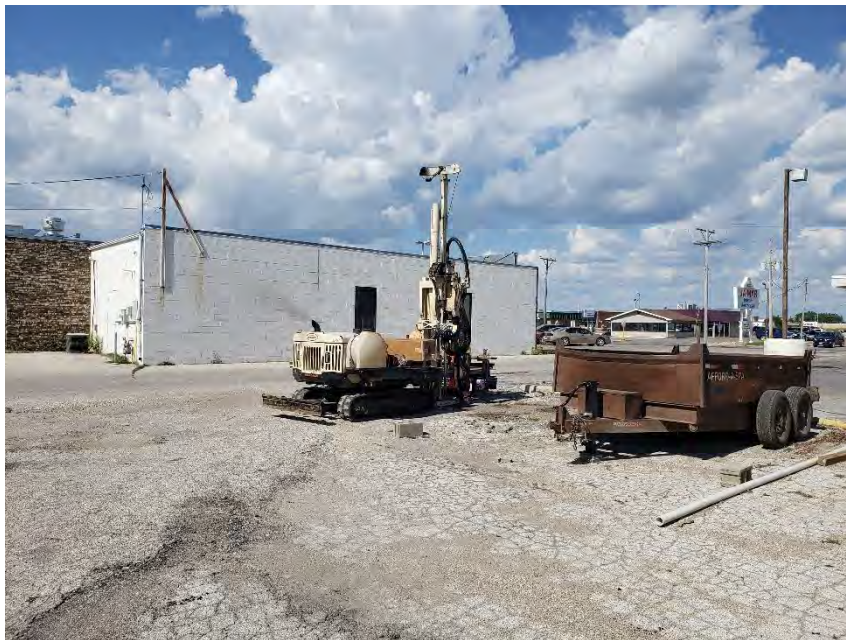
<p>TETRA TECH PROJECT NO. X9030.19F.0086.008 DIRECTION: Northeast</p>	DESCRIPTION	This photograph shows SB-8 location near northeast corner of Sunshine Laundry property; collocated with MIP-7.	26
	CLIENT	Environmental Protection Agency - Region 7	DATE 6/9/2021
	PHOTOGRAPHER	Tim Barbeau
