**Subject: Integrated Site Assessment and Removal Site Evaluation Report
regarding Sunshine Laundry Site, Fort Dodge, Iowa
EPA SEMS Identification No. IAN000706520
U.S. EPA Region 7, START 5, Contract No. 68HE0719D0001
Task Order No. 19F0086.008
Task Monitor: Todd Davis, EPA Site Assessment Manager**

**INTEGRATED SITE ASSESSMENT AND
REMOVAL SITE EVALUATION REPORT**

**SUNSHINE LAUNDRY SITE
FORT DODGE, IOWA**

EPA SEMS ID – IAN000706520

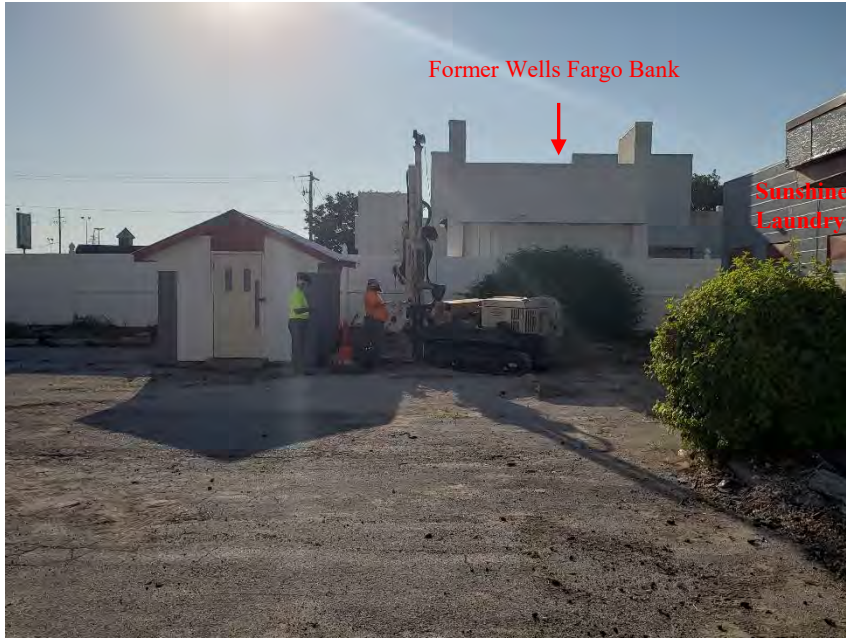
<p>TETRA TECH PROJECT NO. X9030..19F.0086.008 DIRECTION: East</p>	DESCRIPTION	This photograph shows SB-10 location between Sunshine Laundry building and shed; collocated with MIP-10.	27
	CLIENT	Environmental Protection Agency - Region 7	DATE 6/10/2021
	PHOTOGRAPHER	Tim Barbeau

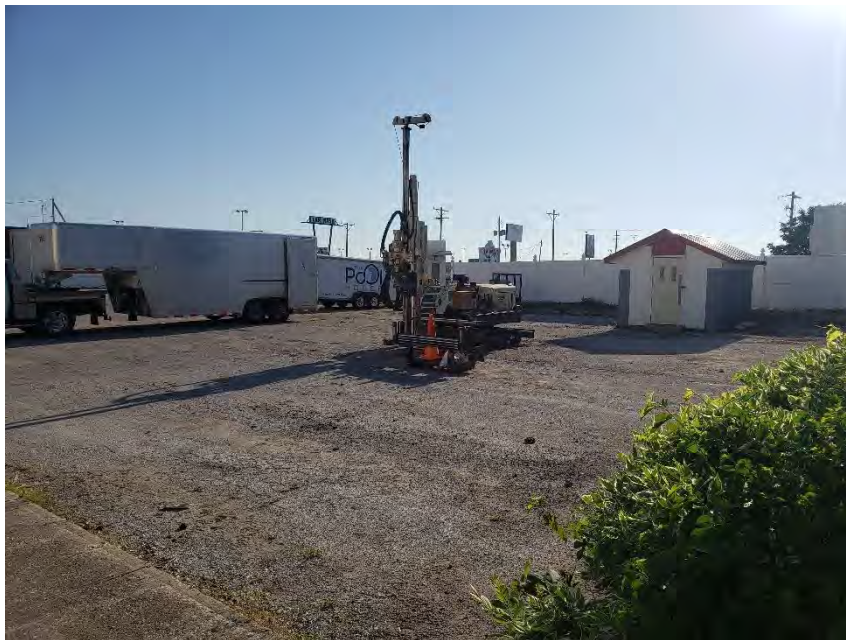
<p>TETRA TECH PROJECT NO. X9030.19F.0086.008 DIRECTION: Northeast</p>	DESCRIPTION	This photograph shows SB-11 location west of shed; collocated with MIP-11.	28
	CLIENT	Environmental Protection Agency - Region 7	DATE 6/10/2021
	PHOTOGRAPHER	Tim Barbeau

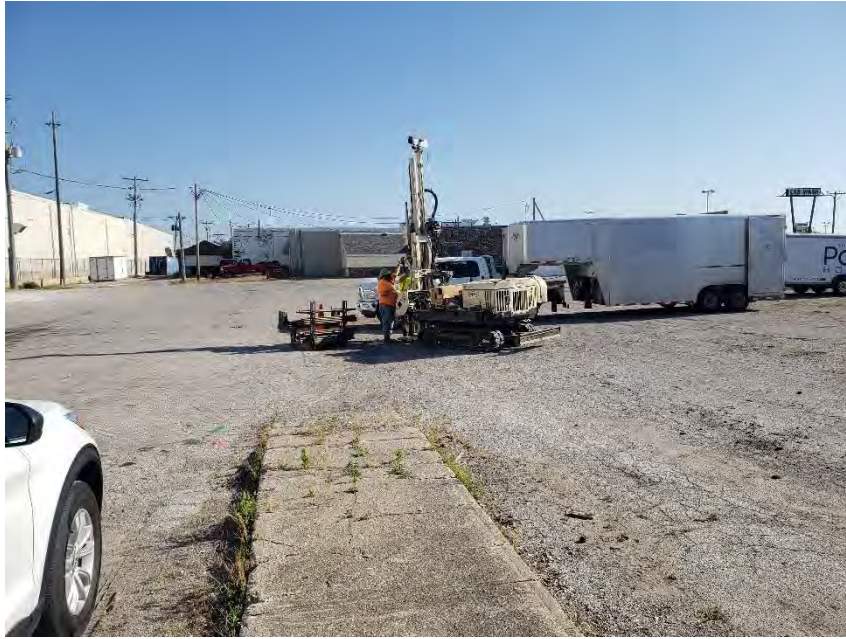
TETRA TECH PROJECT NO. X9030..19F.0086.008 DIRECTION: North	DESCRIPTION	This photograph shows SB-12 location just northeast of stormwater drain; collocated with MIP-12 and TW-8.	29
	CLIENT	Environmental Protection Agency - Region 7	DATE 6/10/2021
	PHOTOGRAPHER	Tim Barbeau

PCE was detected in 17 samples at concentrations as high as an estimated 31,000 $\mu\text{g}/\text{kg}$ in a sample collected at 12-13 feet bgs near a stormwater drain about 50 feet north of the former dry cleaner building. TCE and other PCE degradation compounds were detected in 11 soil samples, generally in the north central portion of the site. The fuel-related VOCs benzene and toluene were also detected in one sample collected in this area. Fuel-related VOCs are known to enhance PCE and TCE degradation (EPA 1998).

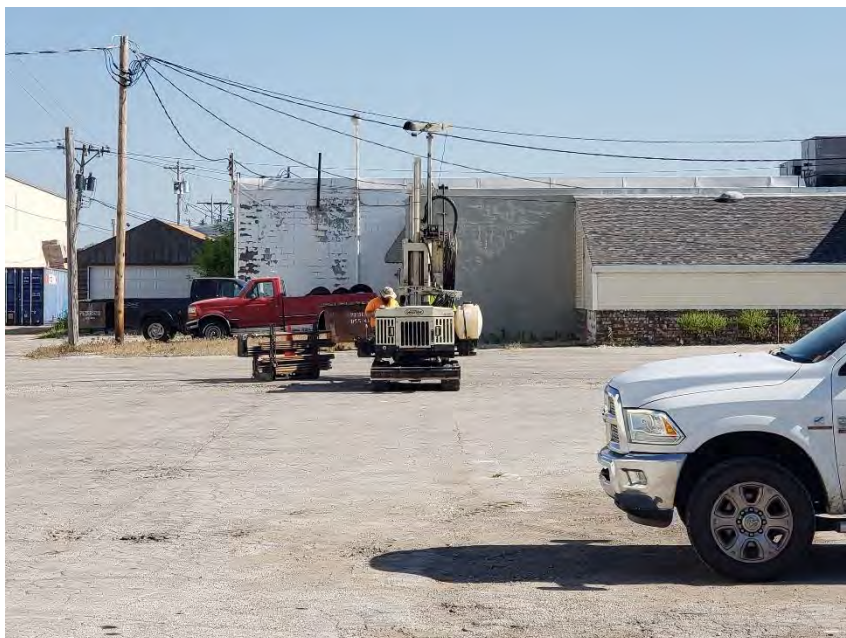
TETRA TECH PROJECT NO. X9030.19F.0086.008 DIRECTION: North	DESCRIPTION	This photograph shows SB-14 location by alley at north collocated with TW-10.	30
	CLIENT	Environmental Protection Agency - Region 7	DATE 6/10/2021
	PHOTOGRAPHER	Tim Barbeau

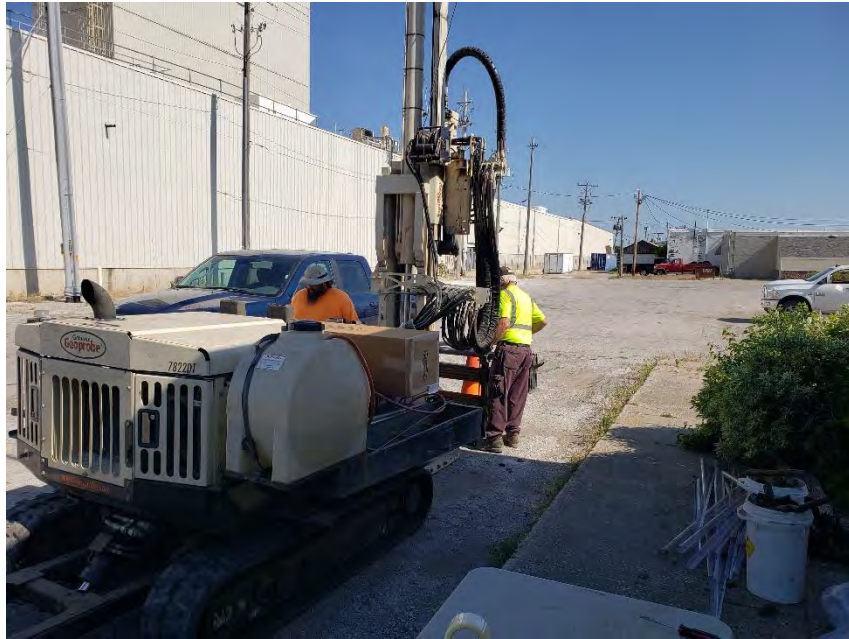
<p>TETRA TECH PROJECT NO. X9030..19F.0086.008 DIRECTION: North</p>	DESCRIPTION	This photograph shows SB-15 just northwest of Sunshine Laundry building; collocated with MIP-13.	31
	CLIENT	Environmental Protection Agency - Region 7	DATE
	PHOTOGRAPHER	Tim Barbeau	6/10/2021

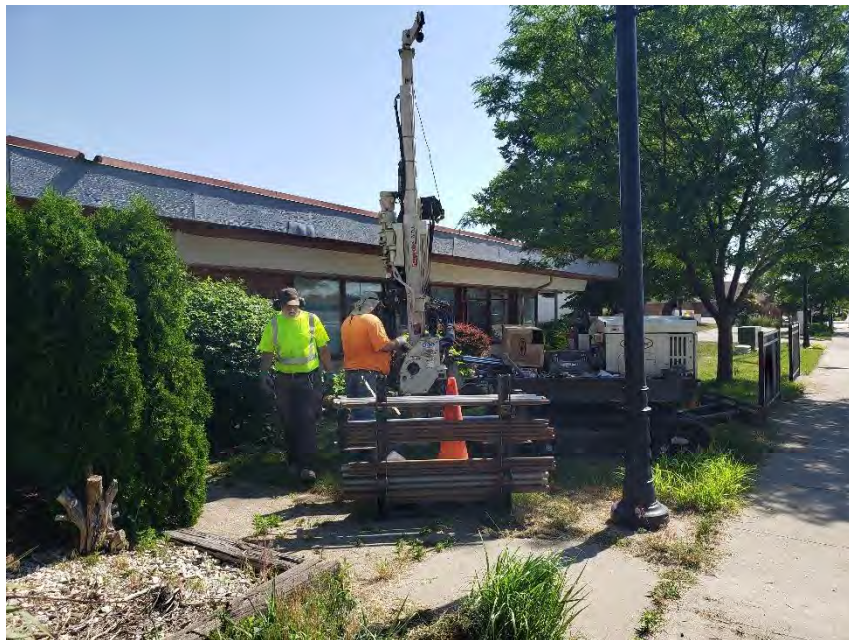
<p>TETRA TECH PROJECT NO. X9030.19F.0086.008 DIRECTION: East</p>	DESCRIPTION	This photograph shows SB-16 south of Sunshine Laundry; collocated with MIP-15 and TW-3.	32
	CLIENT	Environmental Protection Agency - Region 7	DATE
	PHOTOGRAPHER	Tim Barbeau	6/10/2021

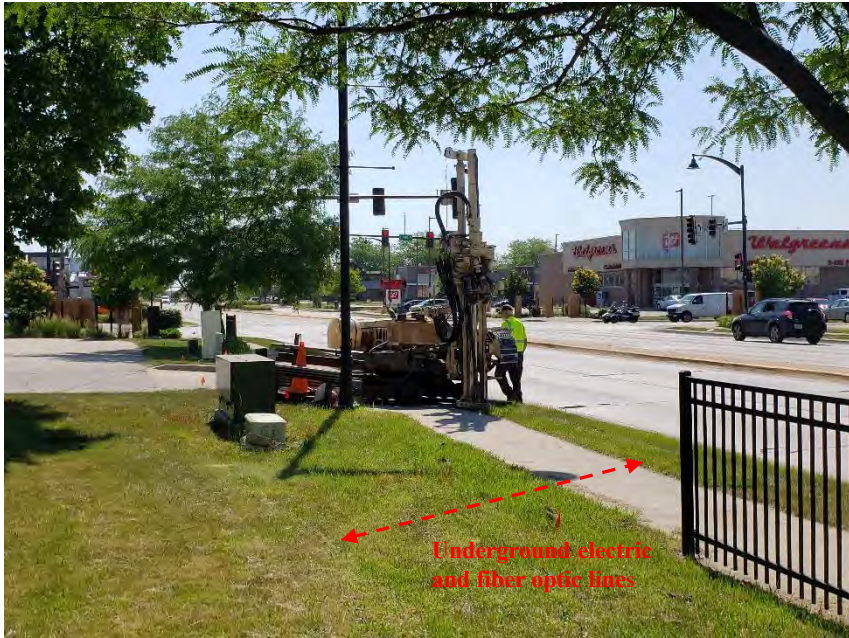
Underground electric
and fiber optic lines

TETRA TECH PROJECT NO. X9030..19F.0086.008 DIRECTION: Southeast	DESCRIPTION	This photograph shows SB-17 at City easement near southeast corner of Sunshine Laundry property; collocated with TW-4.	33
	CLIENT	Environmental Protection Agency - Region 7	DATE
	PHOTOGRAPHER	Tim Barbeau	6/10/2021

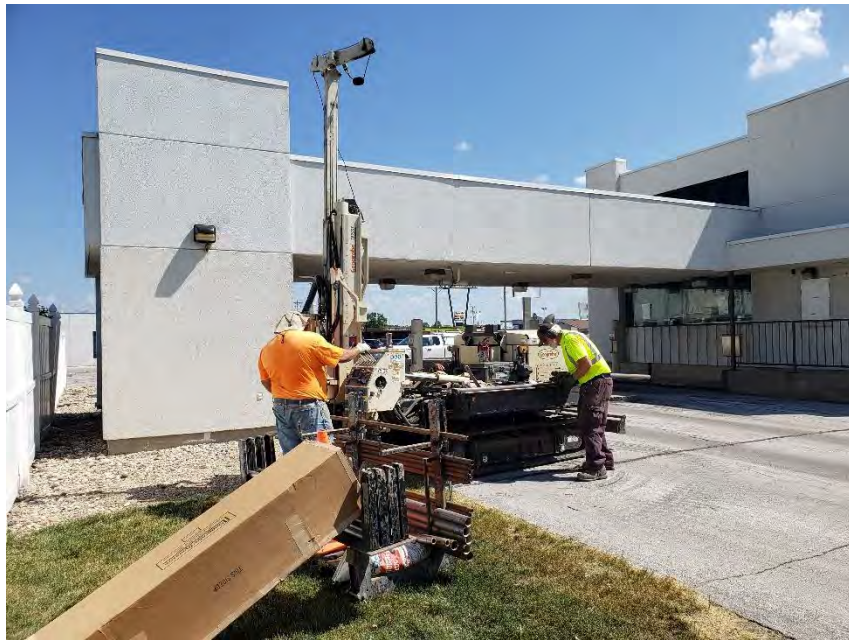
TETRA TECH PROJECT NO. X9030.19F.0086.008 DIRECTION: Northeast	DESCRIPTION	This photograph shows SB-18 southwest of former Wells Fargo Bank drive-through; collocated with TW-5.	34
	CLIENT	Environmental Protection Agency - Region 7	DATE
	PHOTOGRAPHER	Tim Barbeau	6/10/2021

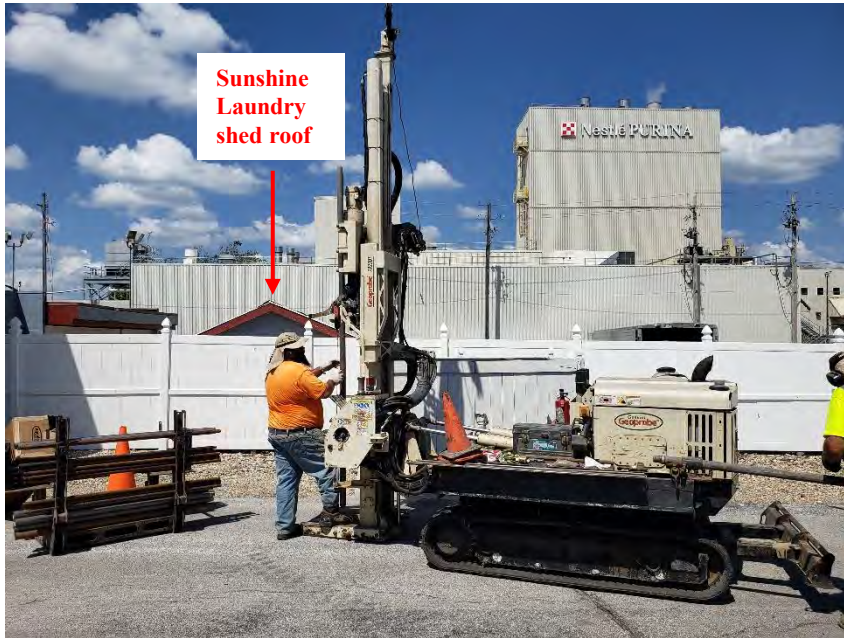
TETRA TECH PROJECT NO. X9030..19F.0086.008 DIRECTION: West	DESCRIPTION	This photograph shows SB-19 location north of drive-through teller lanes for former Wells Fargo Bank.	35
	CLIENT	Environmental Protection Agency - Region 7	DATE 6/10/2021
	PHOTOGRAPHER	Tim Barbeau

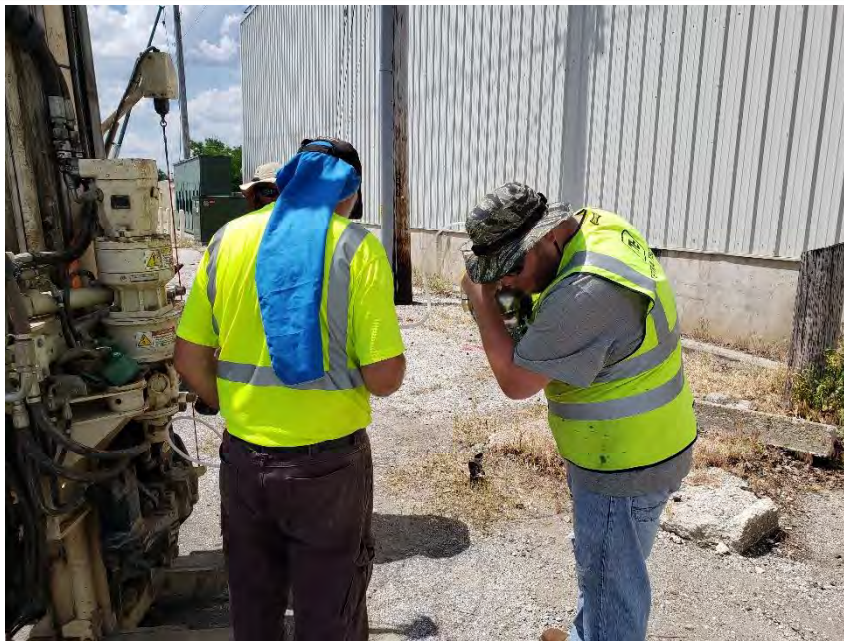
TETRA TECH PROJECT NO. X9030.19F.0086.008 DIRECTION: Southwest	DESCRIPTION	This photograph shows sample collection at SG-1 (MIP-4 location); re-sampled due to water drawn into canister.	36
	CLIENT	Environmental Protection Agency - Region 7	DATE 6/10/2021
	PHOTOGRAPHER	Tim Barbeau

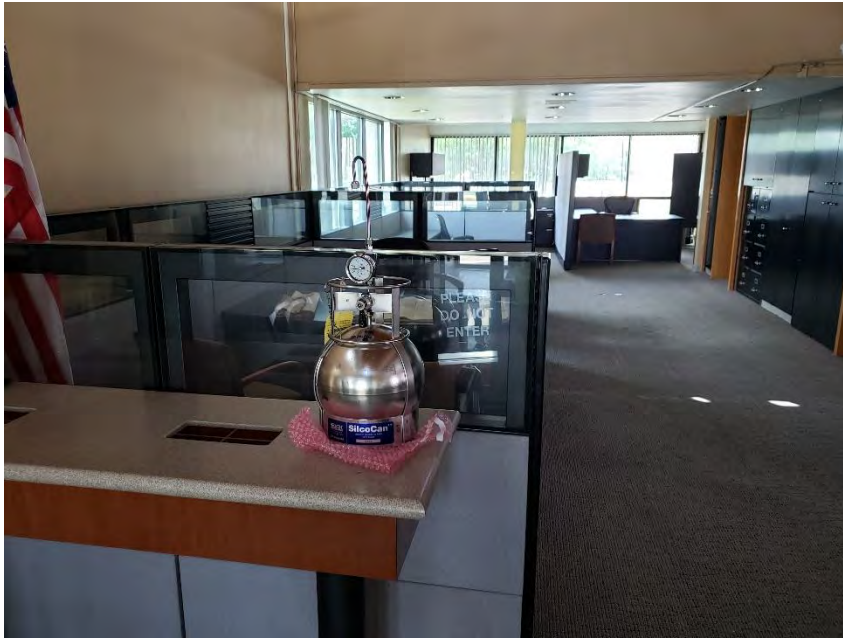
TETRA TECH PROJECT NO. X9030.19F.0086.008 DIRECTION: NA	DESCRIPTION	This photograph shows indoor air sample collection inside former Wells Fargo Bank; sub-slab sample collected in a nearby closet.	37
	CLIENT	Environmental Protection Agency - Region 7	DATE
	PHOTOGRAPHER	Tim Barbeau	6/10/2021

START received permission to collect sub-slab vapor samples at five of the eight properties where owners had granted indoor air sampling access. A hammer drill equipped with a 5/8-inch-diameter concrete bit was used to penetrate the concrete slab at each location. An approximately 4-inch-long, 5/8-inch-diameter stainless steel tube (vapor pin) with a silicon fitting was inserted through the drill hole into the sub-slab material. Vapor pin sample ports are easily removed after completion of sampling, and only the silicon fitting must be replaced for reuse. A removable plug on top of the vapor pin allows resealing of the port and retention of it in place for later sampling, if desired.

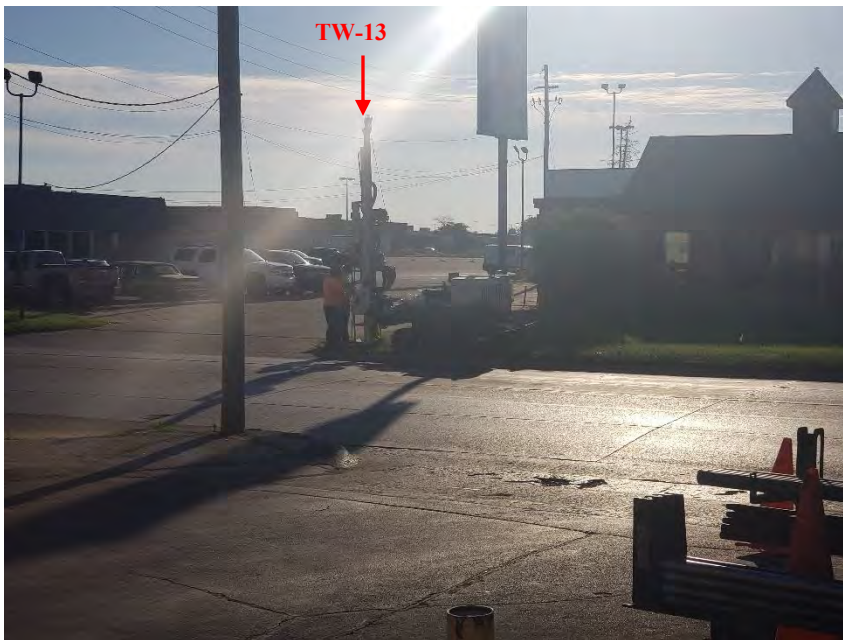
TETRA TECH PROJECT NO. X9030.19F.0086.008 DIRECTION: East	DESCRIPTION	This photograph shows TW-13 location across S. 25 th Street, northeast of site.	38
	CLIENT	Environmental Protection Agency - Region 7	DATE
	PHOTOGRAPHER	Tim Barbeau	6/11/2021

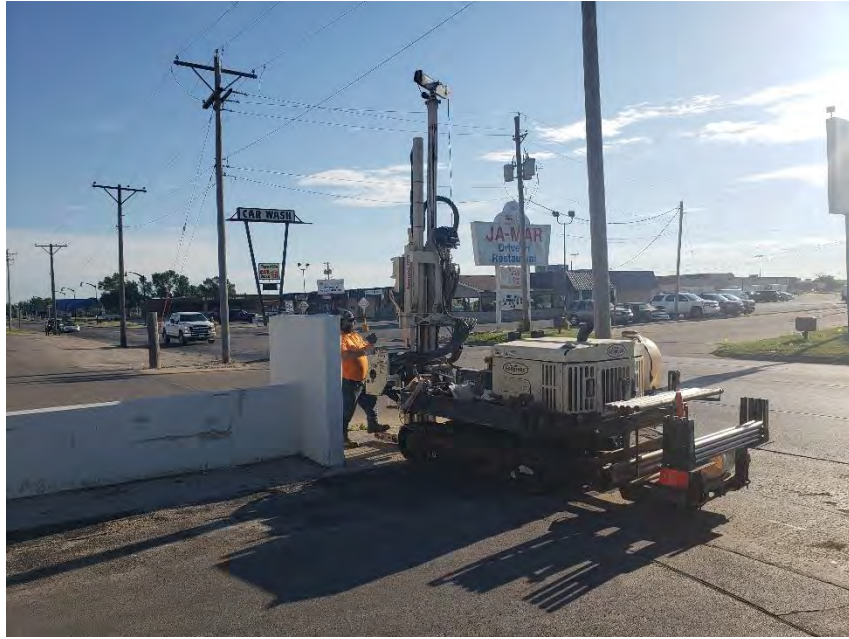
TETRA TECH PROJECT NO. X9030..19F.0086.008 DIRECTION: Northeast	DESCRIPTION	This photograph shows TW-12 location at S. 25 th Street easement at alley and bank's automated teller machine (ATM) drive-through.	39
	CLIENT	Environmental Protection Agency - Region 7	DATE 6/11/2021
	PHOTOGRAPHER	Tim Barbeau

Figures 12 and 13 are PCE and TCE isoconcentration maps for groundwater based on concentrations detected since 2008. Vinyl chloride was detected only in groundwater samples from TW-11 and -12 at the distal end of the groundwater plume, south and north, respectively, of the bank's east entrance.

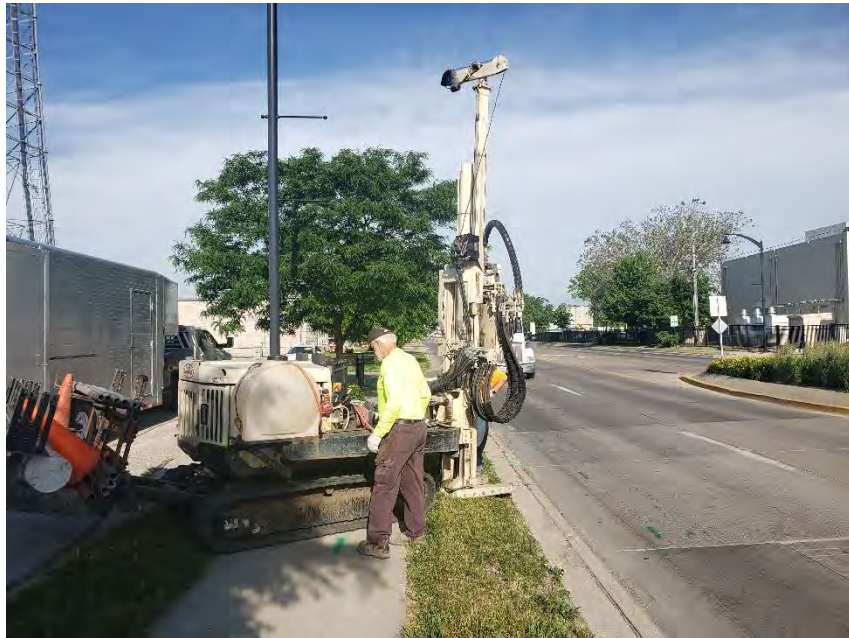
TETRA TECH PROJECT NO. X9030.19F.0086.008 DIRECTION: West	DESCRIPTION	This photograph shows TW-14 location across 5 th Avenue South from Sunshine Laundry property.	40
	CLIENT	Environmental Protection Agency - Region 7	DATE 6/11/2021
	PHOTOGRAPHER	Tim Barbeau
