Buckeye Terminals, LLC

Buckeye Council Bluffs Terminal
829 Tank Farm Road, Council Bluffs, Iowa

Project Overview, Objectives, and Future Opportunities

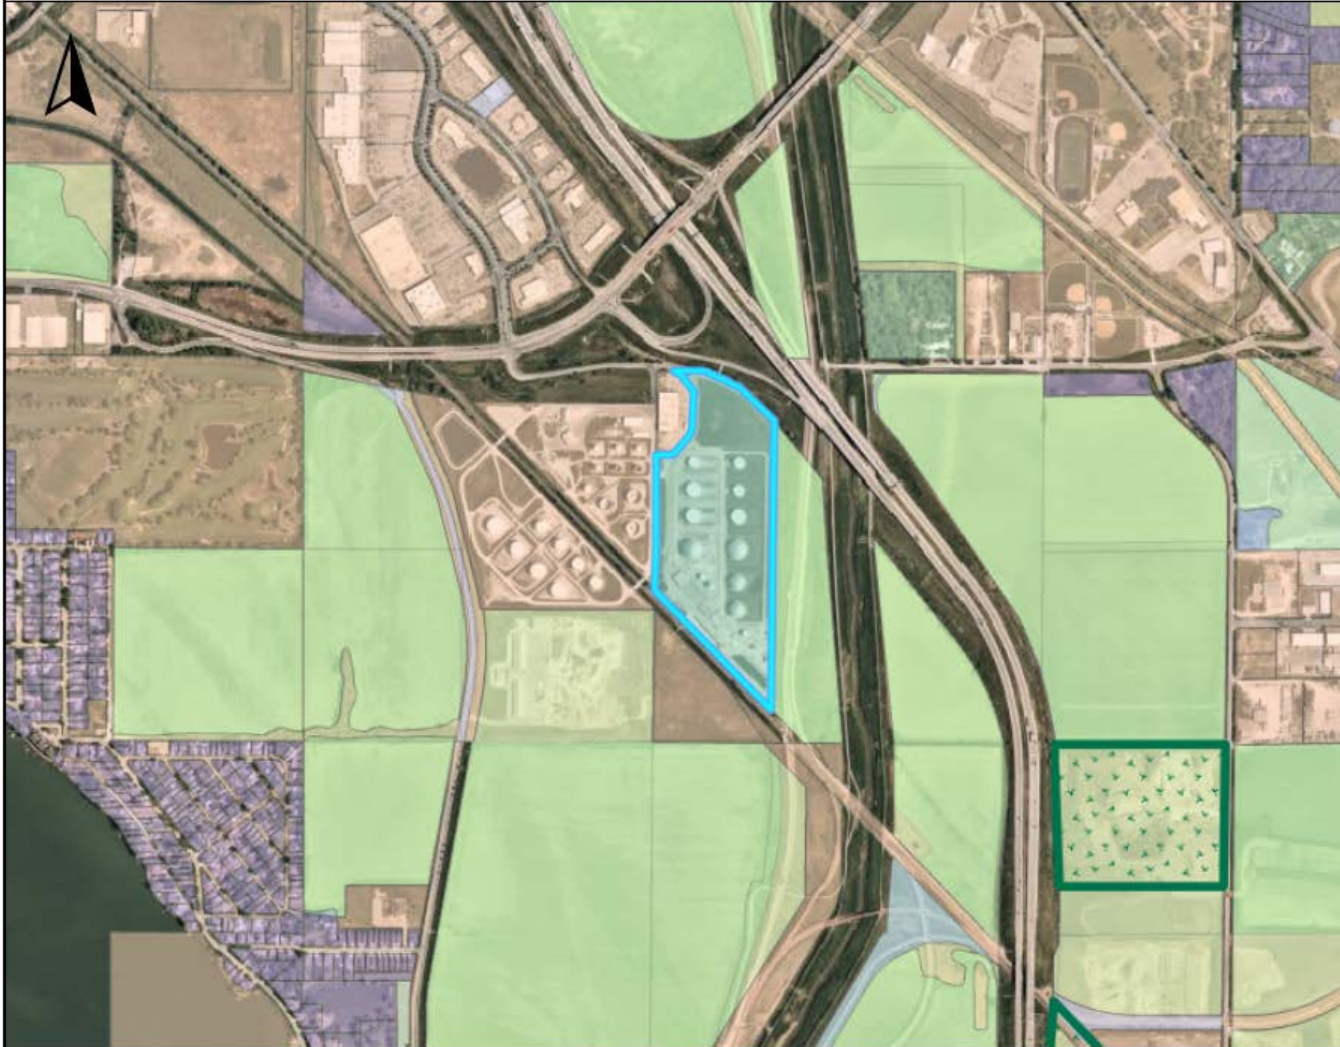
Surrounding properties

- LNAPL measurements limited to ~6 wells near the loading rack, most of the wells have limited LNAPL measured in hundredths.
- Adjacent properties also consist of petroleum terminals, highway, light agriculture, and commercial. No change in anticipated future uses.

Source: Pottawattamie County Assessor GIS Viewer

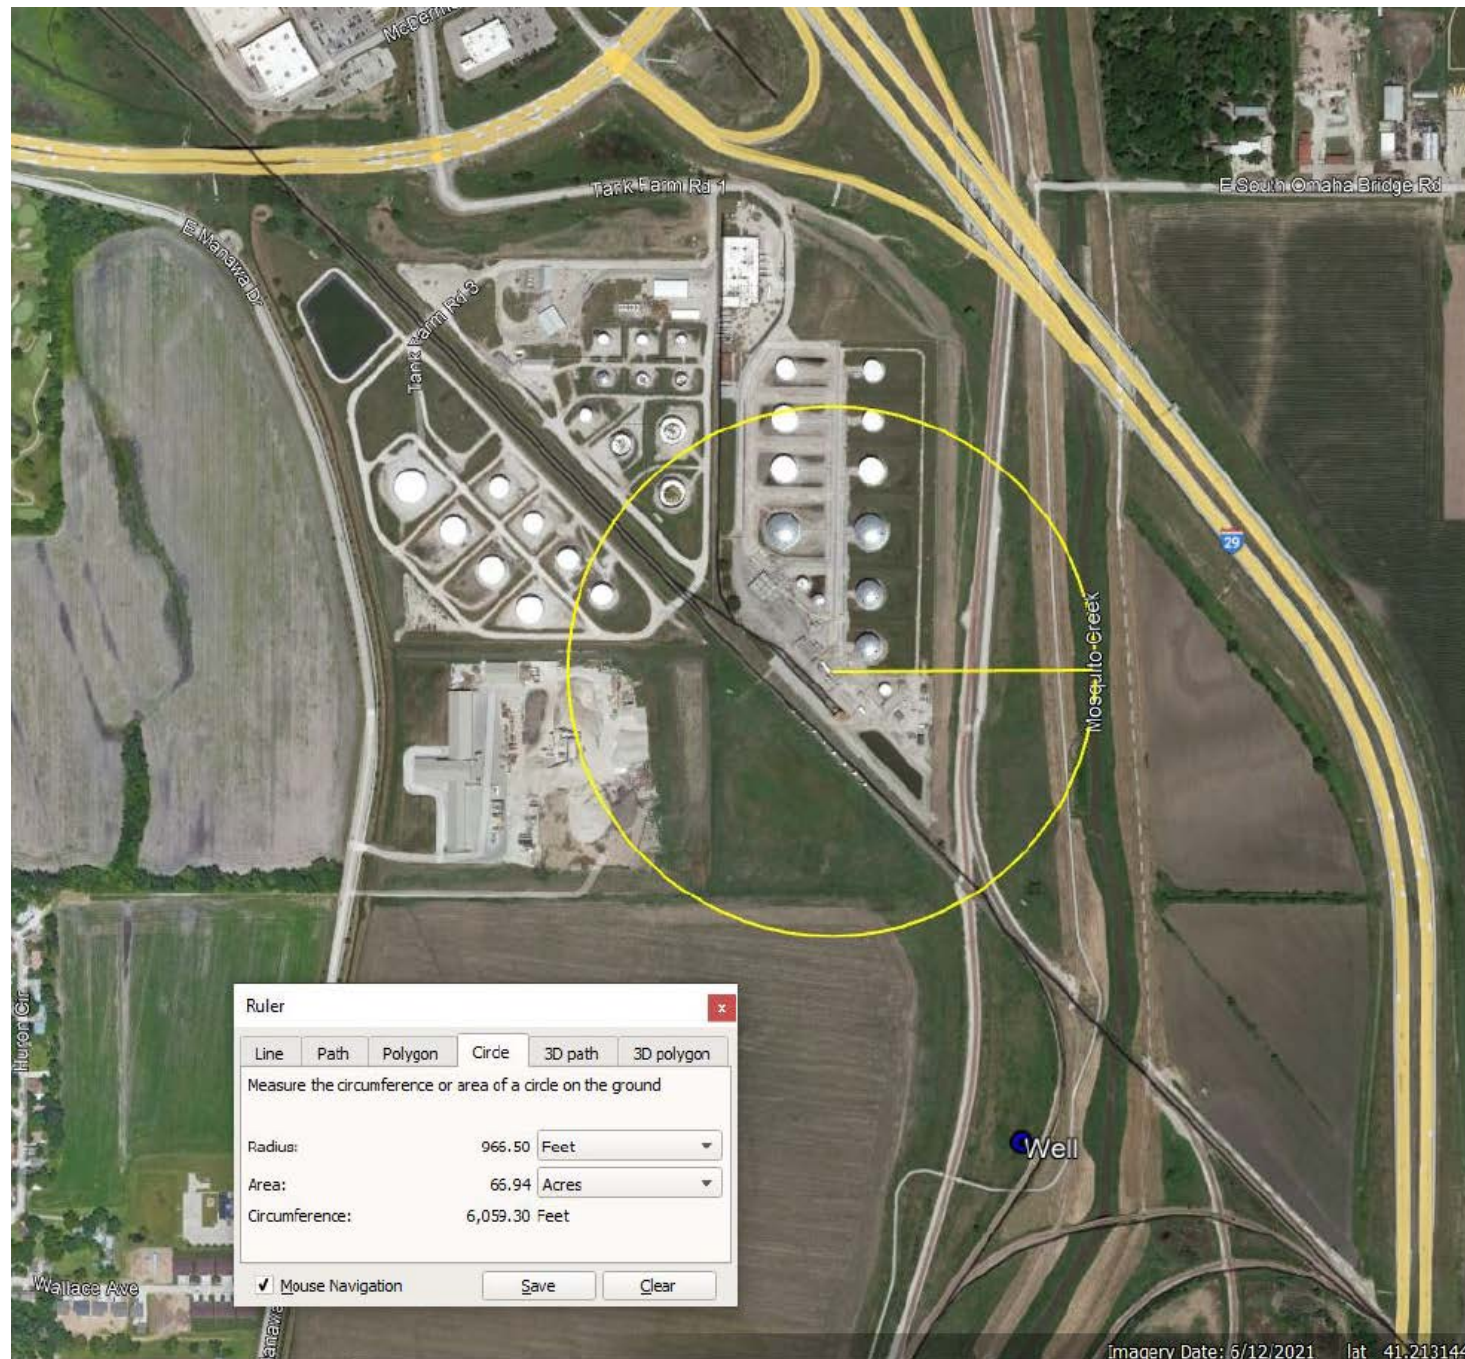
Nearest
surface water:

Mosquito Creek
