SUBJECT: Animal Feeding Operation (AFO) Compliance Inspection for – Borderline Buildings SW Site,
County – Mitchell, – Facility #63657

IOWA DEPARTMENT OF NATURAL RESOURCES AFO INSPECTION REPORT

FACILITY LOCATION	Facility: Borderline Buildings SW Site			Facility ID#: 63657	
	Address: 3327 500th St.		City: Riceville	State: IA	Zip: 50466
	PLSS: Section 12, Wayne Township (T100N, R15W), Mitchell County				
OWNER	Name: Borderline Buildings LLC				
	Address: NA		City: NA	State: NA	Zip: NA
ANIMAL HOUSING TYPE	<input checked="" type="checkbox"/> Confinement <input type="checkbox"/> Open Lot <input type="checkbox"/> Combined (Confinement & Open Lot)				
ANIMAL INFORMATION	Animal Type(s)	Capacity	Current Head	Number of Bldgs./Pens	
	Swine	2400	2400	1	
	Date of Construction: 5/1/05		Date of Expansion: NA

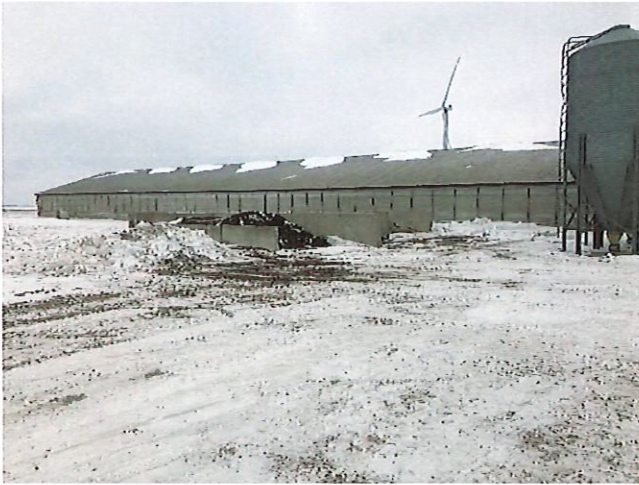
Mortalities are placed in a compost structure. During the inspection, I observed the facility's animal composting area is in a proper location and is well-maintained. No animal parts were visible. The composting area appears to have adequate cover of co-compost (such as wood chips, sawdust or corn stalk bales). I did not observe runoff or ponding of water in this area.

Photo 1—Compost bins

Livestock mortalities must be incorporated into the composting process as quickly as possible. The co-compost must be maintained with an adequate base layer (from 12 to 24 inches thick, depending on the size and number of mortalities), with 6 to 12 inches between carcasses, and a minimum of 12 inches to cover carcasses. Cover should be maintained to control runoff and to prevent access by scavenging animals.

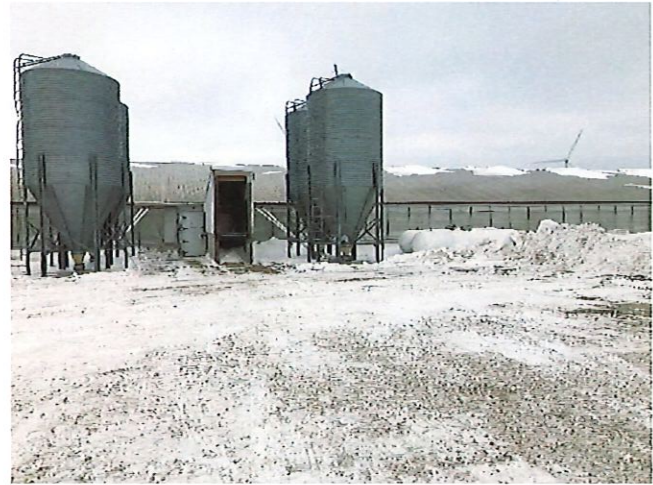
During my inspection, I observed feed is contained in a bulk bin feed system. The bins, feed tubes and various attachments appear to be intact and effectively containing feed. I did not observe feed spilled on the ground from feed transfer to the bins. Inspect this part of the operation frequently, as runoff water could carry spilled feed into a water course where it could create violations of state water quality standards. Discharge of such pollutants would potentially require a National Pollutant Discharge Elimination System (NPDES) permit.

Photo 2—Front of barn, bulk bins

1. Regularly inspect the manure storage structure and make needed repairs.
2. Regularly inspect the bulk feed bins and clean up any spilled feed.
