MEMO

**RE:** Chamness Technology land application/Palestine creek discoloration complaint investigation  
FOCD Complaint No. 30274

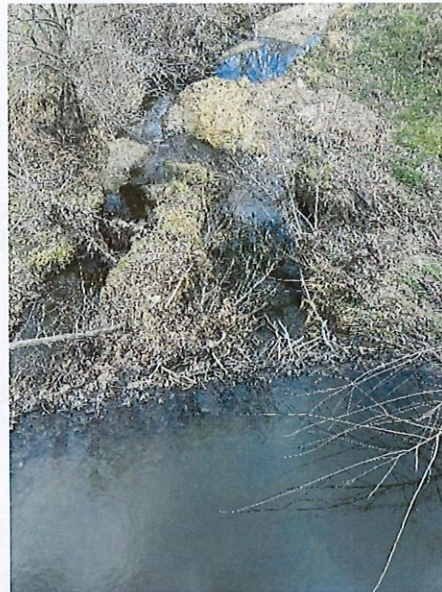
(This picture was taken on the morning of December 6, 2021. The location is at the Palestine Creek bridge crossing a few miles East of Chamness.

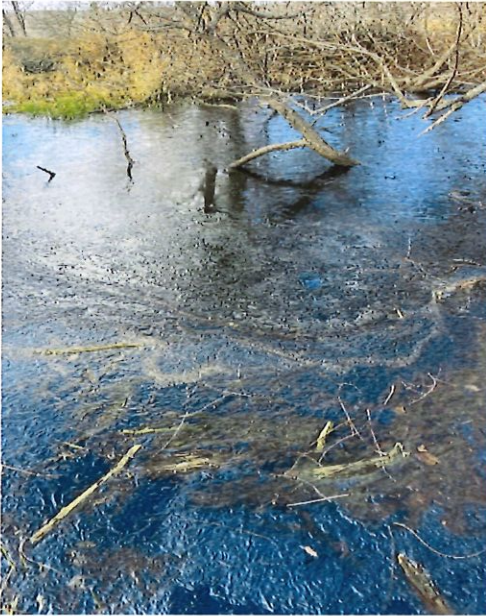
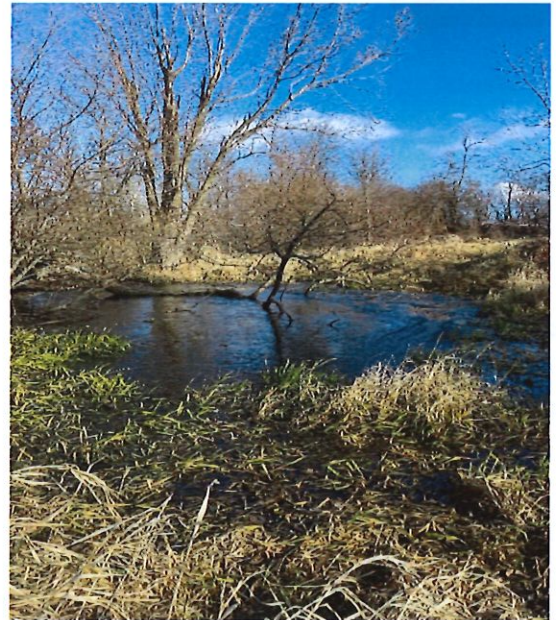
These two photos show the marsh located in the field to the South of Chamness where land application of leachate is occurring. The water quality of the marsh appears to be impacted.

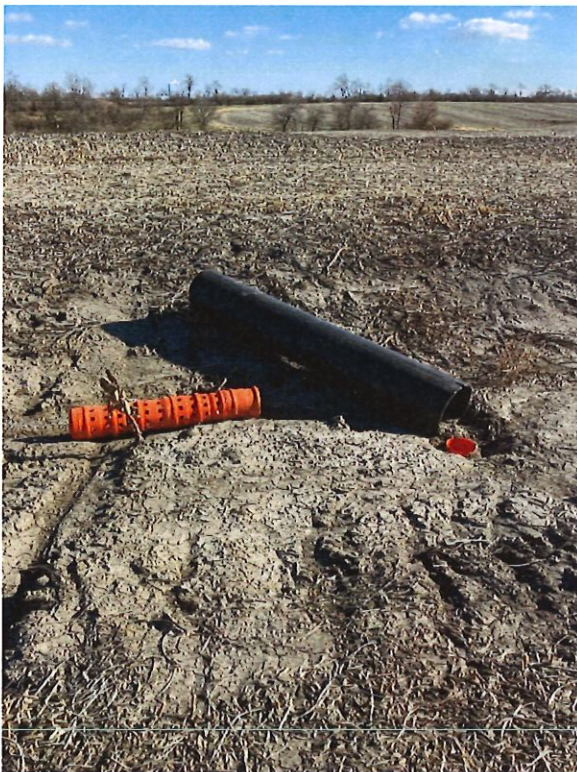
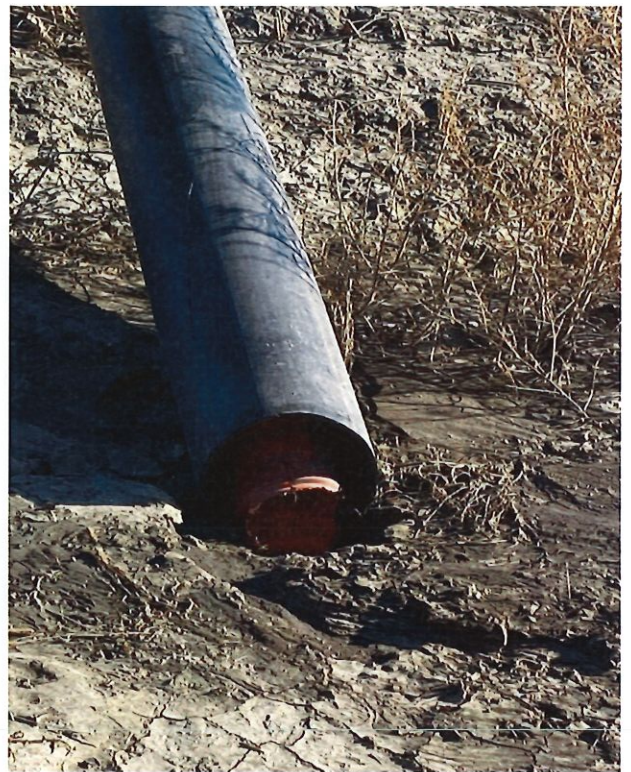
The two above photos show the broken off tile risers found in the field where land application of leachate occurs. Several others in similar stages of disrepair can be found in the same field.

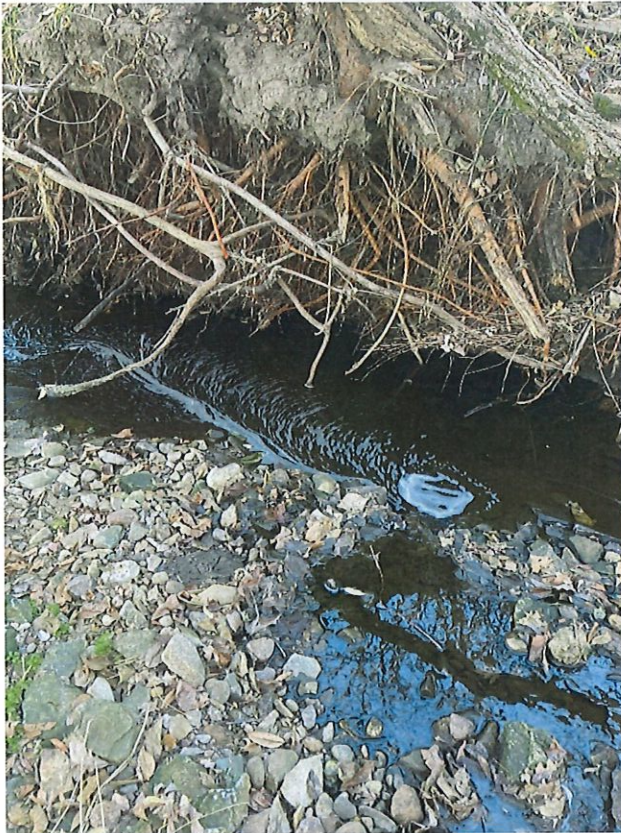
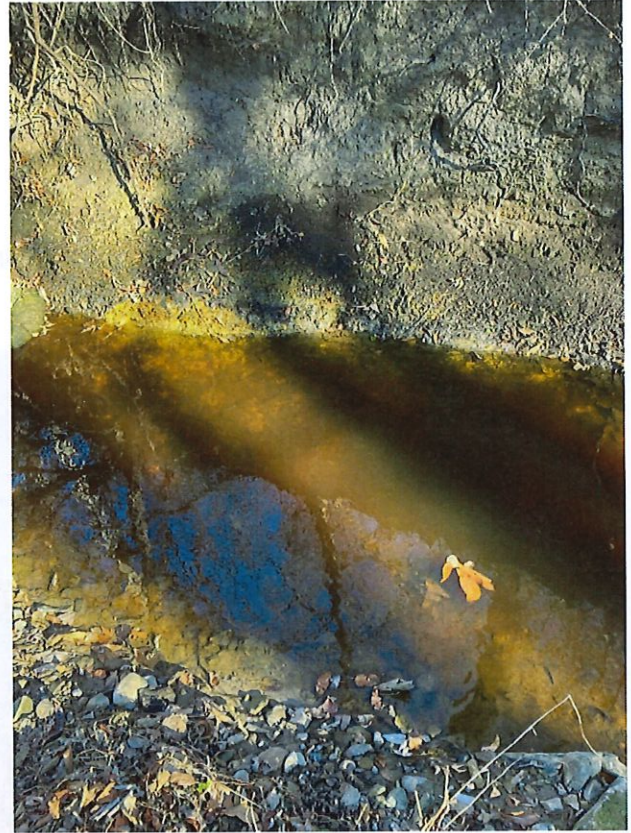
The above photos show the discolored water to the East of Chamness where water samples were collected from Palestine Creek. This location is also East of land application of leachate.

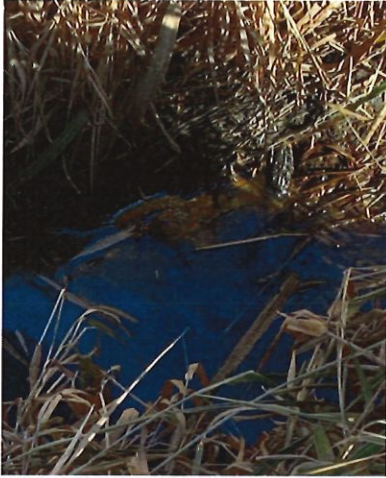
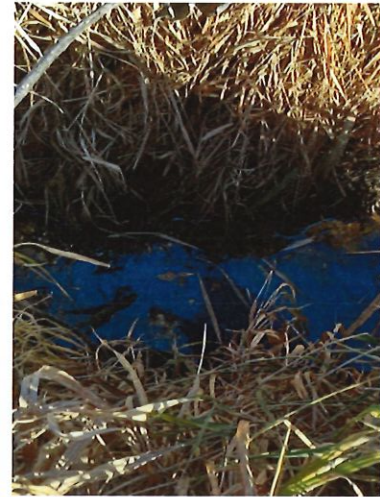
The above pictures show the start of the drainage ditch that turns into a tributary of Palestine Creek.

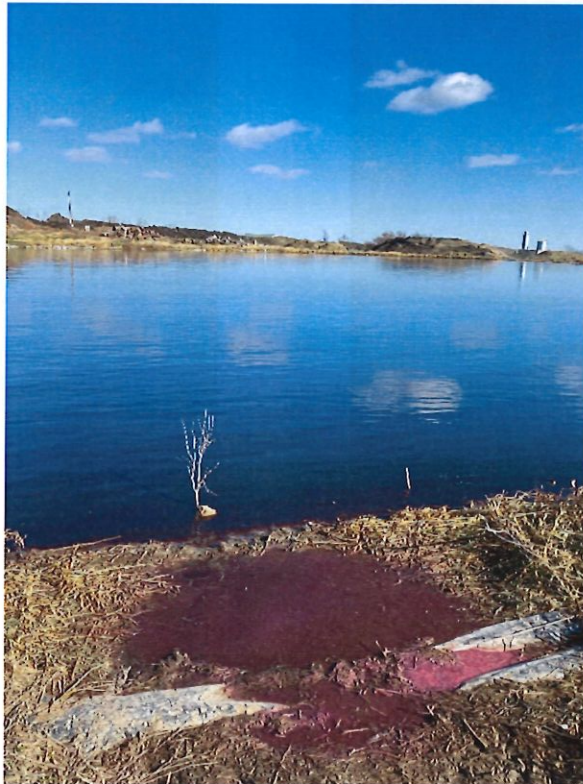
The above photo shows the middle lagoon that is starting to overflow. Two feet of freeboard is also not being practiced.
