**IOWA DEPARTMENT OF NATURAL RESOURCES
FIELD SERVICES AND COMPLIANCE BUREAU
FIELD OFFICE #2 - MASON CITY IOWA**

DATE: February 6, 2025
TO: The Record
FROM: Dan Bratrud
SUBJECT: **Daybreak Foods Complaint #34575 Memo**
3159 Buchanan Ave, Eagle Grove, Sec. 20, Troy Twp, Wright County

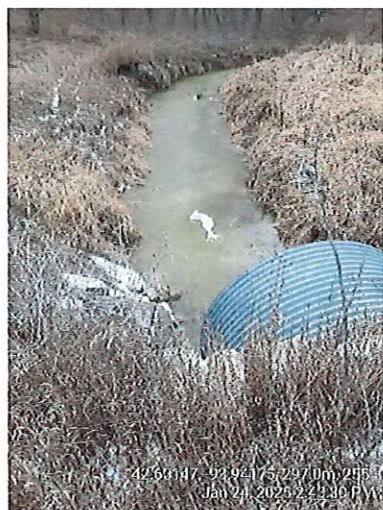
Ditch #49 west of 310th & Buchanan Ave.

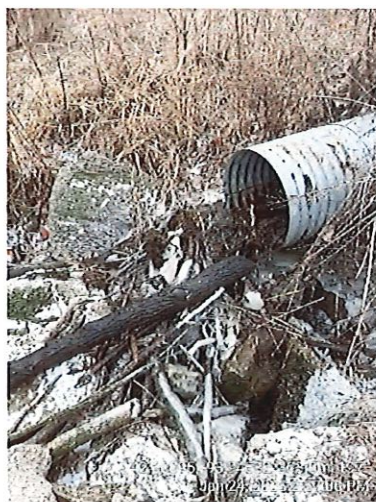
We went to Ditch #49 and met Nick Wilson, Daybreak maintenance. We traced the color back to the storm water (STW) pond outlet. There was a large ball of vegetation that the STW discharge was flowing through so I thought it was maybe tannins. There also was one of the stoplogs that had washed through the STW outlet pipe and laid on the rocks below the outfall.

STW pond outfall with vegetation ball.

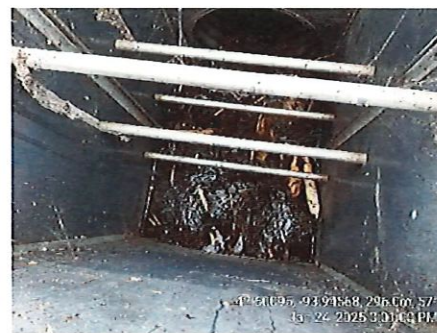
We went to STW pond side of the pipe where I observed several of the stoplogs laying in the grass next to the control structure. We took the cover off from the control structure for the pond and I could see that none of the stoplogs were in place which allowed this to be a free-flowing system. I asked if any of the gentlemen had any idea why the stoplogs had been removed or who would have removed them. None of them knew why or when they had been removed. There was a large number of branches, cornstalks and other vegetation in the pipe, apparently from beavers trying to plug the pipe.

Branches and cornstalks in the control structure.

I stressed the importance of keeping the stoplogs in place and not discharging any of the STW pond water without first sampling for contaminants. We discussed what else could be done to avoid any further discharge. Mr. Hinshaw said that they would plan to rent a pump and pump the pond water to the wastewater lagoon to lower the STW pond level at least 12" – 18" below the outlet pipe. That would hopefully allow enough time for them to figure out a long-term solution. I told the Daybreak staff the discharge was a violation and that an NOV would be issued. I also mentioned that further enforcement was likely and that referral for monetary penalty was being considered.

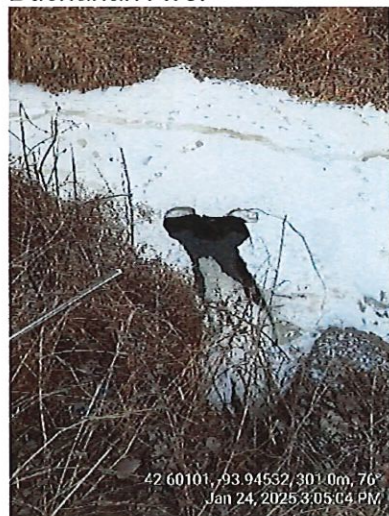
Sample site in Ditch #49 below STW pond outfall.

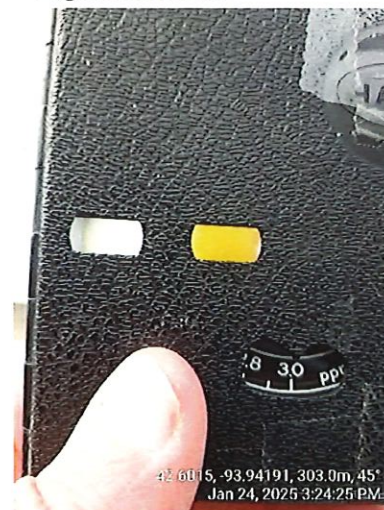
I collected a sample from Ditch #49 just below the STW water pond outfall, the water flowing into the pipe on the pond side, and from Ditch #49 near the Buchanan/310th Street intersection. All three samples tested >3 ppm for ammonia with the HACH field kit. Laboratory samples were collected at all three sites. The laboratory analysis results were received on February 4, 2025, and are listed in the following table.

HACH field sample from Ditch #49 below the outfall.

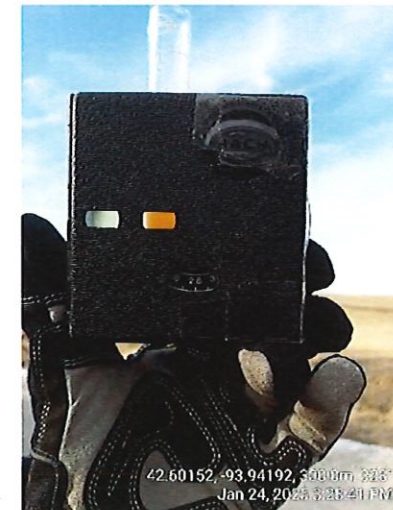
Location	Ammonia	COD
Daybreak STW outlet	16 mg/L	75 mg/L
Daybreak STW pond	16 mg/L	72 mg/L
Daybreak 310 St & Buchanan Ave	20 mg/L	75 mg/L

HACH sample from Ditch #49 At 310th St & Buchanan Ave.

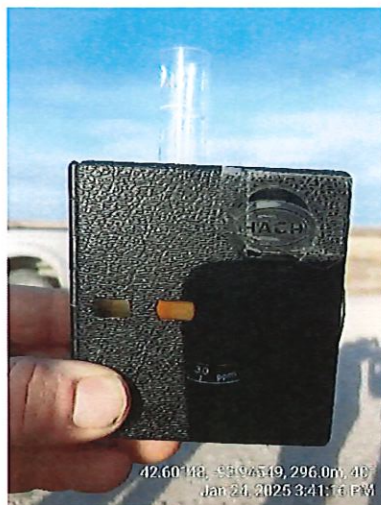
HACH sample from STW pond.

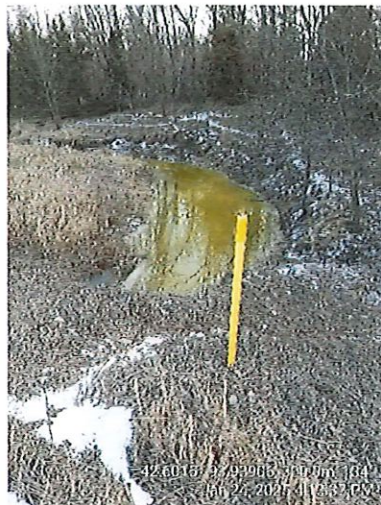
Green color in Ditch #49 approximately 700 feet east of 310th & Buchanan.

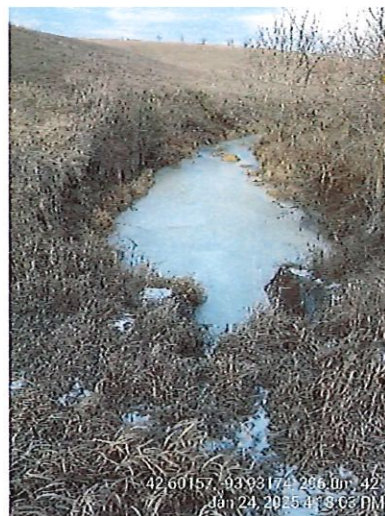
Ditch #49 approximately one half mile east of 310th & Buchanan.

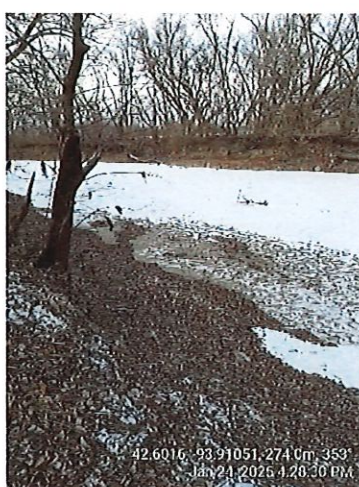
Boone River approximately one mile east of the confluence with Ditch #49.

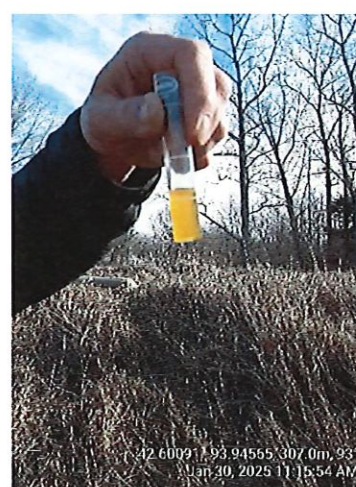
We proceeded to the STW pond outlet where I observed the outfall pipe. The flow from the pond had been stopped to the point that there was barely a trickle coming from the pipe. We walked to the pond side of the outlet and looked into the control structure. The stoplogs were in place and the only flow in the structure was some minor leakage through the stoplogs. We discussed a couple options for sealing the cracks in the stoplogs to stop the leaks. We collected a field sample from the STW pond near the outlet pipe. The HACH field kit showed that the ammonia level was still >3 ppm ammonia.

HACH sample of STW pond still >3 mg/L ammonia taken on 1/30/2025.

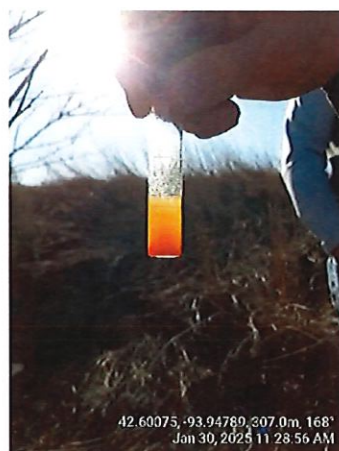
We drove around to the inlet pipe and observed a very small dribble coming from the pipe. I was able to catch enough of the water in one of the HACH field kit vials to do a test for ammonia. The sample immediately precipitated in the vial and turned a bright red/orange color indicating a high ammonia content. I showed the result to the Daybreak staff and told them that I believe we found our answer to the high ammonia content in STW pond.

HACH sample of STW pond inlet taken 1/30/25

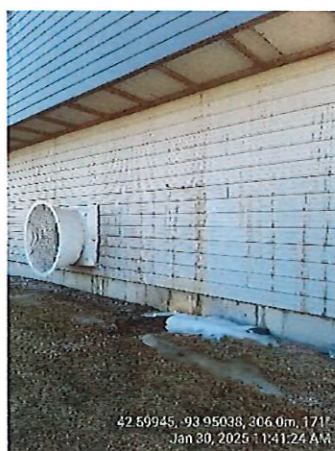
I asked if I could get a look at how the waterline flush water was being discharged from the buildings. Mr. Wilson offered to drive me along the west side of the production buildings and show me the system. We drove to the first of 20 production buildings on the west side of the Daybreak Compound. We stopped at the furthest north building and Mr. Wilson pointed out the discharge pipe coming out of the wall at approximately eight feet off the ground.

Mr. Wilson said the waterlines need to be flushed on a regular basis to keep the lines from air locking and stopping the flow of water to the chickens. He explained that the water flows to ground to an area of rock and then just soaks into the ground and/or flows into the tile surface intakes located between the buildings. That is the water that is discharging to the STW pond. All 20 production buildings have the pipe that discharges the flush water.

Waterline flush pipe through the wall on the north building.

We briefly discussed some possible options for changing the way they manage the flush water. I asked Mr. Wilson if he would try to catch a laboratory sample from the inlet pipe to the STW pond. He agreed to collect a sample so I left two bottles for ammonia laboratory samples with him. I told him that I would follow up again to see if they had pumped the pond down and whether or not he had been able to collect a sample.

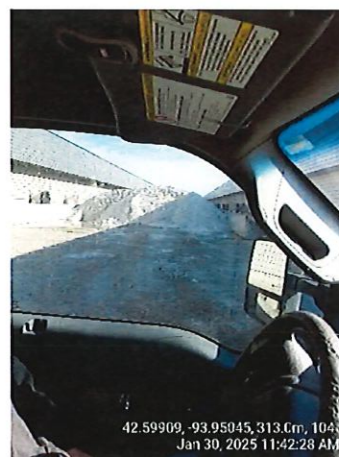
As we drove along the west side of the buildings I observed two piles of processed egg shells stockpiled on concrete slabs. Mr. Wilson explained that the egg shells are piled there during the winter months and during the crop growing season but are land applied in the spring and fall. He also said that when the litter is cleaned out of the barns it is loaded into the trucks along that driveway on the west side of the buildings. I commented that there are quite a number of things going on there that could cause ammonia-laden water to enter the tile surface intakes; however, the waterline flush water is likely the main source.

Egg shell pile between buildings taken 1/30/2025.
