SUBJECT: City of Coin WWTF Industrial Treatment Agreement – 1  
Routine Inspection of Industrial Pretreatment Facility  
NPDES # 7335001-IC1, Staff Action # 180239

**IOWA DEPARTMENT OF NATURAL RESOURCES  
INDUSTRIAL USER INSPECTION**

**FACILITY NPDES # 7335001-IC1**

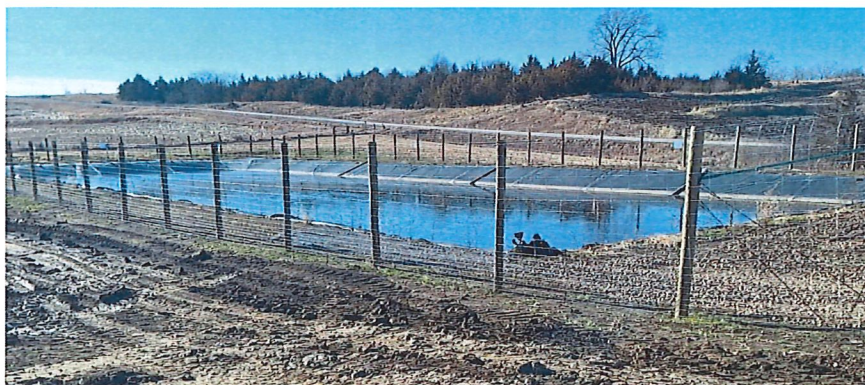
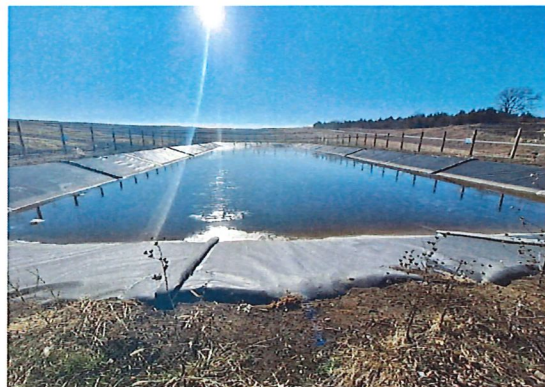
Photos 1-2: New leachate lagoon cell

The Page County Landfill leachate lagoon is secured within the confines of the landfill property and includes a fence and locked gate. A single lagoon receives leachate from all landfill cells. According to Mr. Ward, the cell can hold 770,631 gallons of leachate. The lagoon is synthetically lined and will have an EcoMister Evaporator added in the Spring 2025 that will aid in reducing the leachate that will need to be hauled in the future. During the inspection the lagoon appeared to have enough freeboard. Freeboard is measured from the maximum liquid level to the top elevation of the lagoon berm/wall. Continue to ensure that a minimum of 2 feet of freeboard is maintained in the lagoon to prevent overflow and bypass events.

As we discussed, keeping trees or woody vegetation out of the lagoon area is required. If trees and woody vegetation are allowed to grow, their roots may damage the lagoon's liner and the integrity of the lagoon. Additionally, although the lagoon is synthetically lined, any burrowing animals should be eliminated. The photos below document our observations.

- Fill burrows as they are encountered around the lagoon.
- Continue inspecting the abandoned lagoon.
- Report all bypasses within 24 hours
- Comply with all monitoring and reporting requirements specified in your NPDES operation permit. [ 567-63.9]

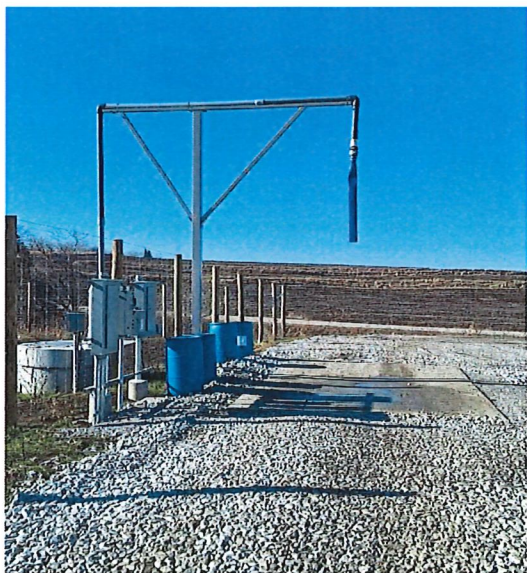
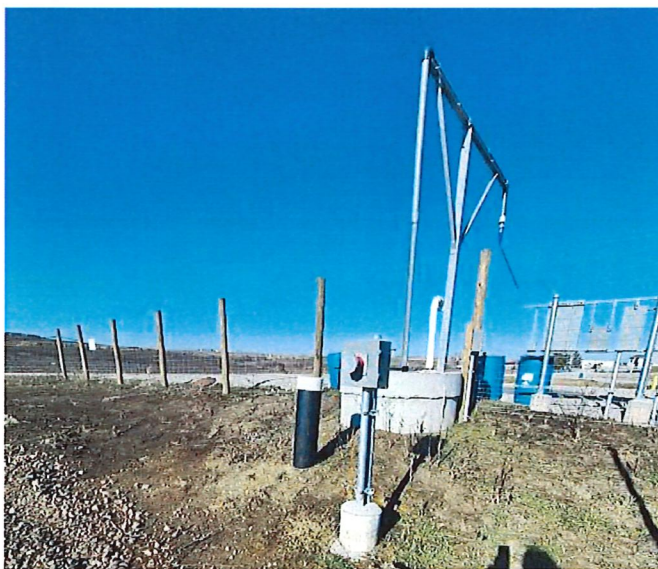
Photos 3-4: Leachate loadout area

According to Mr. Ward, typically the landfill hauls two loads of leachate weekly. Due to an increase in precipitation this year, Mr. Ward is hauling more leachate presently to lower the lagoon depth in preparation for the winter months.

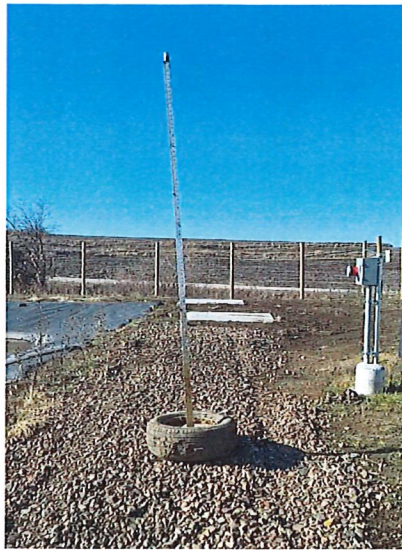
Photo 5: Cell depth measuring device

Mr. Ward stated the cell depth measuring device was pulled out for the winter, but will be placed in the lagoon again in the spring.

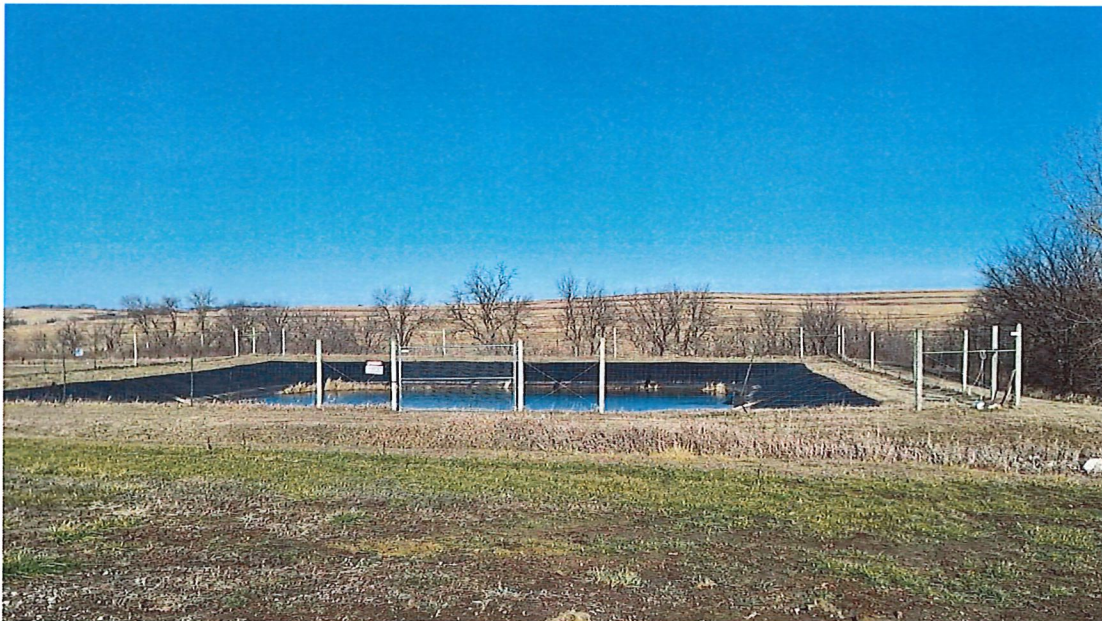
Photo 6: Old leachate lagoon

The Page County Landfill also maintains an old leachate lagoon. Although no leachate flows to this cell any longer, Mr. Ward was advised to maintain this cell in the event it is needed. We did not observe any issues with this lagoon cell. Although the lagoon is no longer used, continue to monitor and inspect it for signs of erosion, animals burrows, and trees. The photo below documents our visual observations.

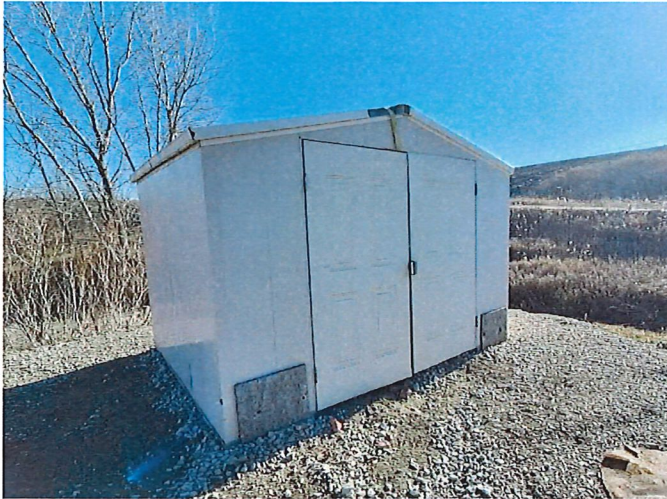
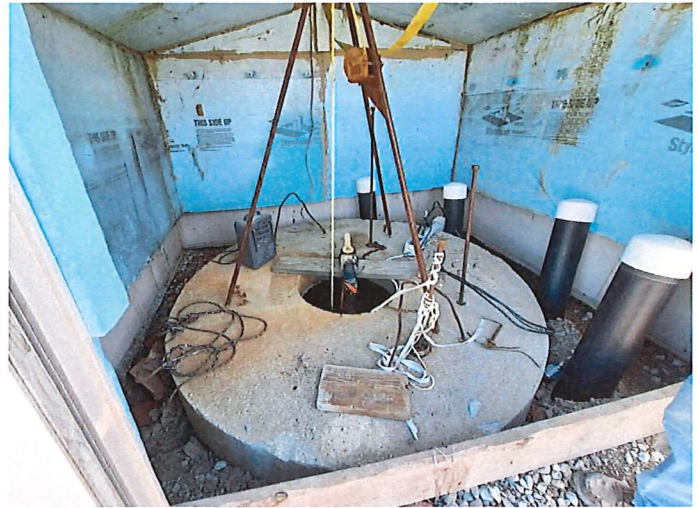
Photos 7-8: Wet well near old leachate lagoon

As discussed above, leachate from the older cells flows via gravity to a wet well where it is pumped to the top of the hill and then gravity flows to the newly constructed leachate pond. It is recommended that the pumps be calibrated per the manufacturer's recommendation to ensure they continue working properly. Observations of the wet well photos are below.

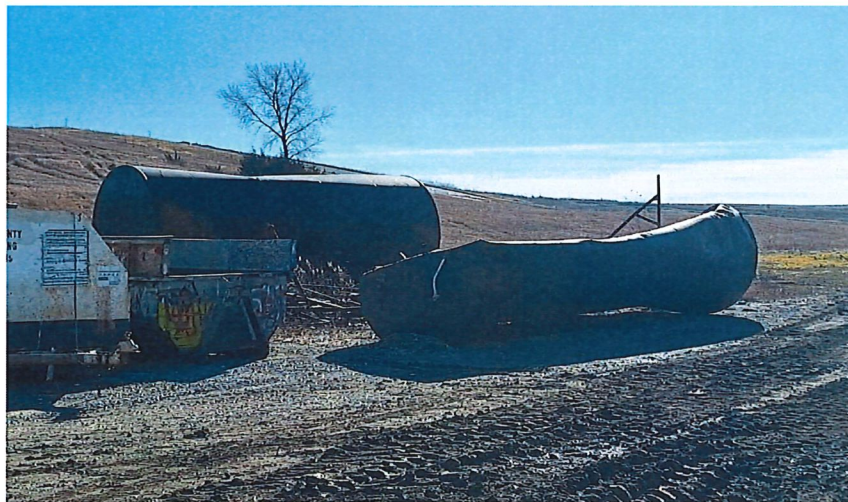
Photo 10: Old leachate holding tank

Mr. Ward believes many of these violations will not be an issue with the new leachate lagoon. He believes the holding tanks were the root cause – lack of daylight and air.

Additionally, Mr. Ward stated that he removed the old leachate holding tanks in September 2024.

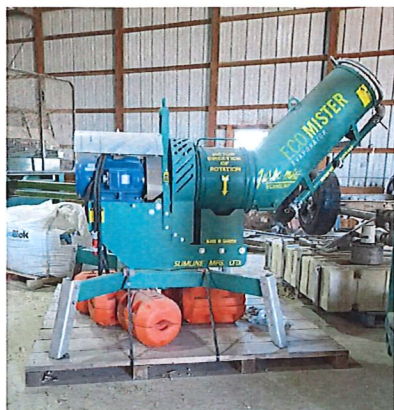
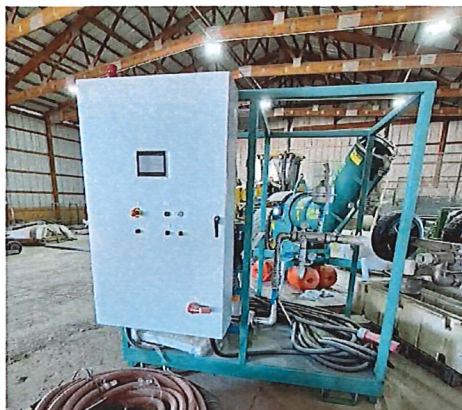
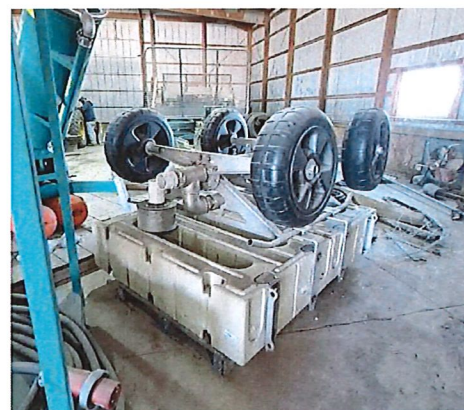
Photos 11-13: EcoMister

Mr. Ward would like to eventually get to a point where leachate does not need to be transported off site for disposal. As part of the upgrade, the Page County Landfill purchased an EcoMister evaporator that will be

installed in the Spring 2025. There are concrete pads located in the northwest and southwest corners of the lagoon to support the EcoMister. The photos below document the EcoMister.
