Subject: Loess Hills Regional Sanitary Landfill Inspection
Permit No. 65-SDP-01-72P, Mills County
Staff Action Nos. 160234 & 162295

REPORT OF INVESTIGATION

SUBJECT: Loess Hills Regional Sanitary Landfill Routine Inspection
Permit #65-SDP-01-72P

Iowa Department of Natural Resources
Sanitary Disposal Project
New Cell Inspection Checklist

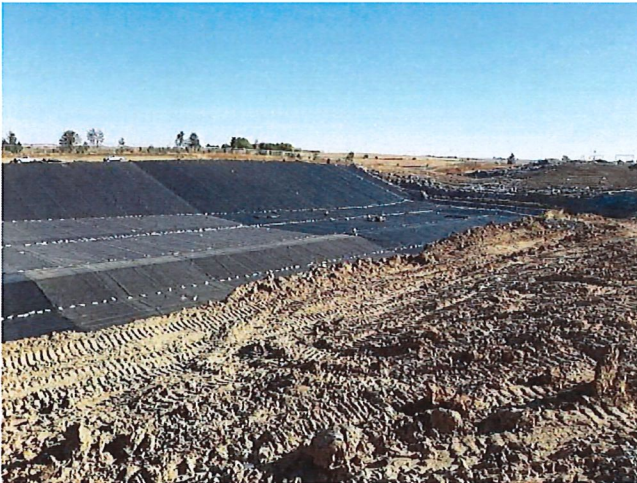
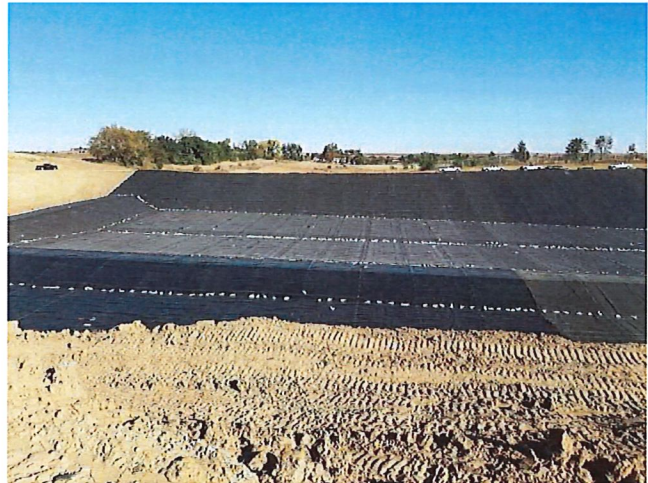
New Cell

- It was noted that a large portion of the west facing slopes had been graded and seeded this year. Due to ongoing drought conditions, the vegetation hasn't fully germinated. There were a few areas of rill erosion that should be addressed as needed.
- Mr. Mitchell stated that in the future, the facility will be closing the leachate lagoon and installing multiple leachate storage tanks. Mr. Franks also noted that the facility would be purchasing a second leachate tanker to ensure they were able to keep up with leachate hauling from the tanks. The facility also has an agreement with Council Bluffs Septic to haul leachate if needed as well.

- Continue to grade and seed intermediate cover as needed.
- The facility must abide by all requirements in the Operation Permit.
- The facility must abide by all requirements in the General Permit #1 (storm-water) including developing and maintaining a Storm Water Pollution Prevention Plan.

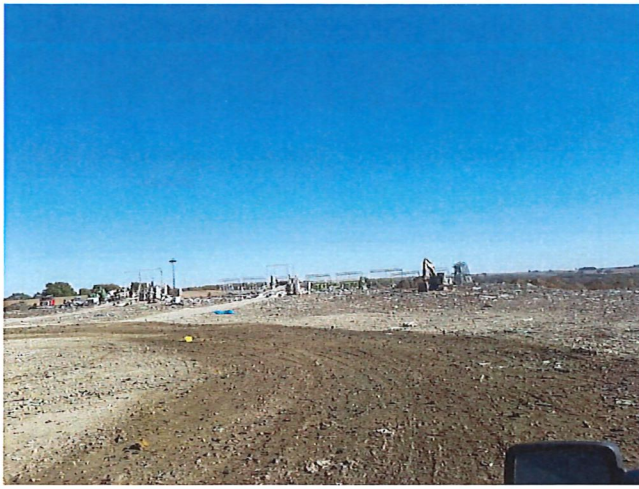
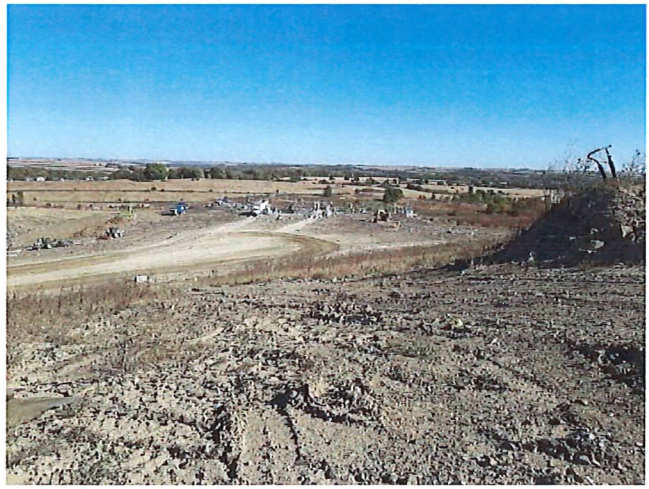
Tipplers w/ Bull Fencing

- During construction of the new cell, the facility is adding a stormwater retention basin along the west side of the landfill. Mr. Mitchell stated that they would be cleaning out the existing stormwater basin out in the near future.
- The facility continues to use fluff as alternative daily cover in addition to dirt. The facility will also be adding additional fencing around the landfill to help control litter from leaving the site. Landfill staff are also making routine visits to the residential area to the north to retrieve any windblown litter in addition to picking it up along Highway 34 as mentioned in previous inspection reports.
