RE: Metro Park West Landfill

**Boone and Green County Municipal Solid Waste Landfill Units**

Permit #08-SDP-03-84

2024 Spring Statistical Report - IDNR Comment Letter (Doc. 110789)

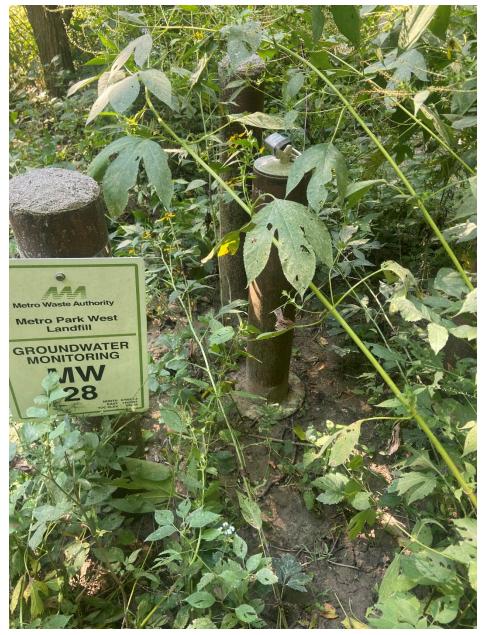
Figure 1: MW-28 observed facing South with understory vegetation surrounding the well. No visible signs of ongoing standing water in the area.

The combination of these factors—substantial rainfall and the well's location in a floodplain—resulted in the observed standing water. However, during a subsequent observation on September 11<sup>th</sup>, 2024, no signs of standing water or potential areas for water pooling were noticed at MW-28. Photos of the well taken during this observation are attached for your reference.

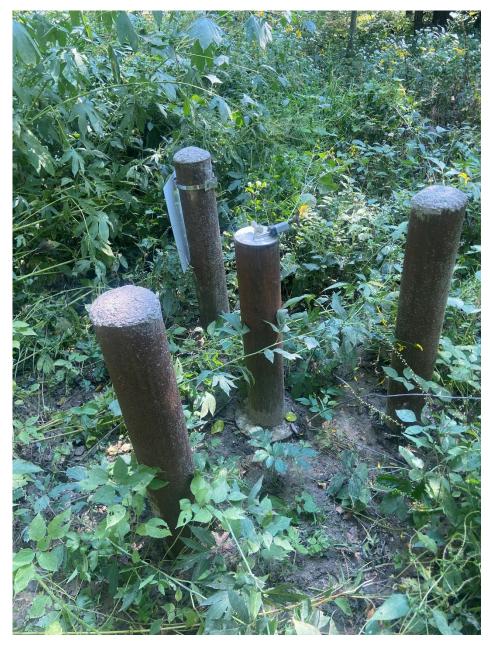
${\it Figure~2: MW-28 \ taken~looking~East.~No~observable~standing~water~or~obvious~areas~for~potential~pooling.}$
