Response to Comments
Operating Permit No. 07-SDP-12-89 Renewal Application
Viking Pump Foundry Sand Landfill, Cedar Falls, Iowa

Viking Pump Foundry Sand Landfill

VIKING PUMP FOUNDRY SAND LANDFILL CEDAR FALLS, IOWA DESIGN AND OPERATIONAL PLAN

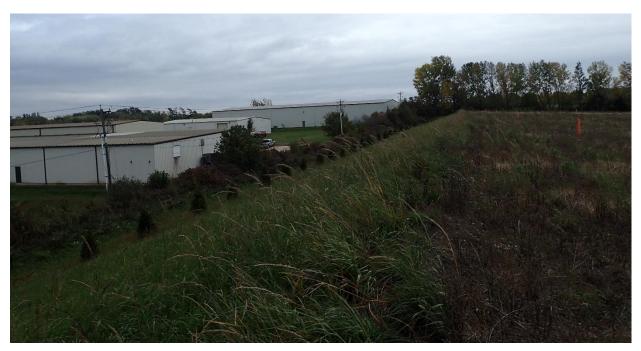
Photo 1 10/14/2016. North area and back side of landfill, looking northeast.

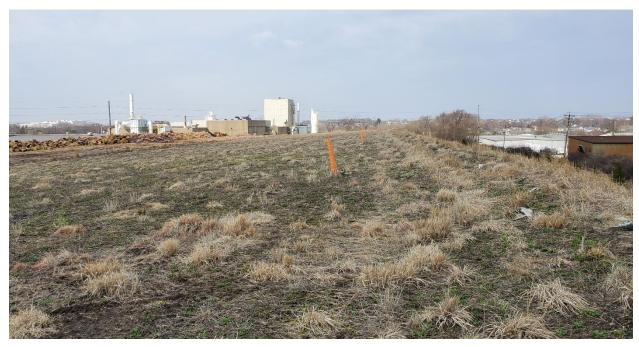
Photo 5 4/8/2020. North area of landfill, looking west.

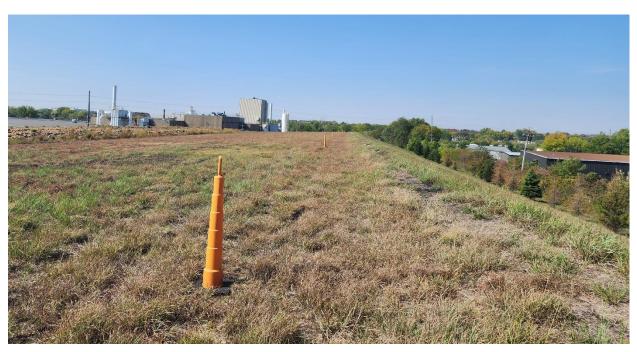
Photo 8 10/2/2023. North area of landfill, looking west.

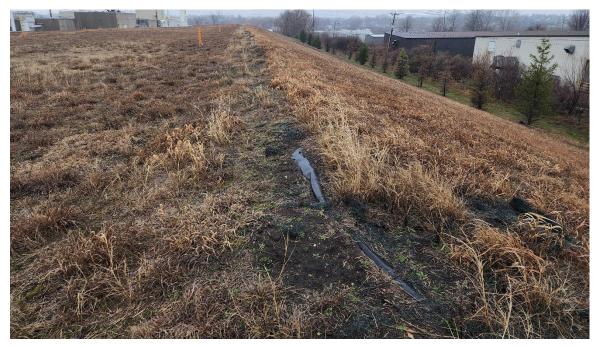
Photo 9 4/1/2024. North area of landfill, facing west, showing exposed membrane (not part of the cover).

- The qualified contractor will not drive on the foundry sand protective layer unless low ground pressure equipment is used or minimum of 3 ft of sand is placed. Currently the only area of the Landfill without a minimum of 3 ft of sand are portions of the north side of the Landfill.
