**RE: SEMI-ANNUAL INSPECTION – SPRING 2026
POWESHIEK COUNTY SLF
CLOSURE PERMIT NO. 79-SDP-1-73C
HLW P.N. 6011-25A.750**

SPRING 2026 INSPECTION

POWESHIEK COUNTY SANITARY LANDFILL
POWESHIEK COUNTY, IOWA

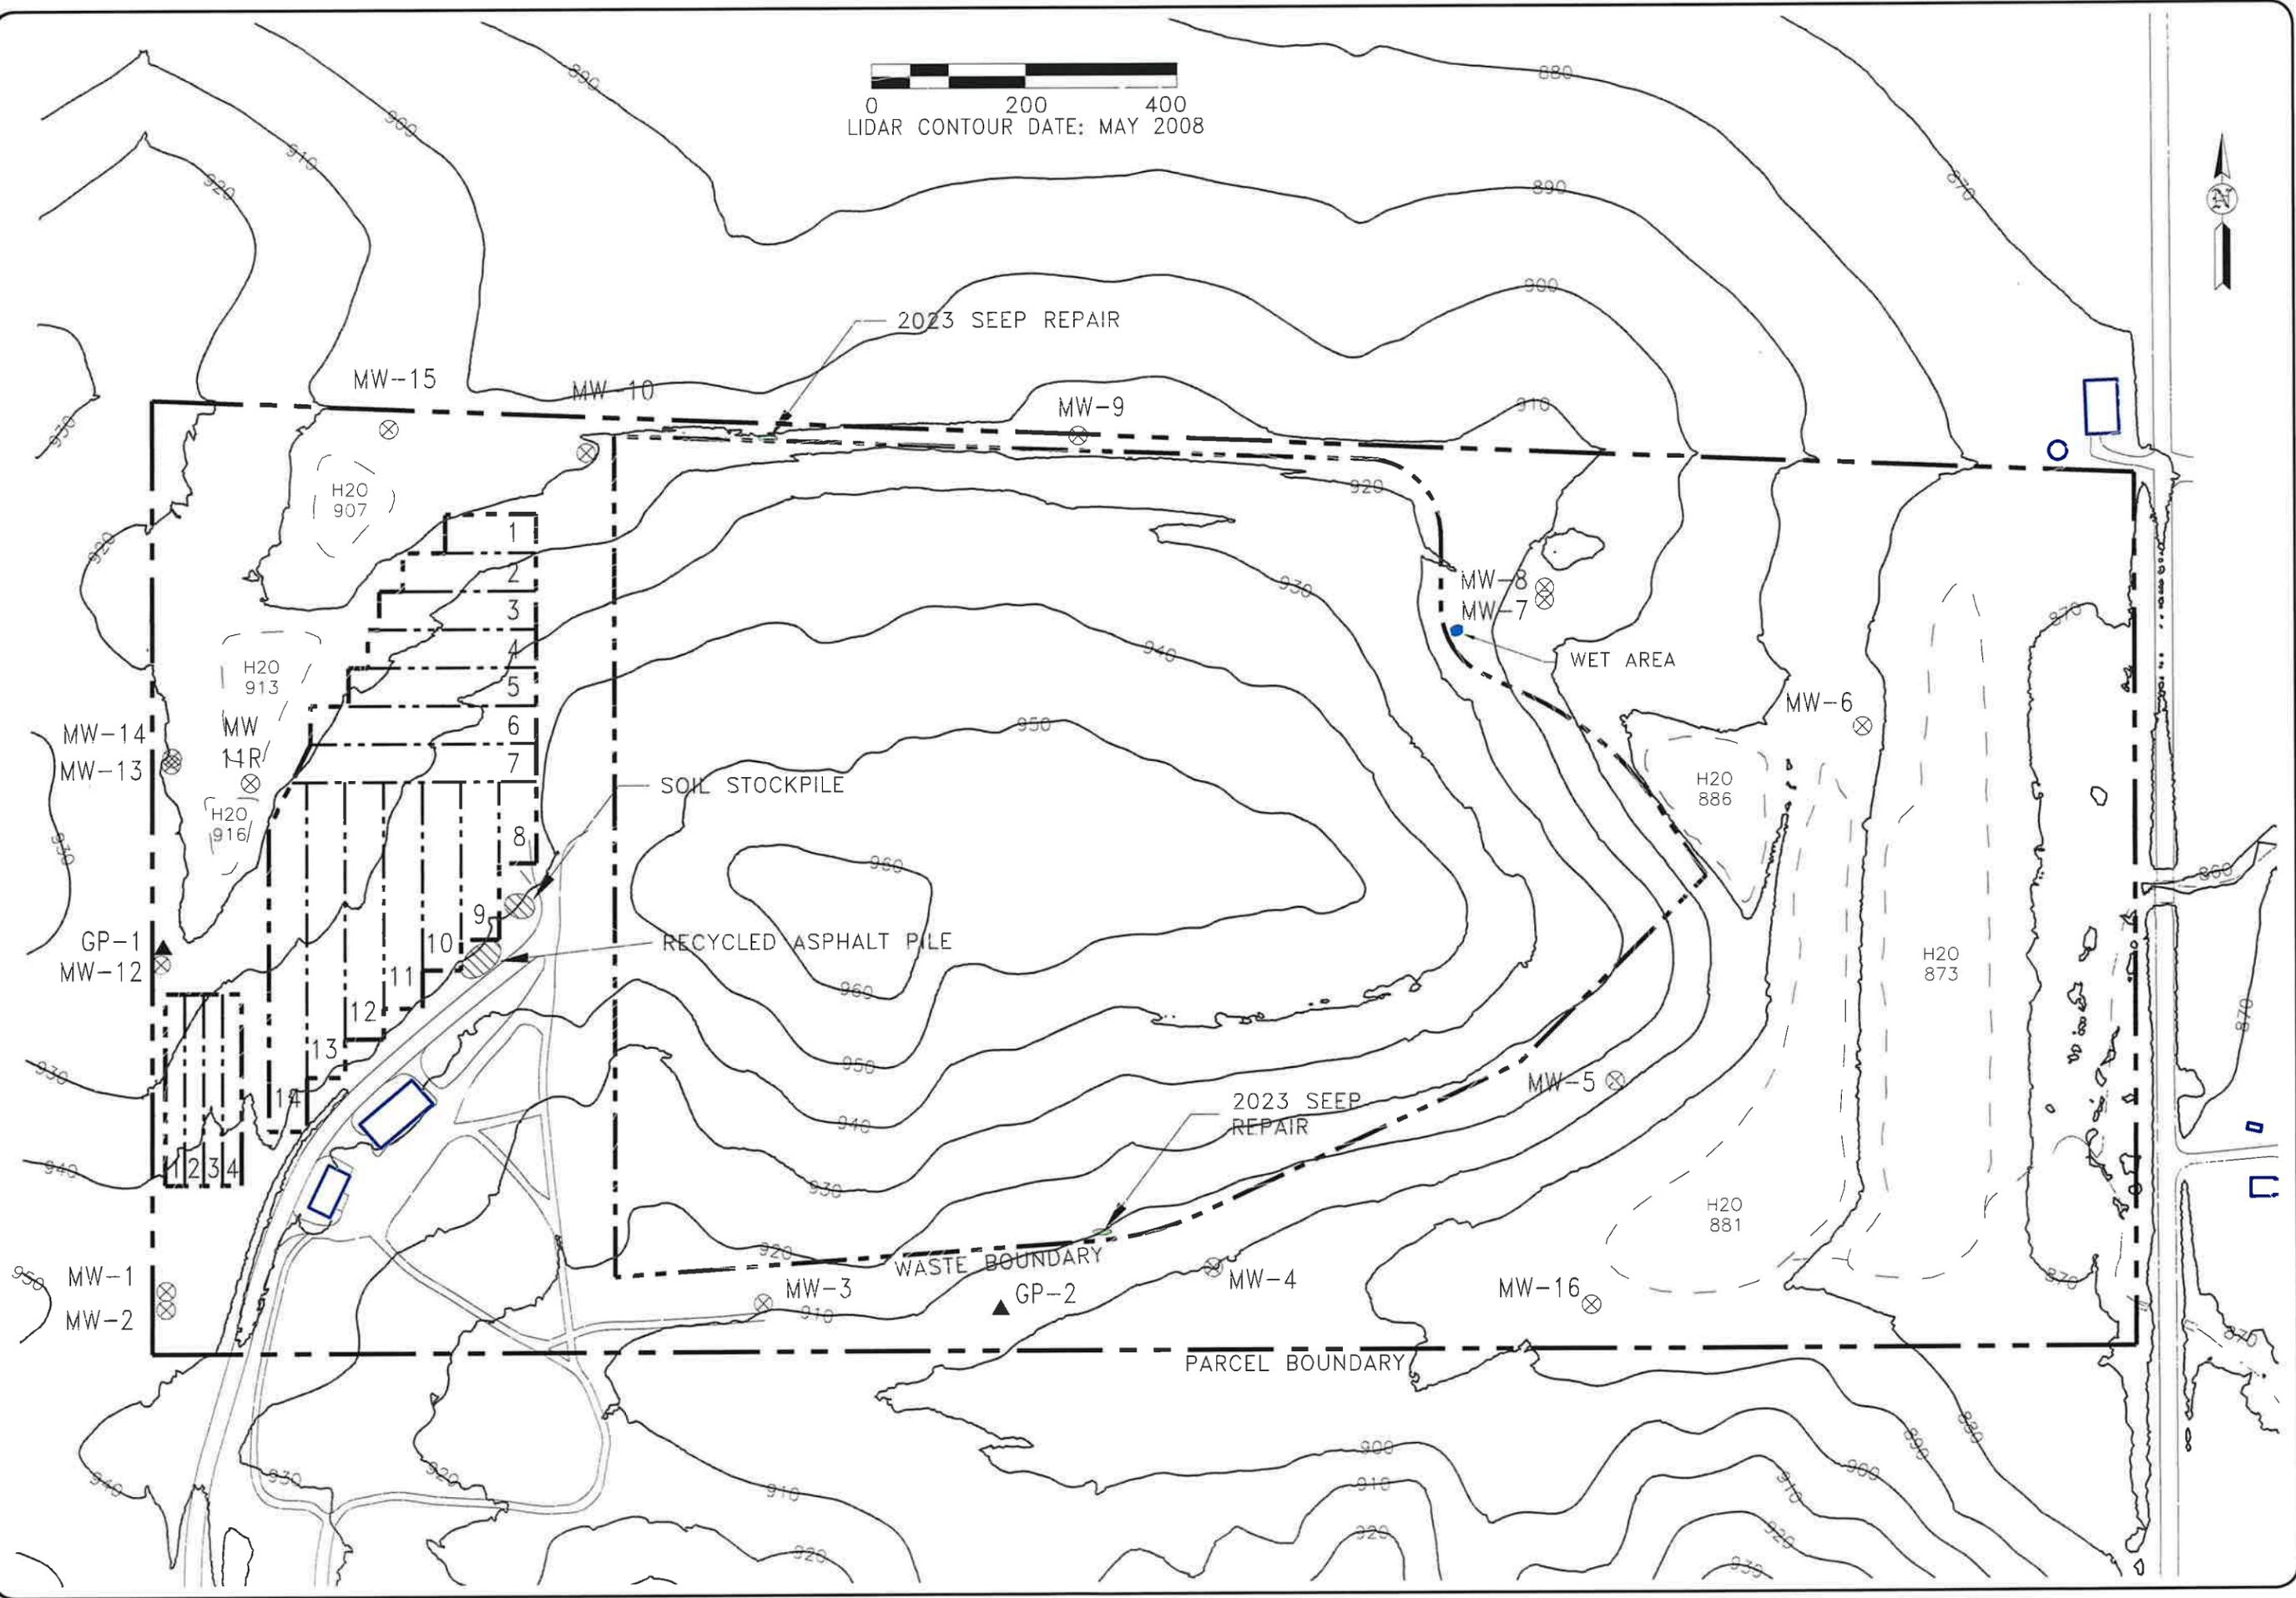
FIGURE: 1

County staff previously stockpiled soil at the end of the access road at the approximate location shown on Figure 1. The soil is available for use in future repairs at the landfill if necessary. As noted during past correspondence, a portion of the original stockpile was located on the landfill cap. Details on the management of the portion of the stockpile located over the landfill cap were included in the “Response Letter to IDNR Letter Dated July 20, 2015” (Doc #84777). This document was approved by IDNR in Permit Amendment #10 (January 20, 2016). The steps outlined in the work plan in Doc #84777 will be followed and the required documentation submitted to IDNR when the entire stockpile has been removed from the landfill cap area. Based on observations during this inspection, no material has been removed from the stockpile since the Fall 2025 inspection.

A temporary stockpile of recycled asphalt has been placed along the access road to the west of the soil stockpile. This stockpile appears to be outside of the waste boundary to the east but may infringe on the south side of Trenches 9-11. The majority of the stockpile has been removed, the approximate location of the remaining stockpile is shown on Figure 1.

As documented in the December 7, 2023 letter (Doc #108401), two (2) potential seep areas were repaired by County staff in November, 2023. Figure 1 is attached illustrating the referenced repair areas.

The areas of repair were observed during this inspection. Vegetation is established on the disturbed soil areas adjacent to the rock and geotextile repair areas.

Review of the north repair area indicated that the perimeter of the repair was dry and no moisture was observed.

Review of the south repair area indicated that the south side (downslope side) of the repair was wet with wildlife activity noted. No leachate was observed flowing in this area.

1. Monitor bare area southwest of MW-7.
2. Continue to monitor the repaired seep areas.
3. Continue to monitor the soil and asphalt stockpiles.
4. Continue to remove trees from the cap and terrace letdown ditch.
5. Continue to monitor settled areas for signs of ponding or drainage issues.
6. Continue to monitor the terrace channels for evidence of ponding or overtopping. Regrade terrace channels to eliminate ponding as necessary.
7. Continue to monitor vegetation and erosion and repair as necessary.
8. Continue to monitor diversion and drainage systems and repair as necessary.
