Re: Ending Post-Closure Review
City of Hawarden Sanitary (C&D) Landfill
Permit No. 84-SDP-02-75

Ending Post-Closure Review

City of Hawarden Sanitary (C&D) Landfill
Permit No. 84-SDP-02-75
Hawarden, Iowa

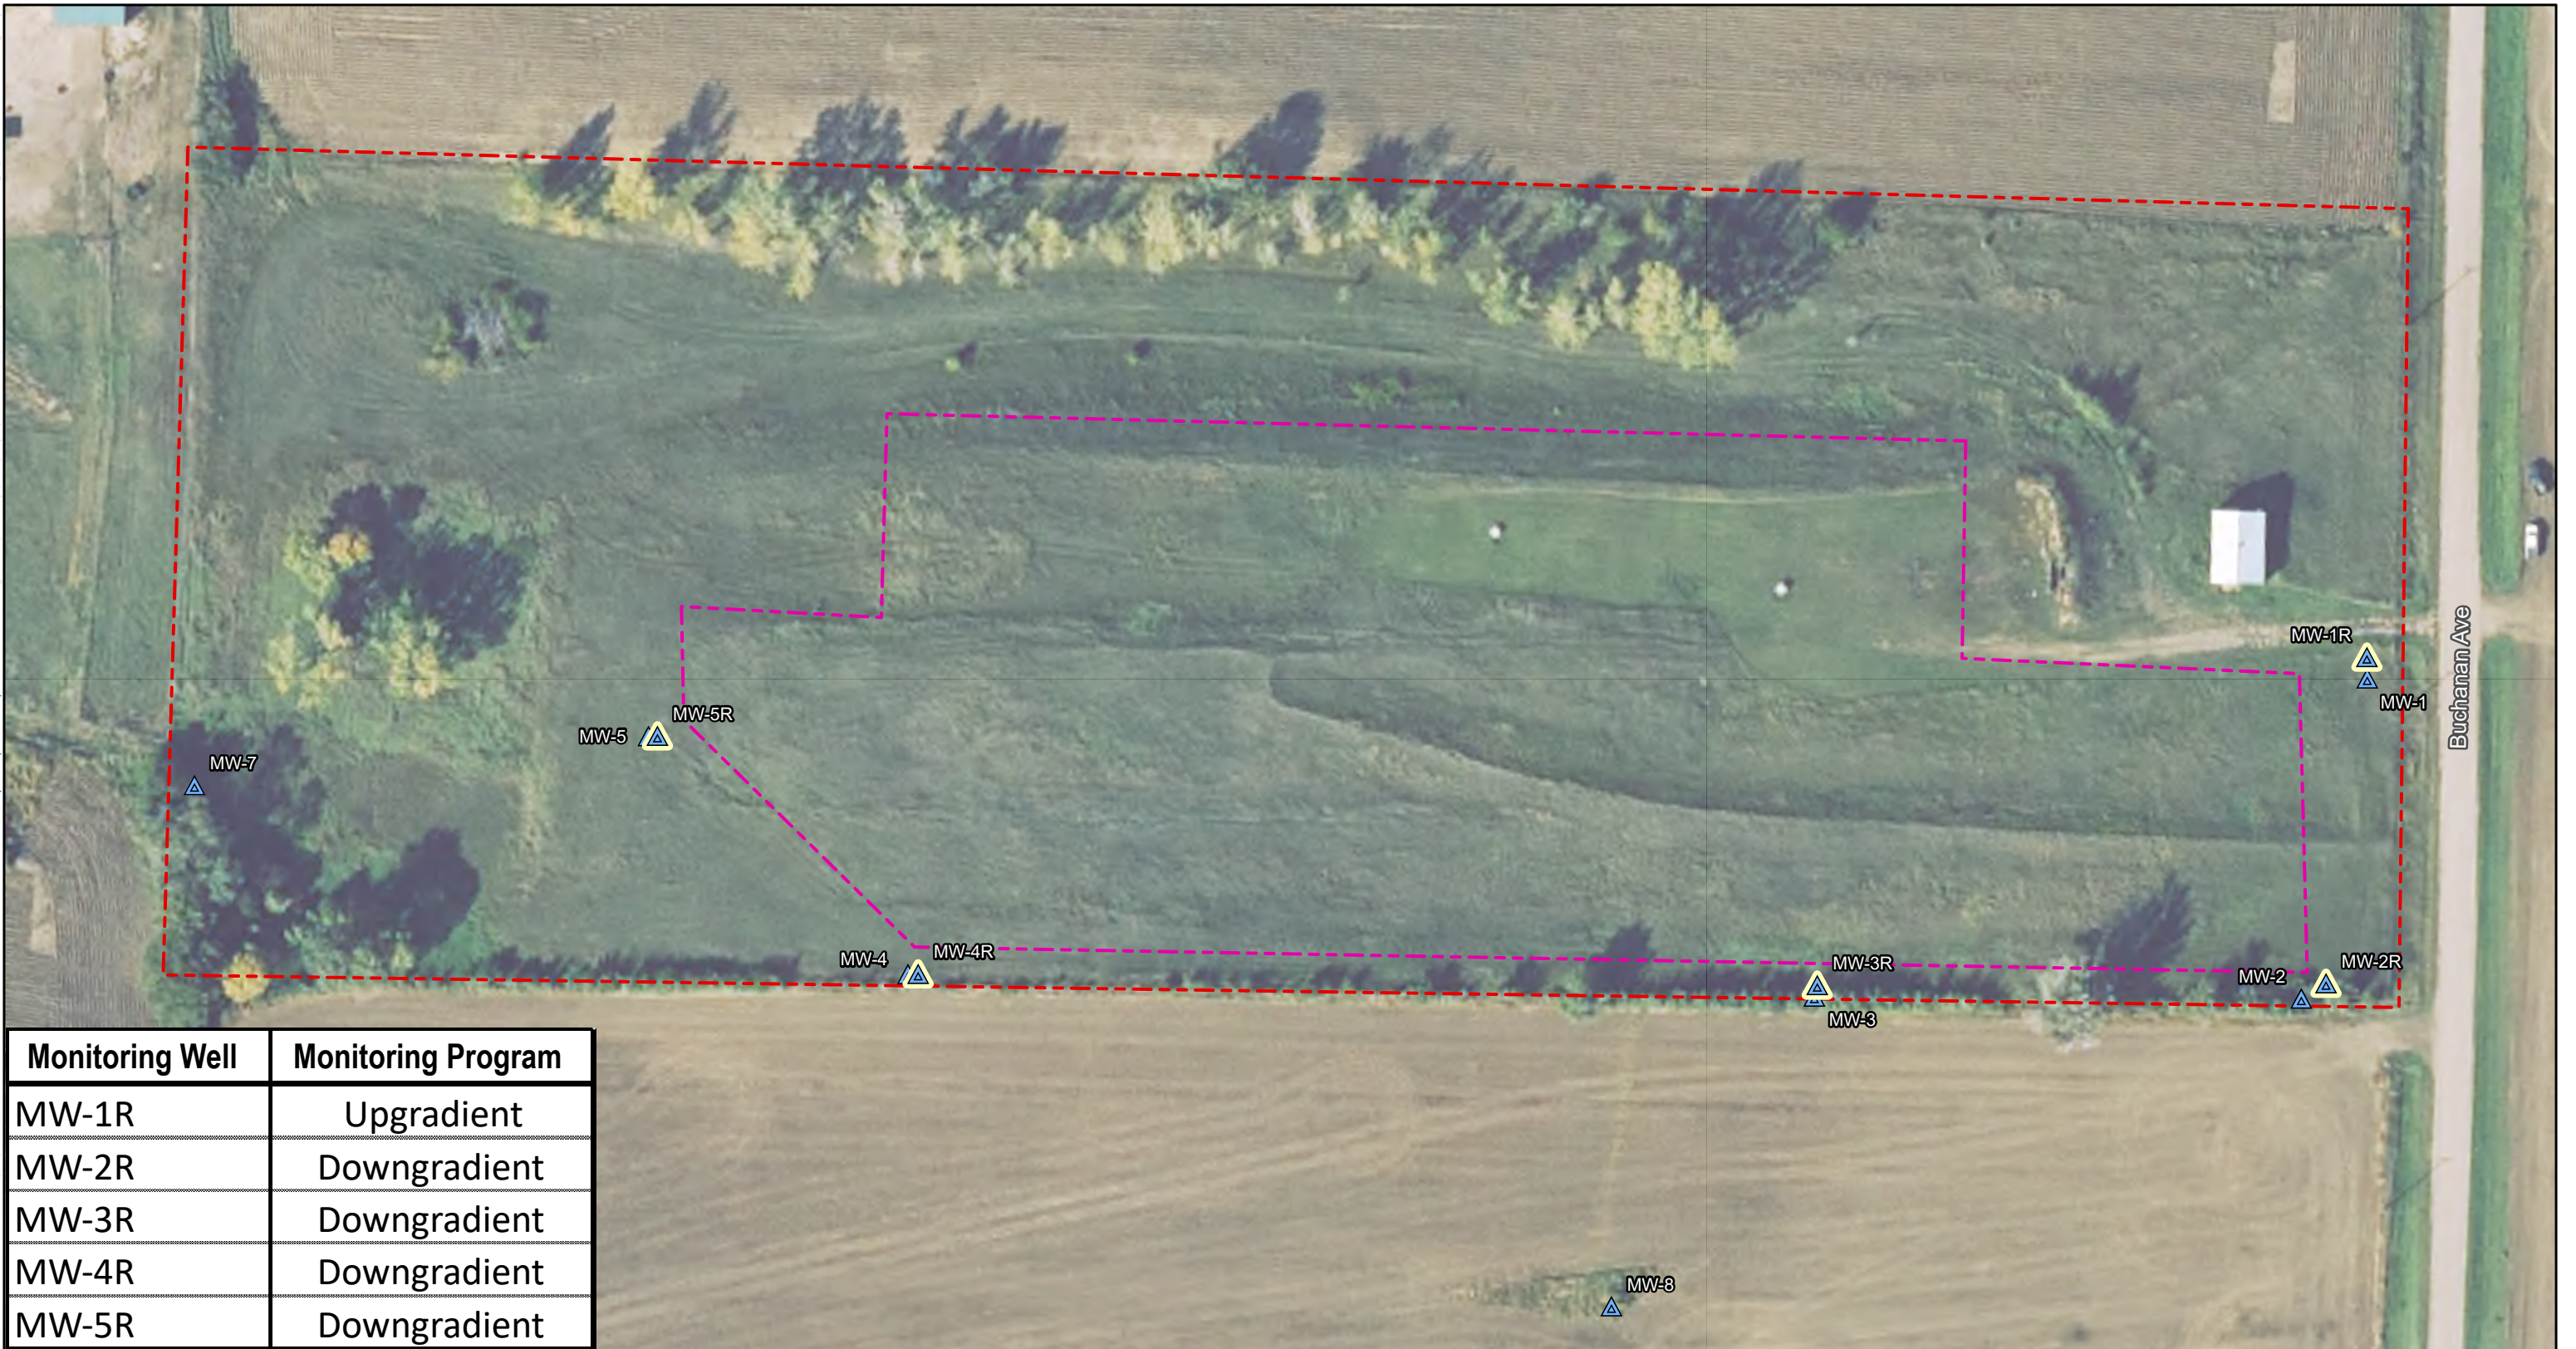
Figure 1
Approved Monitoring Network

The Landfill property and Hydrological Monitoring System Plan (HMSP) monitoring network is depicted in **Figure 1**. **Figure 1** indicates the locations of each monitoring well and its respective monitoring program. Groundwater monitoring for the Landfill consists of samples from one monitoring well along the east side (MW-1R, upgradient), one monitoring well along the west side (MW-5R), and three monitoring wells along the south side (MW-2R, MW-3R, MW-4R).

Monitoring Well	Monitoring Program
MW-1R	Upgradient
MW-2R	Downgradient
MW-3R	Downgradient
MW-4R	Downgradient
MW-5R	Downgradient

The Landfill property is depicted in **Figure 1**. The Landfill is located approximately 5 miles north of the City of Hawarden and is described as being in Section 23, Township 95 North, Range 48 West; NE NETR IN (Parcel C), in Sioux County, Iowa.
