**RE: Metro Park East Sanitary Landfill – Phase II Unit and CWTS  
Permit No. #77-SDP-01-72  
Response to Comments on 2025 Annual Water Quality Report (IDNR Document No. 115946)**

METRO WASTE AUTHORITY  
METO PARK EAST LANDFILL

EXISTING SITE  
UTILITY MAP

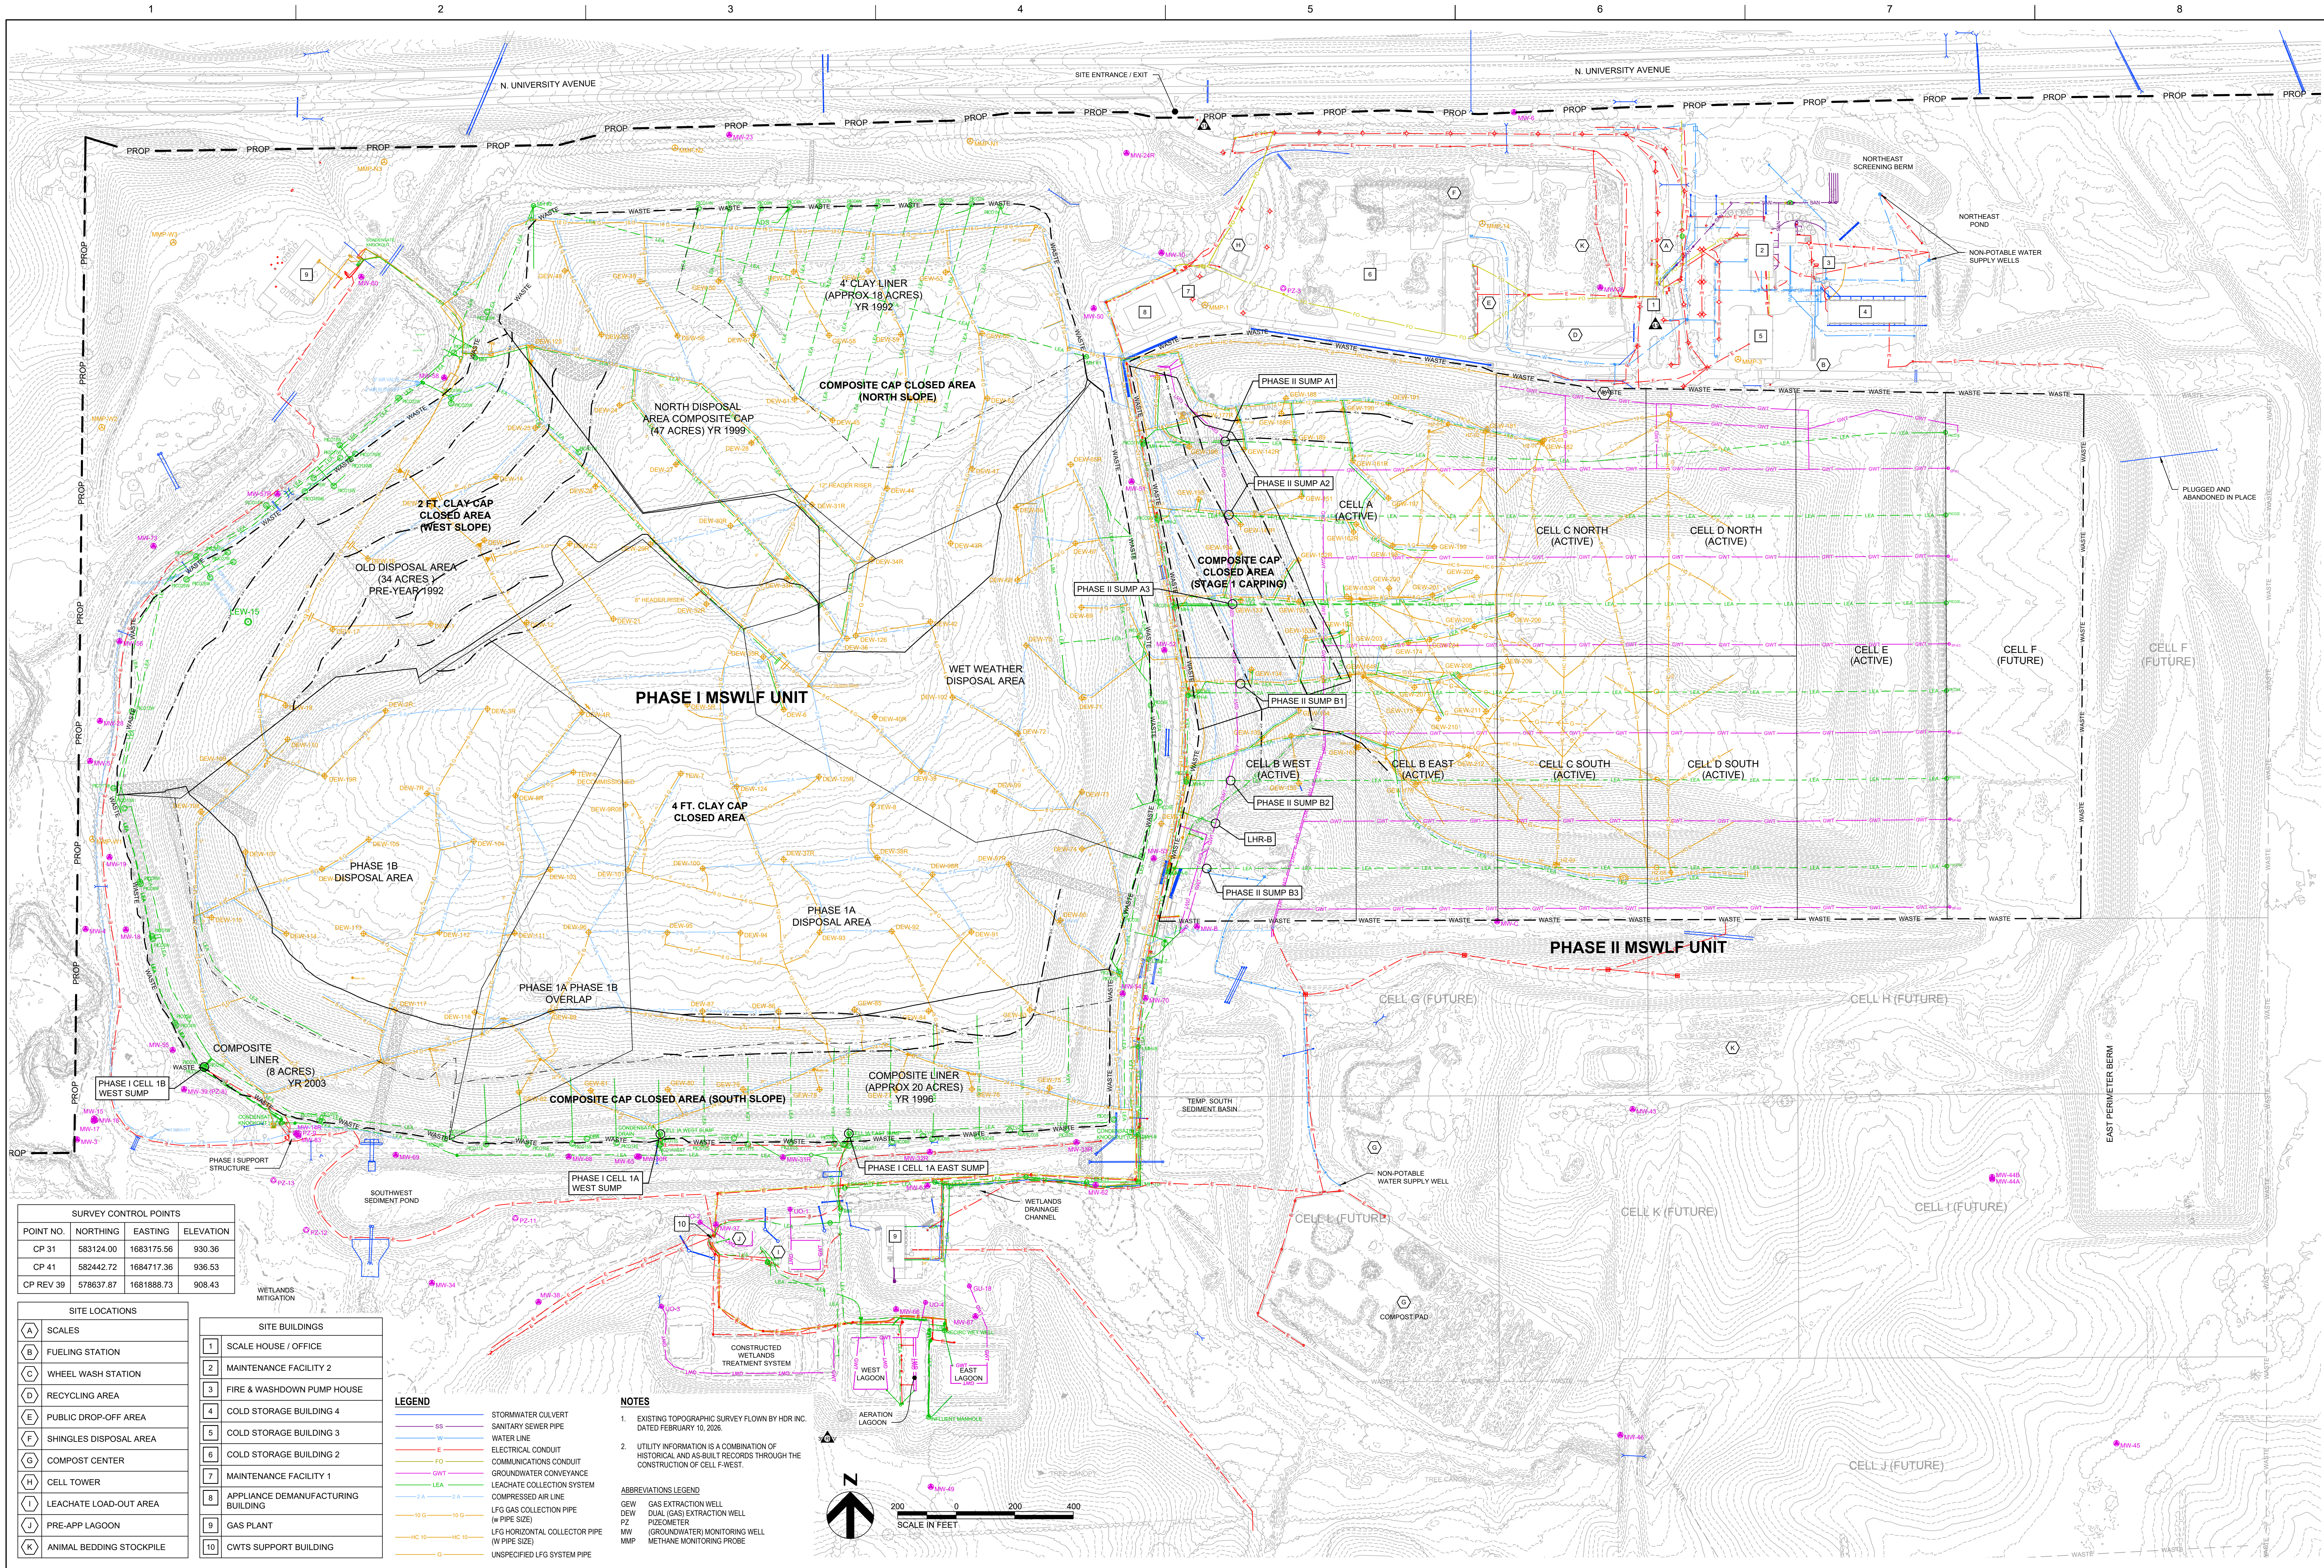
**Response:** Table 1 is attached which summarizes the identifications of access points for jetting and cleaning of leachate lines at both the Phase I and Phase II areas at the site. The locations of the access points for jetting equipment are summarized on Table 1 with grid coordinates which are applicable to the attached Figure 1.

**Response:** To address terms and acronyms, a table will be included in each future Leachate Collection System Performance Evaluation Report (LCSPER) for MPE summarizing the definitions and descriptions. For the 2025 LCSPER, the terms and acronyms are defined and described on the attached Table 2 to this letter. Terms and acronyms that define a feature or structure at the MPE Landfill are depicted on the attached Figure 1.

For reference, the Graphs from Appendix B of the 2025 LCSPER have been attached to this document with updates indicating either the bottom of the sump or transducer measurement elevation and the common liner elevation where waste is deposited adjacent to the sumps. For spatial reference, the locations of the Phase I and Phase II sumps and LHR-B are depicted on the attached Figure 1.

(A) - The grid coordinate notes the general location of the feature identified under the MWA ID and Contractor ID columns on the attached Figure 1.

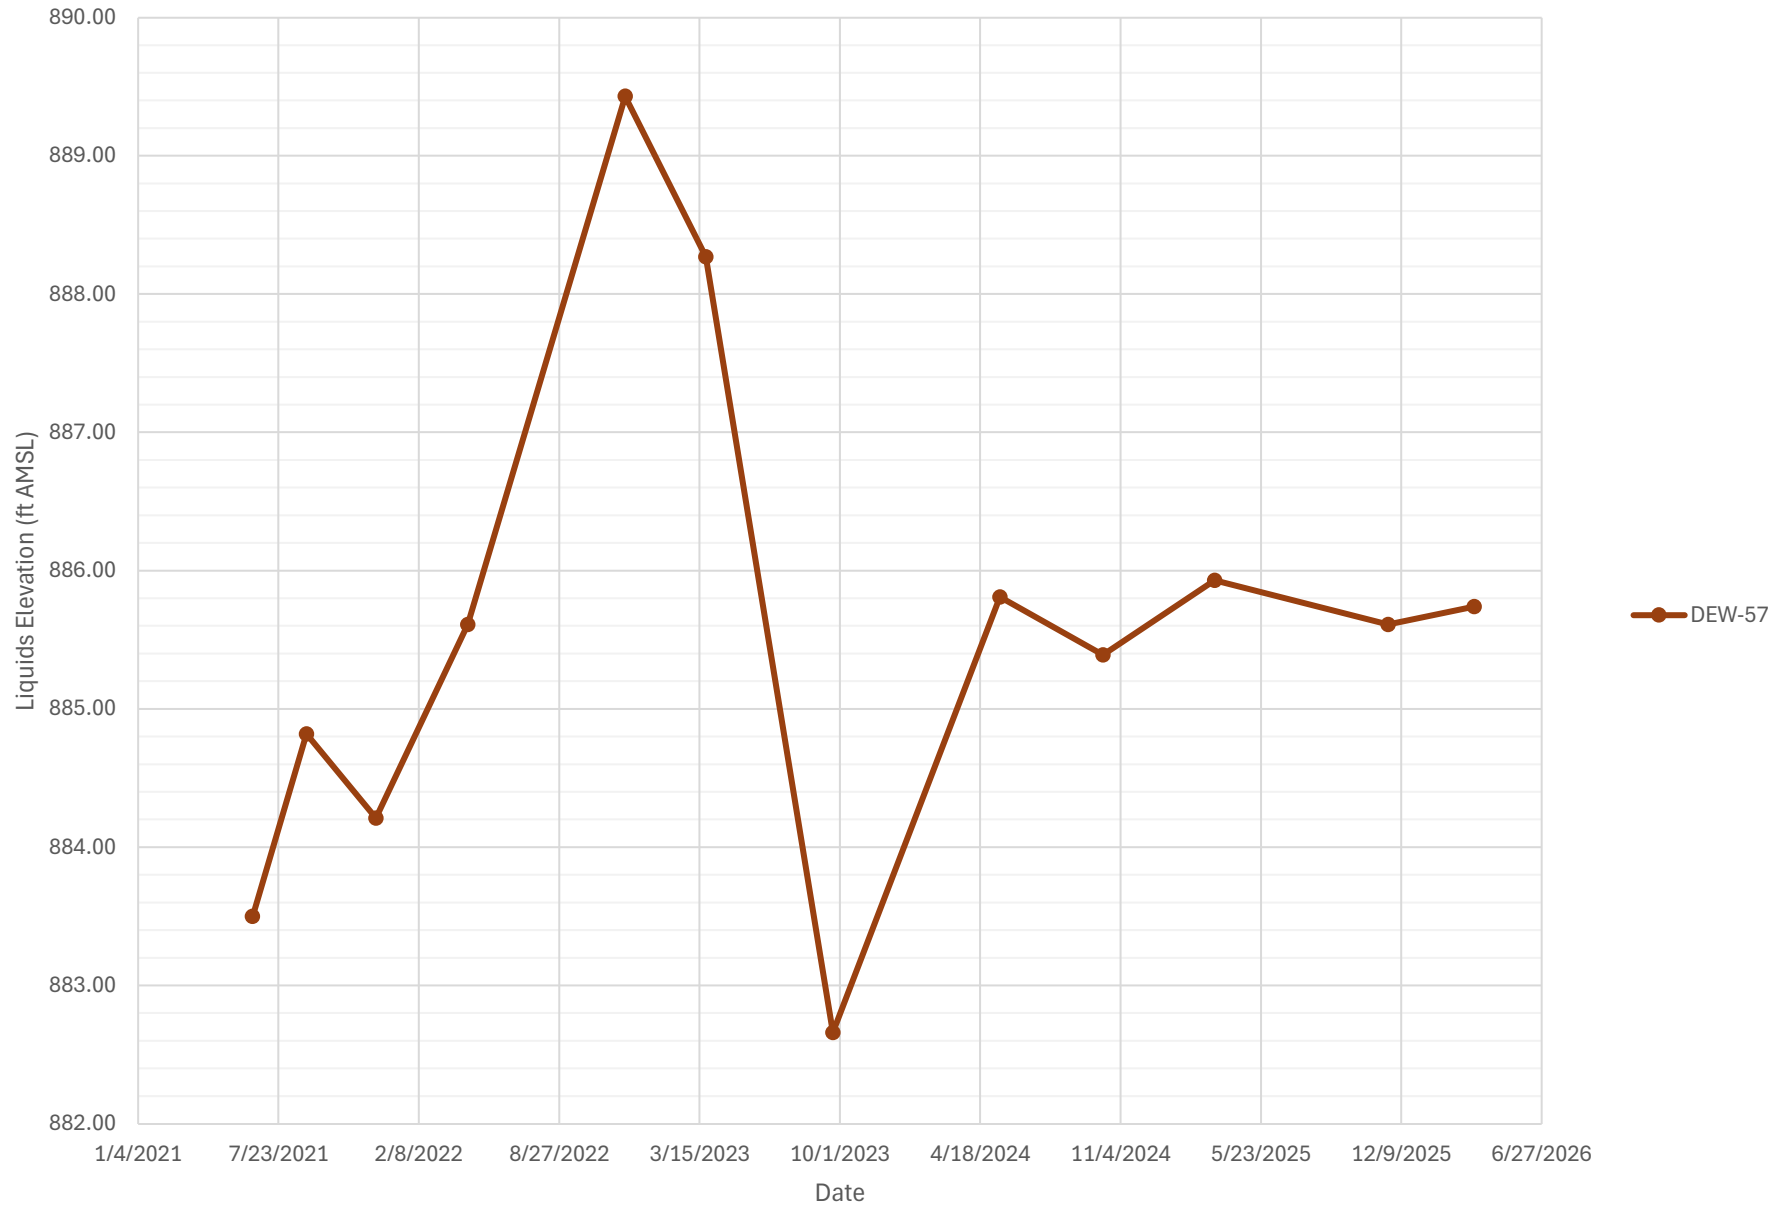
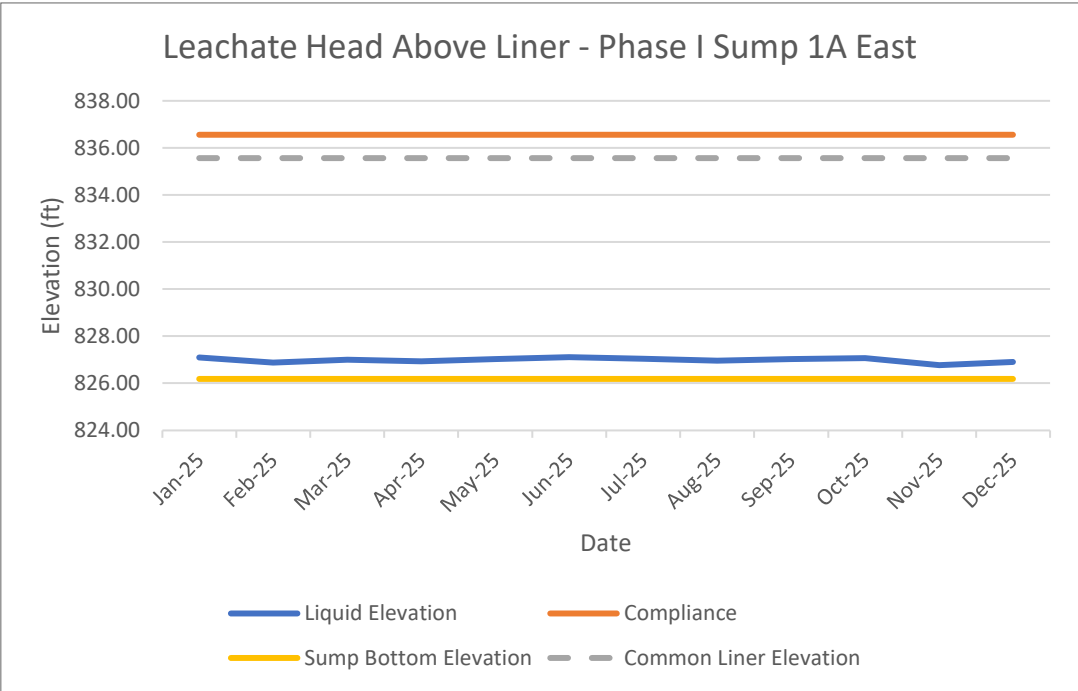
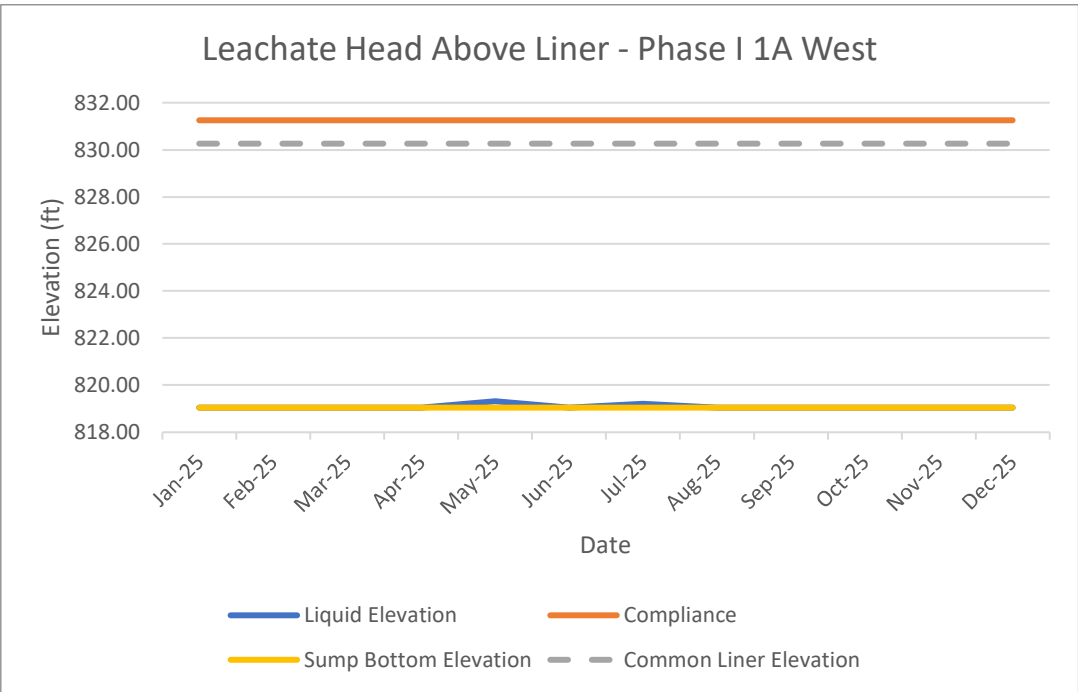
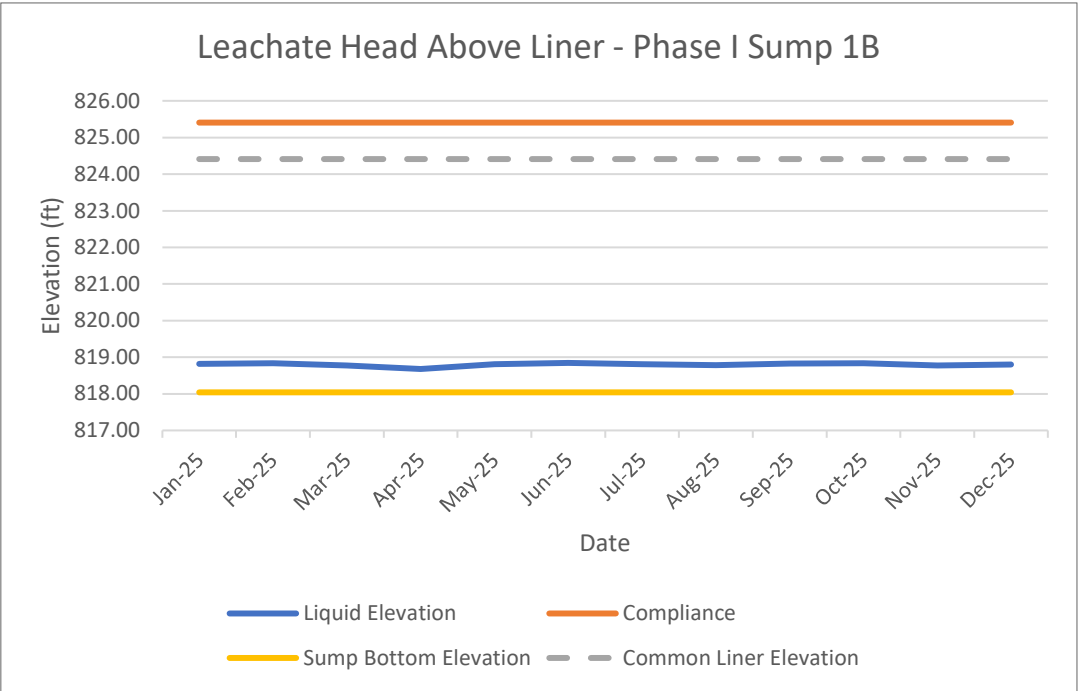
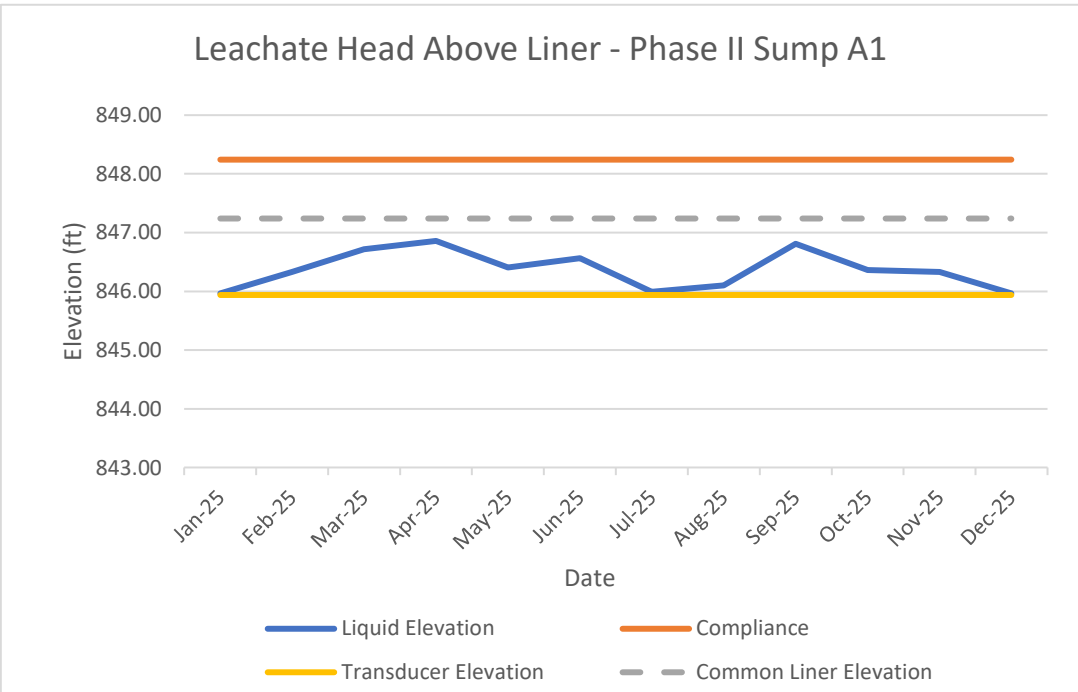
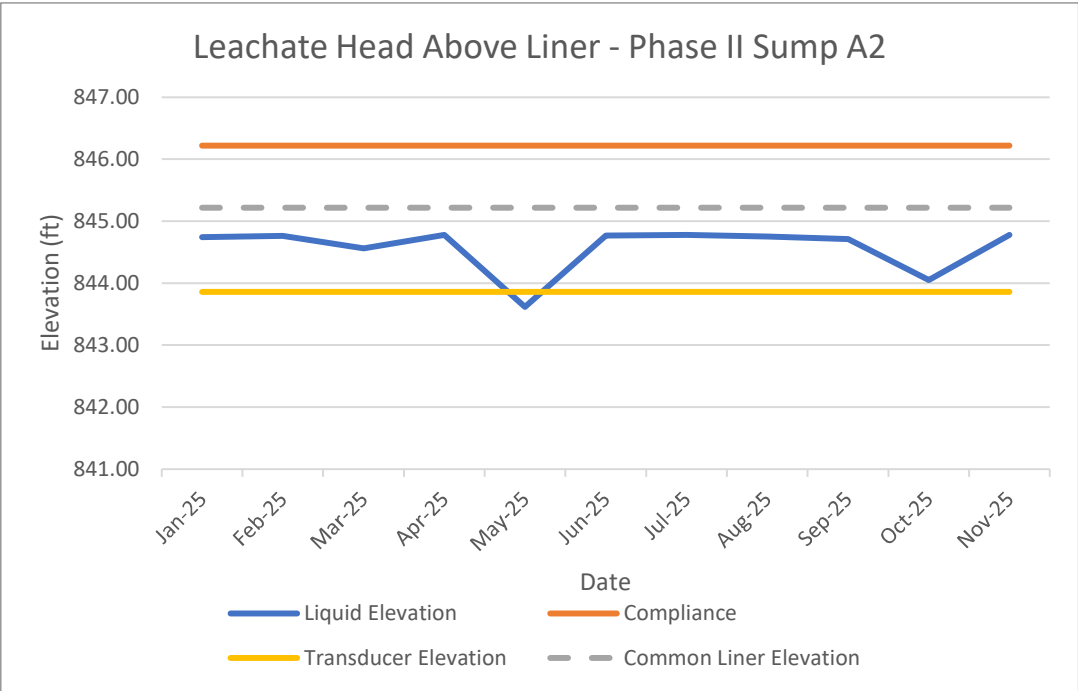
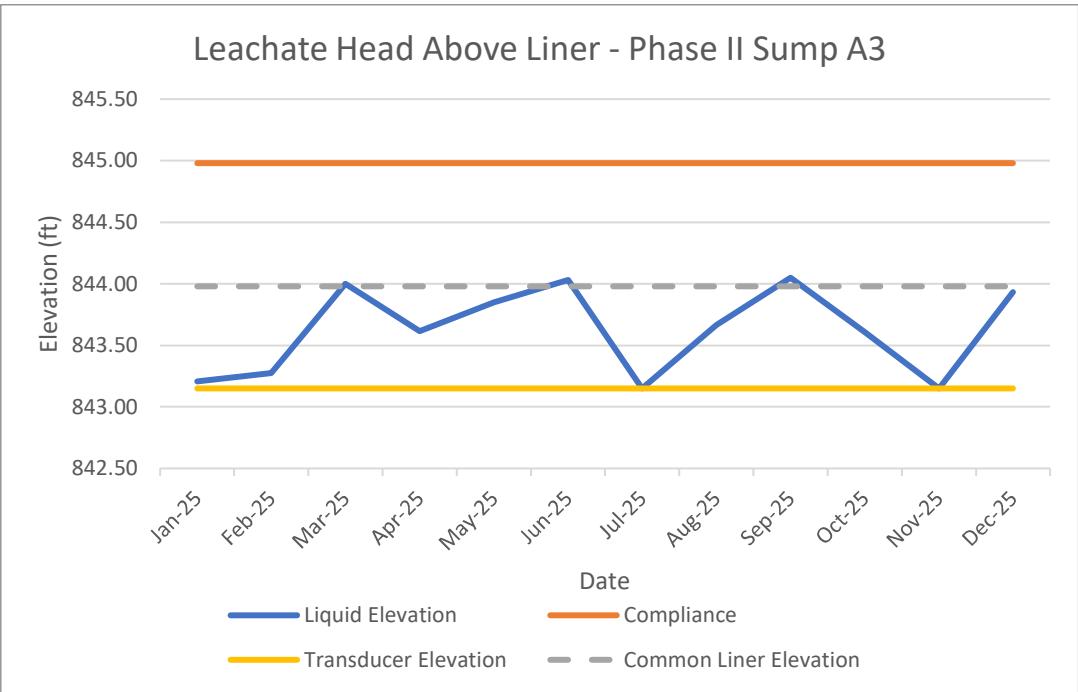
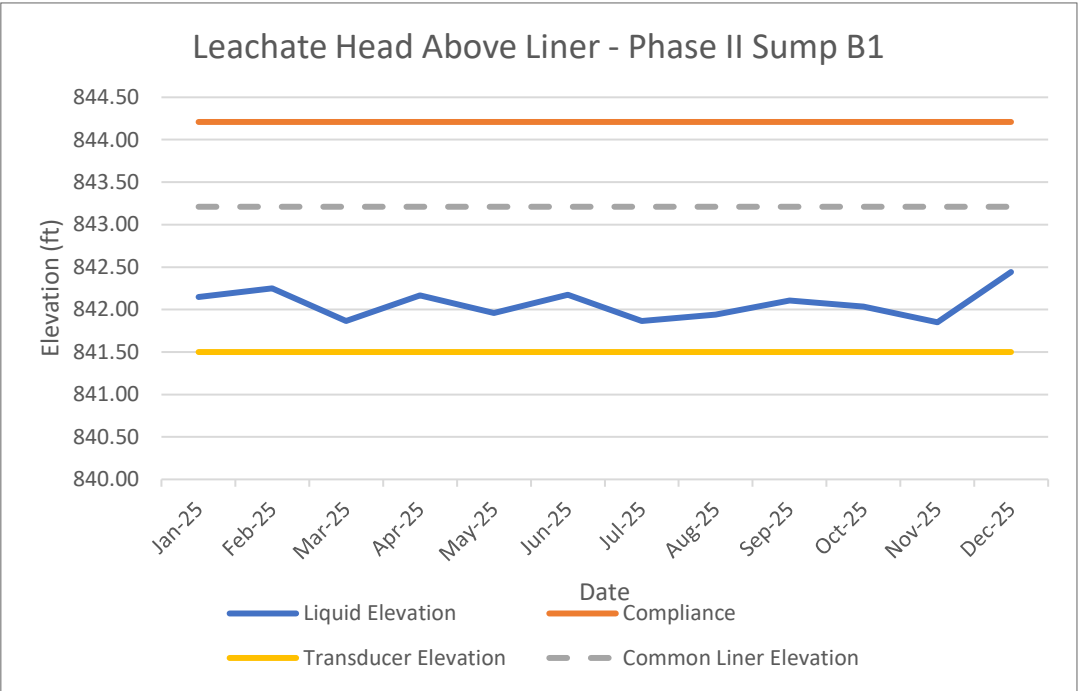
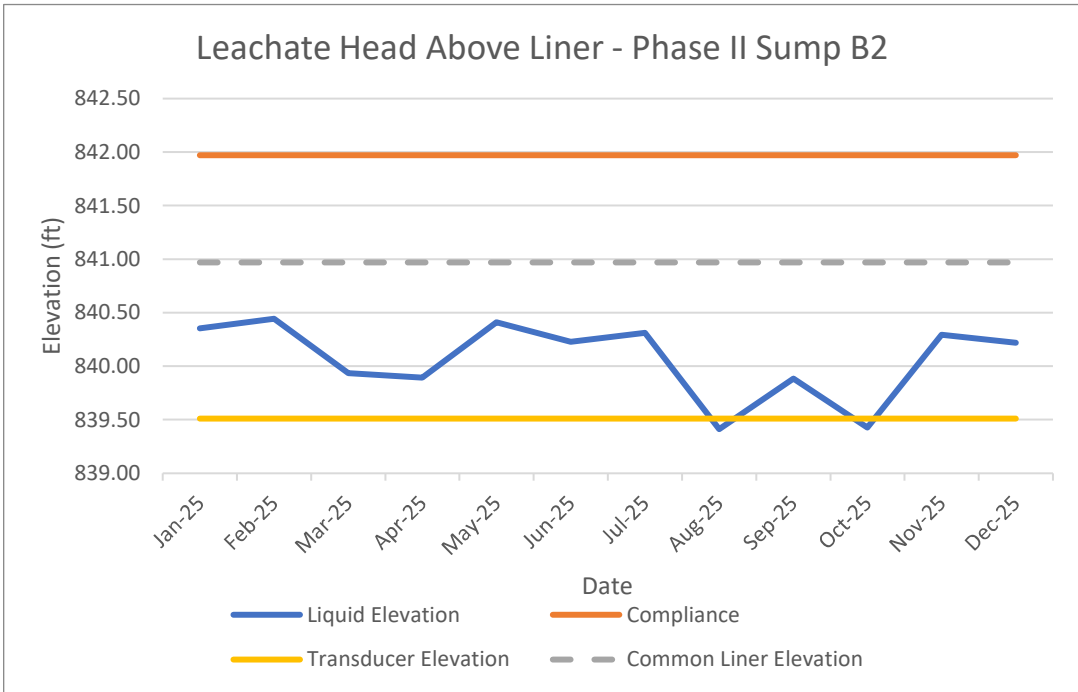
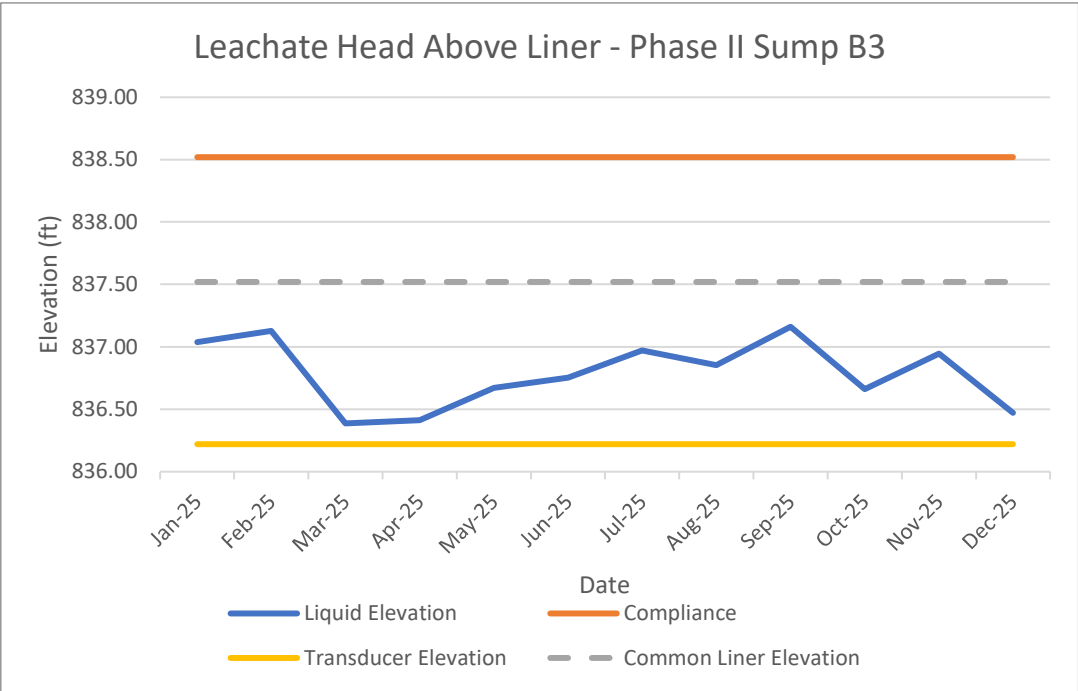
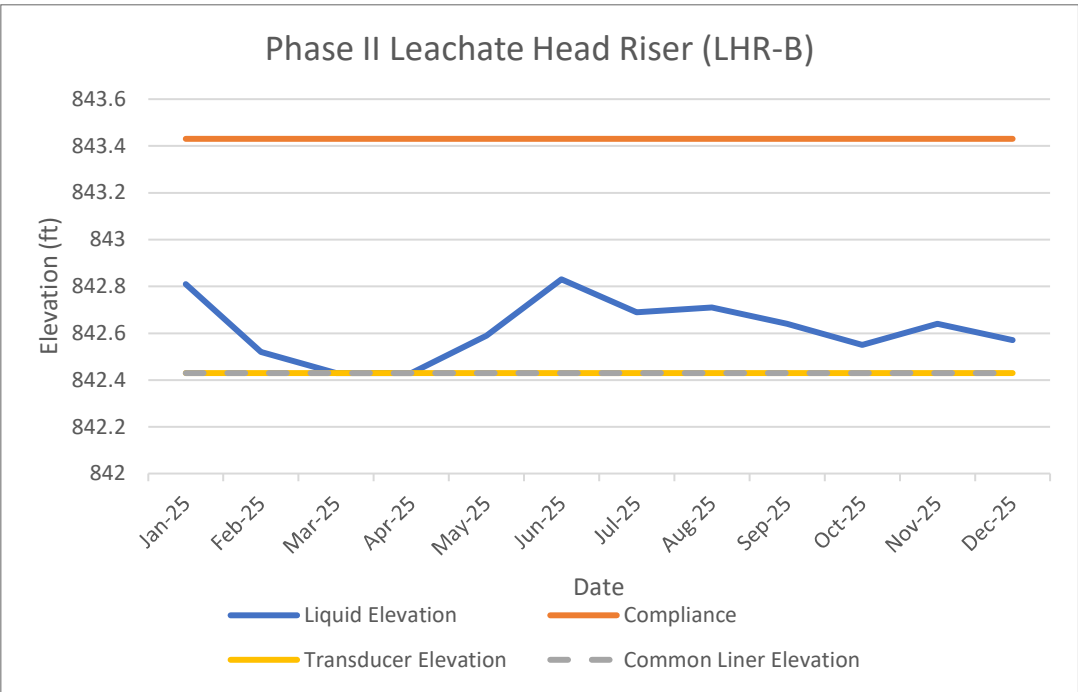
Graph 1: Liquids Elevations - MPE Phase I

Leachate lines associated with PICO3N, PICO4N, and PICO8N are located on the northeast side of the Phase I unit. Leachate gauging conducted in this general area includes monitoring point DEW-57. Historical leachate levels from this monitoring point was graphed to identify if leachate levels are influenced by the inability to clean the referenced leachate lines. Based on the leachate gauging data at DEW-57, which is depicted on the attached Graph 1 for the period from June 2021 through March 2026, leachate levels have varied by intervals ranging eight feet during the period. Measurements during the last five semiannual sampling events were more consistent with variation ranging approximately 0.5 feet. DEW-57 is located near the leachate line with

access point PICO8N. Leachate levels at DEW-57 appear to be consistent with historical ranges and do not appear to be increasing in elevation.

**Response:** With regard to the Phase I Sump 1A East compliance elevation, this was previously addressed in HDR's response letter dated February 28, 2023 (IDNR Document No. 105973). The response letter was drafted to address IDNR's comments on the 2022 Annual Water Quality Report which were provided in a letter dated January 31, 2023 (IDNR Document No. 105568). Both the Phase I Sump 1A East and Phase I Sump 1A West were designed, permitted, and constructed in 1995 and 1996. Each sump was placed in an excavation to focus leachate migration to the sump and the extraction pump. The installation of the sumps in these excavations place them lower than the common liner elevation where waste is deposited and where the compliance threshold is calculated.

The Phase I Sump 1B was constructed in 2003 with the construction of the Phase 1B landfill expansion. Similar to Phase I Sump 1A East and Phase I Sump 1A West, the Phase 1B sump measurement point is lower than the common liner elevation where waste is deposited. Details regarding the Phase 1B landfill expansion are detailed in the Minor Permit Revisions to Closure/Post-Closure Plan and Phase 1B Permit Application dated April 16, 2004 (IDNR Document No. 55733)

The Phase II sumps (A1, A2, A3, B1, B2, and B3) and the leachate head riser (LHR-B) were constructed with shallower monitoring points relative to the common liner elevation. Thus, the difference between the compliance elevation and the measurement point is narrower at the Phase II monitoring locations when compared to the Phase I monitoring locations. The Phase II sumps as indicated in the August 2007 Construction Quality Assurance Report (IDNR Document No. 6785) were constructed with a bottom that is approximately two feet lower than the common liner elevation where the waste is deposited.
