**Subject: Monitoring Well Abandonment Documentation  
Interstate Power and Light Company Ottumwa-Midland Landfill (OML)  
Permit #90-SDP-8-92P**

Subject: Monitoring Well Abandonment Documentation  
Ottumwa Midland Landfill  
Permit No. 90-SDP-08-92P  
Interstate Power and Light Company  
Ottumwa, Iowa

### Photo Log

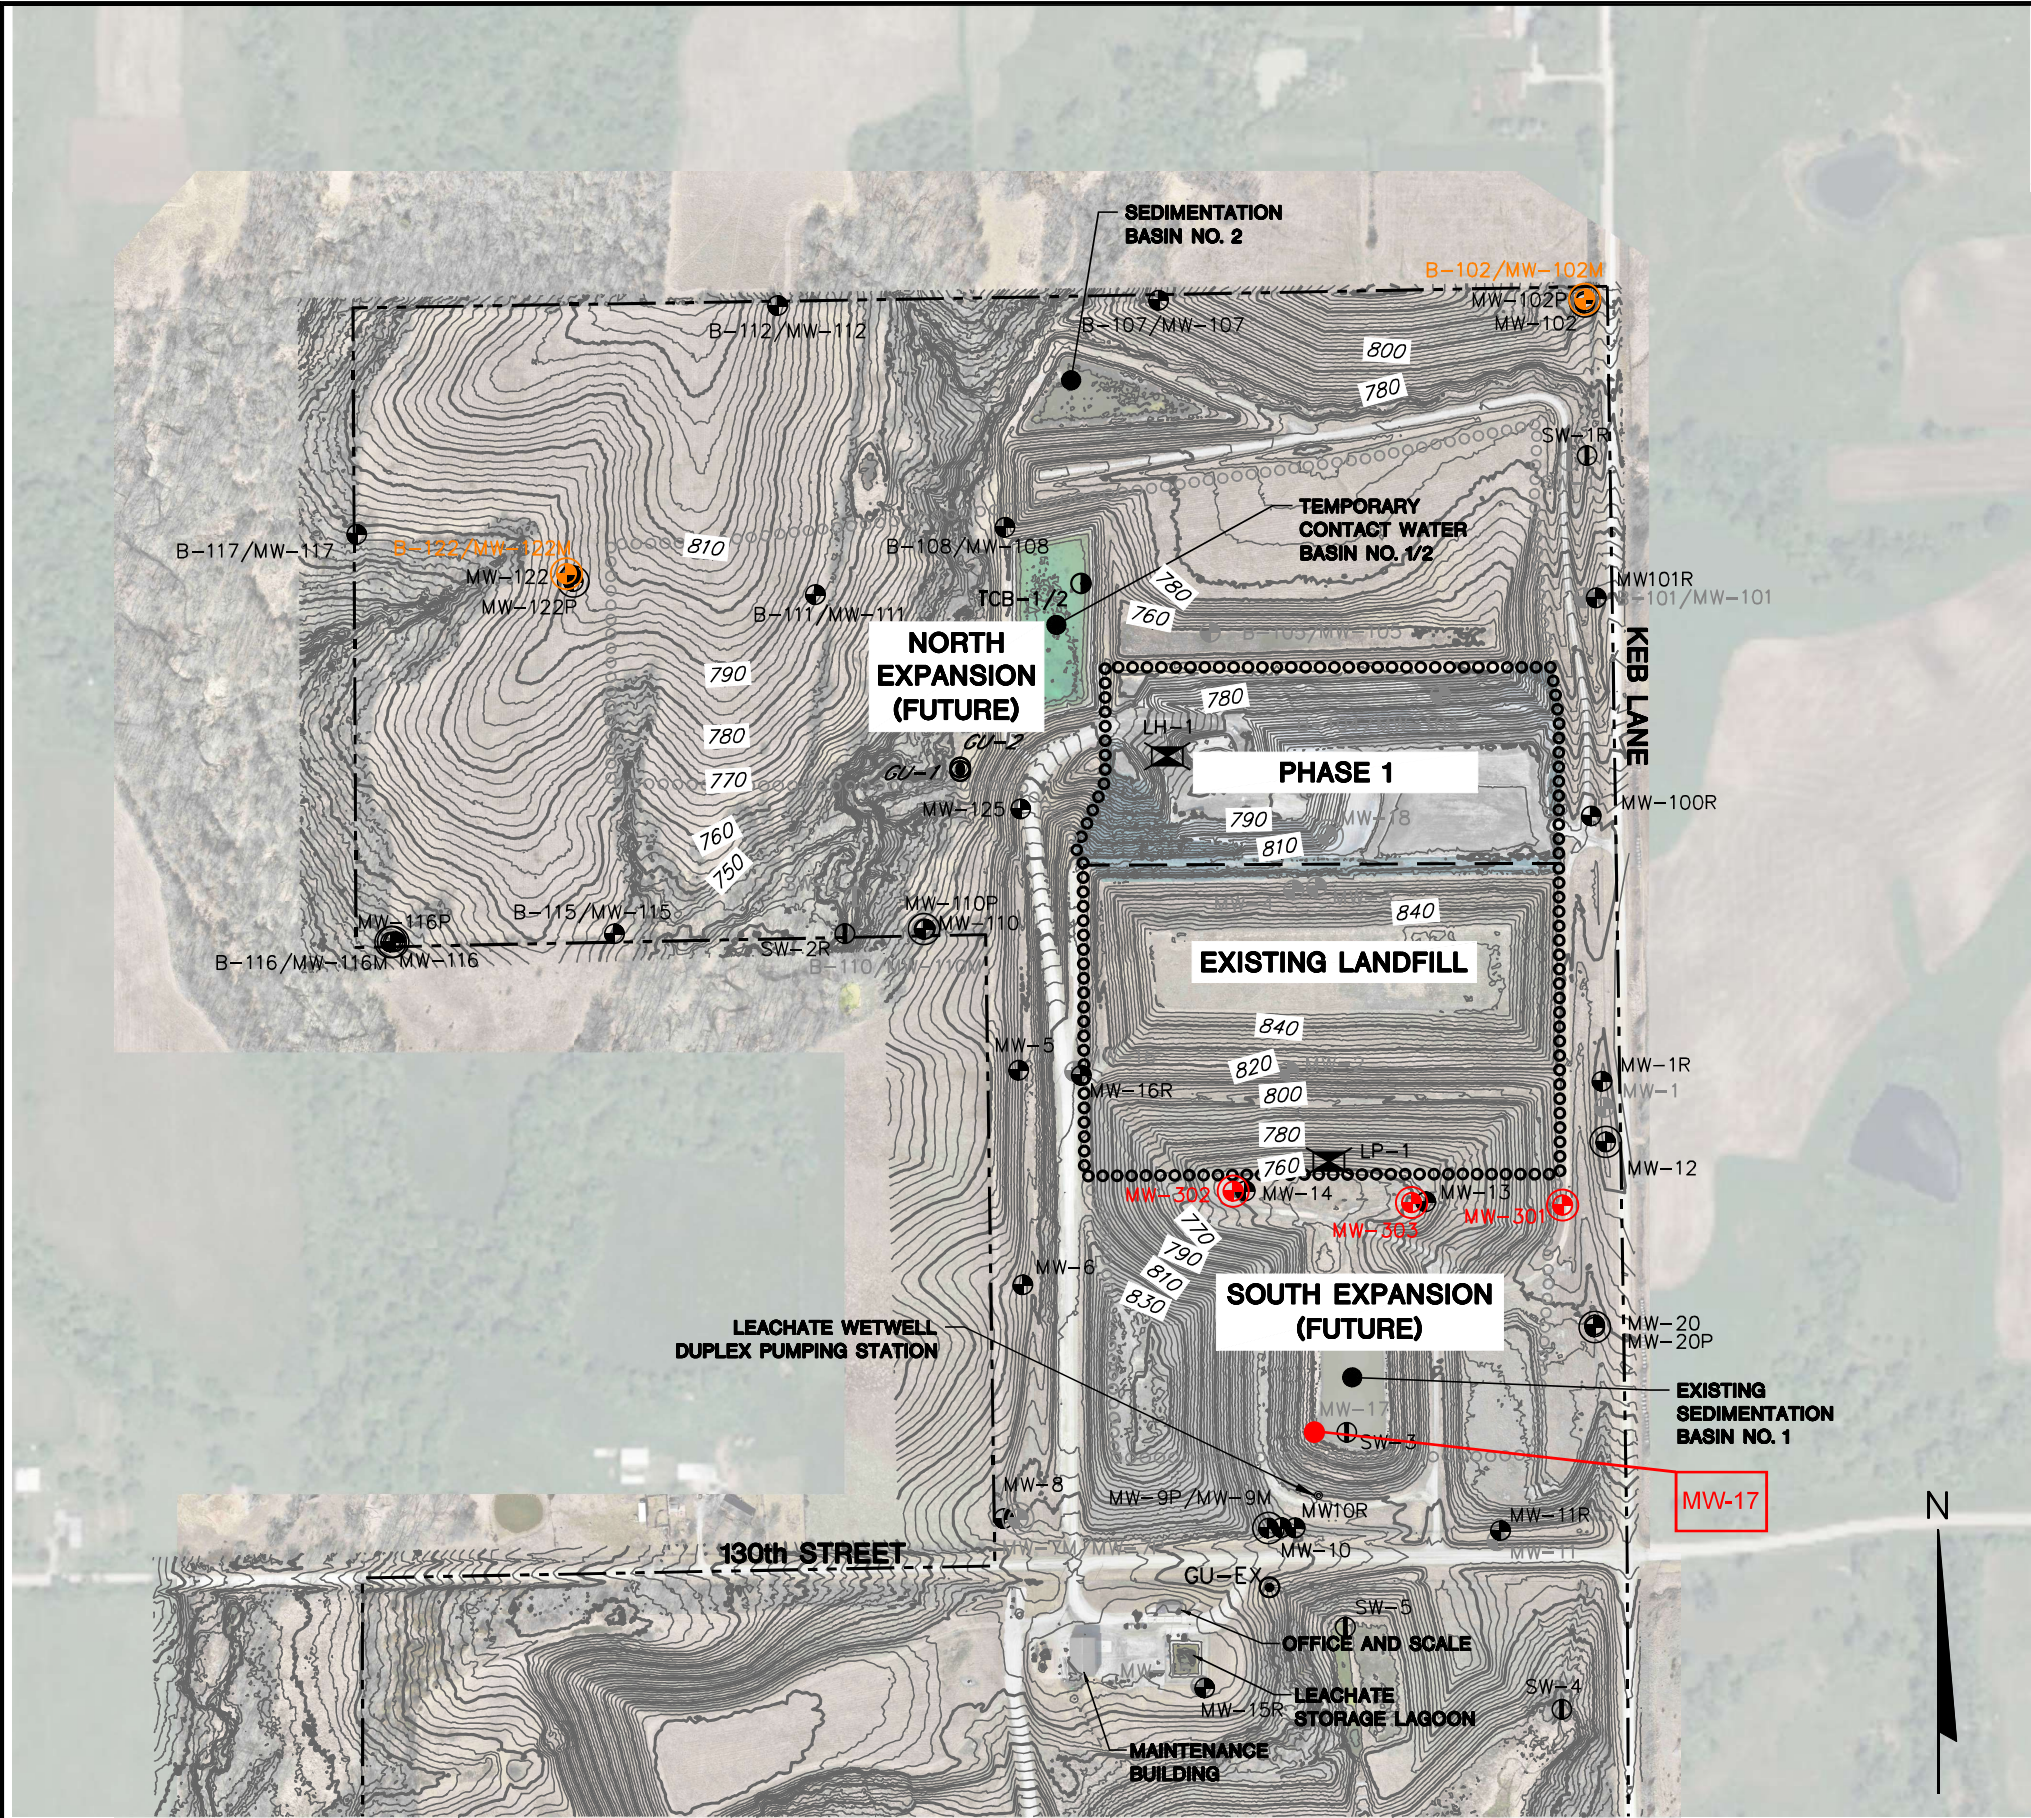
IDNR approved abandonment of MW-17 without replacement in an email dated May 29, 2026, in accordance with Iowa Administrative Code (IAC) 567.39. The location of MW-17 is shown on **Figure 2**.

12. MW-17 WAS ABANDONED SEPTEMBER 9, 2026 DUE TO INSUFFICIENT WATER VOLUME FOR WATER LEVEL AND/OR SAMPLE COLLECTION DURING SAMPLING EVENTS.

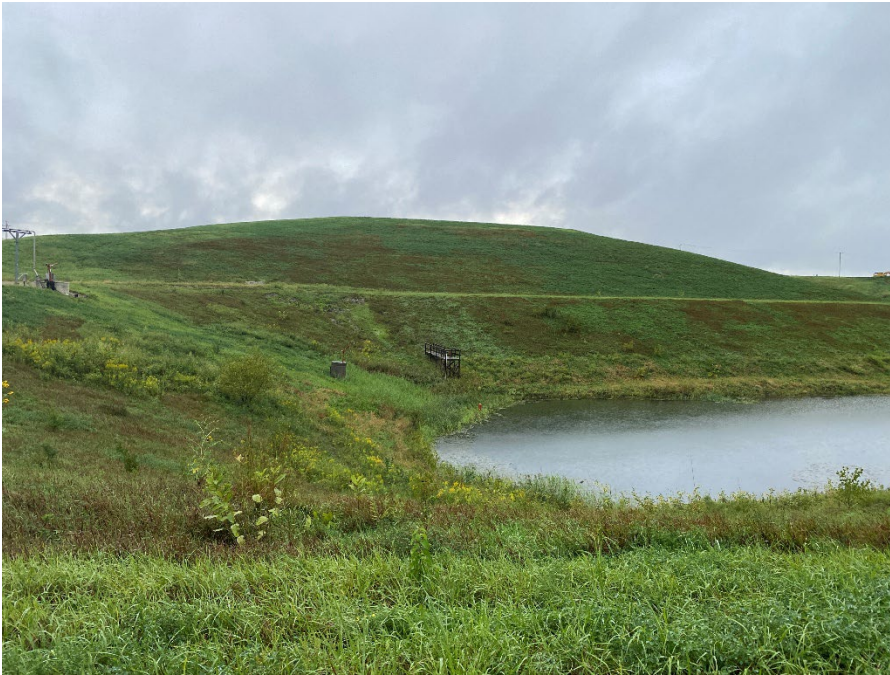
**Photo 1:** MW-17, located at the end of the boardwalk access. (Looking northwest)

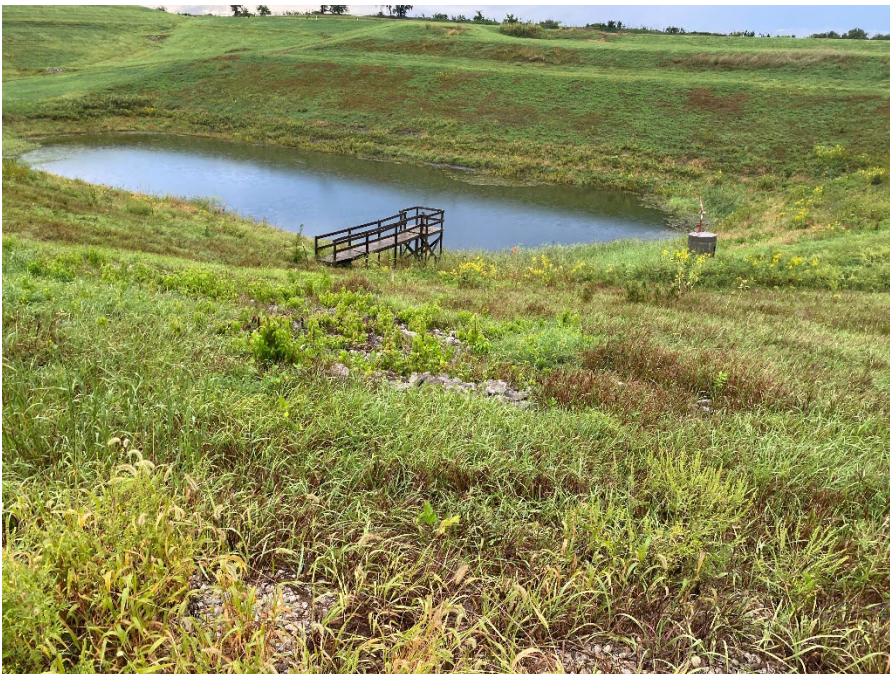
**Photo 2:** MW-17 location at the end of the wooden boardwalk structure. (Looking northeast)

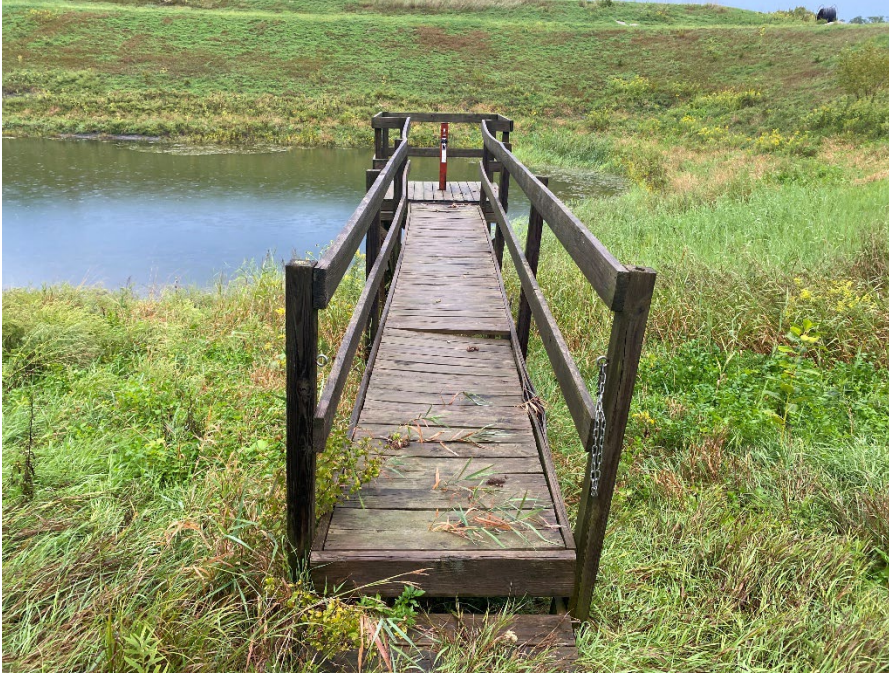
**Photo 3:** Condition of boardwalk to well prior to well abandonment. (Looking east)

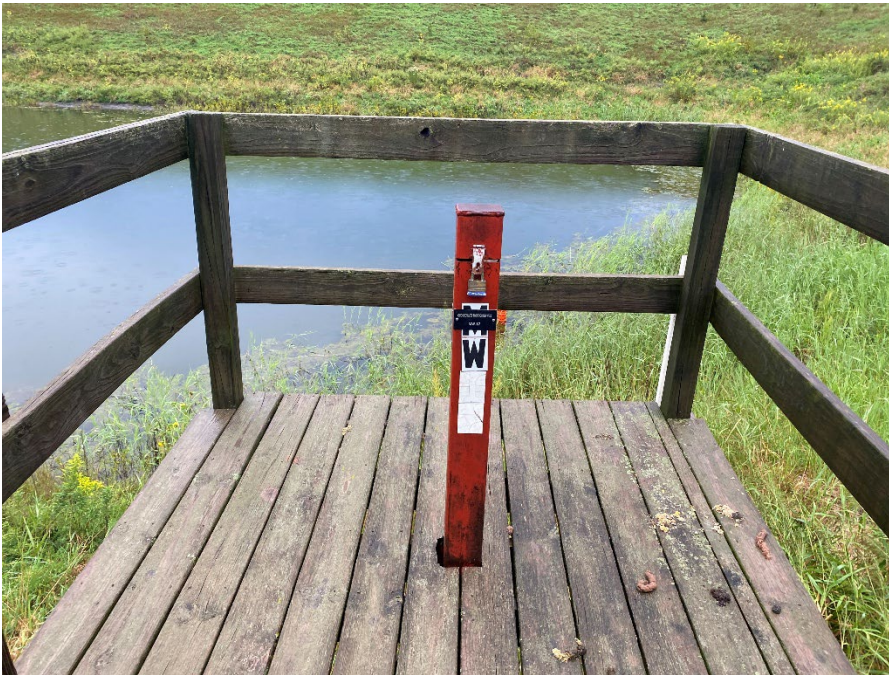
**Photo 4:** MW-17 condition prior to abandonment. (Looking east)

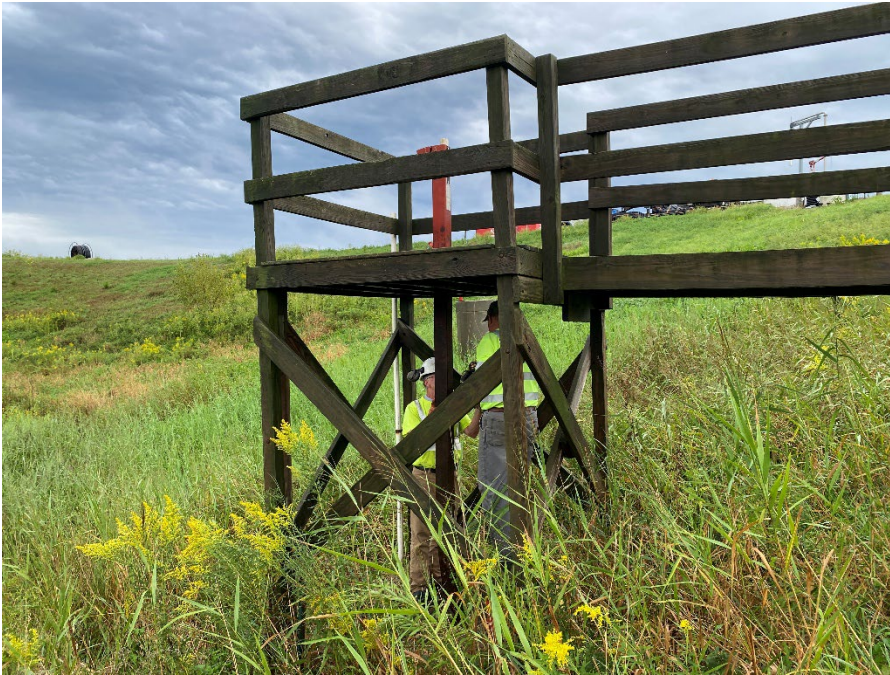
**Photo 5:** MW-17.  
(Looking southeast)

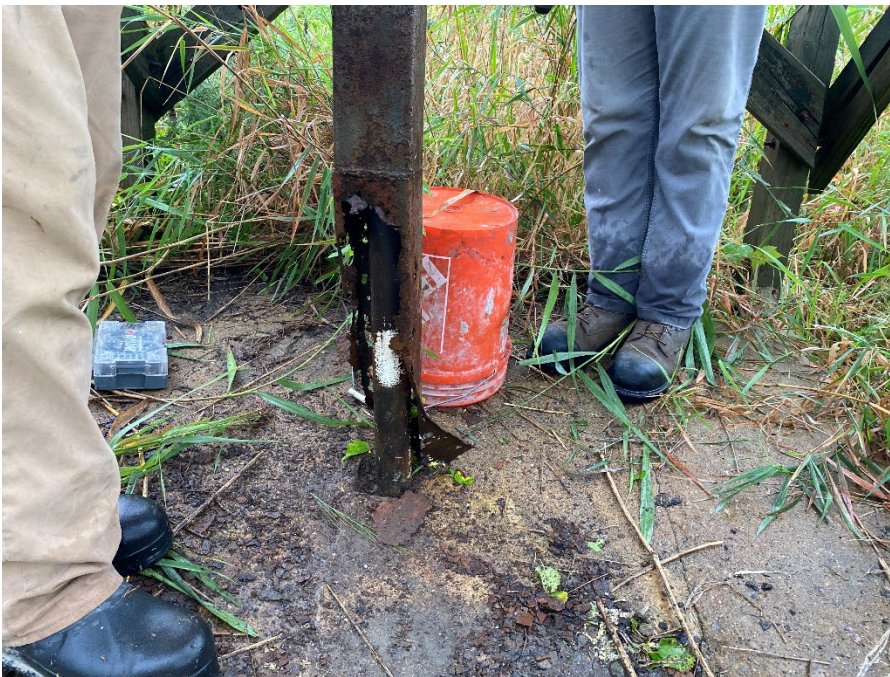
**Photo 6:** MW-17 protop  
prior to abandonment.  
Rusted out, did not require  
additional tools to remove.  
(Looking down)

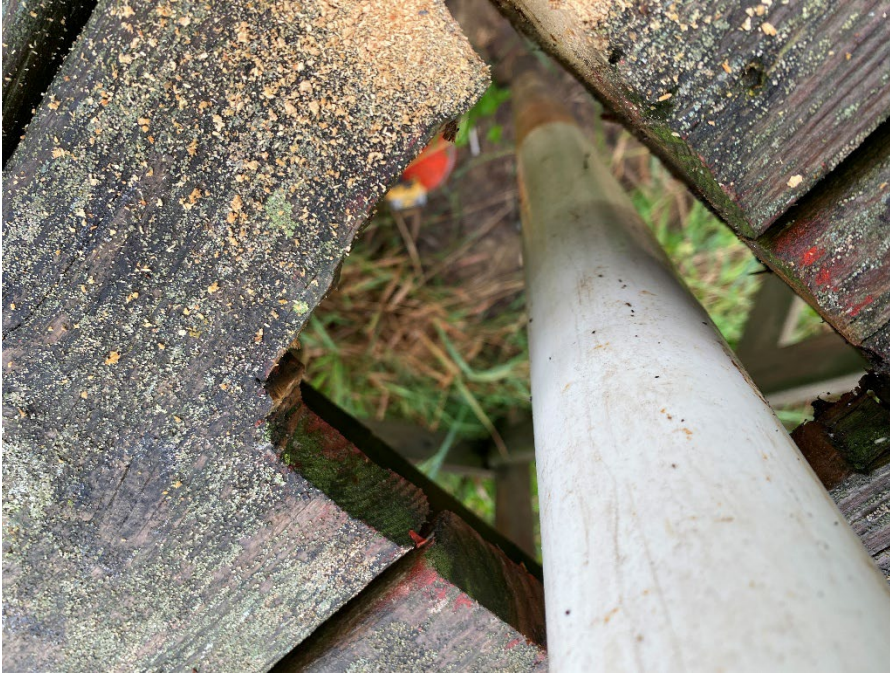
**Photo 7:** Made minor cuts on either side of well to lift protop off well. (Looking down)

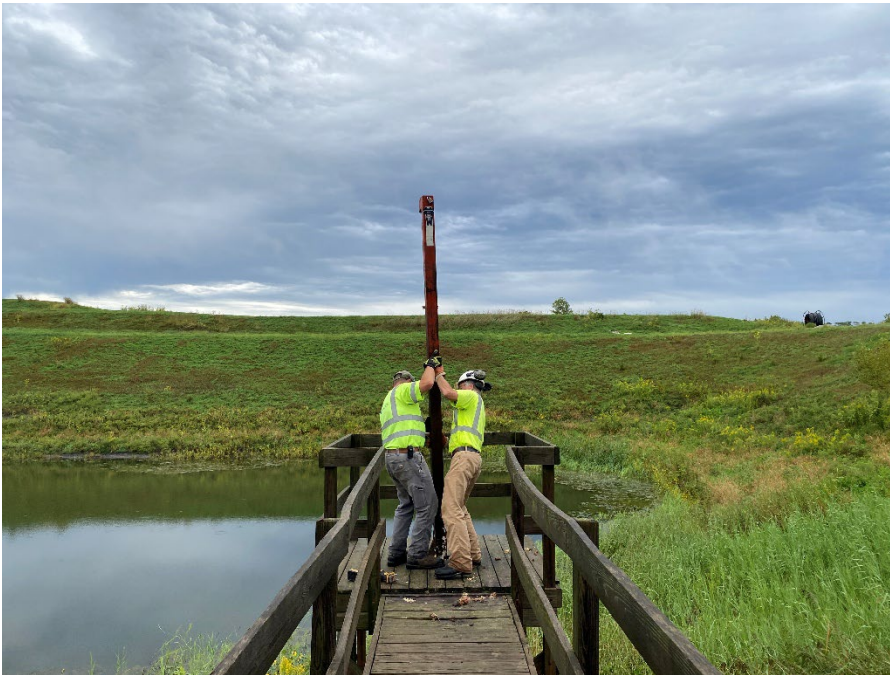
**Photo 8:** Removing MW-17 protop. (Looking east)

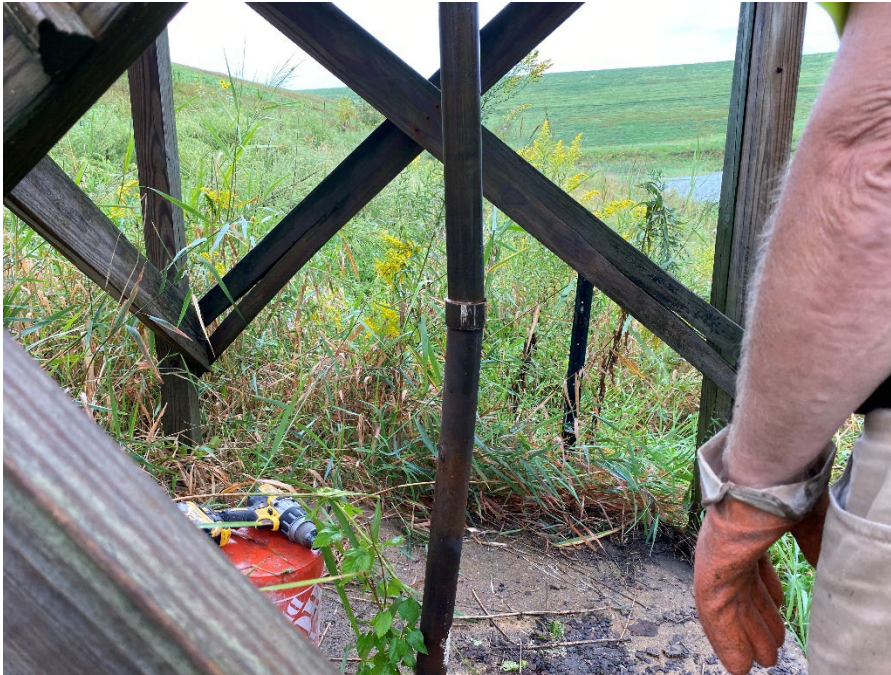
**Photo 9:** PVC of MW-17 was bent. (Looking north)

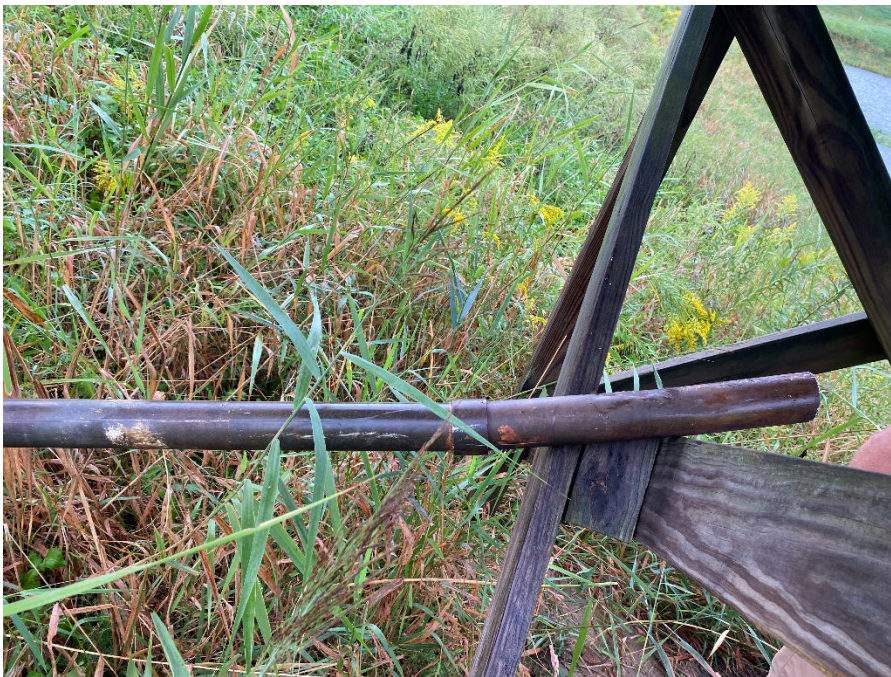
**Photo 10:** Cut PVC stickup. (Looking down)

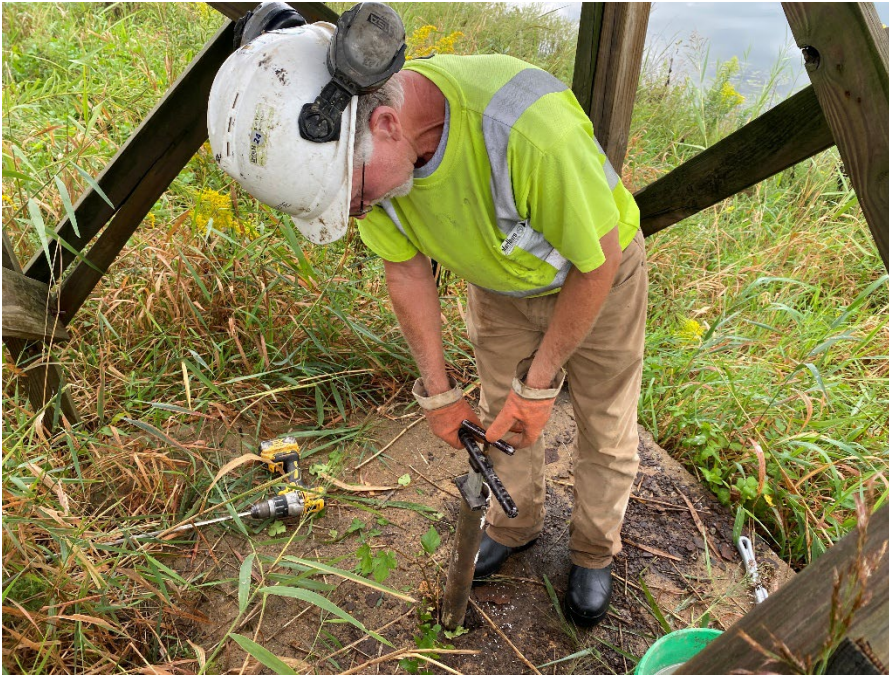
**Photo 11:** Certified driller cutting PVC to 4 feet below ground surface. (Looking down)

Monitoring well MW-17 was abandoned in place on September 9, 2026. The protective casing (protop) was cut to grade level and the 2-inch PVC well casing was cut 4 feet below grade. The

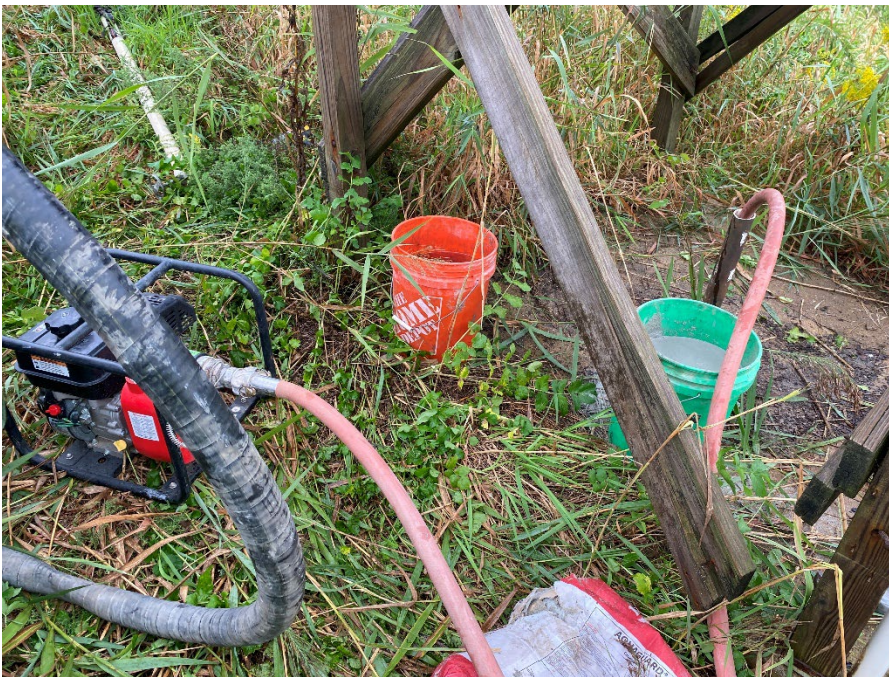
**Photo 12:** Tremie set up to abandon MW-17 with grouting from the bottom up. (Looking down)

remaining well was tremie grouted from the bottom of the 2-inch PVC casing to ground surface, then topped with granular bentonite and concrete. The abandonment form documenting the abandonment is included as **Attachment A** and was submitted to IDNR and the local Wapello County agent by email on October 5, 2026, within the 30-day required period. A photo log of the abandonment work is included as **Attachment B**.

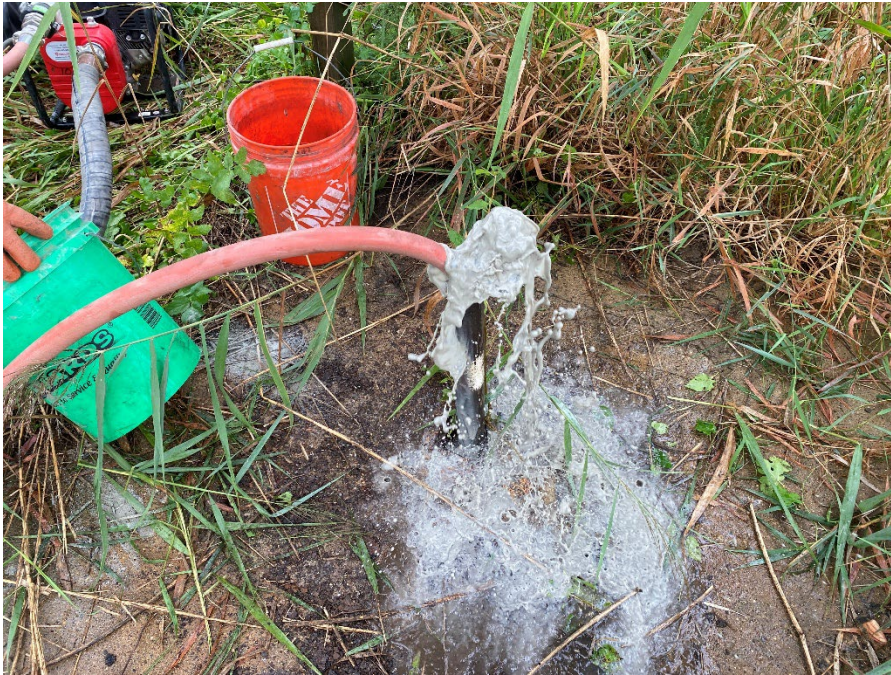
**Photo 13:** Grout overflowing from well after tremie piping from bottom to surface. (Looking down)

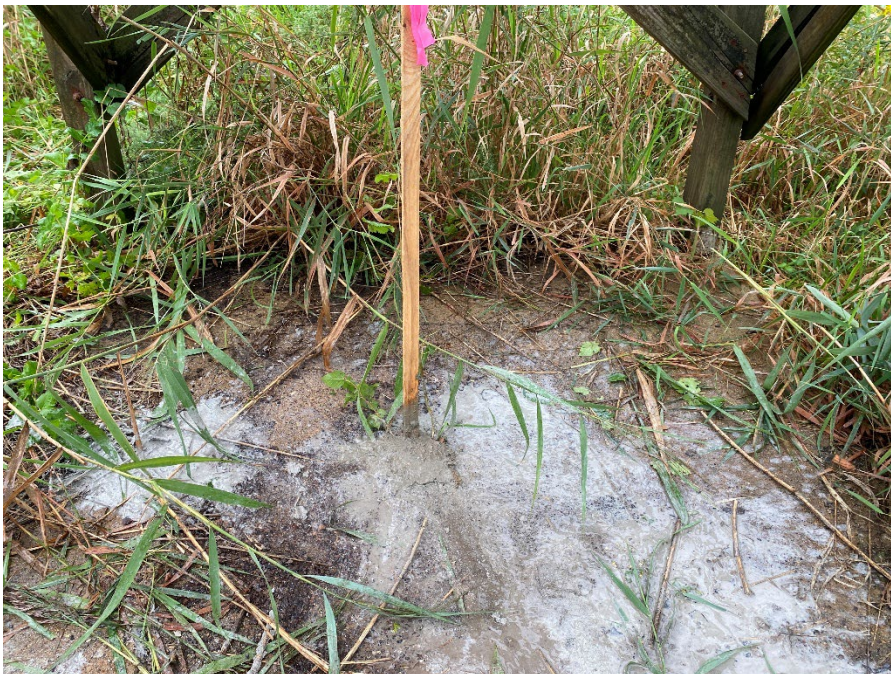
**Photo 14:** Final abandonment. PVC cut to approximately 4 feet bgs and protop to ground surface. The concrete pad supports the wooden structure so it could not be fully removed. Hole topped with granular bentonite, sealed with concrete.
