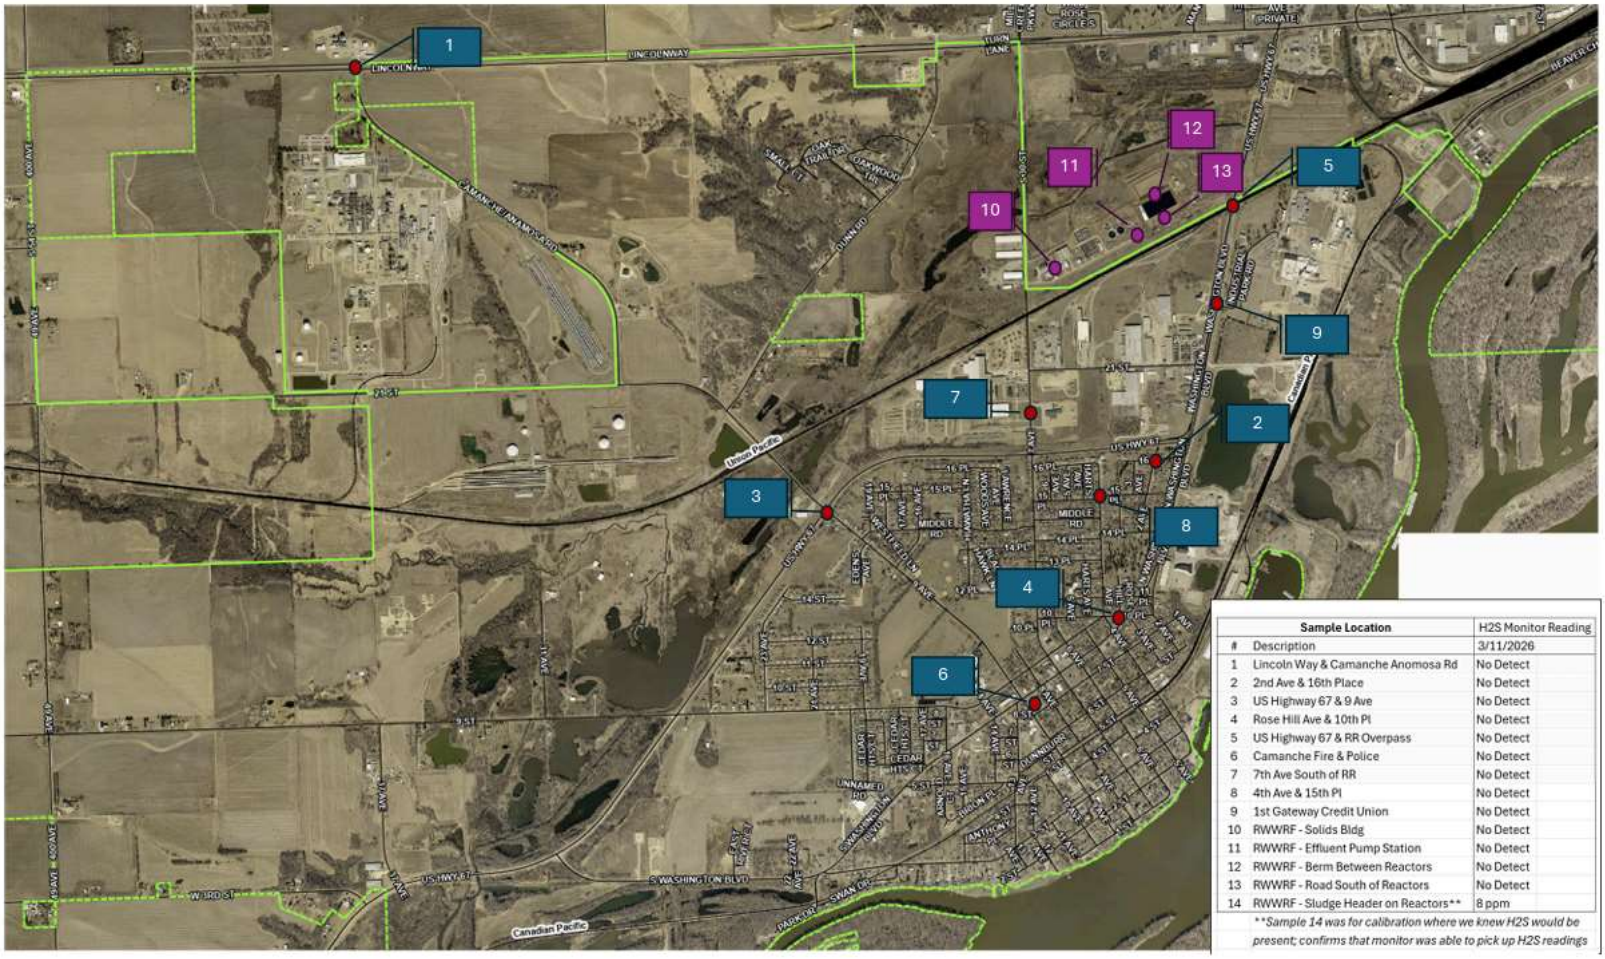
Sample Location		H2S Monitor Reading
#	Description	3/11/2026
1	Lincoln Way & Camanche Anomosa Rd	No Detect
2	2nd Ave & 16th Place	No Detect
3	US Highway 67 & 9 Ave	No Detect
4	Rose Hill Ave & 10th Pl	No Detect
5	US Highway 67 & RR Overpass	No Detect
6	Camanche Fire & Police	No Detect
7	7th Ave South of RR	No Detect
8	4th Ave & 15th Pl	No Detect
9	1st Gateway Credit Union	No Detect
10	RWWRF - Solids Bldg	No Detect
11	RWWRF - Effluent Pump Station	No Detect
12	RWWRF - Berm Between Reactors	No Detect
13	RWWRF - Road South of Reactors	No Detect
14	RWWRF - Sludge Header on Reactors**	8 ppm

***Sample 14 was for calibration where we knew H2S would be present; confirms that monitor was able to pick up H2S readings*
