RE: Post-Closure Care - Reduction Termination Plan
Proposed End to Regulation under IAC 567, Chapter 113 and Proposed End to the Closure Permit

Bremer County Sanitary Landfill, IDNR Permit #09-SDP-01-75C

SITE PLAN

BREMER COUNTY SANITARY LANDFILL
WAVERLY, IOWA

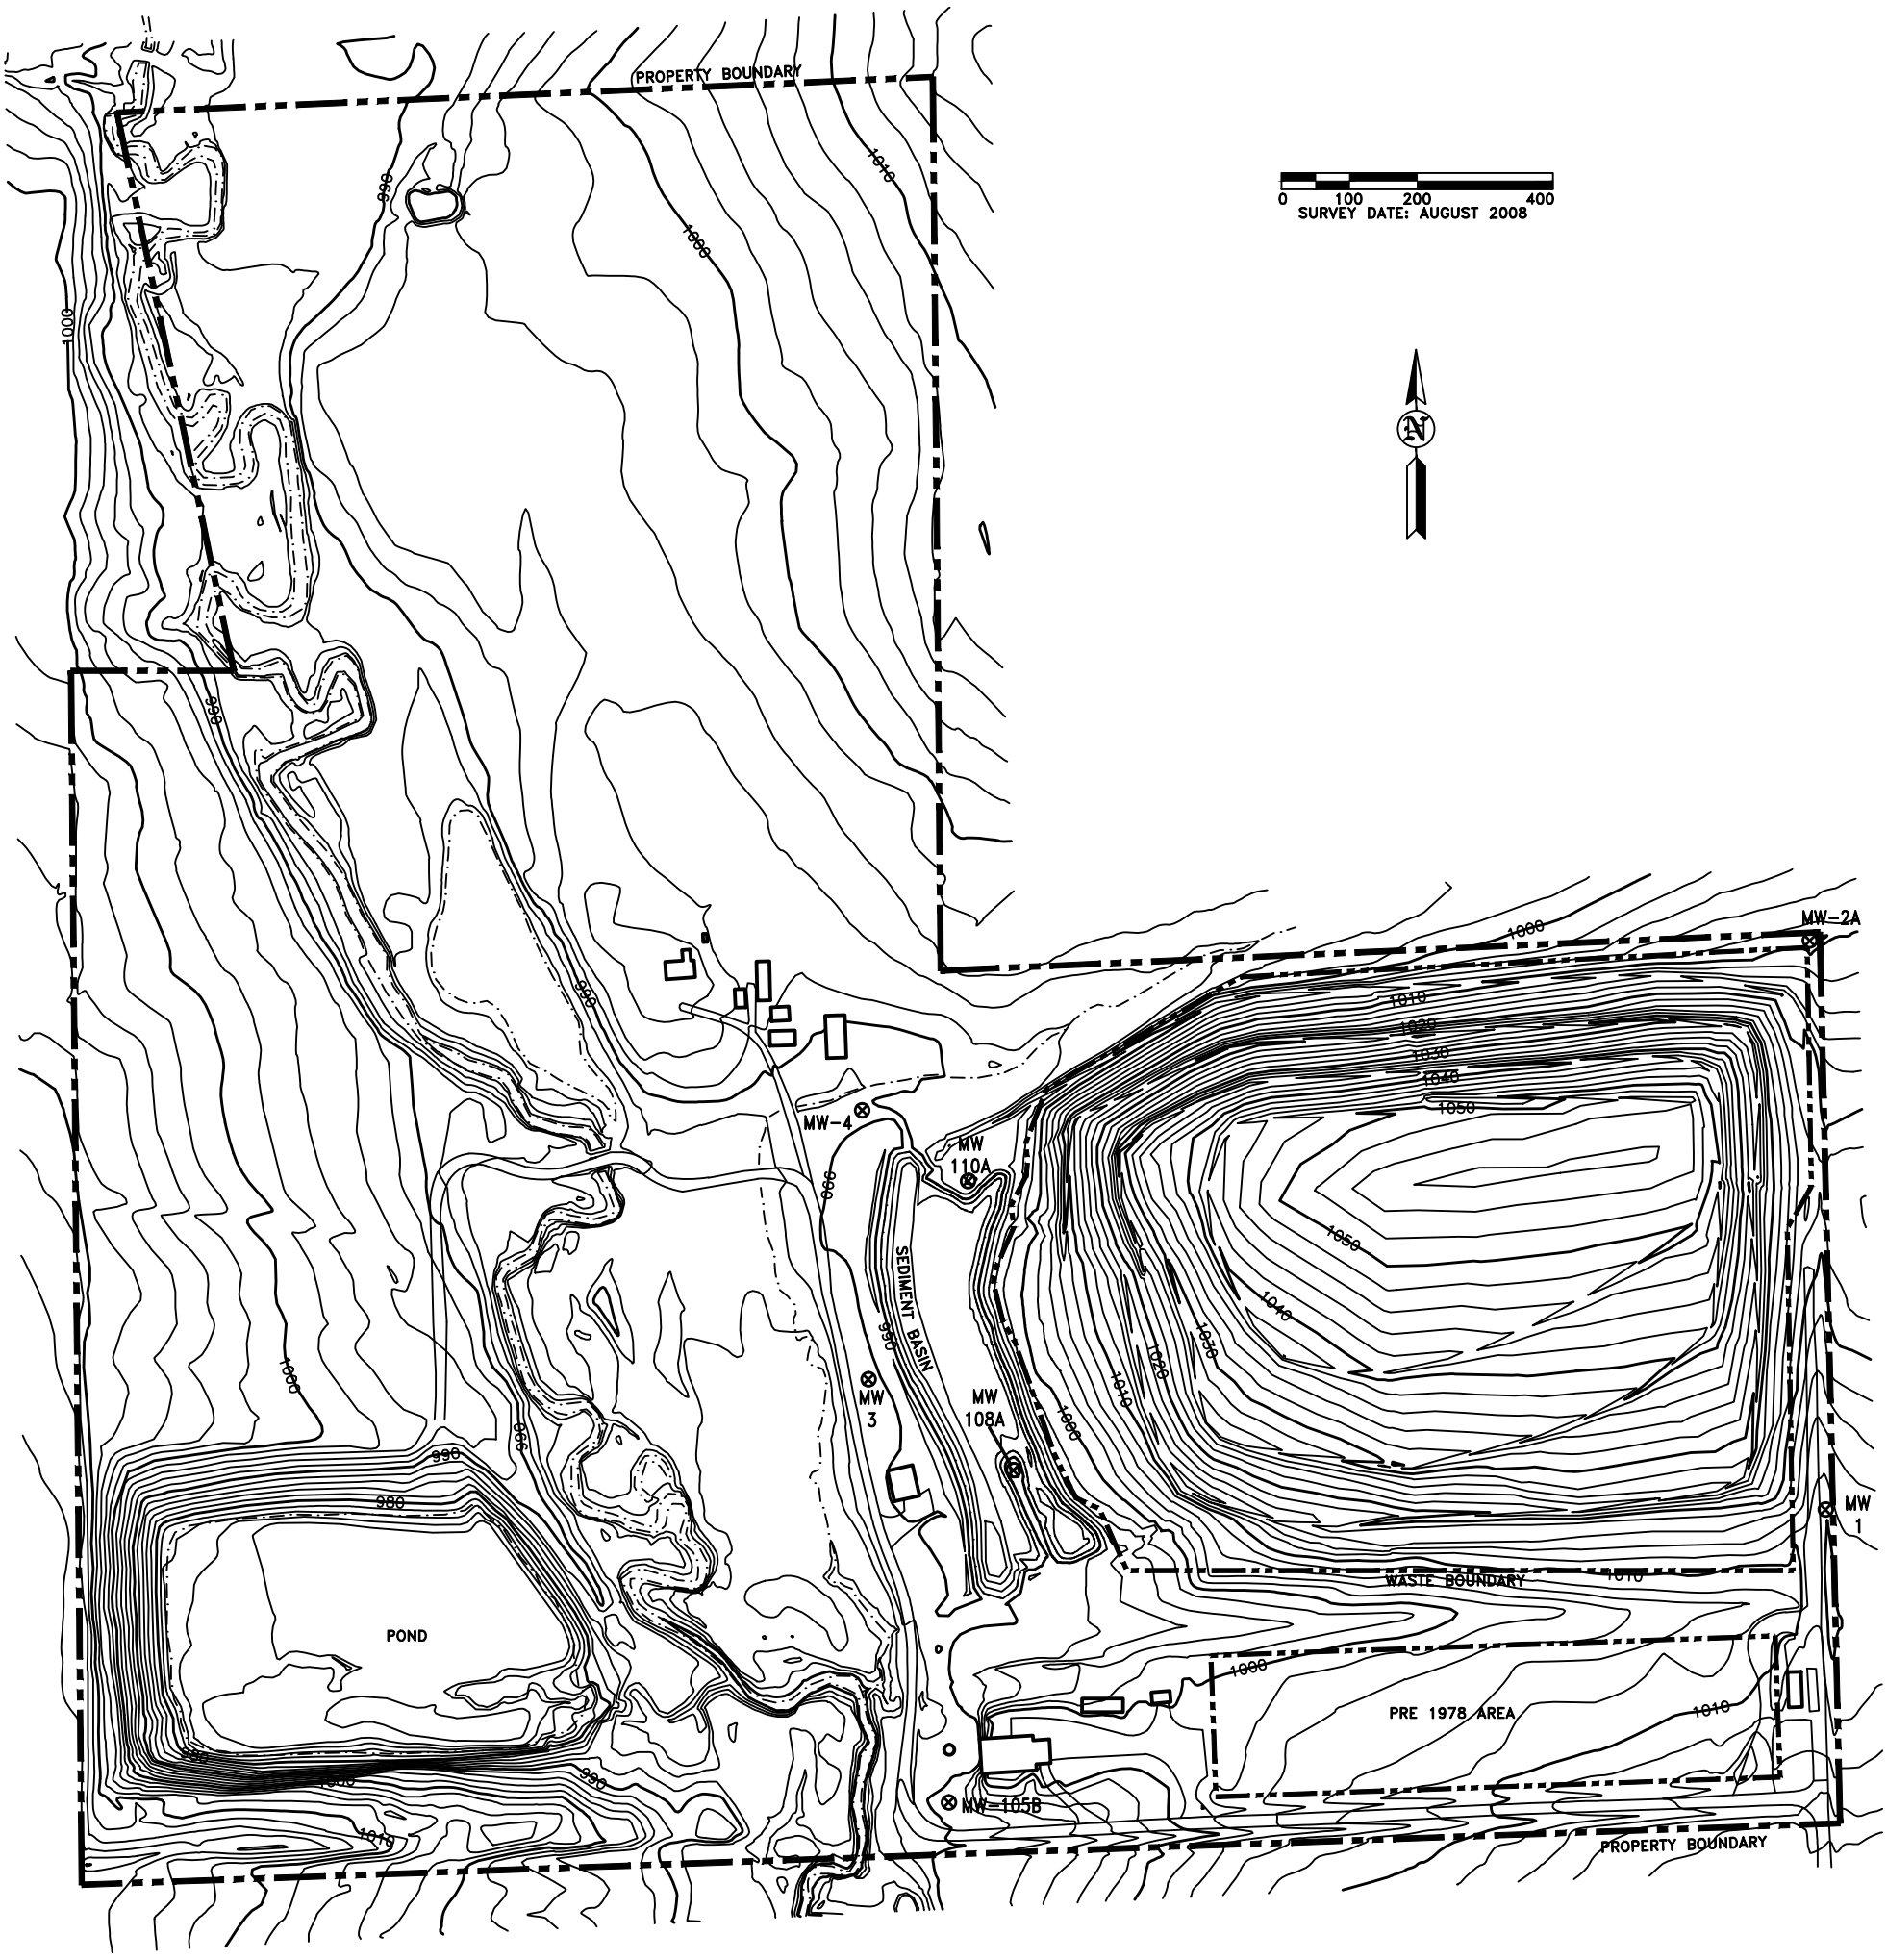
FIGURE: 1

This Post-Closure Care Reduction-Termination Plan (PCC RTP) is offered to satisfy the requirements under paragraph 1.b. of the April 17, 2024(sic) IDNR Letter (Doc #112883)). Figure 1, Site Plan, is attached illustrating the site features, monitoring wells, and gas probes.

Landfill gas was historically monitored in the breathing zone at the site perimeter. Between 2018 and the present, subsurface landfill gas has been monitored in the headspace of dedicated subsurface gas monitoring probes GP-1 through GP-5.

Since subsurface monitoring began in 2018 (as percent of the lower explosive limit) no explosive gas has been detected to date at any subsurface monitoring point at the site. The concentrations of subsurface gas monitoring are all reported as 0% LEL in the dedicated gas probe during each monitoring episode. Water level measurements collected at the time of gas monitoring indicate that all subsurface probes are open to the vadose zone.

In 2022, sixteen (16) passive landfill gas vents were installed through the cap of the landfill to augment source control at the site and to improve landfill cap vegetation. Record information for the vent installations was submitted to the IDNR on July 15, 2022 (Doc #103616). The vents are documented as passively venting gas from the landfill and vegetation is improved

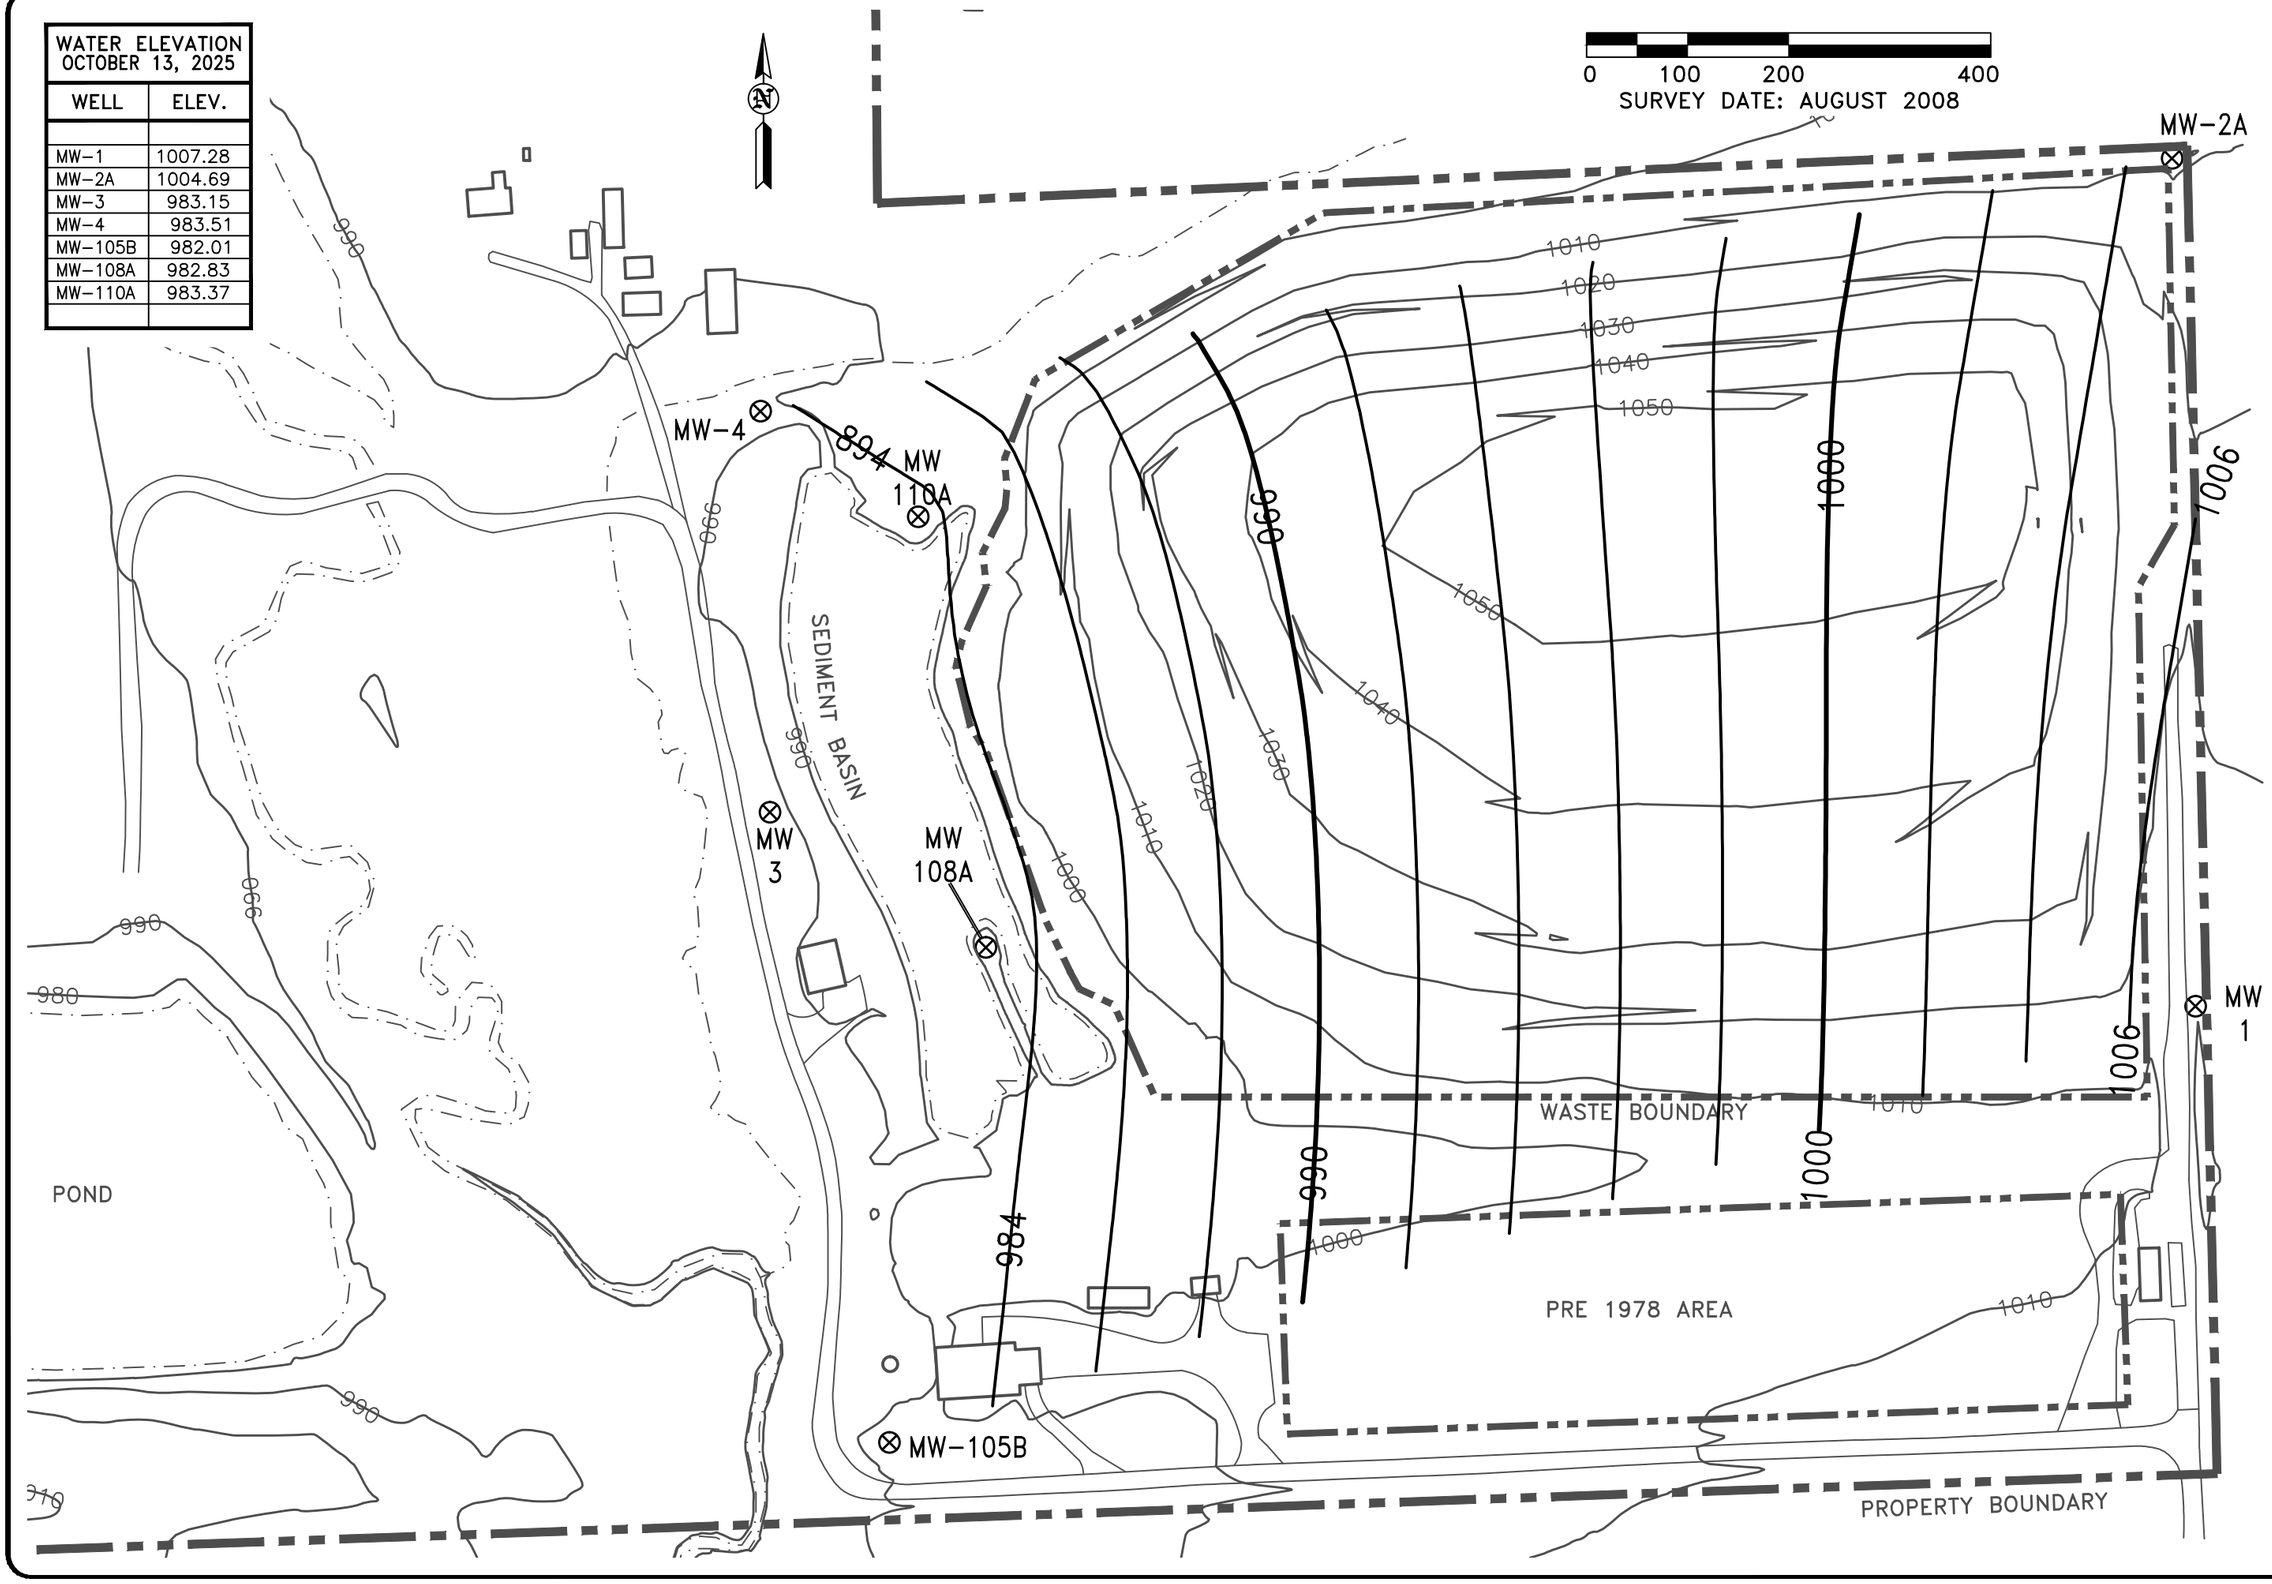
FIGURE: 3

WATER ELEVATION OCTOBER 13, 2025	
WELL	ELEV.
MW-1	1007.28
MW-2A	1004.69
MW-3	983.15
MW-4	983.51
MW-105B	982.01
MW-108A	982.83
MW-110A	983.37
