February 1, 2002

**Subject:** 3M Ames Iowa

**DESCRIPTION OF FINDINGS**

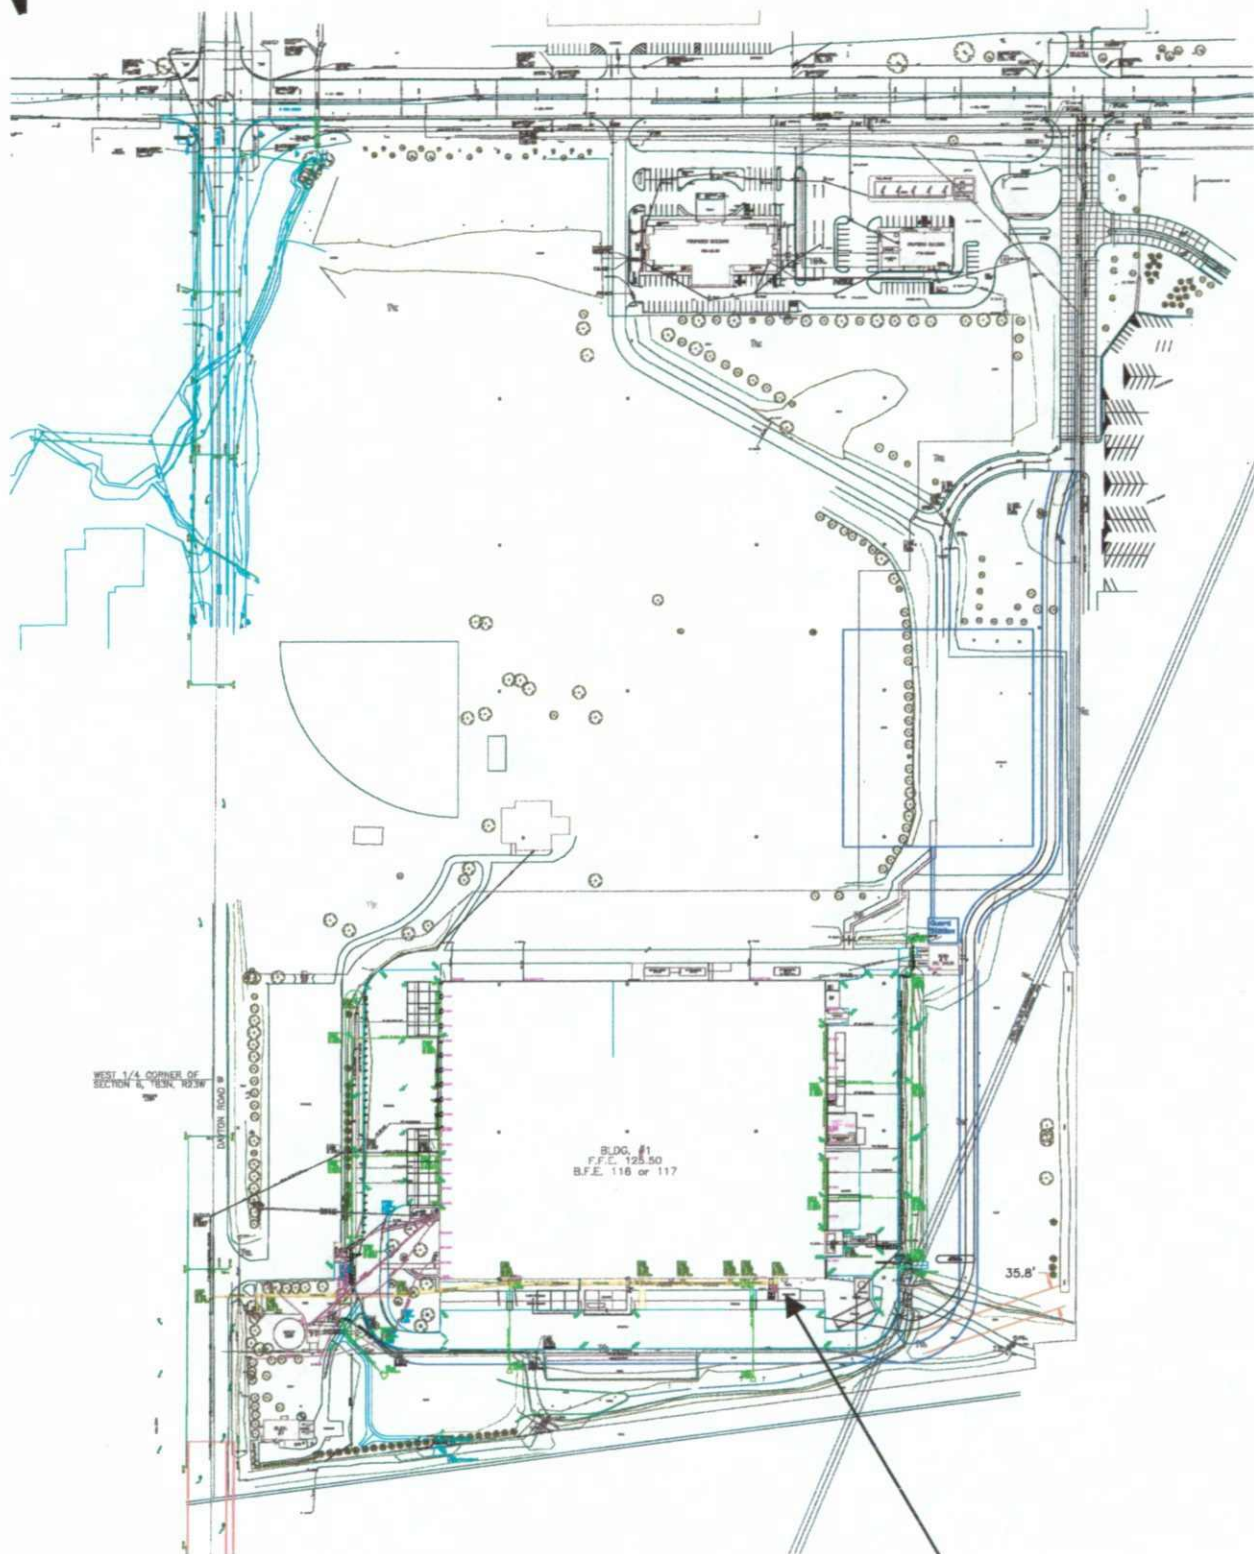
Figure 5- Facility Overview

The Facility has been in operation since 1970 and has primarily manufactured abrasives, such as sandpaper. The facility also manufactured Trinata Tile during the late 70s and early 80s. Figure 5, shows an overview of the facility with an arrow pointing to the construction area of interest.

Area of Interest
