Re: Cedar Valley Recycling and Transfer Stormwater Compliance Inspection

REPORT OF COMPLIANCE EVALUATION INSPECTION
(INDUSTRIAL STORMWATER)

AT
Cedar Valley Recycling & Transfer
1920 Water Street
Waterloo, Iowa 50703

ON
MAY 10 AND 12, 2022

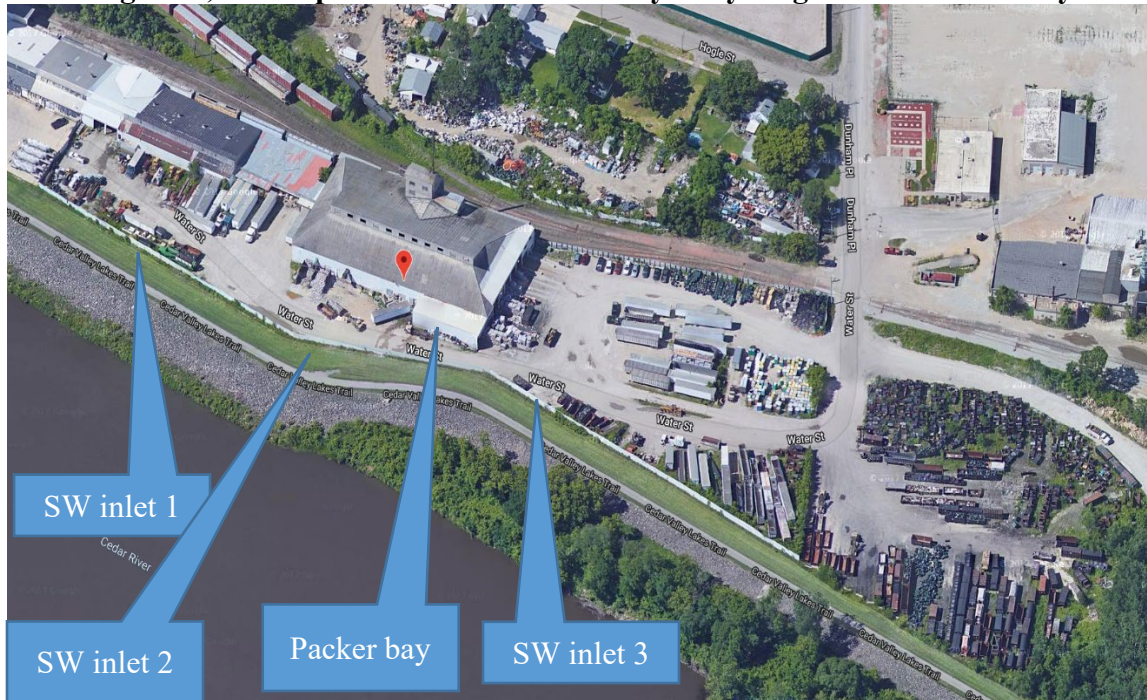
Figure 1, Aerial photo of the Cedar Valley Recycling & Transfer facility

The facility also stores empty and full open-top containers. Containers usually full of material received and/or material ready to be hauled doff. In addition, proceed material also stored outdoor exposed to stormwater (Figure 1).

Generally, surface runoff would flow west and southwest towards the three stormwater inlets located along the west fence line. The three inlets discharge to the Waterloo Municipal Separate Stormwater Sewer System (MS4) which discharge directly to the Cedar River. Surface runoff would also leave the site from beneath the west fence line into the grassy area long the levee.

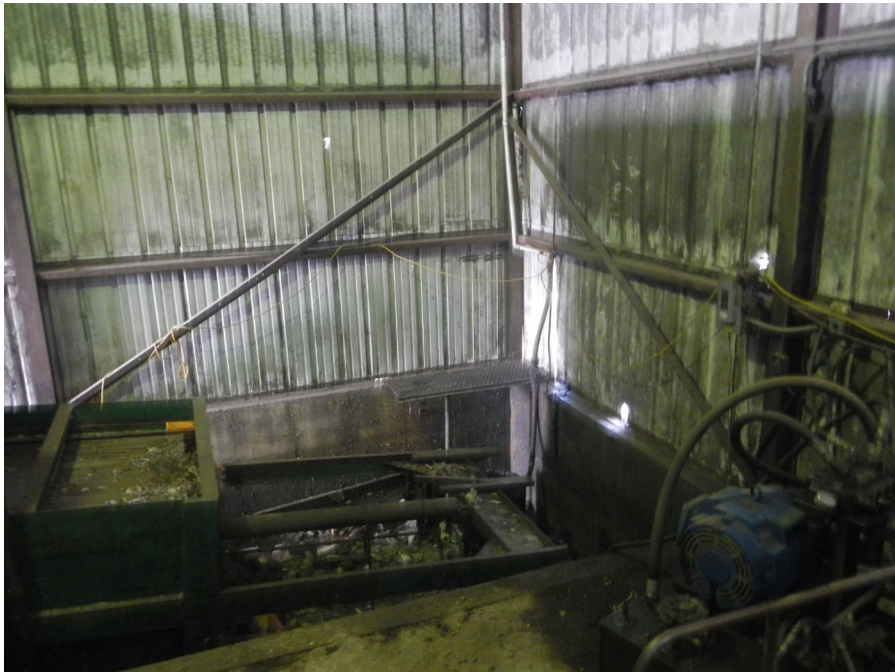
Industrial Stormwater Inspection Direction: West	DESCRIPTION	Compactor pit.	DSCN1203
	PHOTOGRAPHER	Naji J. Ahmad 913 551 7190	Date: 05/10/2022

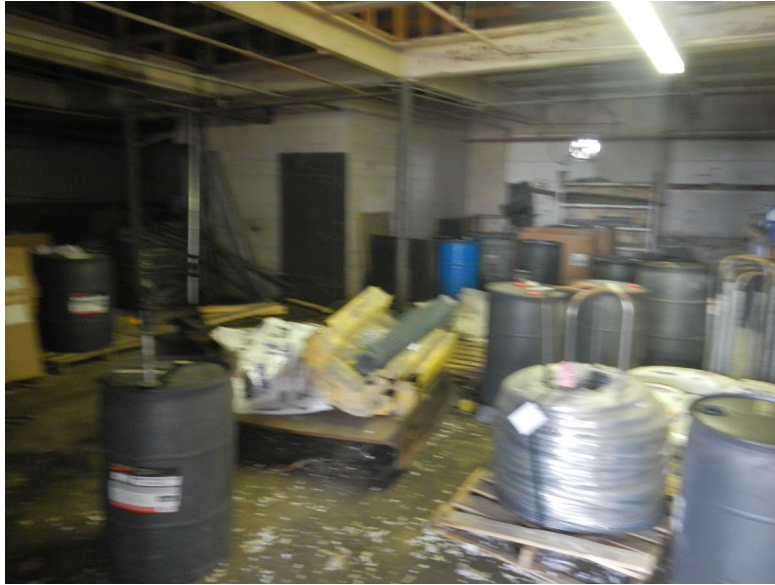
Industrial Stormwater Inspection Direction: SE	DESCRIPTION	Storage area.	DSCN1204
	PHOTOGRAPHER	Naji J. Ahmad 913 551 7190	Date: 05/10/2022

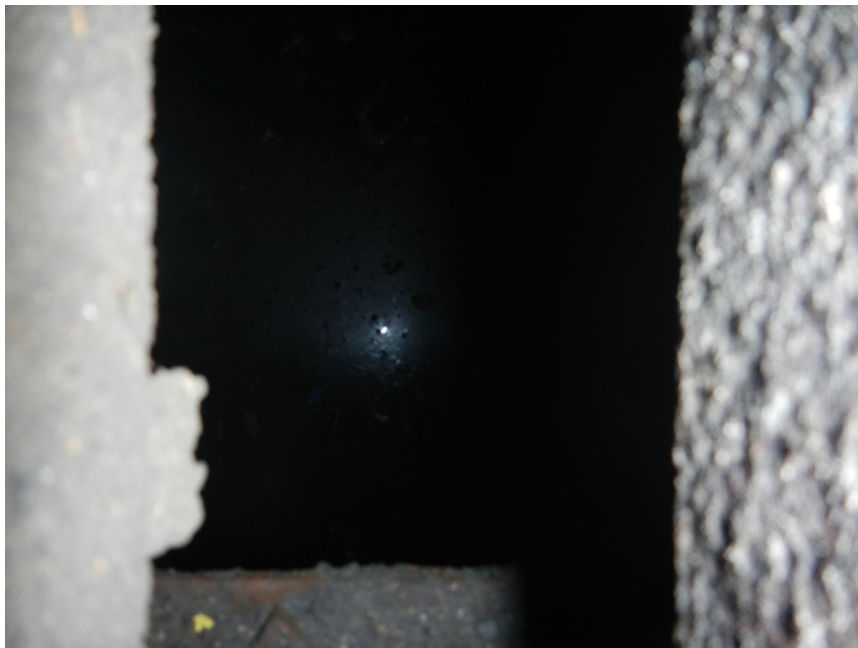
Industrial Stormwater Inspection Direction: West	DESCRIPTION	Inside of the floor pit	DSCN1205
	PHOTOGRAPHER	Naji J. Ahmad 913 551 7190	Date: 05/10/2022

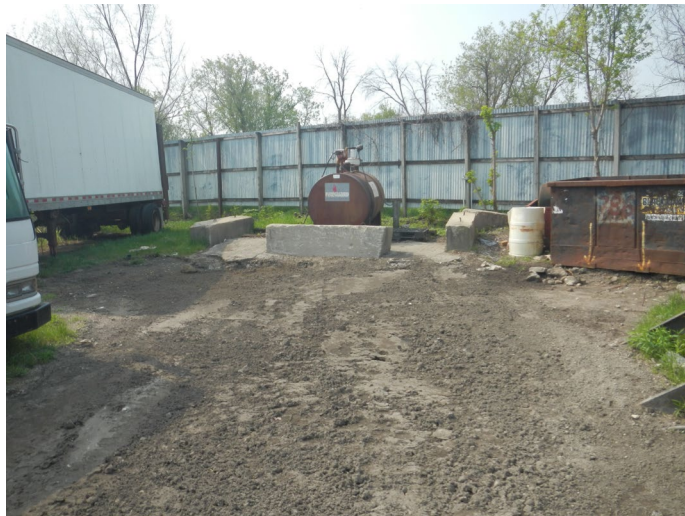
Industrial Stormwater Inspection Direction: West	DESCRIPTION	AST storage tank within a containment.	DSCN1221
	PHOTOGRAPHER	Naji J. Ahmad 913 551 7190	Date: 05/10/2022

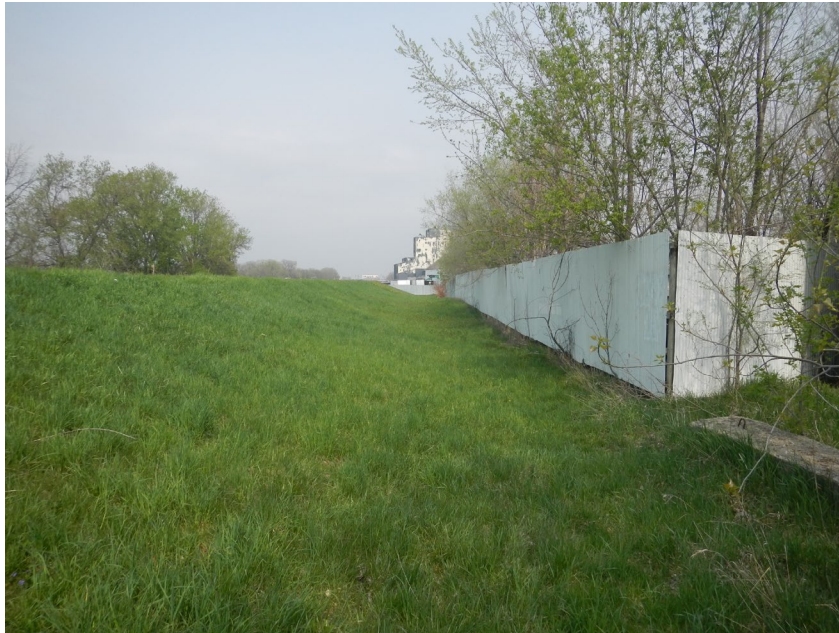
Industrial Stormwater Inspection Direction: SE	DESCRIPTION	Grassy area beyond the facility fence along the levee.	DSCN1222
	PHOTOGRAPHER	Naji J. Ahmad 913 551 7190	Date: 05/10/2022

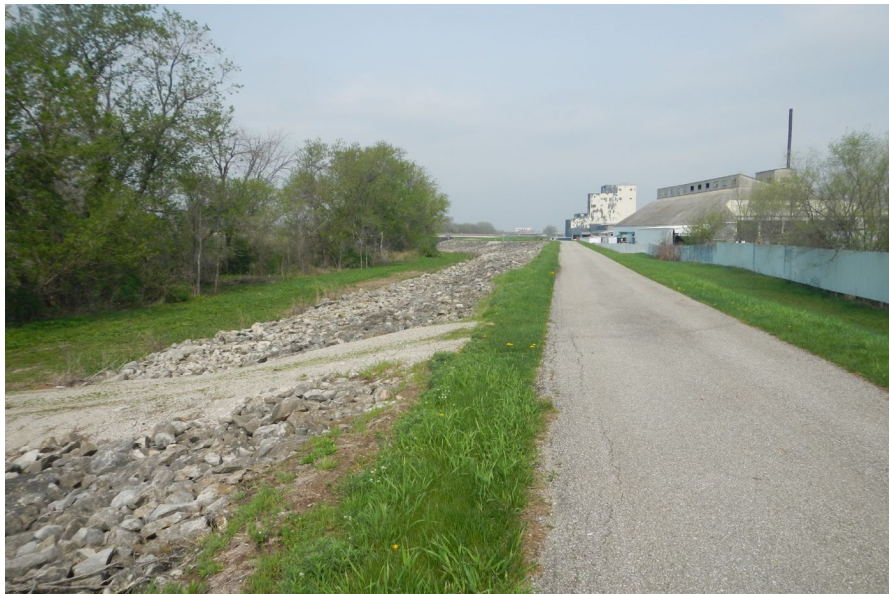
Industrial Stormwater Inspection Direction: West	DESCRIPTION	The levee along Cedar River.	DSCN1223
	PHOTOGRAPHER	Naji J. Ahmad 913 551 7190	Date: 05/10/2022

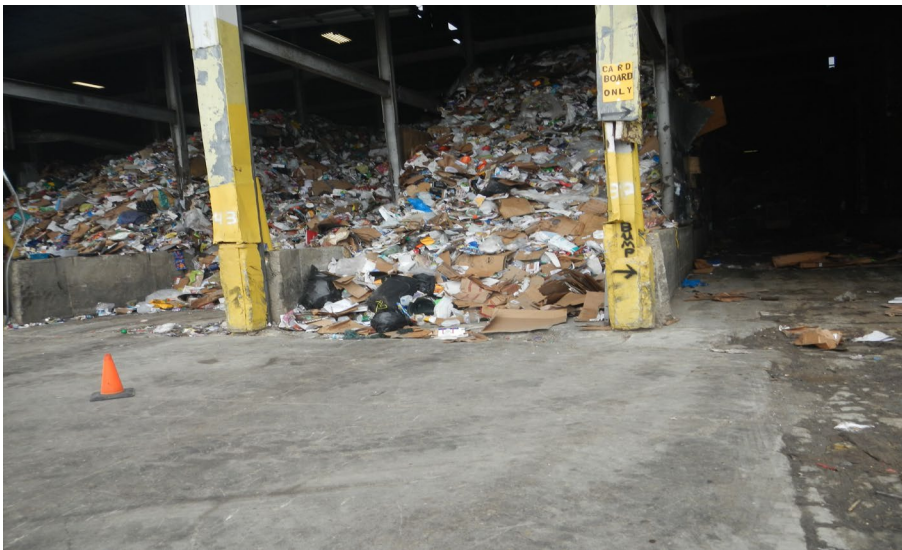
Industrial Stormwater Inspection Direction: West	DESCRIPTION	Receiving bay.	DSCN1227
	PHOTOGRAPHER	Naji J. Ahmad 913 551 7190	Date: 05/10/2022
