RE: Humboldt County Sanitary Landfill - Spring 2025 Biennial Landfill Inspection Report
Permit #46-SDP-02-83C; Evergreen Engineers #9041

Humboldt County Sanitary Landfill

Spring 2025 Biennial Landfill Inspection Report

Evergreen Engineers Project #9041

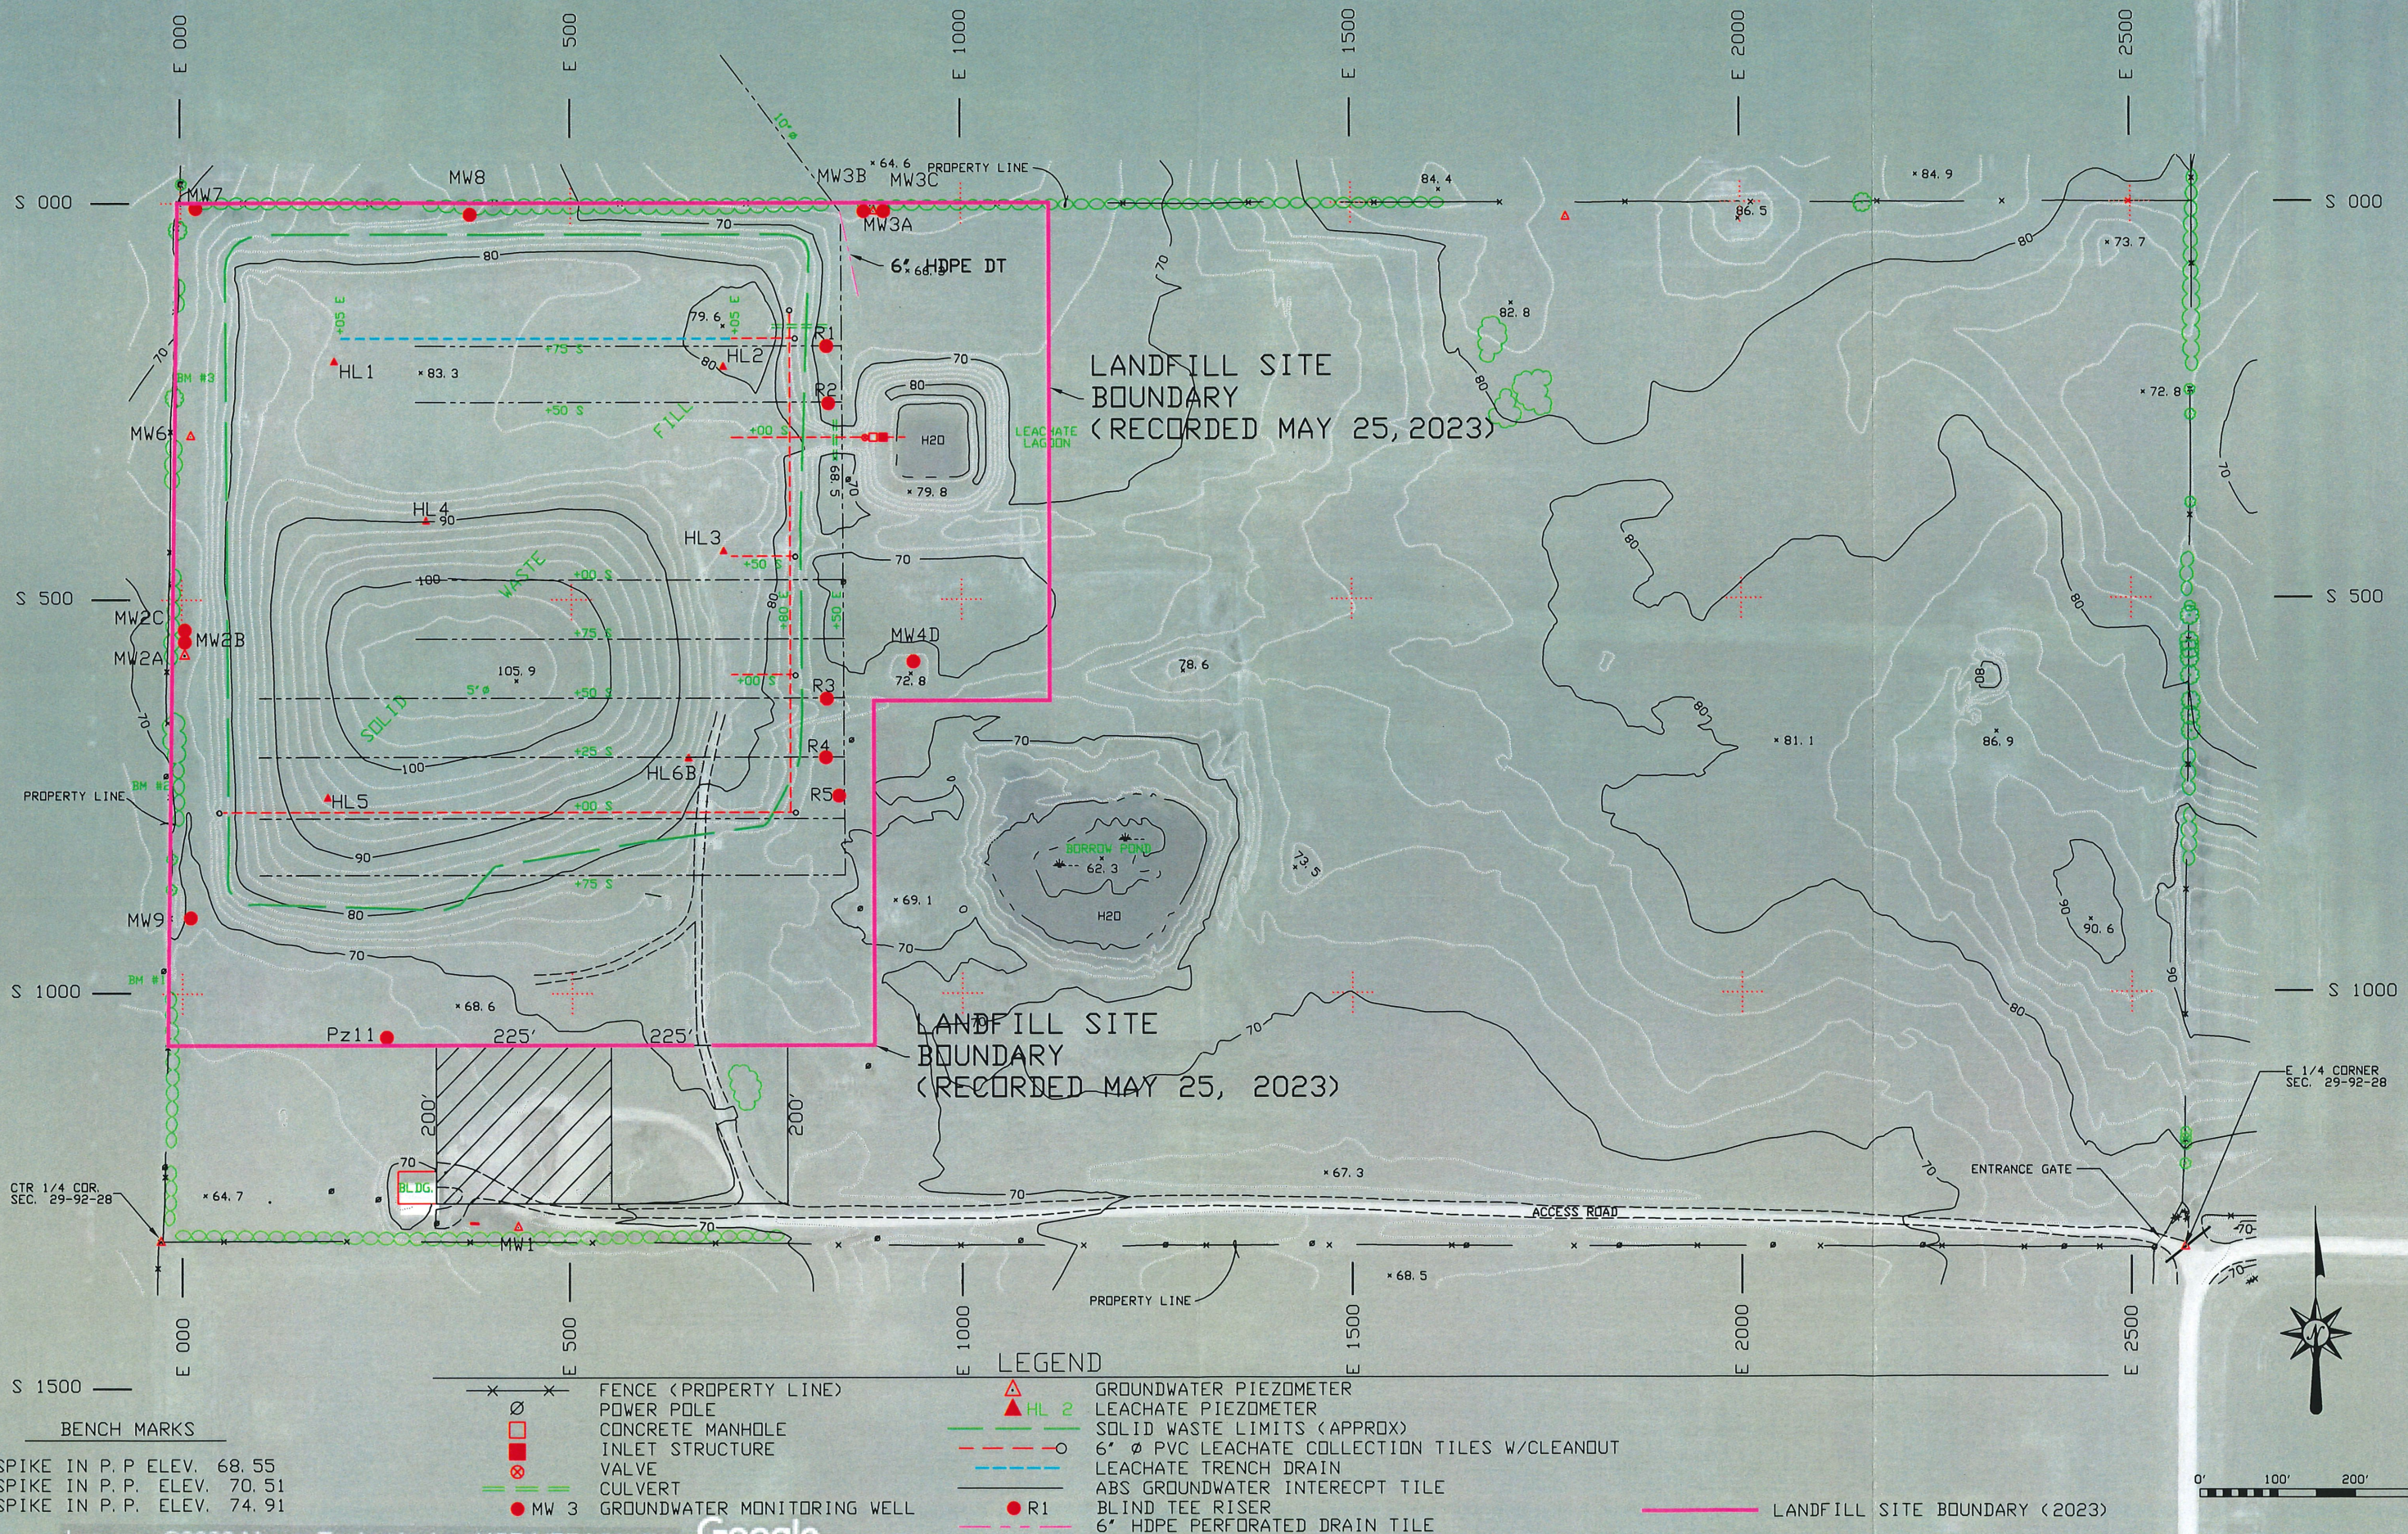
Photos were taken of the north side of the landfill, showing the repaired areas over old trench-filled solid waste locations.
