**EnviroNET, Inc.**  
**Professional Environmental Services**  
**1225 East River Drive #101**  
**Davenport, IA 52803-5752**  
**WOSB, SBA, & BBB CERTIFIED**

**REFERENCE: 2026 FALL SEMI-ANNUAL ENGINEERING INSPECTION REPORT**  
**CONTINENTAL CEMENT – DAVENPORT CKD LANDFILL**  
**301 EAST FRONT STREET, BUFFALO, IA 52728**  
**PERMIT NOS. 82-SDP-16-97P AND 82-SDP-15-96C**

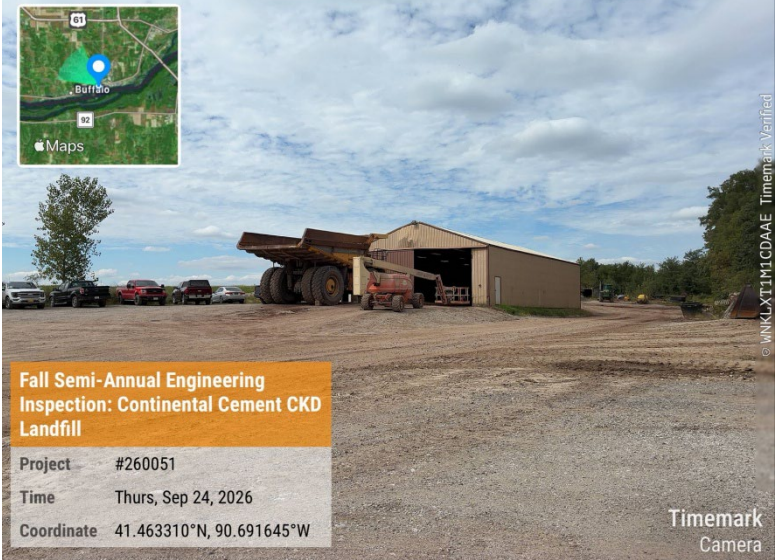
| Enviro <b>NET</b> Inc. | | PHOTOGRAPH LOG | |
|---|---|---|---|
| <b>Photo No.</b><br>6 | <b>Date:</b><br>09/24/2026 | | |

| Enviro <b>NET</b> Inc. | | PHOTOGRAPH LOG | |
|---|---|---|---|
| <b>Description:</b><br>View looking northwest at access road on the east side of the landfill. Earthwork contractor, Grey Rock, equipment and parking area also in view. | | | |

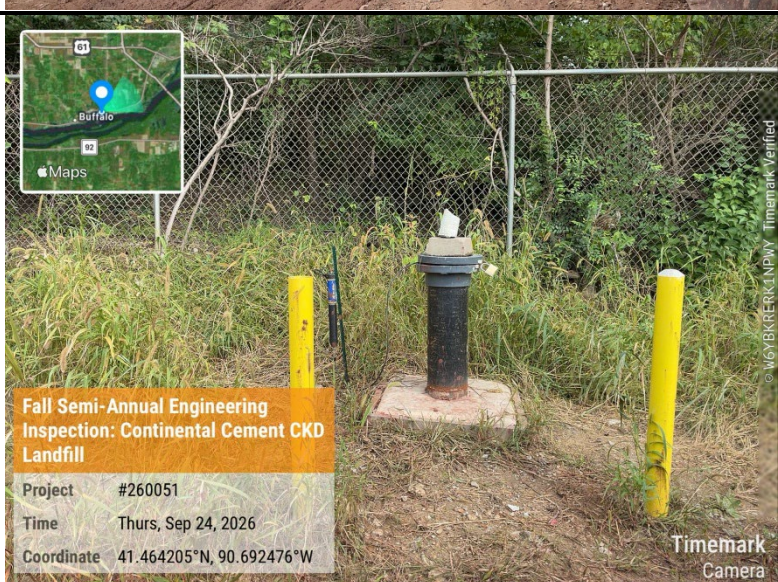
| Enviro <b>NET</b> Inc. | | PHOTOGRAPH LOG | |
|---|---|---|---|
| <b>Description:</b><br>View looking east at BMW-26-02CR, which was redrilled earlier this summer. Well was locked but did not have a nameplate. Continental personnel confirmed nameplate will be installed after inspection. | | | |

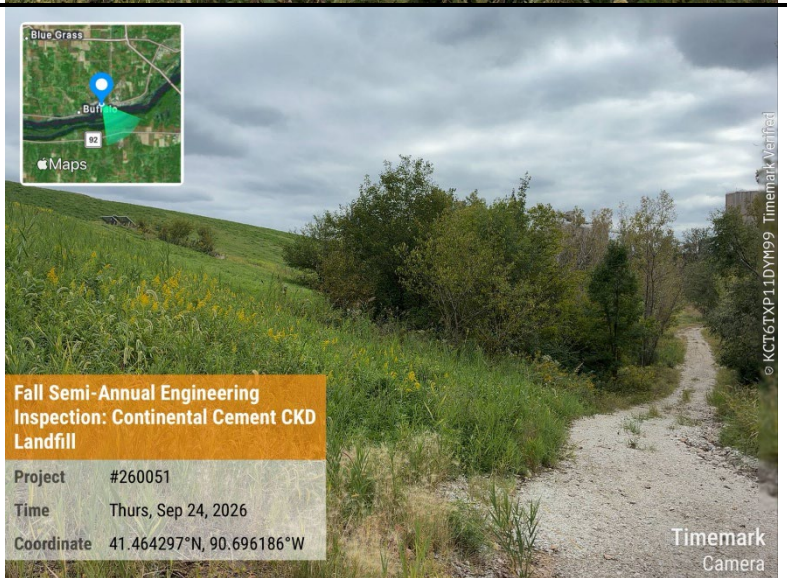
| Enviro <b>NET</b> Inc. | | PHOTOGRAPH LOG | |
|---|---|---|---|
| <b>Description:</b><br>View looking southeast along access road on the westside of the landfill area. | | | |

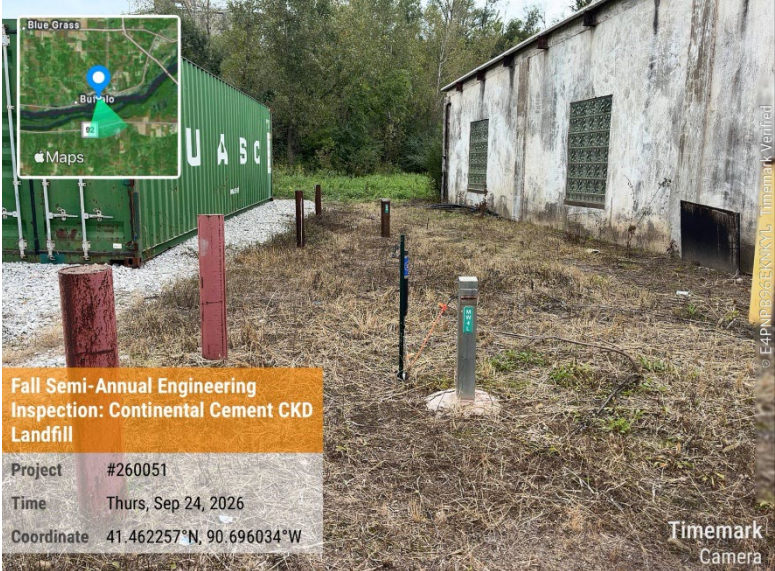
| Enviro <b>NET</b> Inc. | | PHOTOGRAPH LOG | |
|---|---|---|---|
| <b>Description:</b><br>View looking south at monitoring wells MW-4, MW4L, & MW-18 located near the Quarry Building. Wells were locked and had nameplates at time of inspection. | | | |

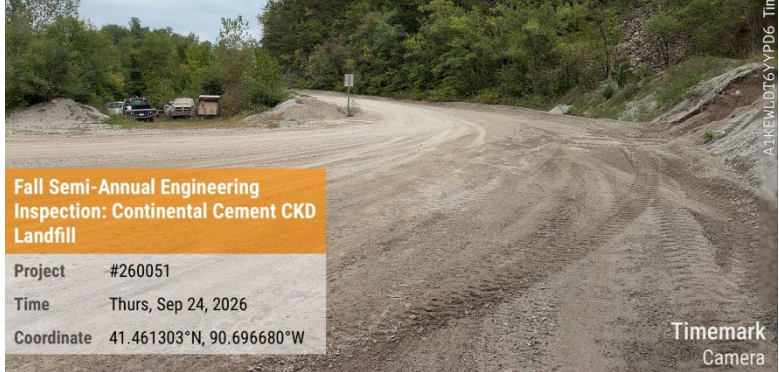
| Enviro <b>NET</b> Inc. | | PHOTOGRAPH LOG | |
|---|---|---|---|
| <b>Description:</b><br>View of access road leading out of the landfill area. | | | |
