Re: FW: Marion Lofts- Follow-up

Thanks for the information, there are multiple concerns with the 2010 Phase II as noted in the following:

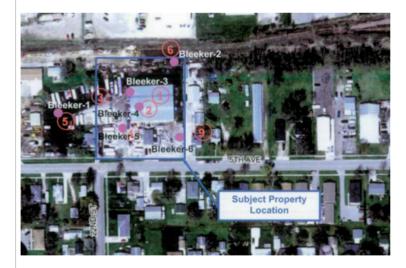
Thank you very much for the response. Below is an excerpt from the Phase II that was performed in September 2010 for the City of Marion showing the areas that were tested on the Bleeker property and the recommendations of the Environmental Consultant.

It appears that from the image above as it compares to the map you provided, the areas in question (shingle area and machine shop) were tested and were below cumulative cancer and noncancer risk regulatory limits for both a site worker and a site resident. Additionally, the consultant did recommend providing this report to the IDNR for review and a request for a No Further Action Letter. Attached, please find a letter dated November 11, 2011 stating that no follow-up action is required based on the Phase II findings. I also wanted to add some more commentary on the two areas mentioned in the IDNR letter:
