IOWA DEPARTMENT OF NATURAL RESOURCES  
CONSTRUCTION DOCUMENTS

FOR  
LODGE REPAIR

AT  
AA CALL STATE PARK  
KOSSUTH COUNTY, IOWA  
D1FY19-1

PROJECT #19-02-55-01  
PLANS PREPARED BY  
LAND AND WATERS BUREAU  
CONSERVATION AND RECREATION DIVISION

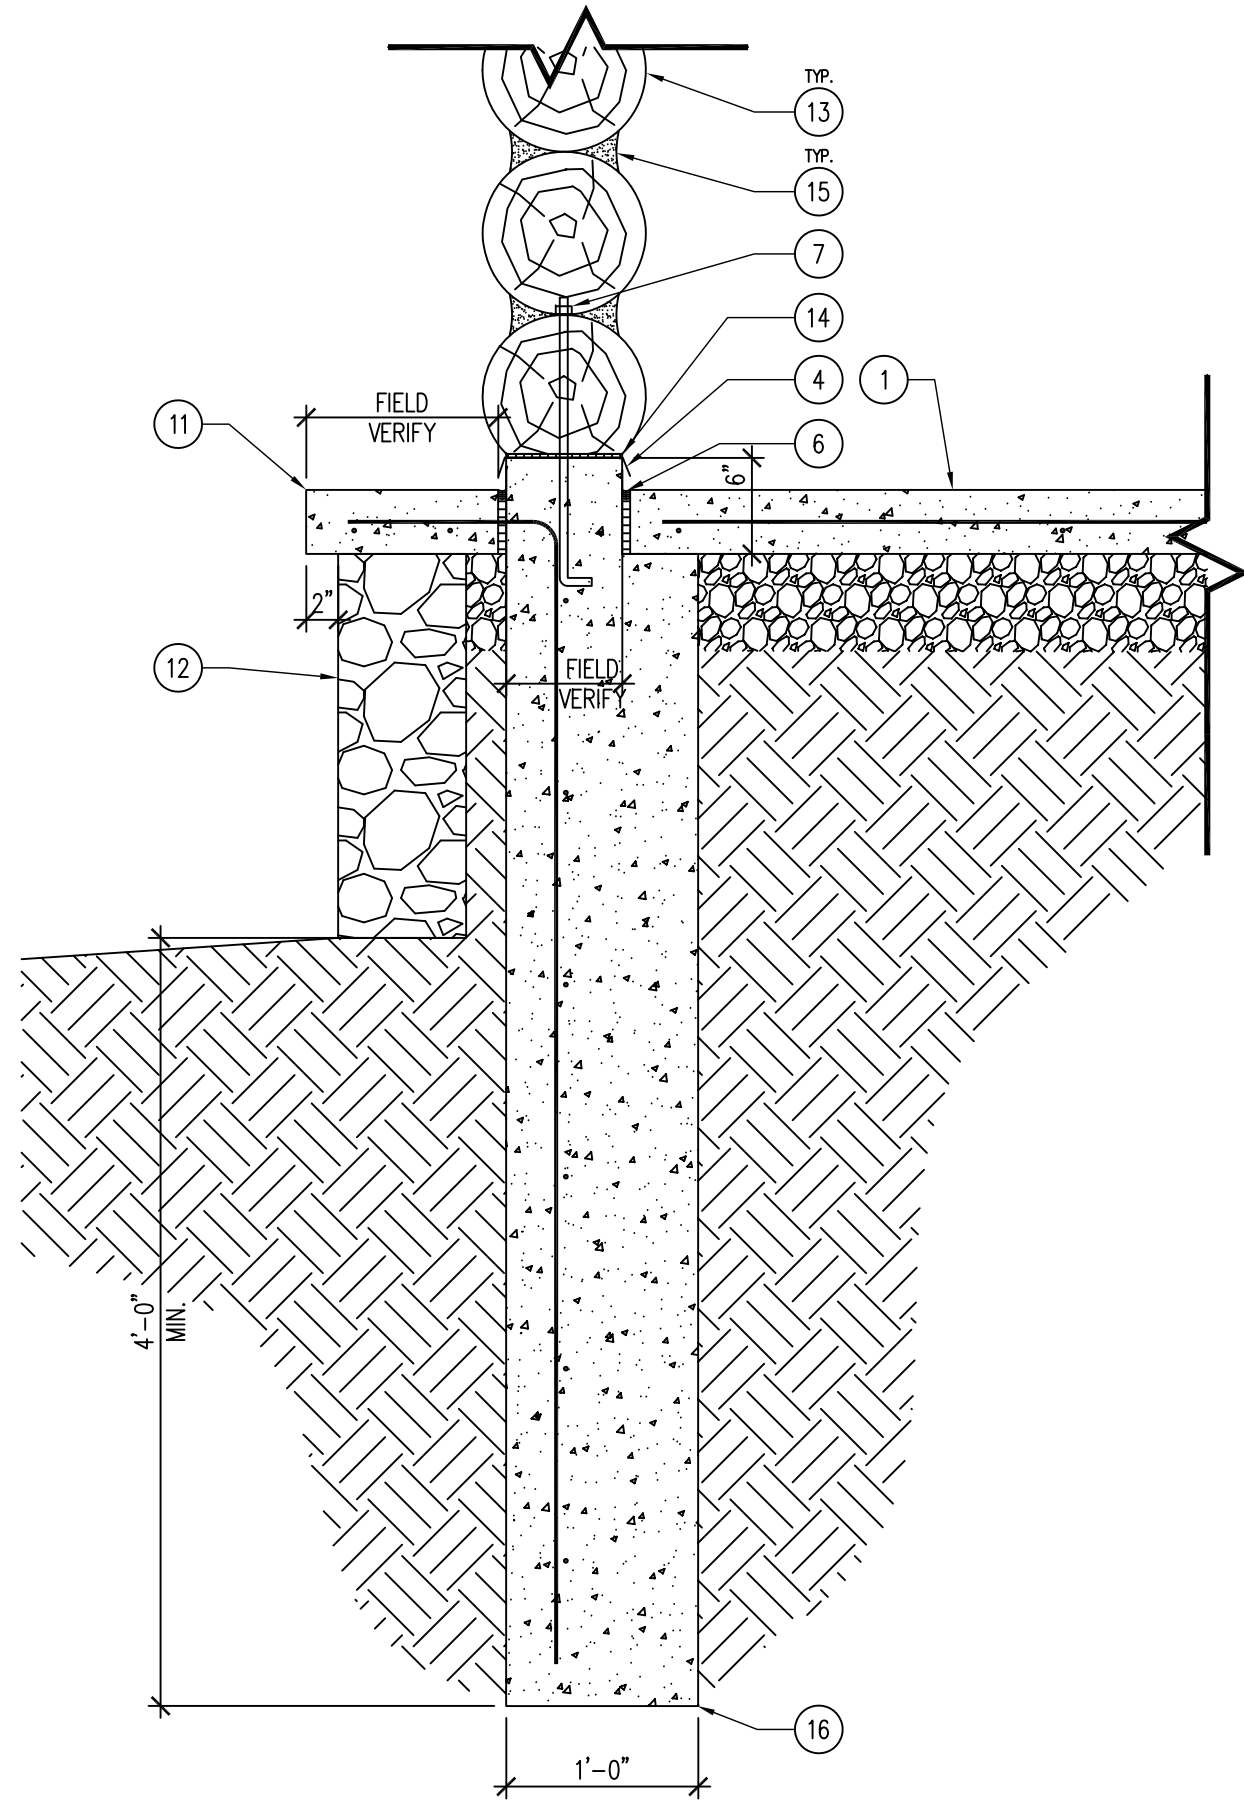
**02** PUMP HOUSE DETAIL – FOOTING & HORIZONTAL MEMBERS  
SCALE: 1" = 1'-0"

13. NEW SEASONED, WHITE OAK LOG FOR PUMPHOUSE, MATCH EXISTING LOGS DIAMETER. MATCH EXISTING LAYOUT, INSTALL CHINKING REINFORCEMENT, STAINLESS STEEL NAILS OR LATH. STAIN TO MATCH EXISTING LODGE.

CONTRACTOR SHALL REBUILD ENTIRE PUMP HOUSE WITH NEW, SEASONED, WHITE OAK LOGS OF SIMILAR DIMENSION TO EXISTING LOGS. A NEW PERIMETER FOOTING AND SLAB TO BE REPLACED AS WELL. ALL NEW CHINKING TO BE PERMA-CHINK, COLOR TO BE MEDIUM GRAY 224.

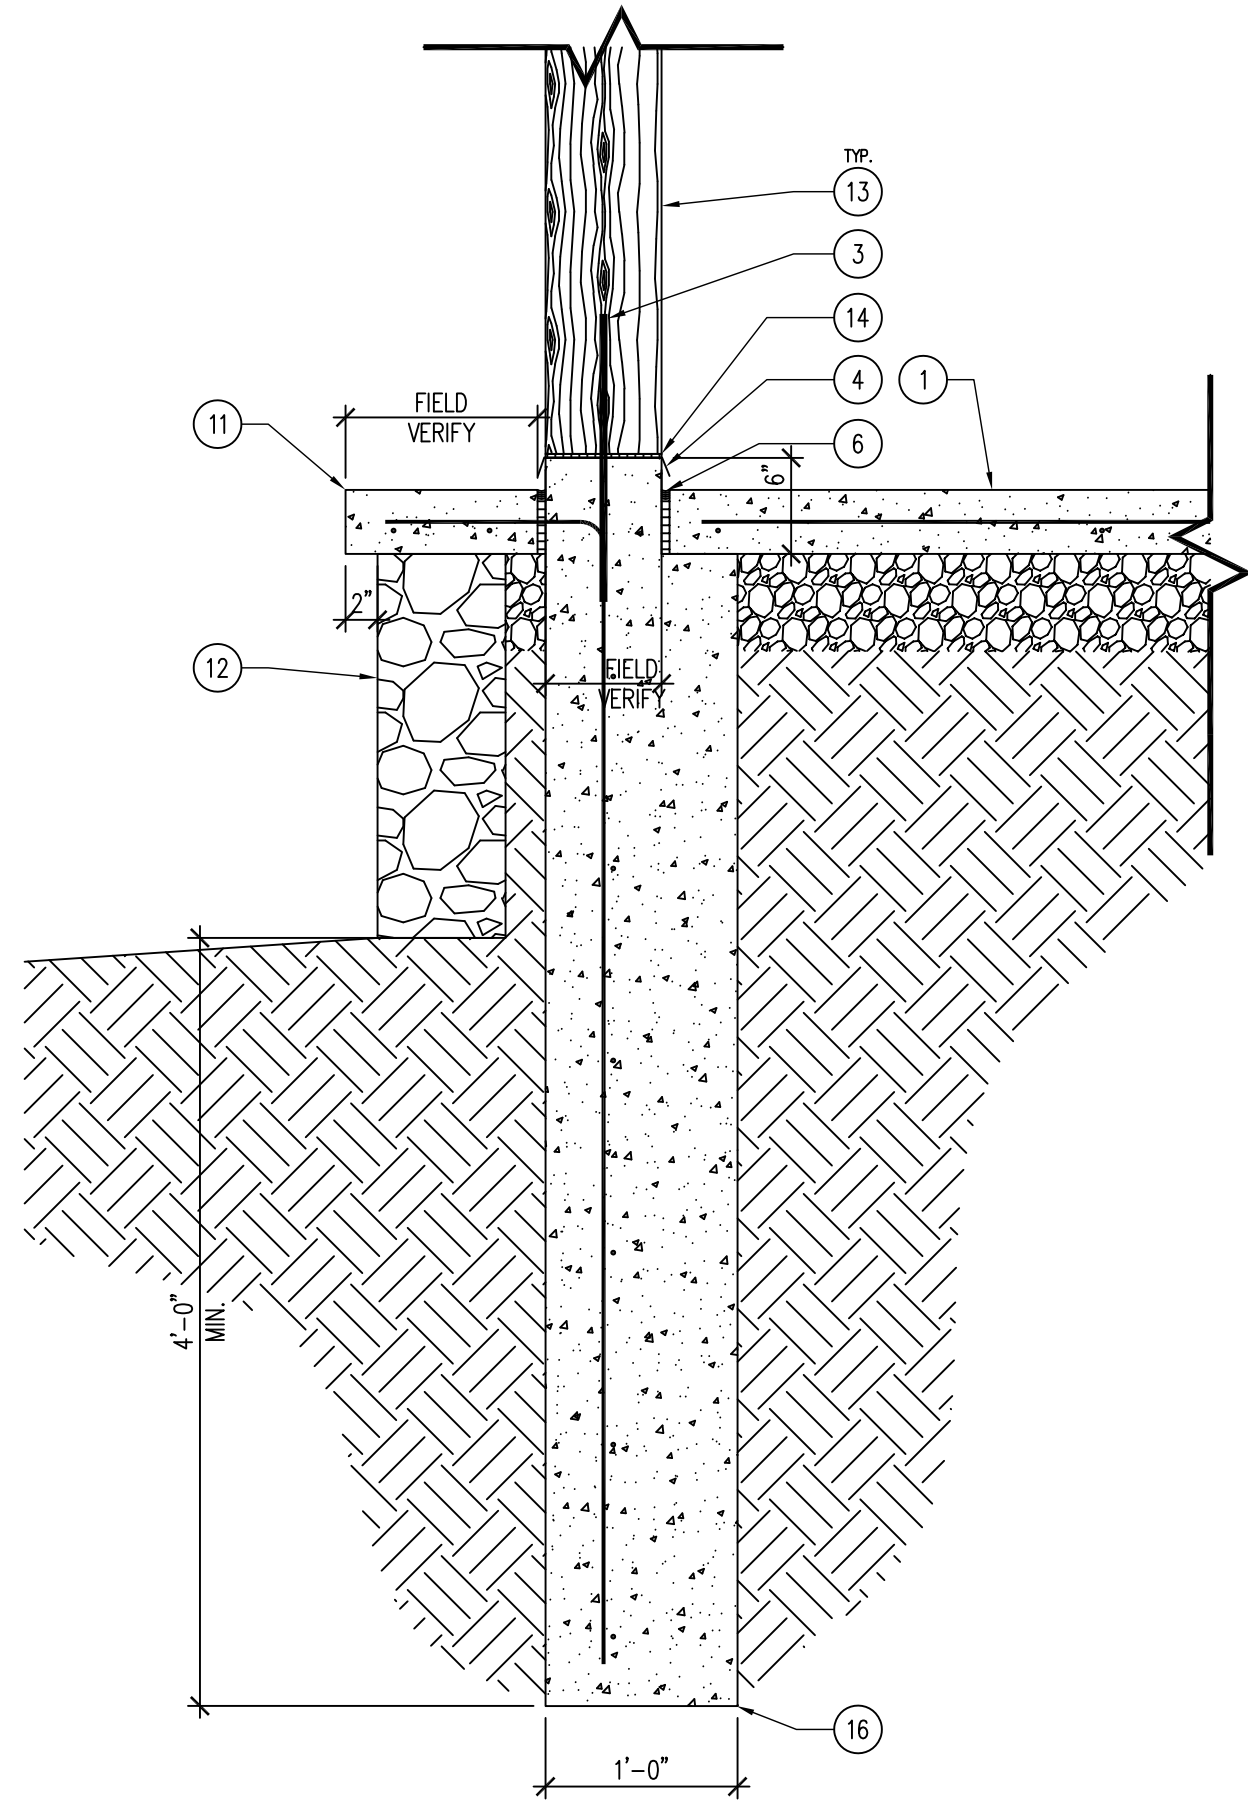
**01** PUMP HOUSE SECTION – FOOTING & VERTICAL MEMBERS  
SCALE: 1" = 1'-0"

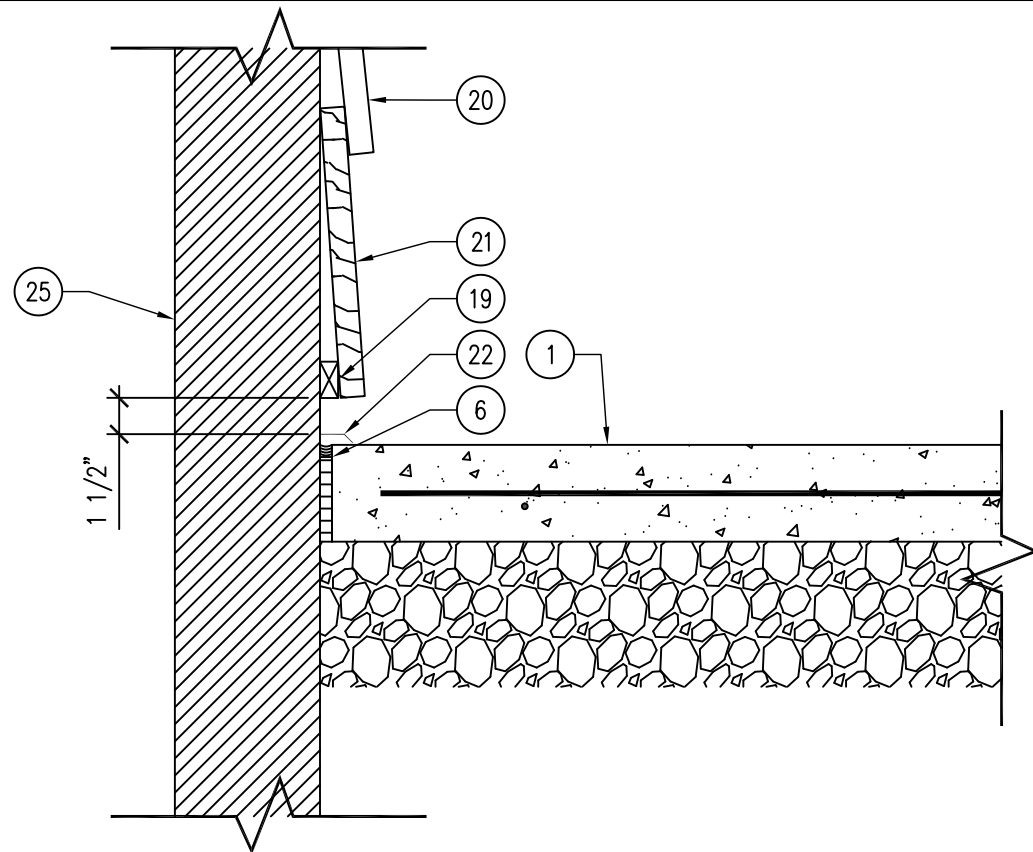
02 LODGE DETAIL – REAR KITCHEN WALL  
SCALE: 1" = 1'-0"

- A. ALL MORTAR TO BE TYPE "N" (ASTM C270), COLOR TO BE WHITE.
- B. CONTRACTOR TO THOROUGHLY CLEAN ENTIRE EXTERIOR OF LODGE AFTER COMPLETION. CONTRACTOR SHALL USE NON-IONIC DETERGENT, USING LOW-PRESSURE WASHING WITH NATURAL BRISTLE BRUSHES ON MASONRY, HIGH-PRESSURE WASH ON WOOD.
- C. ALL FASTENERS AND HARDWARE TO BE STAINLESS STEEL.
- D. CONTRACTOR TO FIELD VERIFY ALL DIMENSIONS.
- E. CONTRACTOR TO RESTORE ALL FINISHES DISTURBED IN THE PROCESS OF RESTORATION.
- F. ALL STAIN TO BE SIKKENS CETOL EXTERIOR STAIN, COLOR TO BE DETERMINED WITH COLOR MATCH SWATCHES. APPLY TWO (2) COATS TO ALL SURFACES.

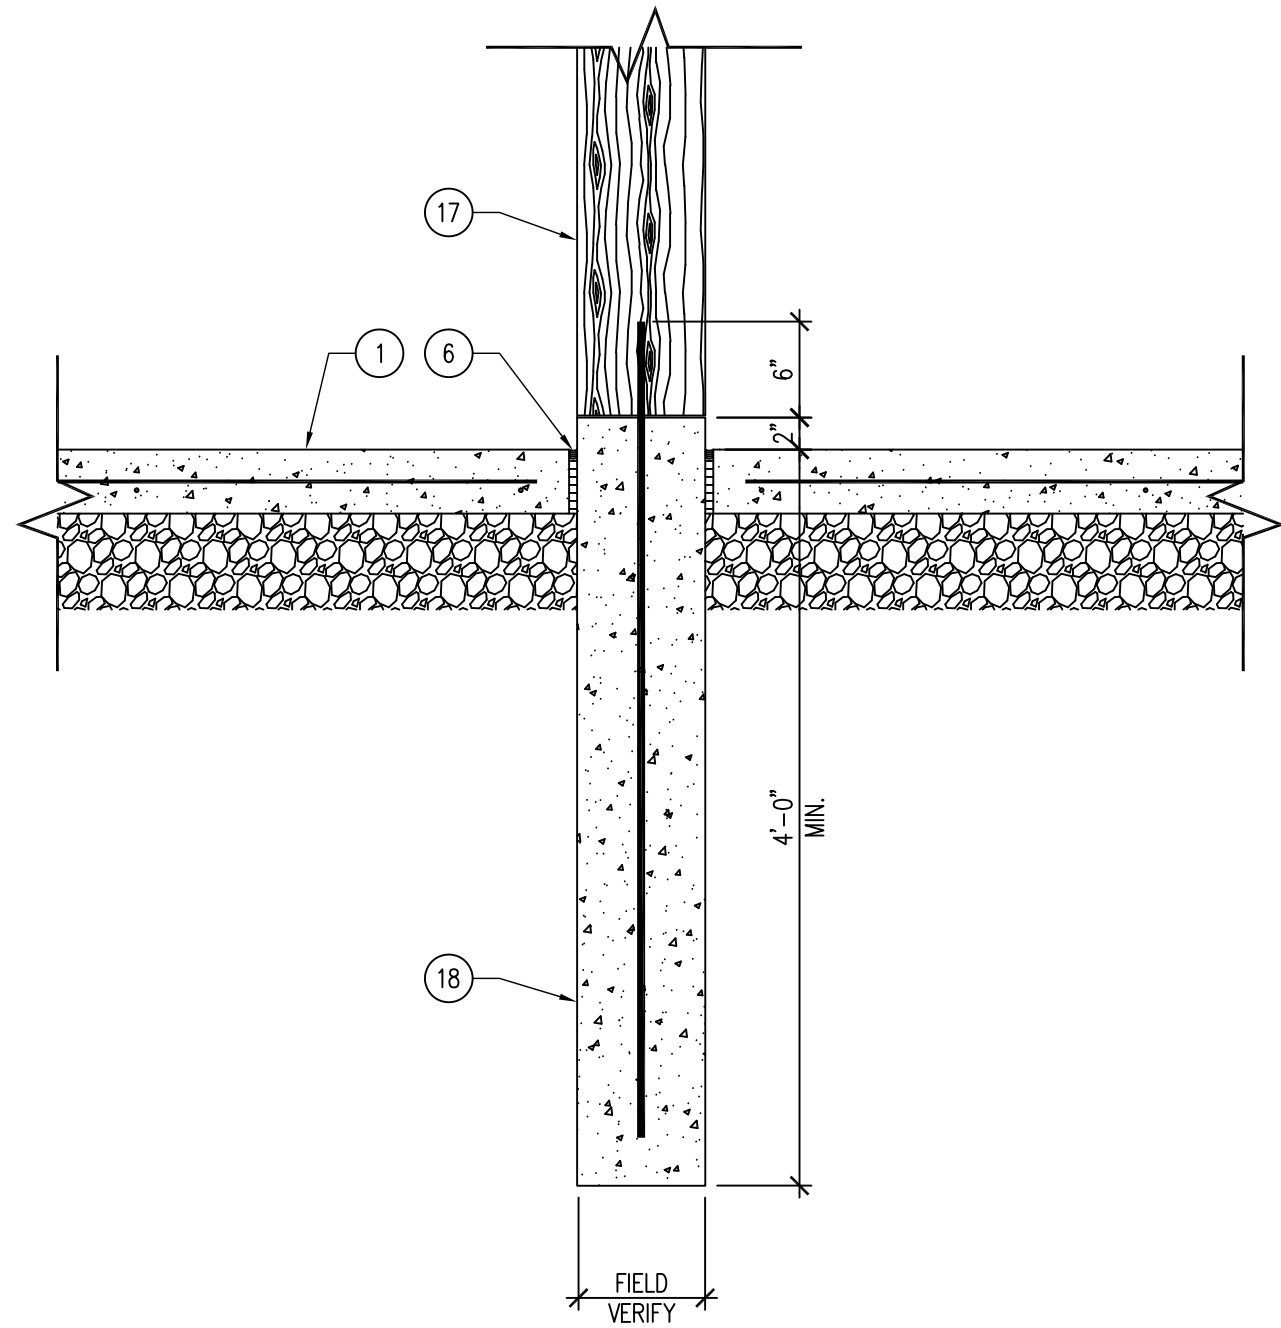
01 LODGE DETAIL – BREEZEWAY COLUMN  
SCALE: 1" = 1'-0"

CONCRETE PATIO TO BE REPLACED IN REAR OF THE BUILDING, CONCRETE TO BE 4" PCC OVER 6" OF SUBBASE, WITH #4 EPOXY COATED REBAR 24" O.C. BOTH DIRECTIONS. CONCRETE TO BE DOWELED INTO EXISTING SLAB AS SHOWN. THE CONTRACTOR SHALL ALSO REPLACE TWO (2) COLUMN FOOTINGS IN THE BREEZE-WAY AREA AS SHOWN.

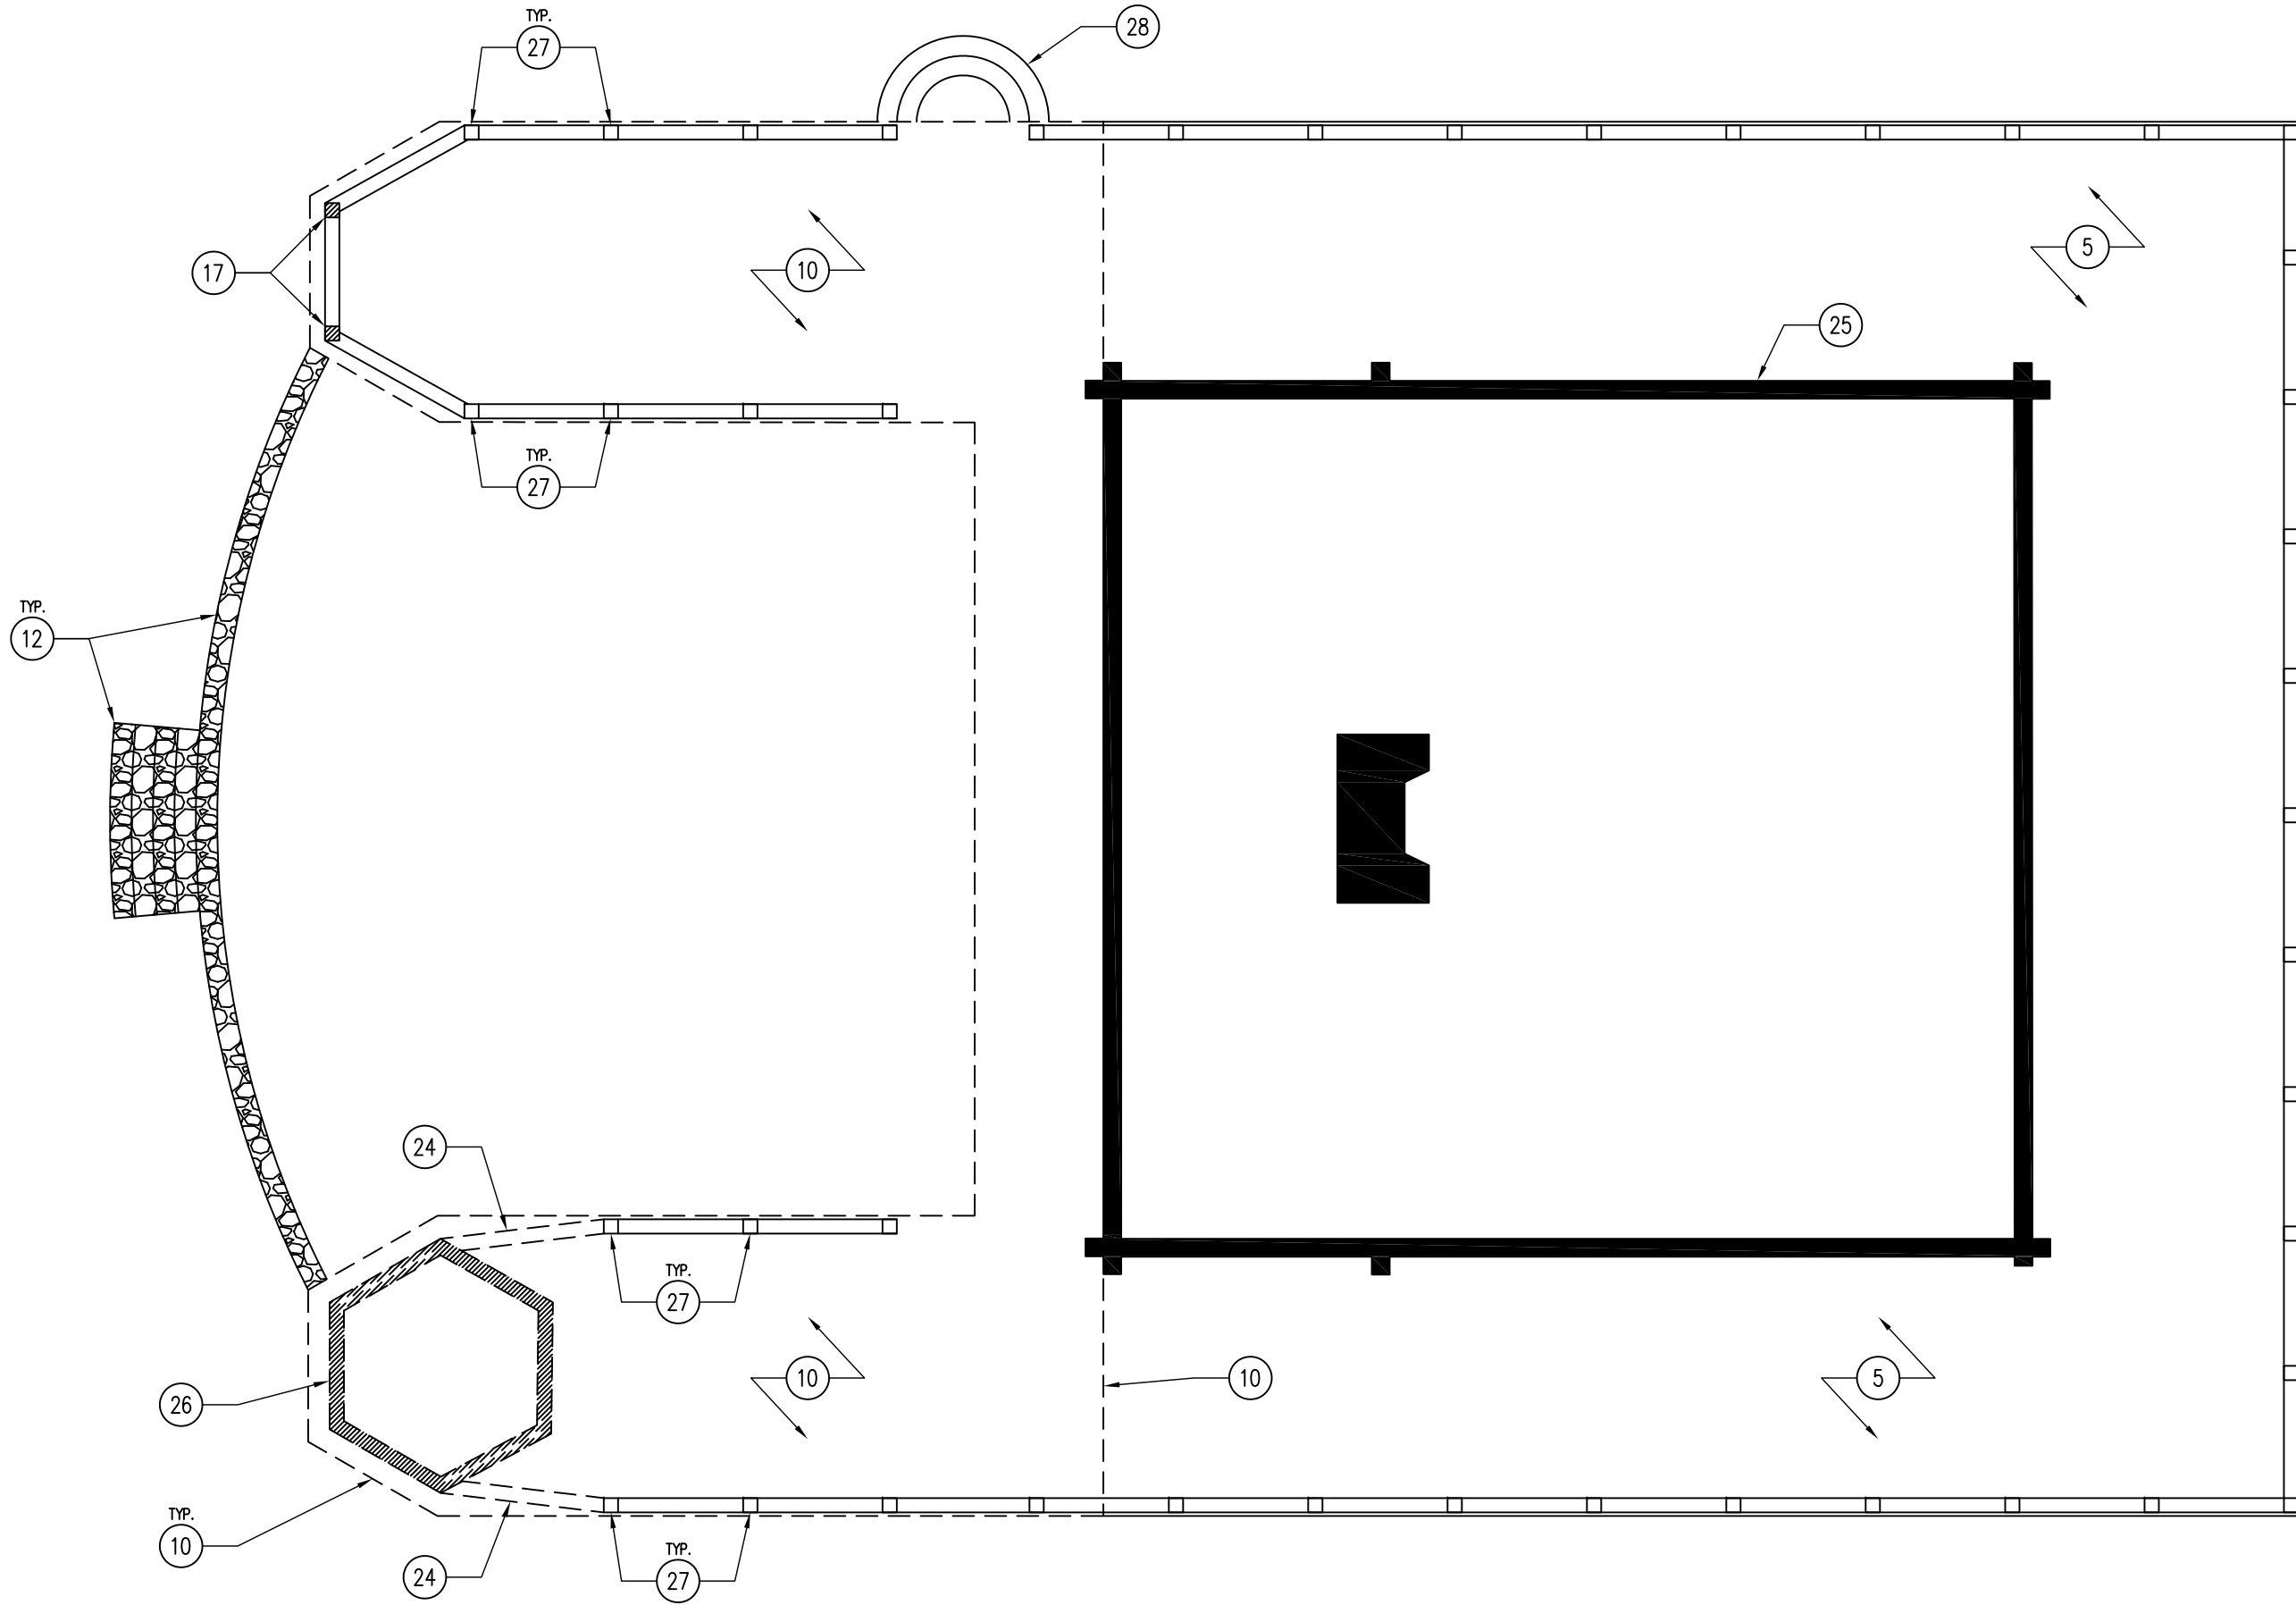
**01** DEMOLITION FLOOR PLAN – LODGE  
 SCALE: 1/8" = 1'-0"

CONTRACTOR SHALL DEMOLISH ALL ITEMS SHOWN IN THE DRAWINGS, CONCRETE IN THE REAR OF THE BUILDING, PUMP HOUSE WALLS, ROOFING, AND AREAS OF SIDING AS SHOWN. SPECIAL CARE SHALL BE TAKEN TO NOT DAMAGE ADJACENT AREAS OF DEMOLITION.

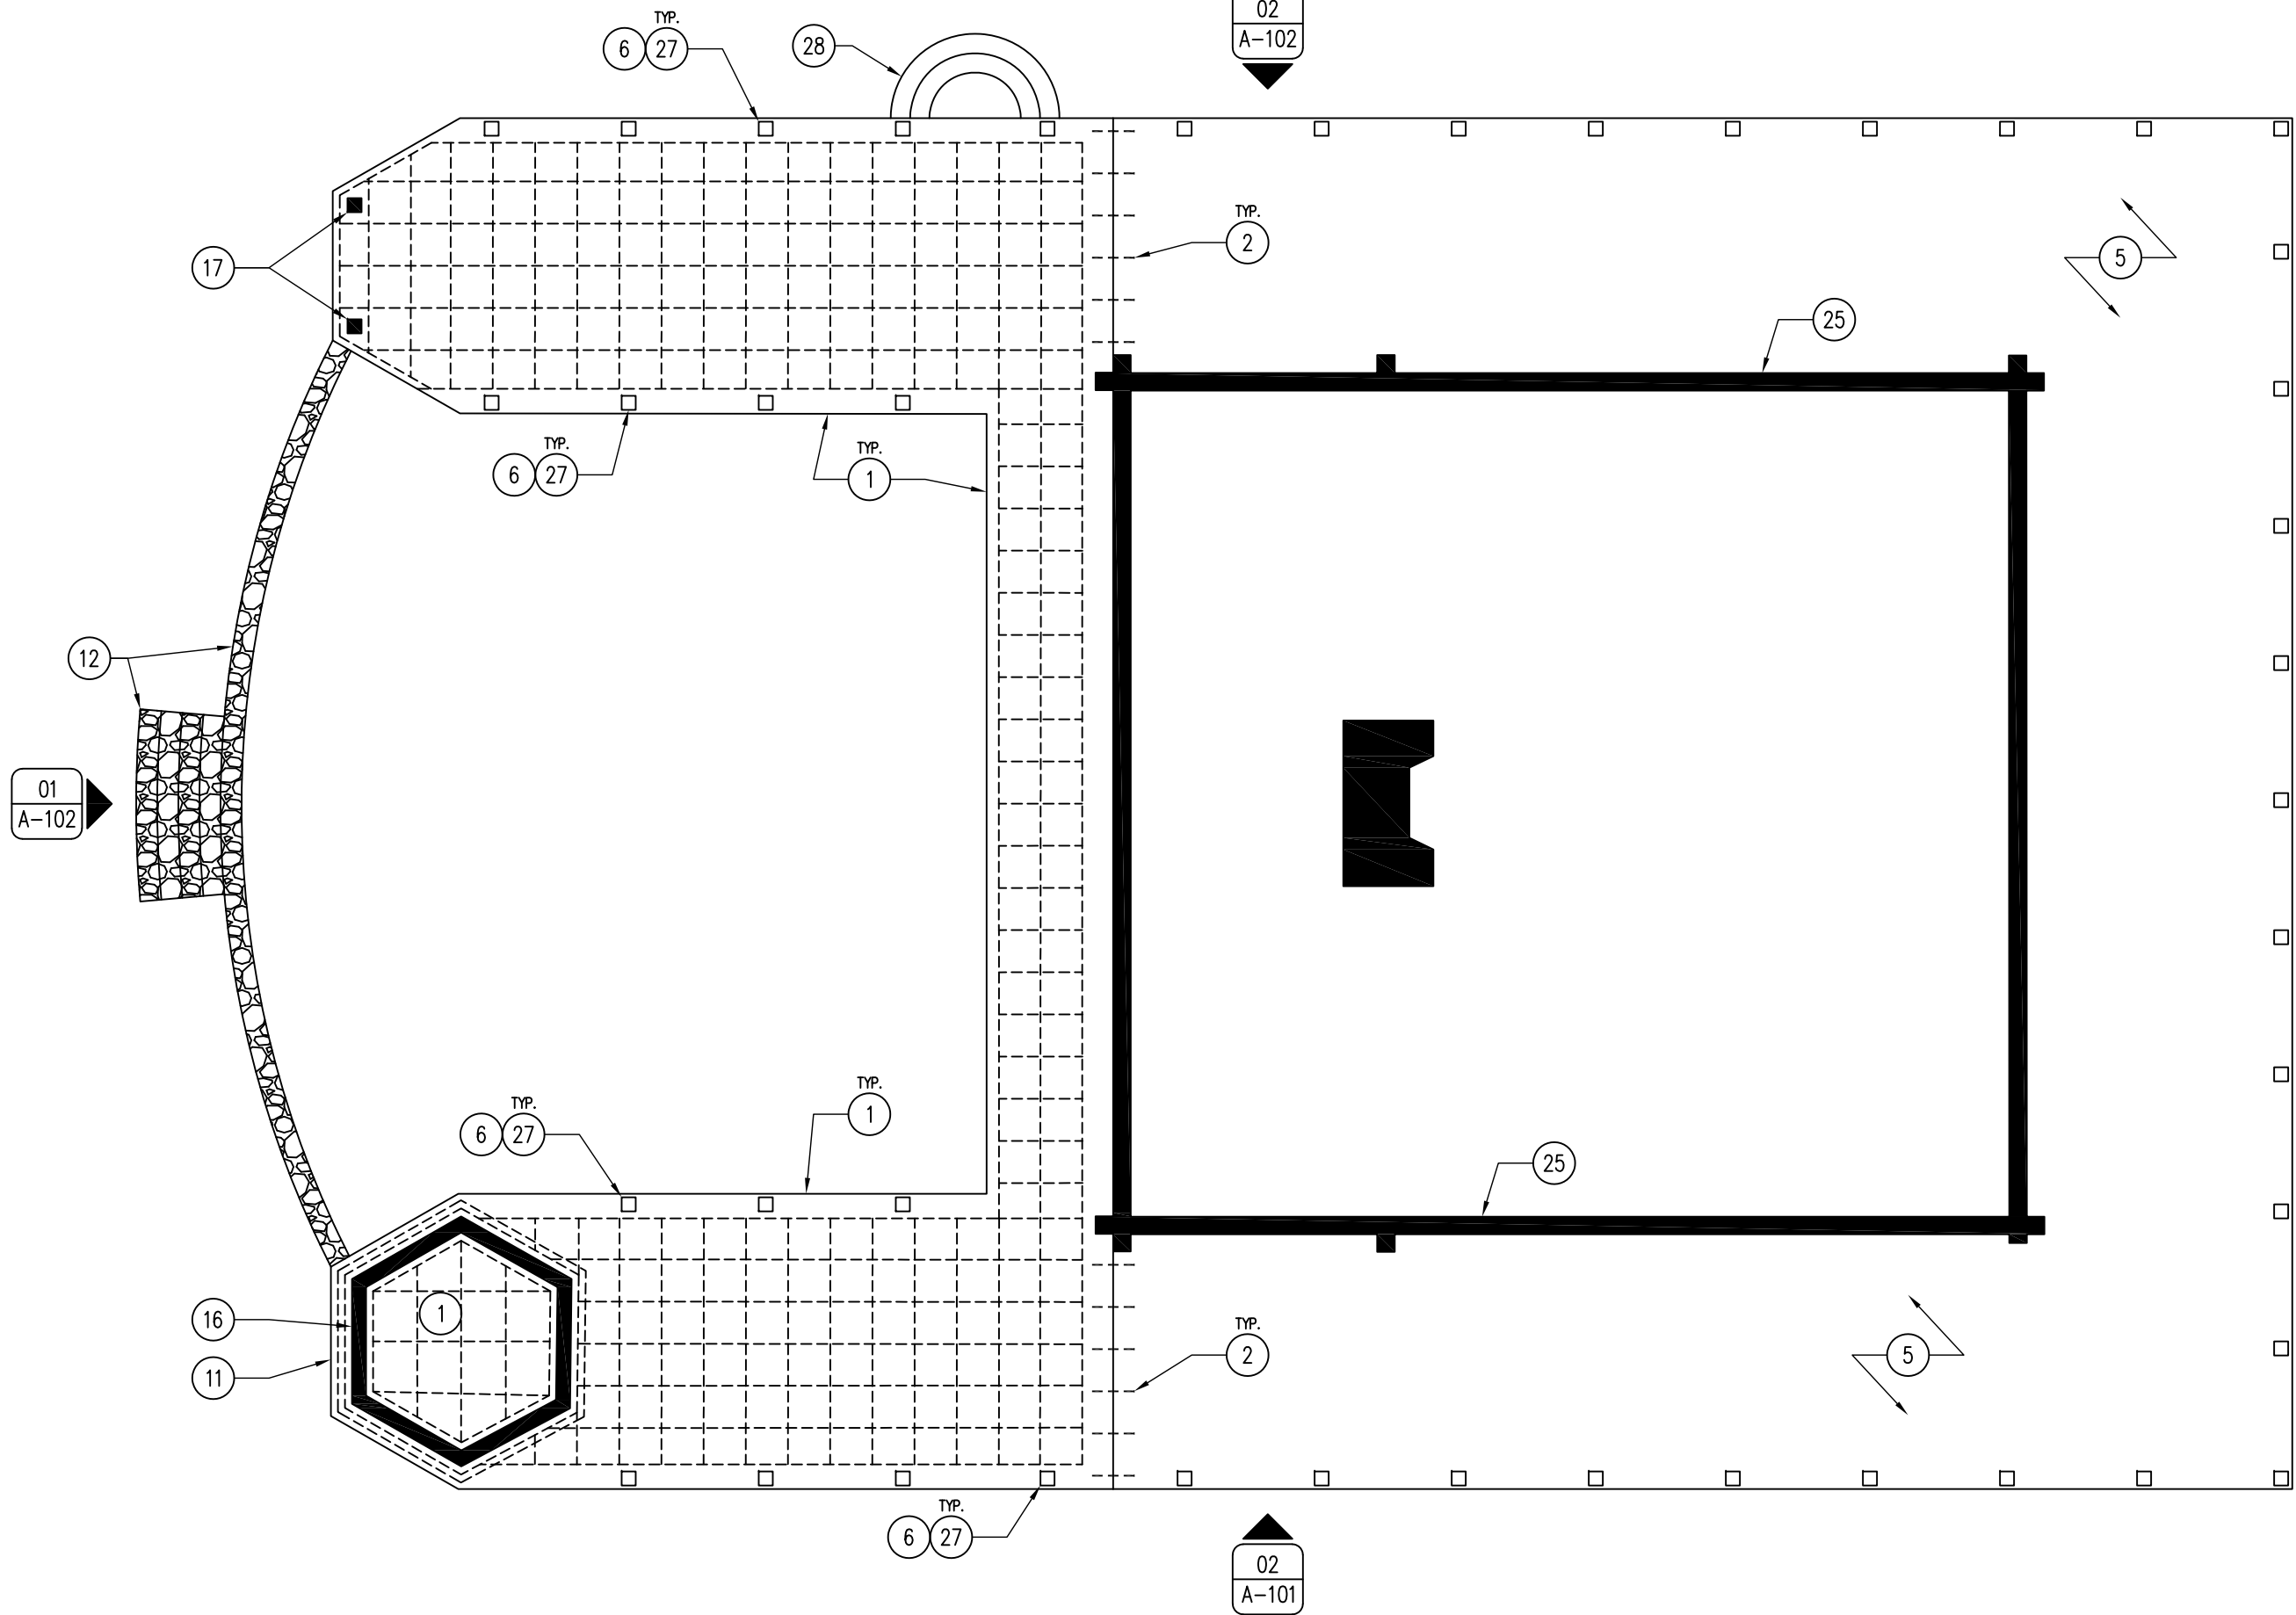
**01** REFERENCE FLOOR PLAN - LODGE  
 SCALE: 1/8" = 1'-0"

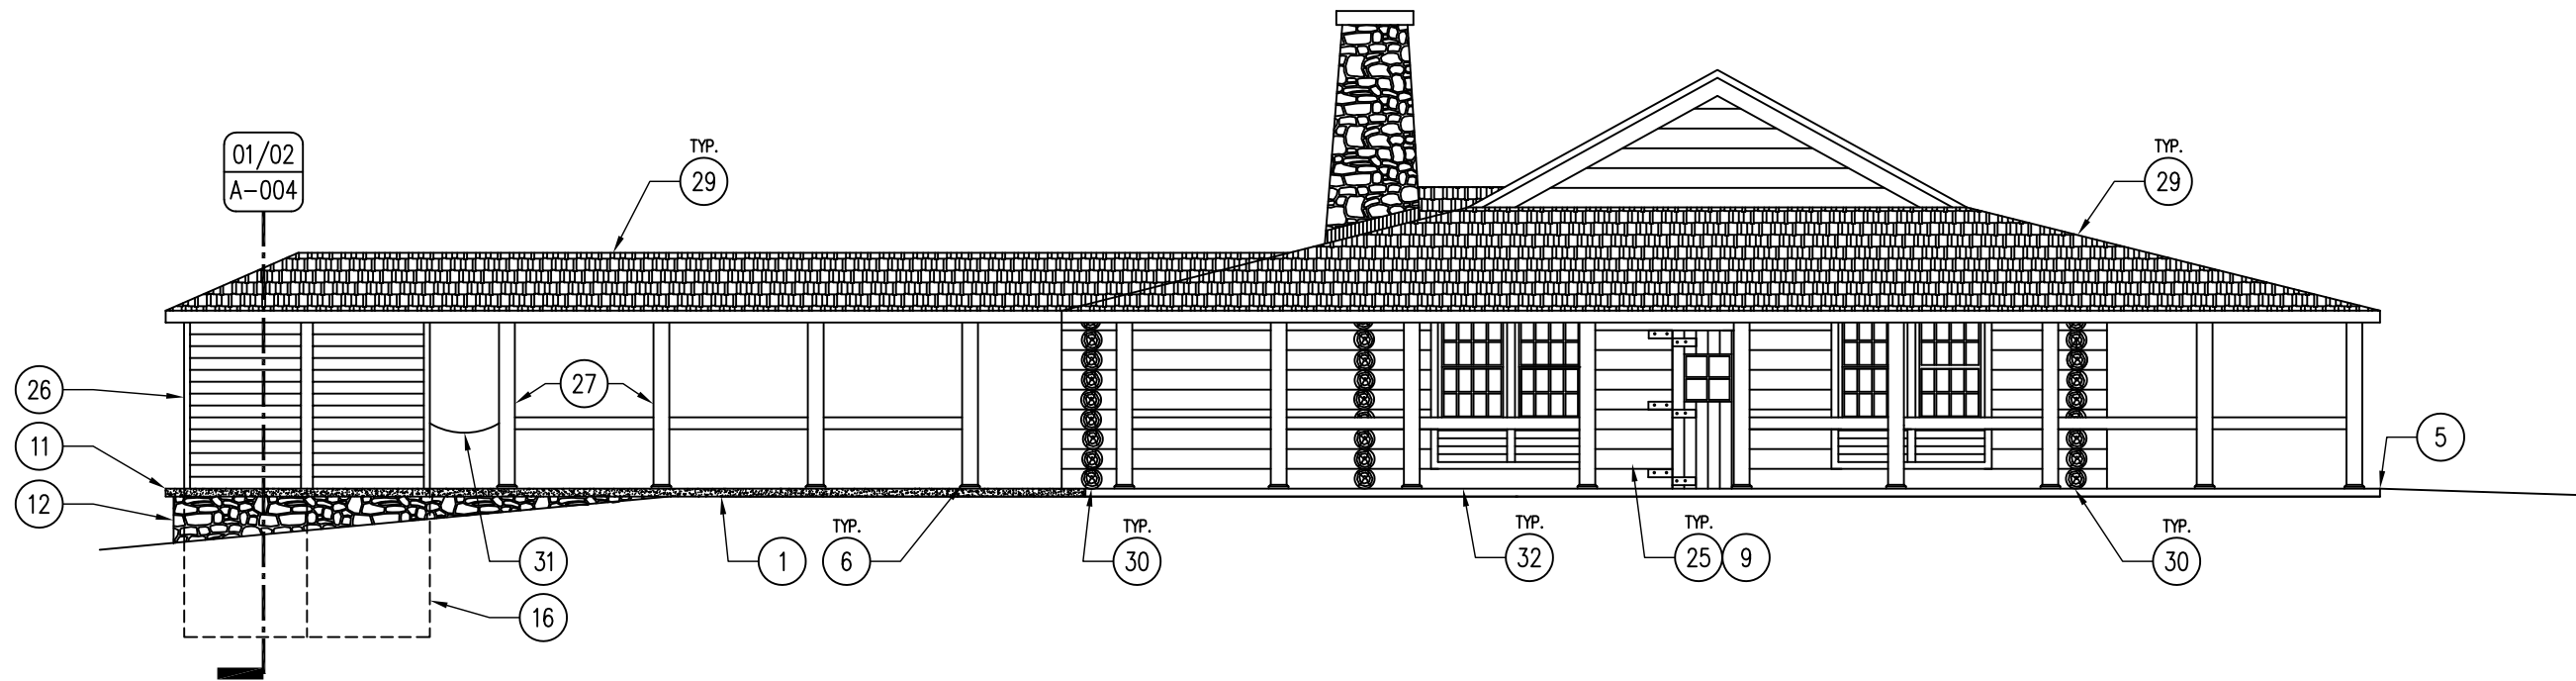
02 LODGE ELEVATION - EAST  
SCALE: NTS

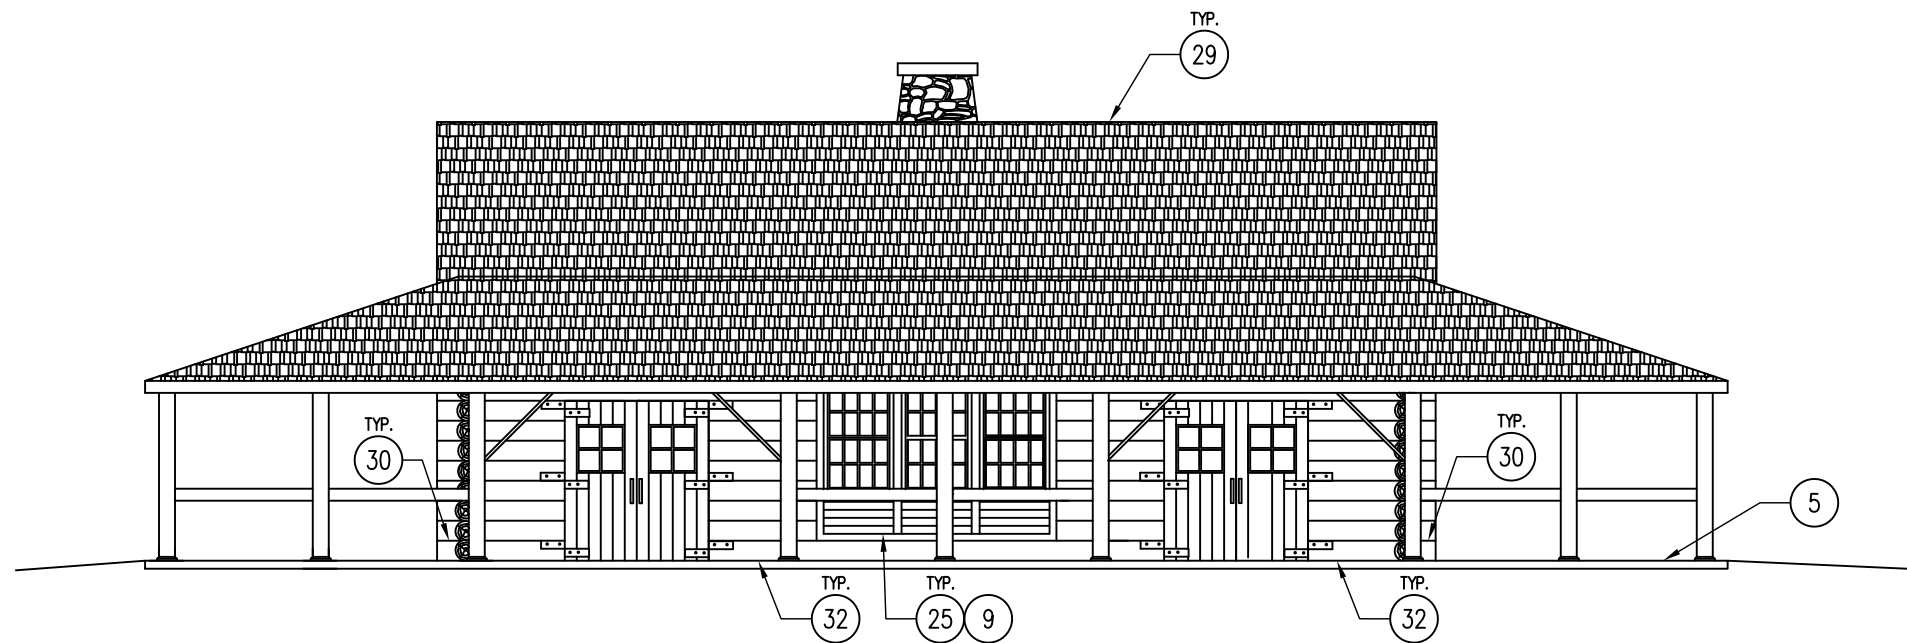
01 LODGE ELEVATION - SOUTH  
SCALE: NTS

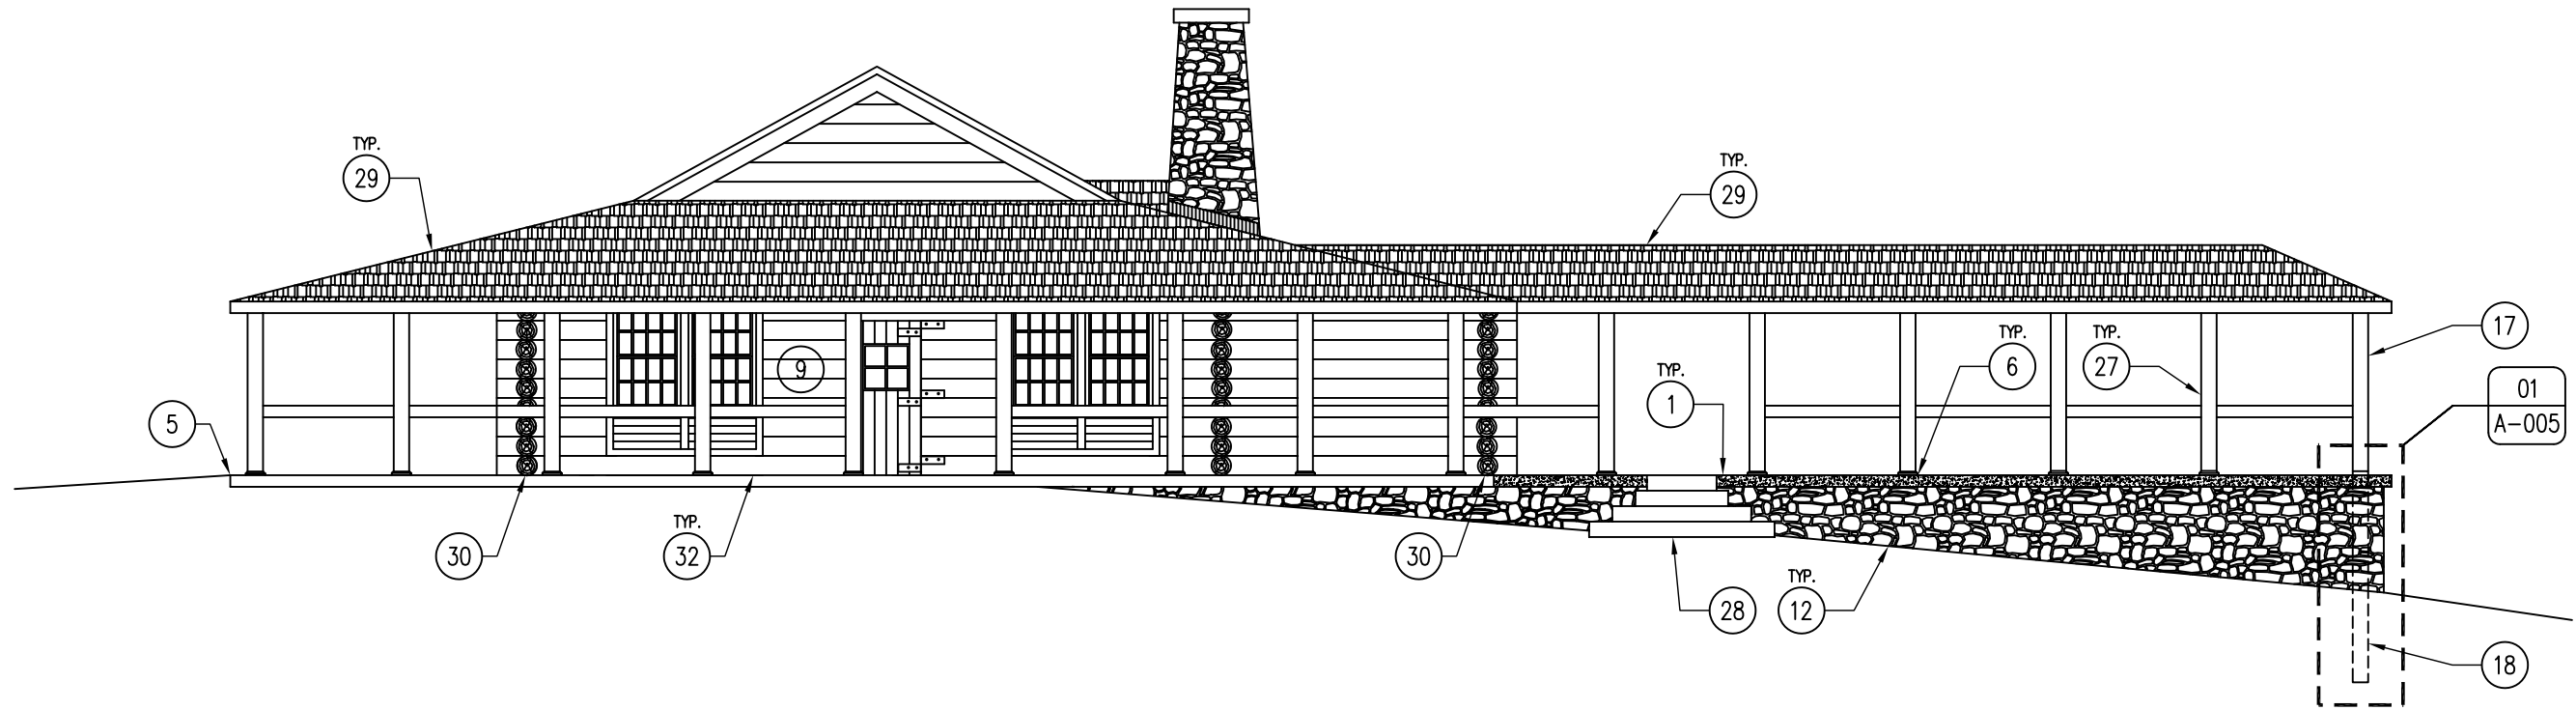
02 LODGE ELEVATION - EAST  
SCALE: NTS

28. EXISTING CONCRETE STAIR TO REMAIN.
29. REMOVE ALL EXISTING SHINGLES AND UNDERLAYMENT, INSTALL GRACE, SELF-ADHERED, ICE AND WATER SHIELD OVER ENTIRE ROOF, THEN INSTALL CERTAINTEED LANDMARK TL, COUNTRY GRAY, SHINGLES OVER ENTIRE ROOF WITH DARK BRONZE DRIP EDGE. INSPECT SHEATHING FOR DAMAGE PRIOR TO INSTALL OF NEW ROOFING.

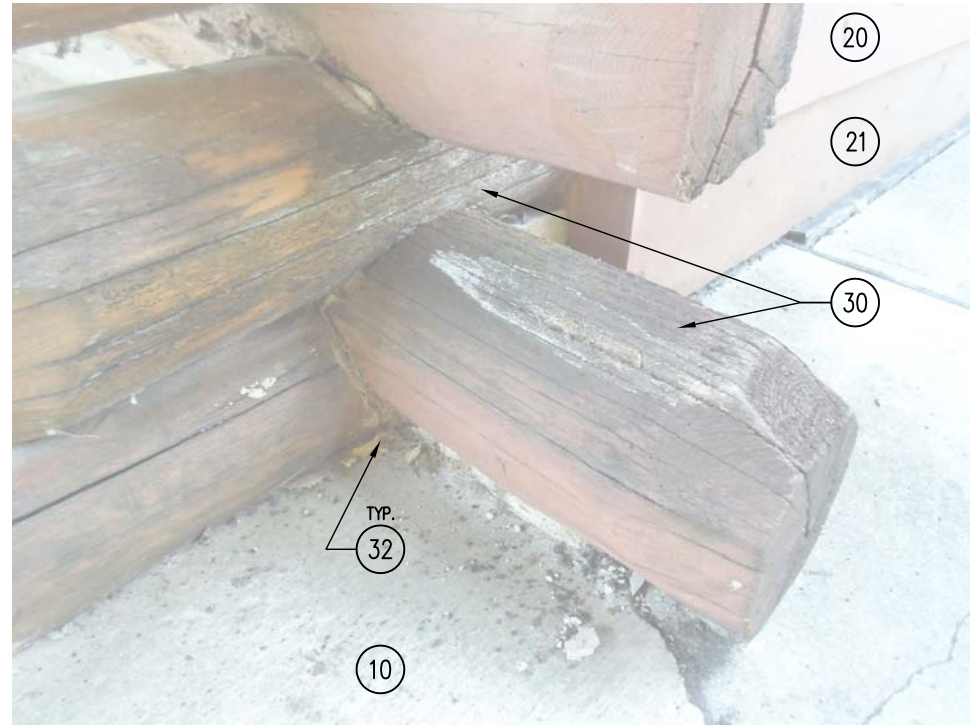
04 LODGE PICTURE – LOG TAILS  
SCALE: NTS

30. EXISTING LOG TAIL, REMOVE PUNKY AND ROTTEN WOOD DOWN TO SOLID WOOD, REBUILD WITH EPOXY AND PAINT TO MATCH EXISTING LODGE WOOD. ACCOUNT FOR TEN (10) LOG TAIL REPAIRS.

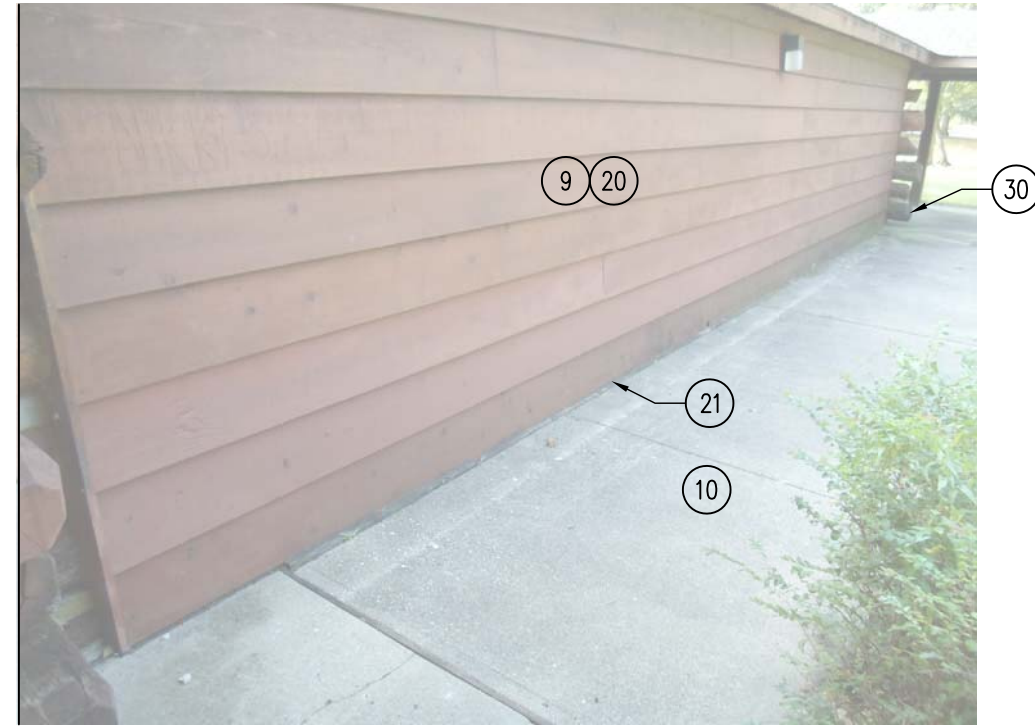
03 LODGE PICTURE – EXTERIOR KITCHEN WALL  
SCALE: NTS

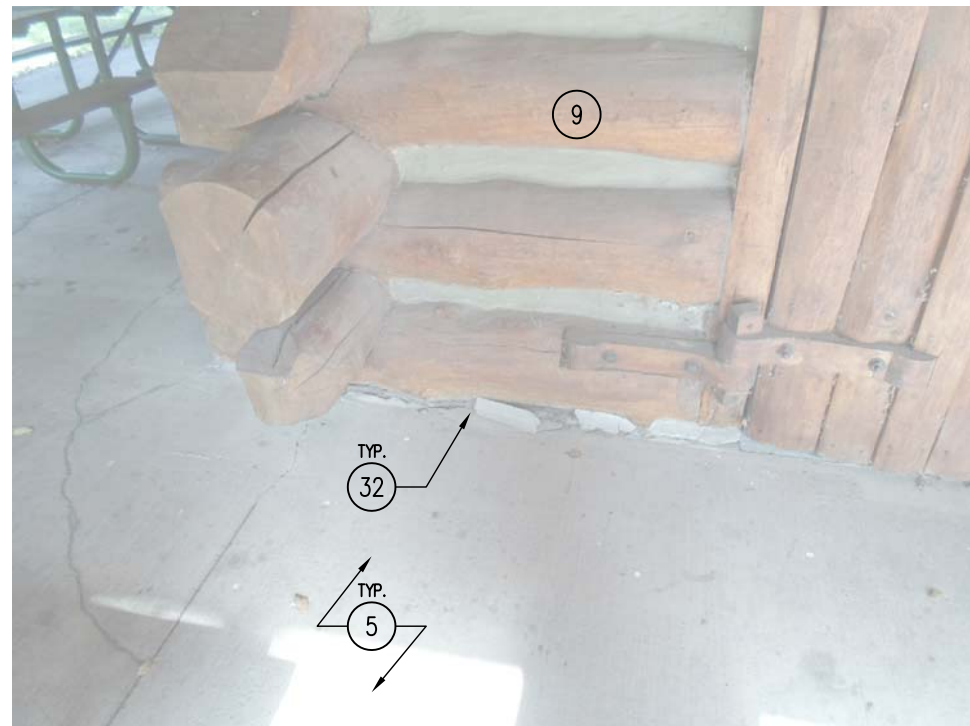
02 LODGE PICTURE – EXTERIOR WALL  
SCALE: NTS

CONTRACTOR SHALL REMOVE ALL CHINKING ON THE SILL LOG AT THE LODGE AND THOROUGHLY CLEAN THE ENTIRE EXTERIOR OF THE LODGE. THE CONTRACTOR SHALL THEN REPLACE ALL CHINKING ON THE SILL LOG WITH NEW PERMA-CHINK CHINKING, COLOR TO BE MEDIUM GRAY 224.

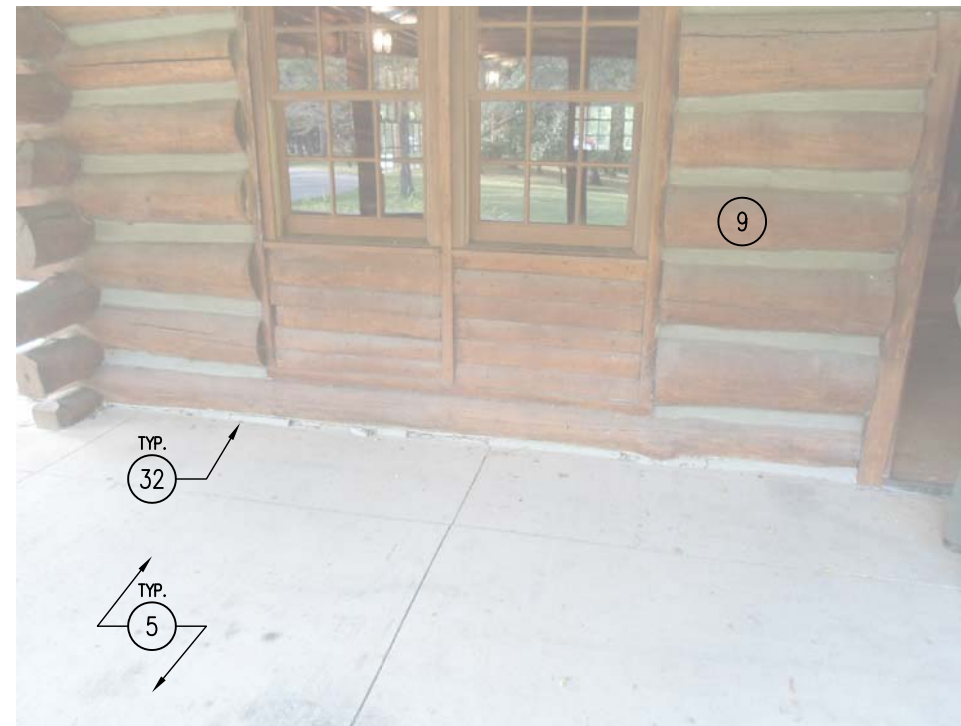
01 LODGE PICTURE – EXTERIOR WALL  
SCALE: NTS
